# National Transportation Safety Board

CEN25LA225

## EXAMINATION SUMMARY

Location: Temple, Texas  
Date: June 26, 2025  
Time: 1130 central daylight time  
Airplane: Tecnam P2010, N258CM

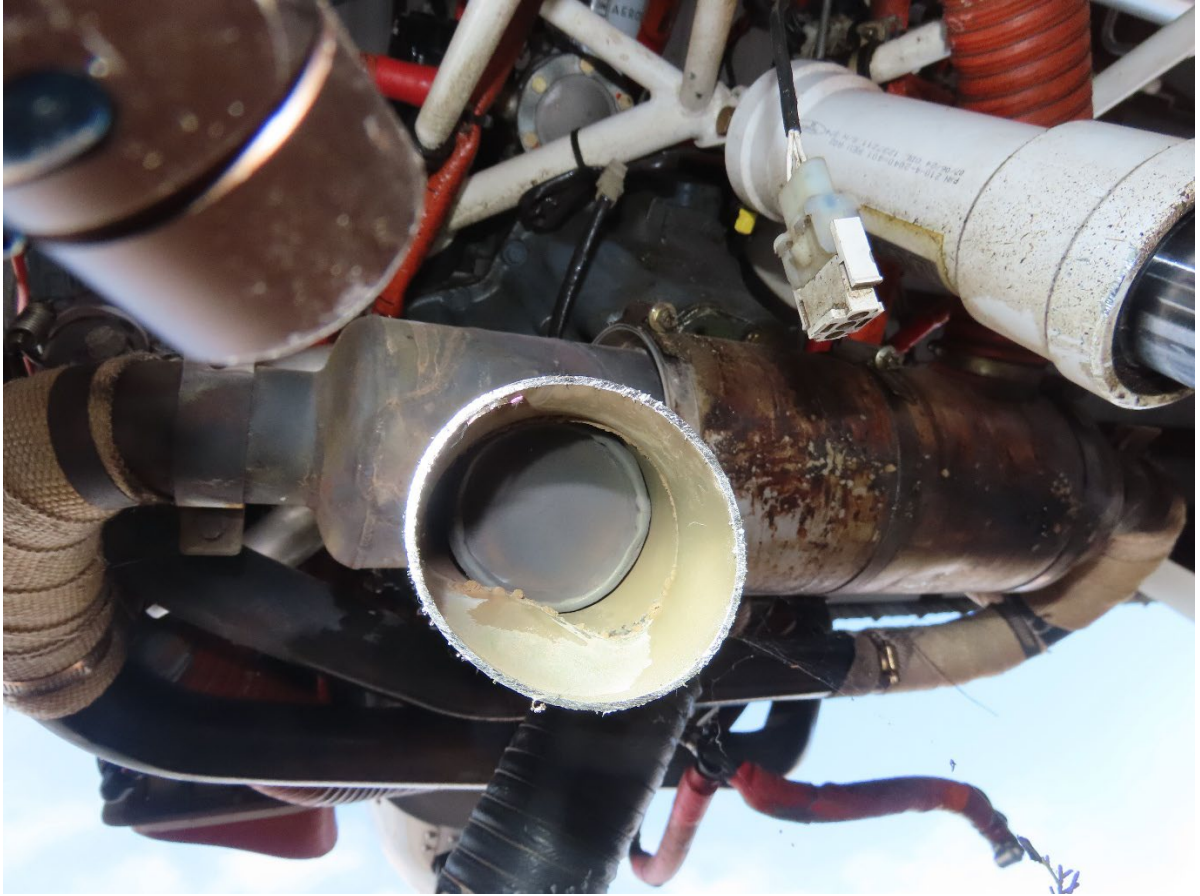
The engine remained attached to the fuselage. Two of the 3 wooden propeller blades were broken near the hub. The upper and lower cowls were removed. Upon removal of the cowl, no major impact damage was noted to the engine or its components. All controls moved freely and through their full range of motion with no noted issues. The intake was checked, and the air filter and servo throat were found free and clear of any debris. The exhaust pipe was crushed closed from impact forces and had to be opened manually for viewing. The outboard 4 in. of tailpipe were cut off to observe the exhaust system. A blockage was observed at the top of the exhaust pipe where the pipe and muffler shroud intersect. A round metallic disk was found blocking the exhaust pipe and created a 95% blockage to the pipe (Figure 1). To accommodate an engine run, fuel was plumbed into the engine from the right-wing root fuel line and the propeller blades were cut to a uniform length near the hub. With the exhaust blockage present, the engine started without hesitation. The engine ran rough, and rpm would fluctuate. The engine was run for about 3 minutes at various rpm and both left and right tanks.

**Figure 1.** Blocked exhaust as found

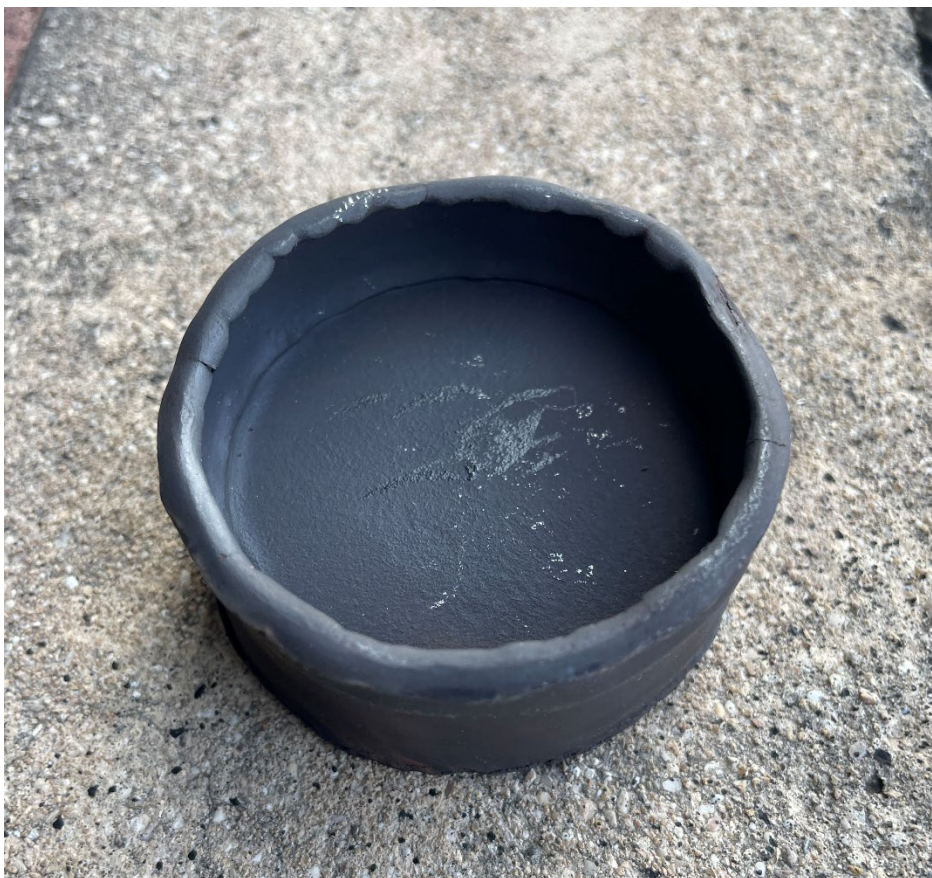
The exhaust pipe was cut and the blockage was removed (Figure 2). A second engine run was performed. The engine started and ran at various rpm and ran smoother than the first test run. The fuel selector was switched from left to right with no anomalies noted. Further examination of the muffler revealed that much of the flame tube was not present. The edges of the remaining flame tube had mushroom deformation. The removed disc had similar mushroom deformation.

**Figure 2.** Obstruction removed from exhaust pipe.
