CEN25LA230

## INVESTIGATION PHOTOGRAPHS

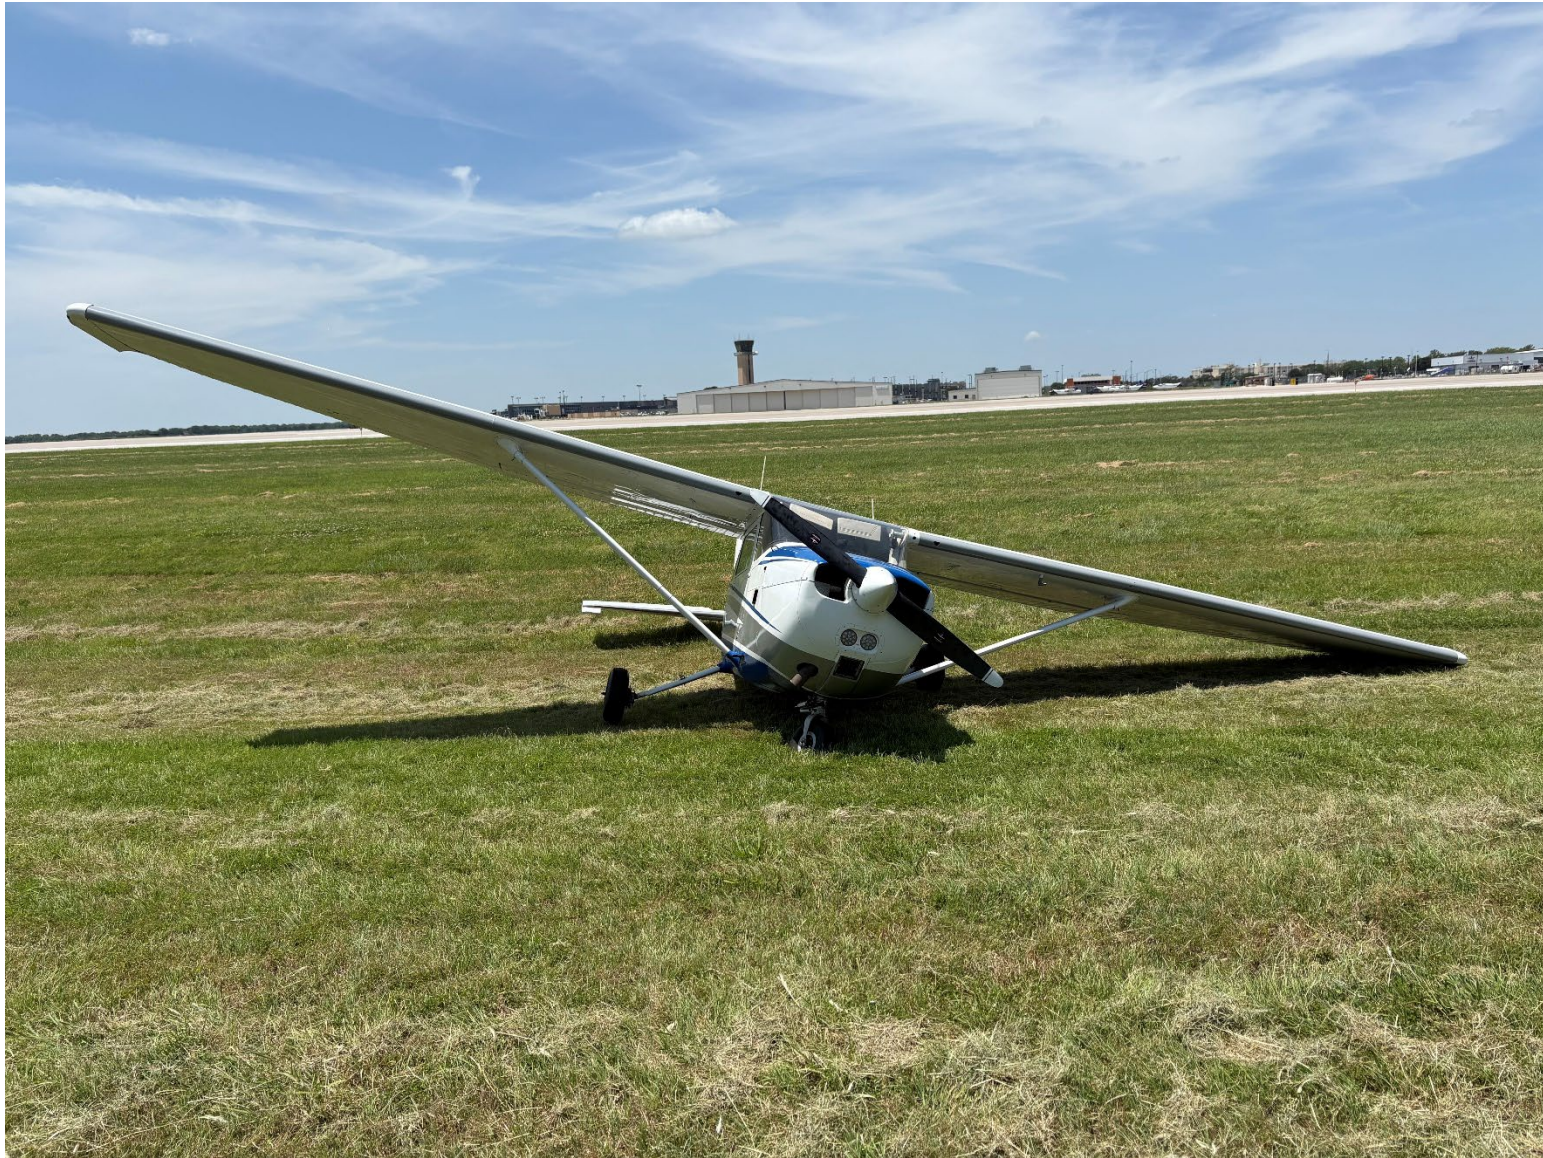
**Photograph 1 - View of the front of the airplane at the accident site (courtesy of the Federal Aviation Administration)**

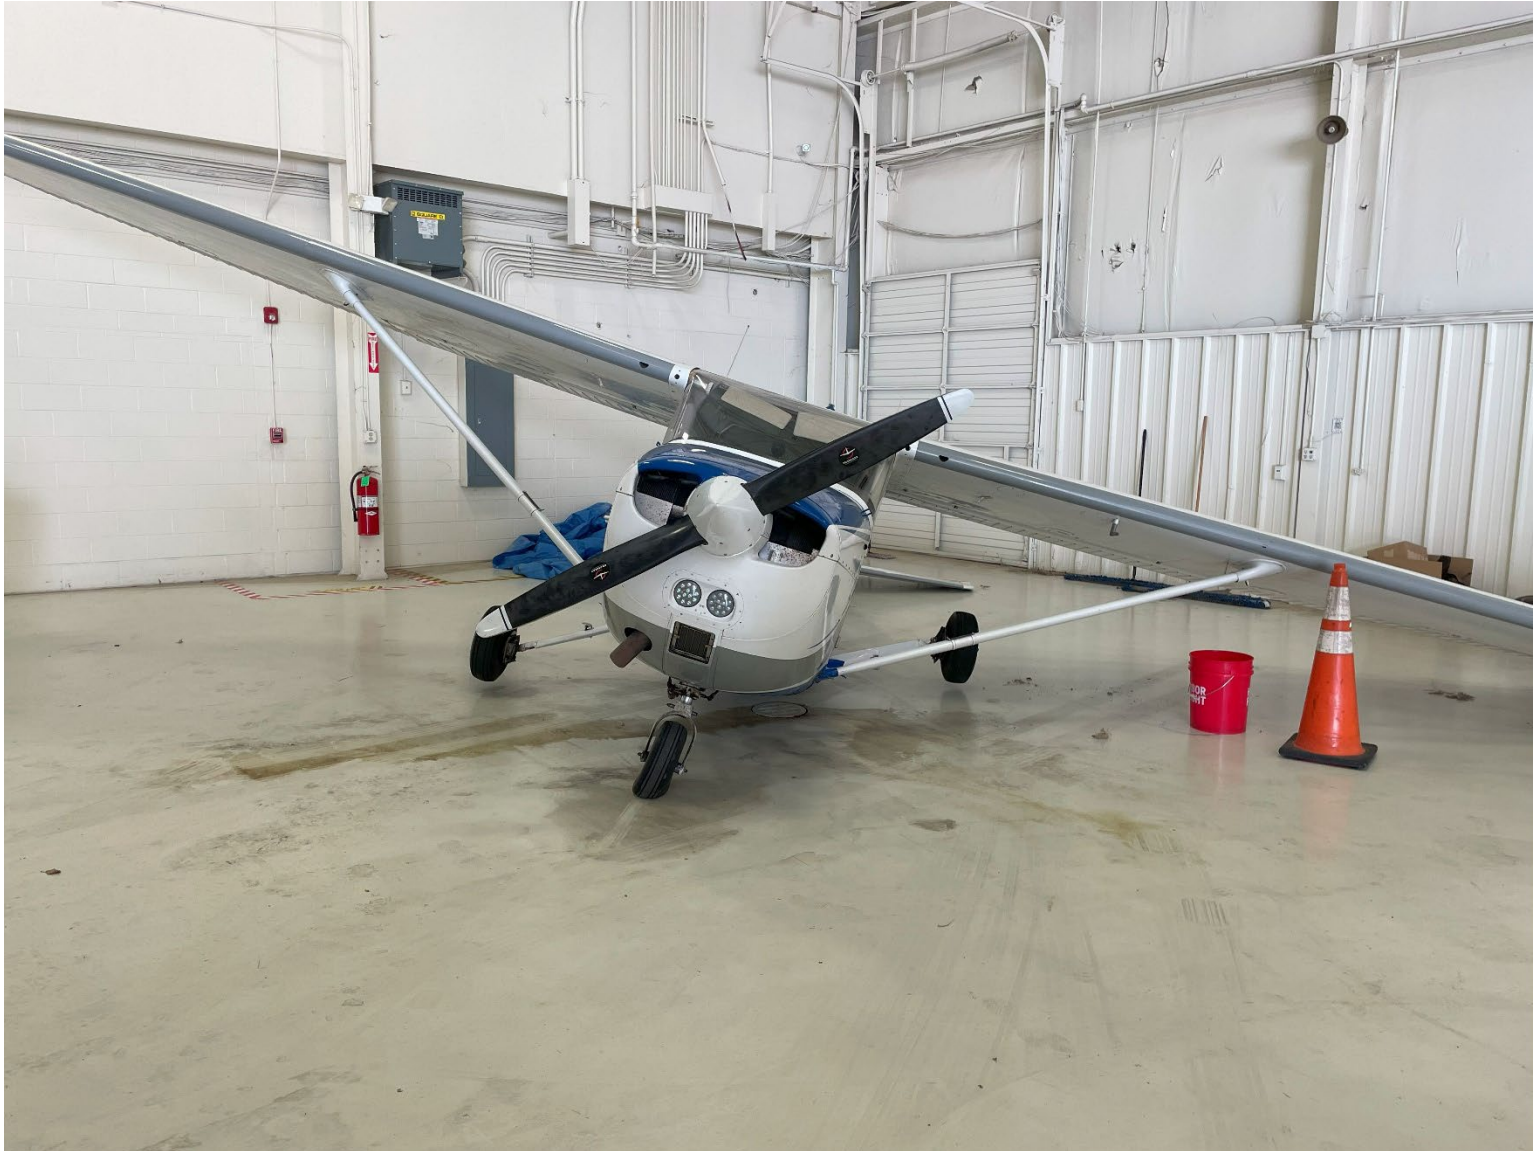
**Photograph 2 - View of the front of the airplane inside of a hangar (courtesy of the Federal Aviation Administration)**

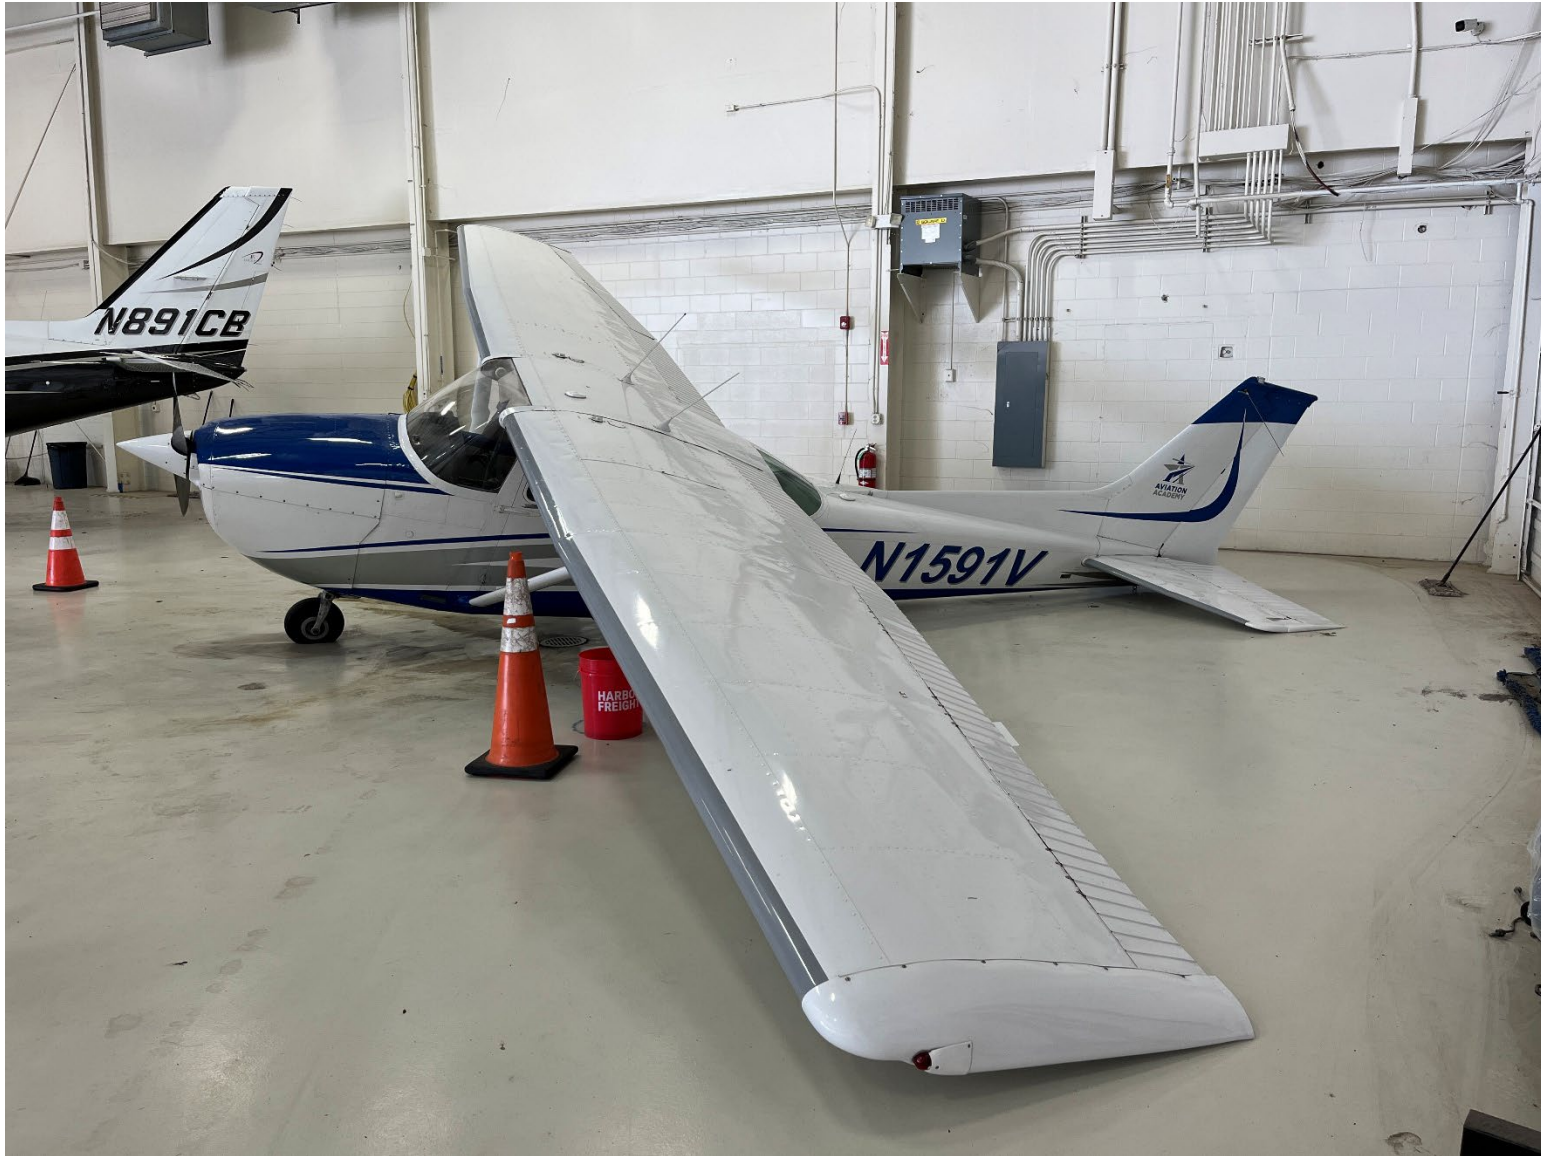
**Photograph 3 - View of the left side of the airplane inside of a hangar (courtesy of the Federal Aviation Administration)**

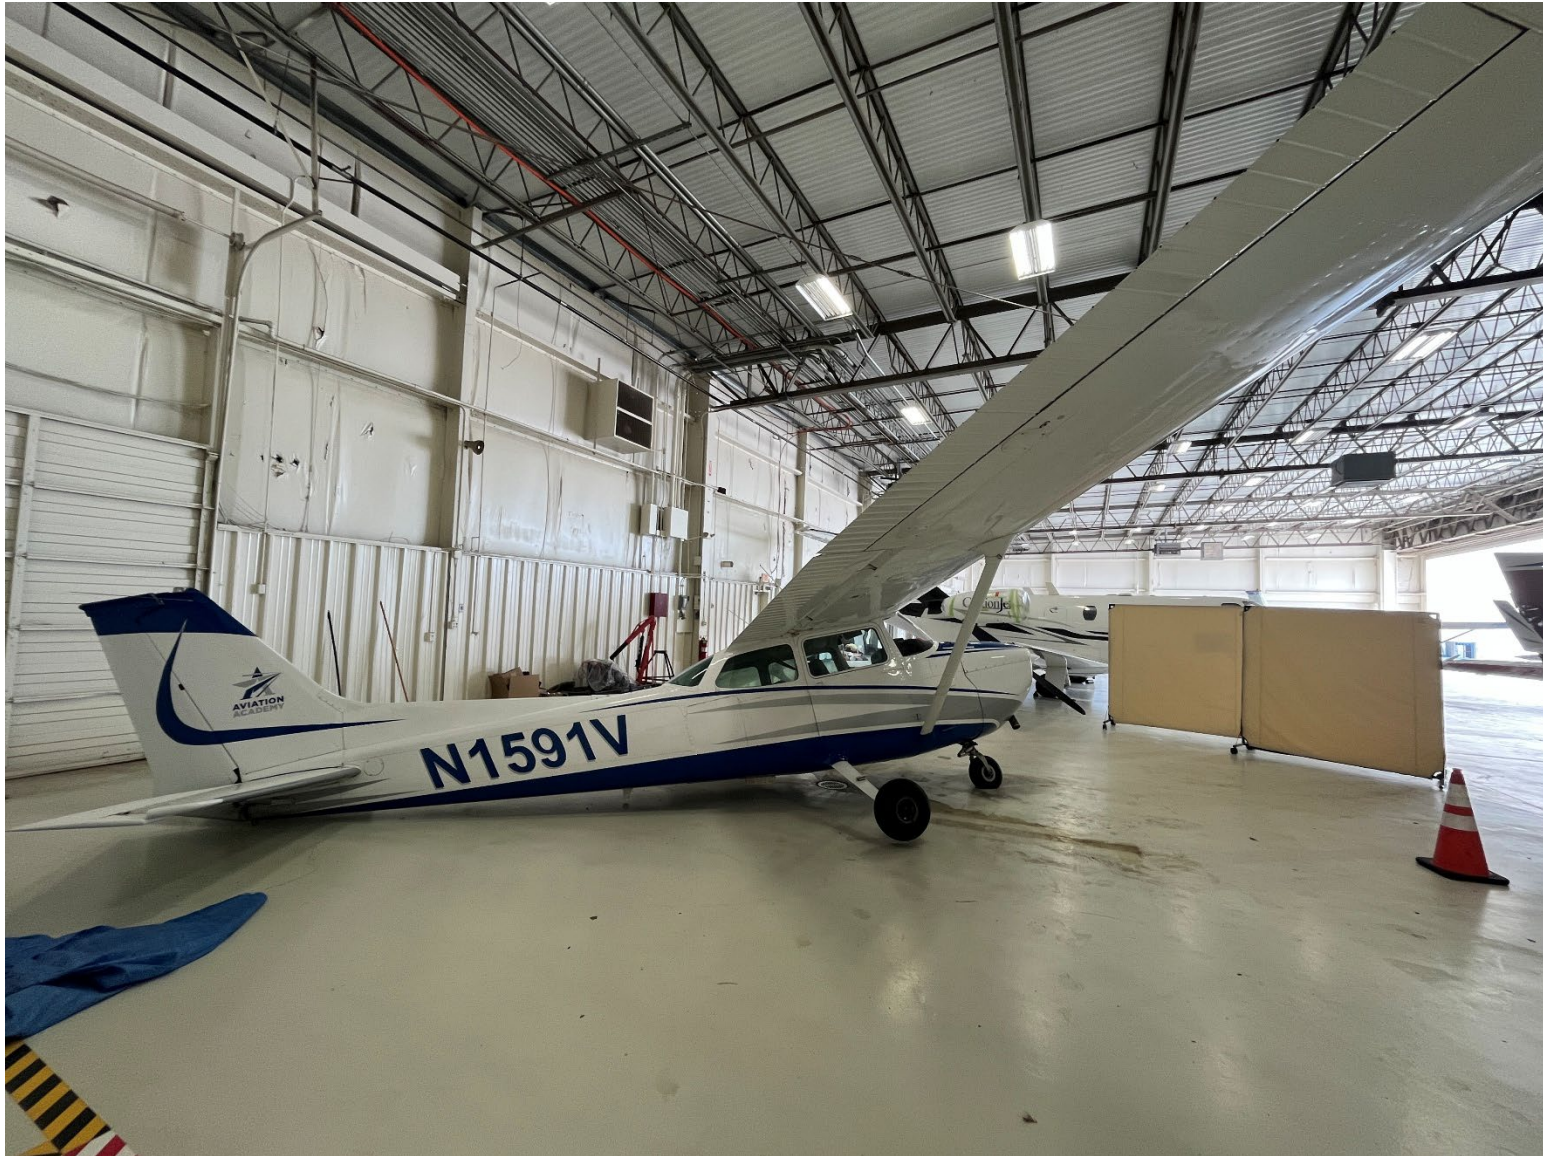
**Photograph 4 - View of the right side of the airplane inside of a hangar (courtesy of the Federal Aviation Administration)**

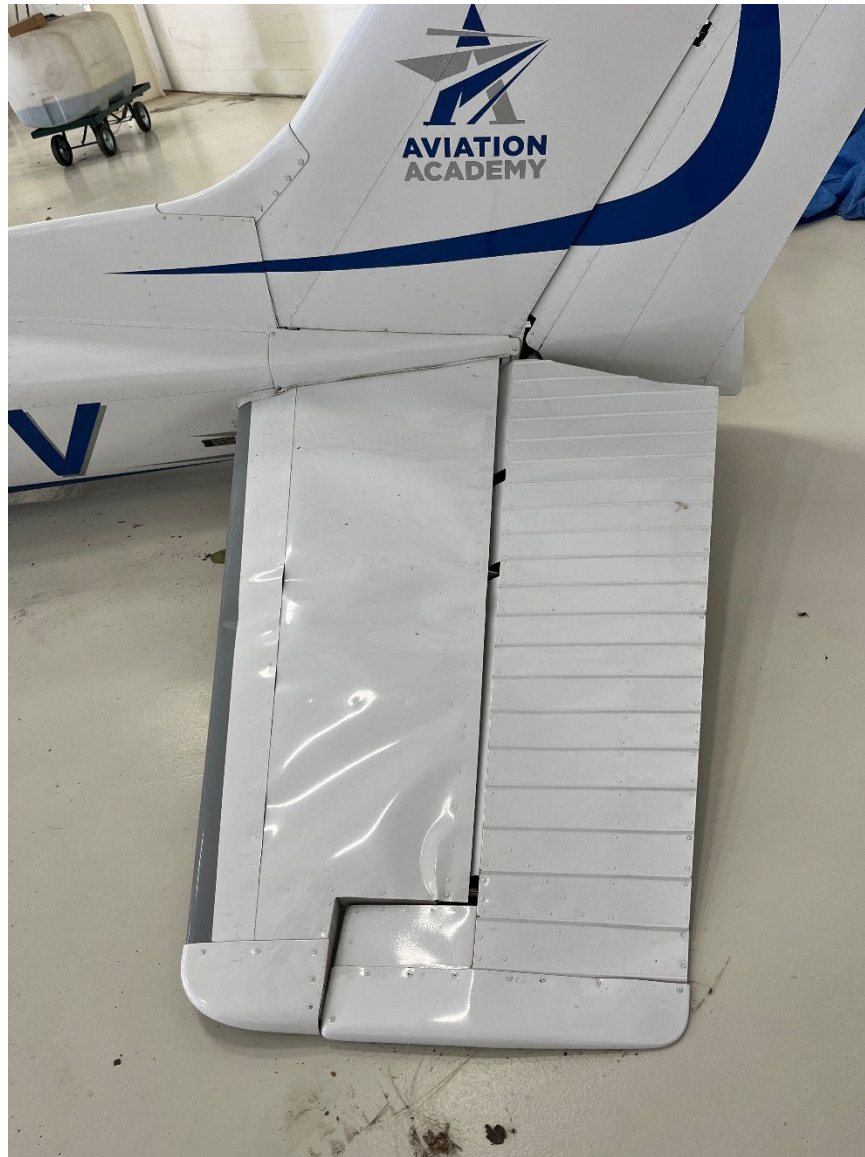
**Photograph 5 - View of the substantial damage sustained to the left horizontal stabilizer  
(courtesy of the Federal Aviation Administration)**
