## Federal Aviation Administration Inspector's Report

**Re:** N1591V left gear collapse

**Event ID:** 967860 **NTSB ID:** Not available at this time

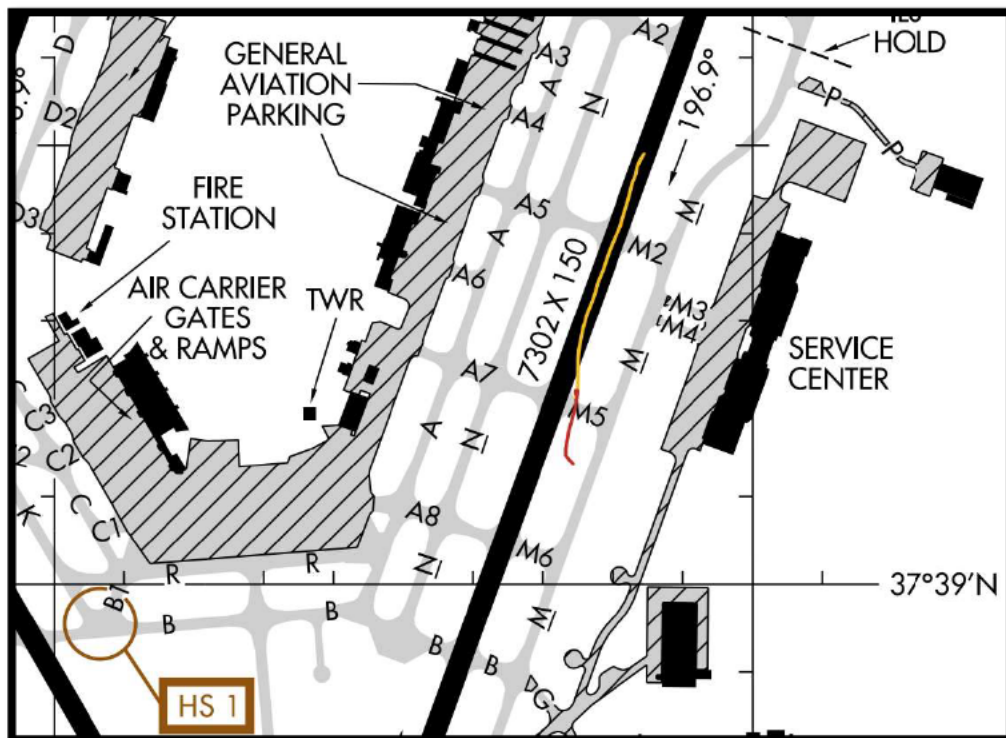
**WICHITA DWIGHT D EISENHOWER NATIONAL AIRPORT (ICT)**  
Travel of aircraft before impact of taxiway sign and after to resting point

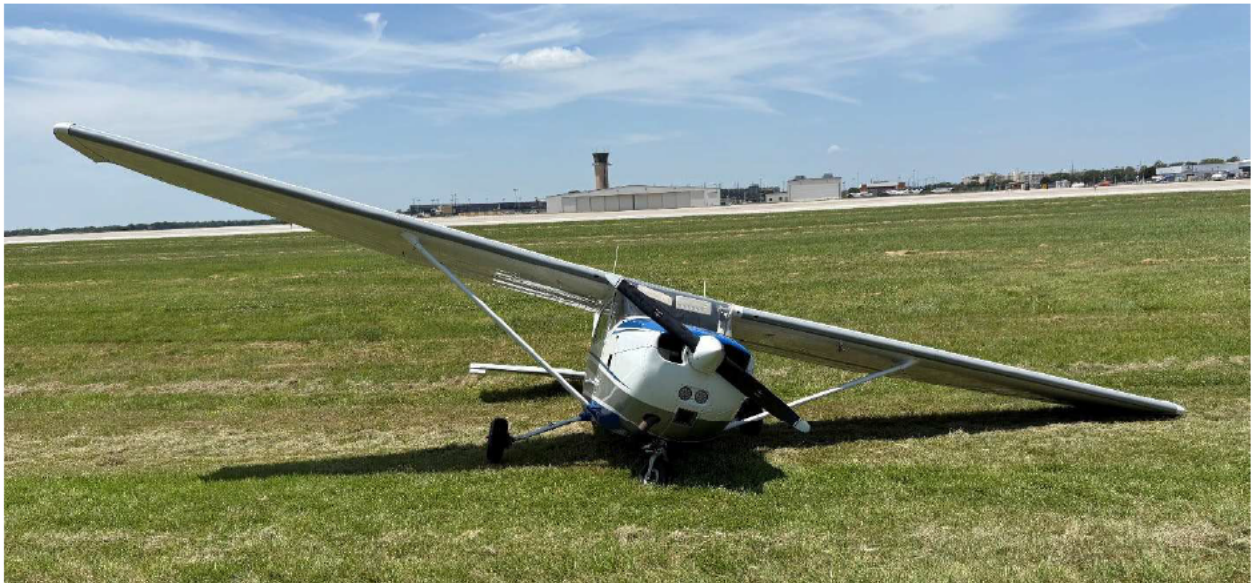
N1591V aircraft facing east, south of taxiway M5 with ICT control tower for reference.

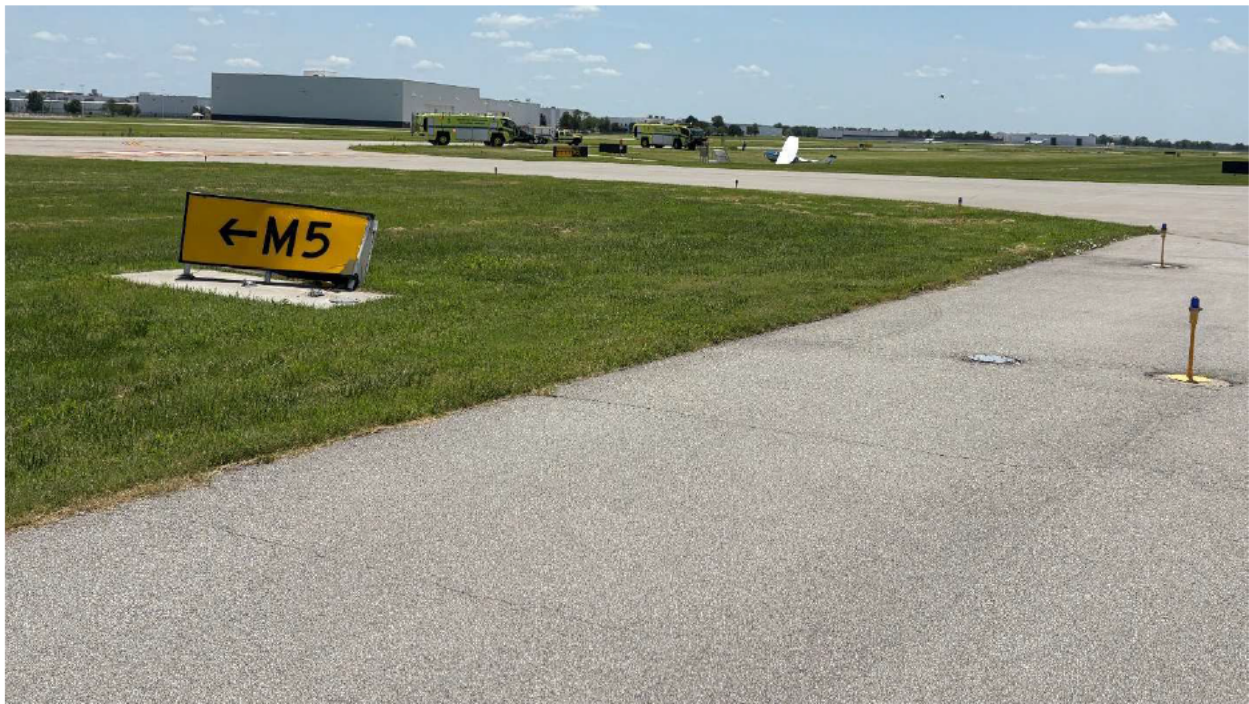
Photo view to south southeast. Damage to sign M5 pavement to the right is the edge pavement of runway 19L. Rescue trucks are parked facing west on taxiway M.

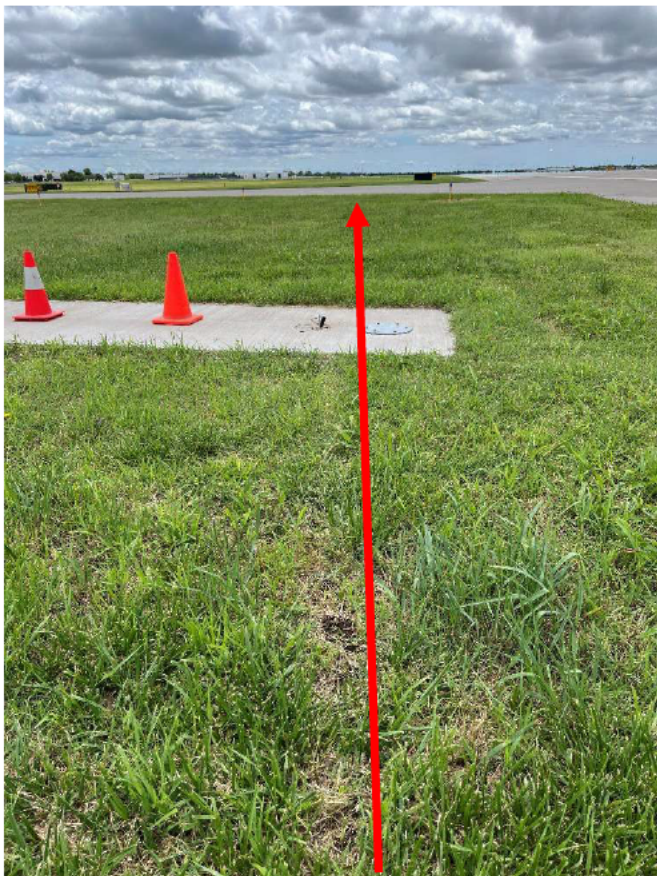
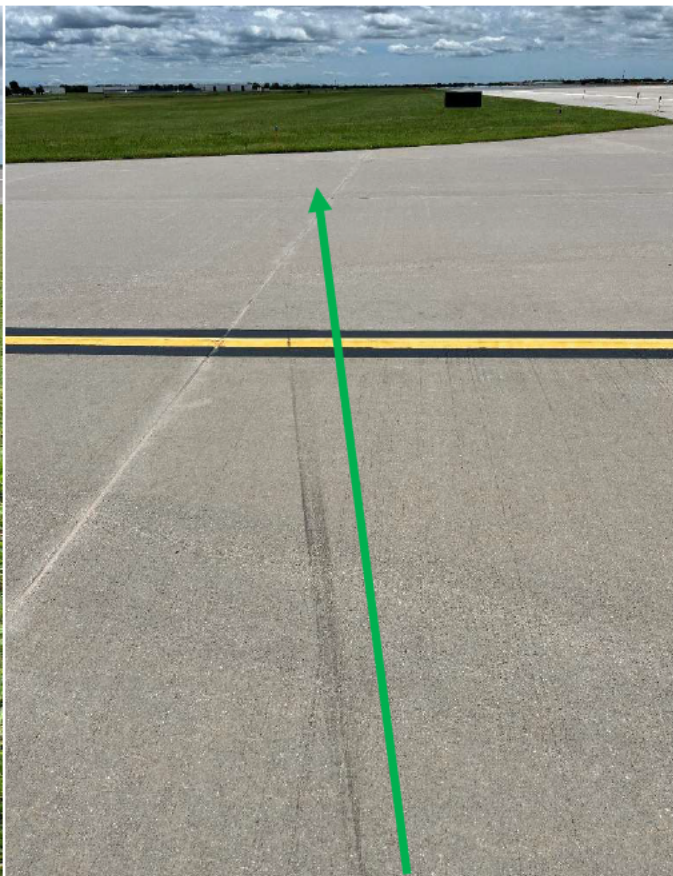
Red arrow parallels the left tire mark in the grass.

The green arrow parallels the right main tire mark.

Both photos facing south.

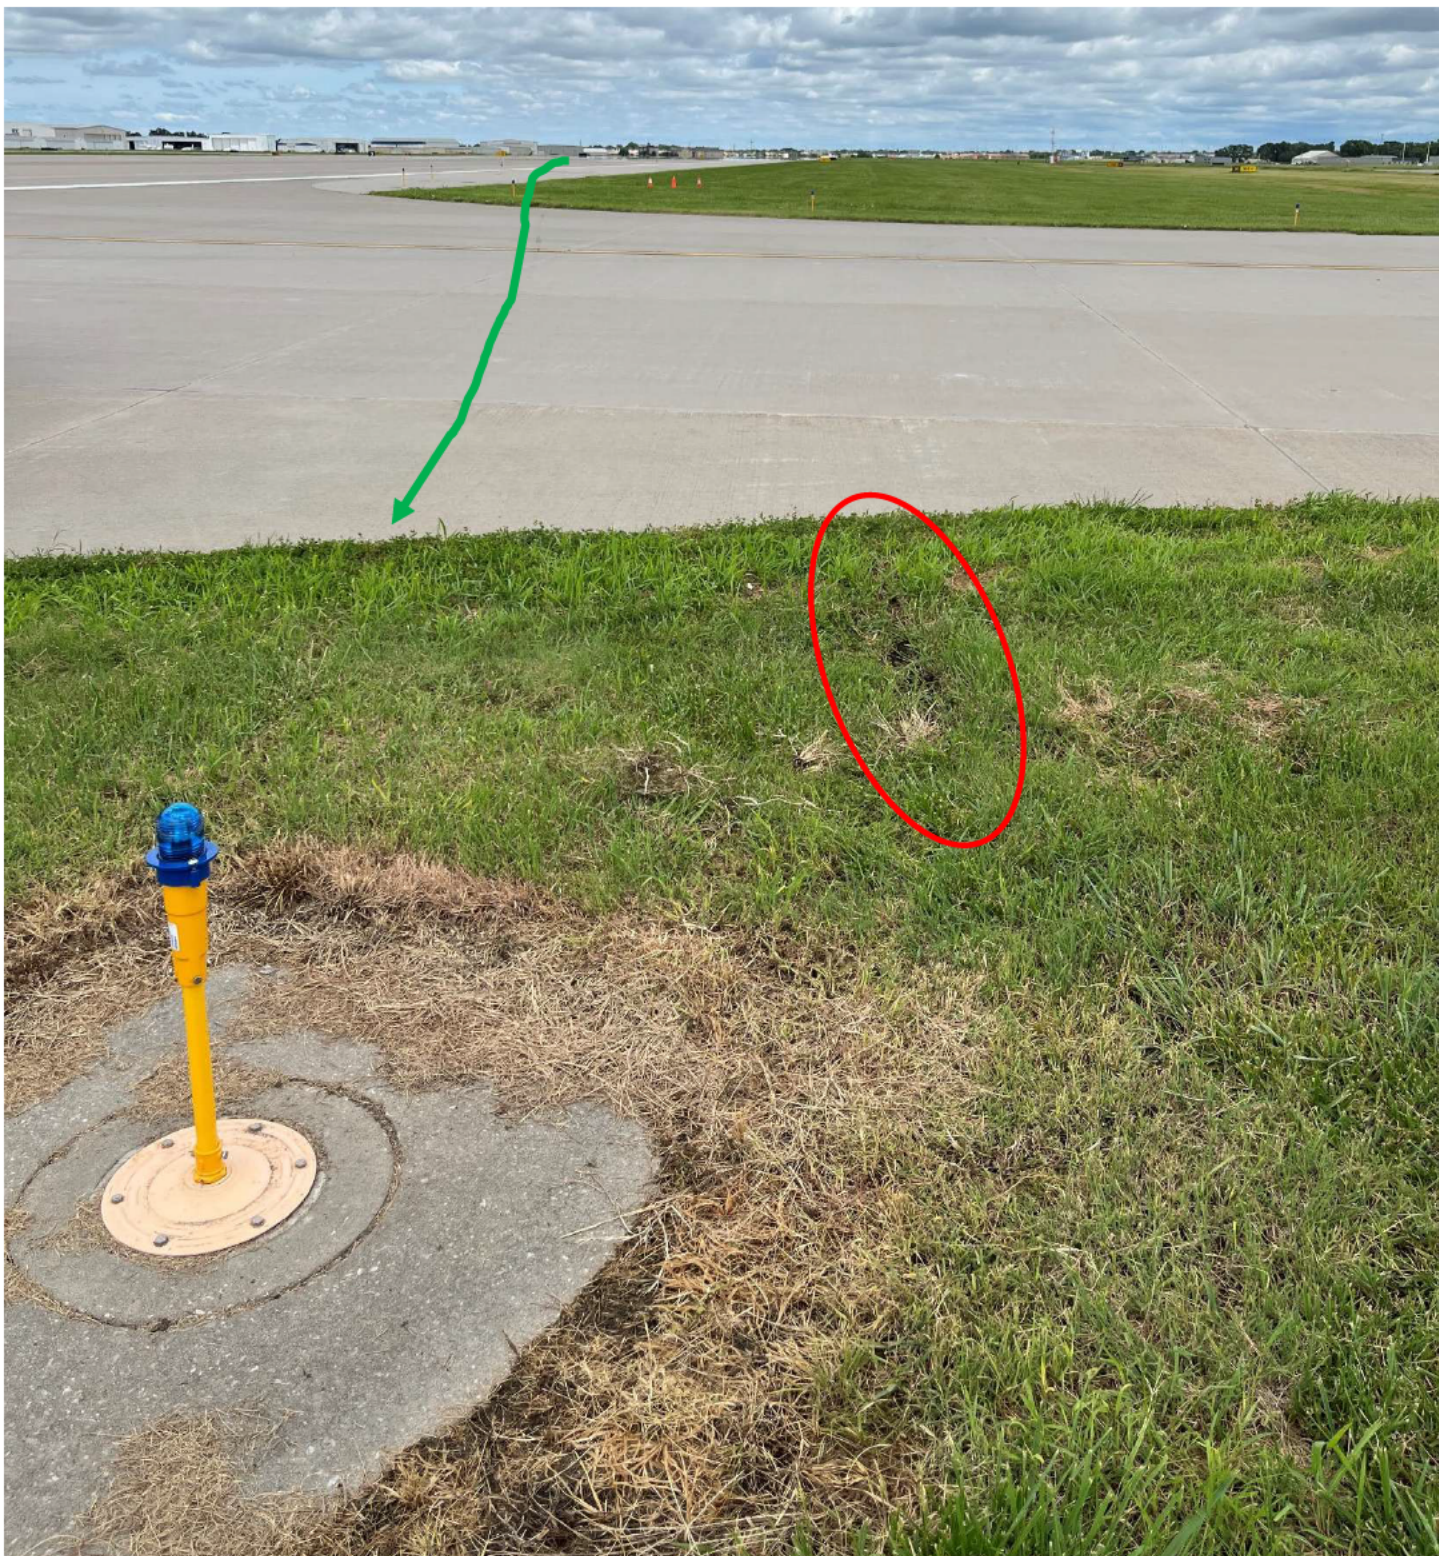
The green arrow parallels the right main tire mark. The red circle is a ground scar from the left main gear leg fairing. Blue taxiway light replaced due to impact with belly of aircraft.

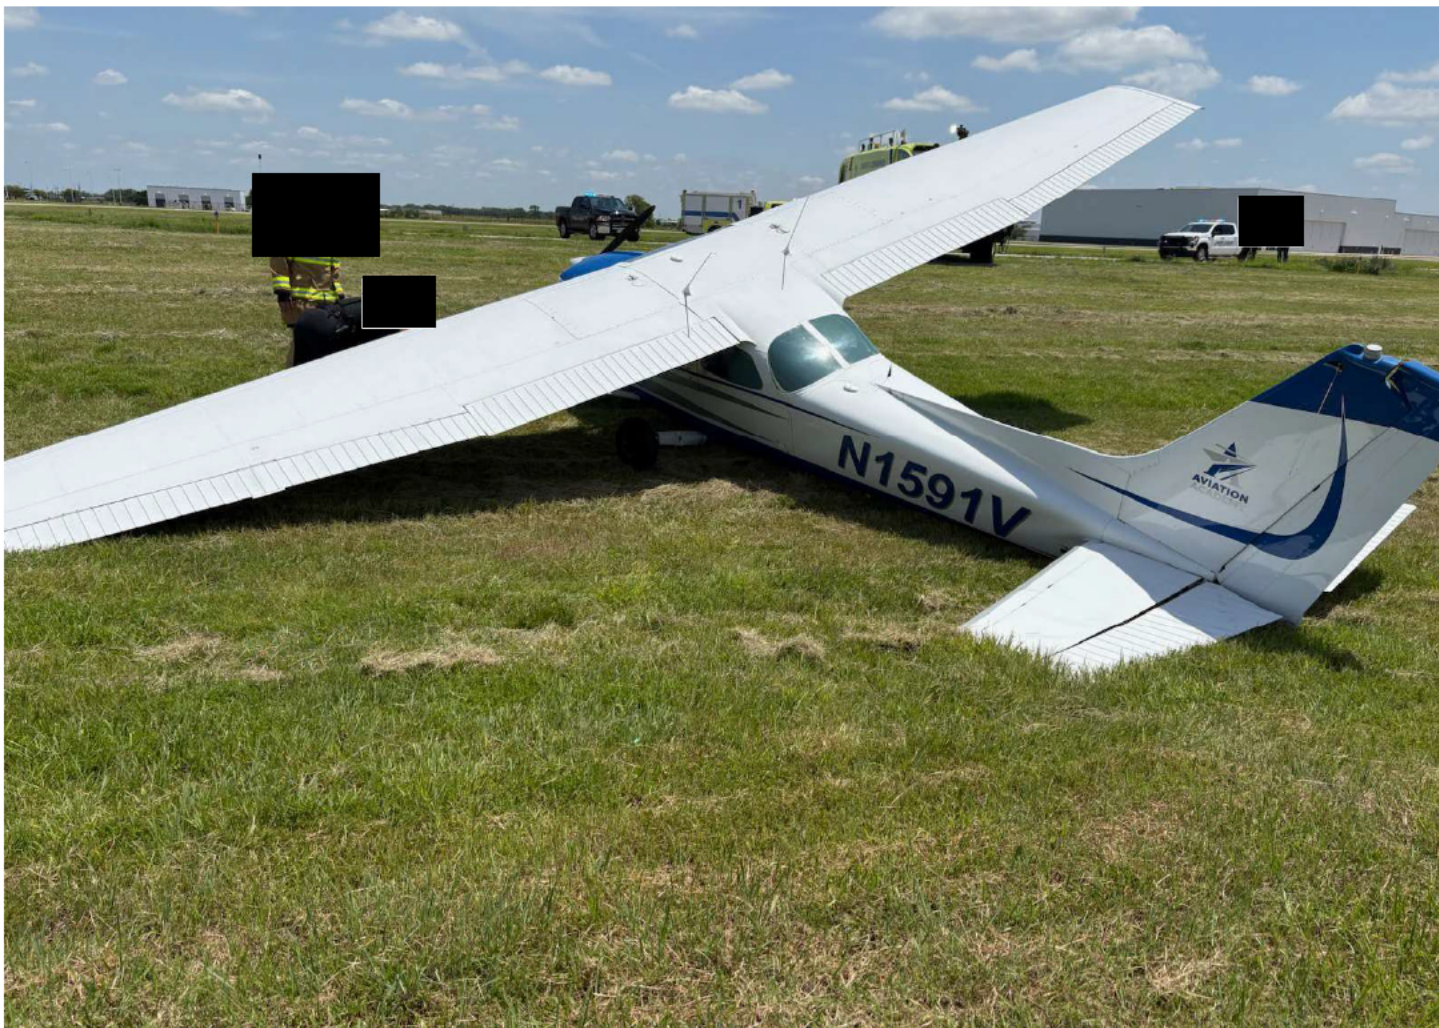
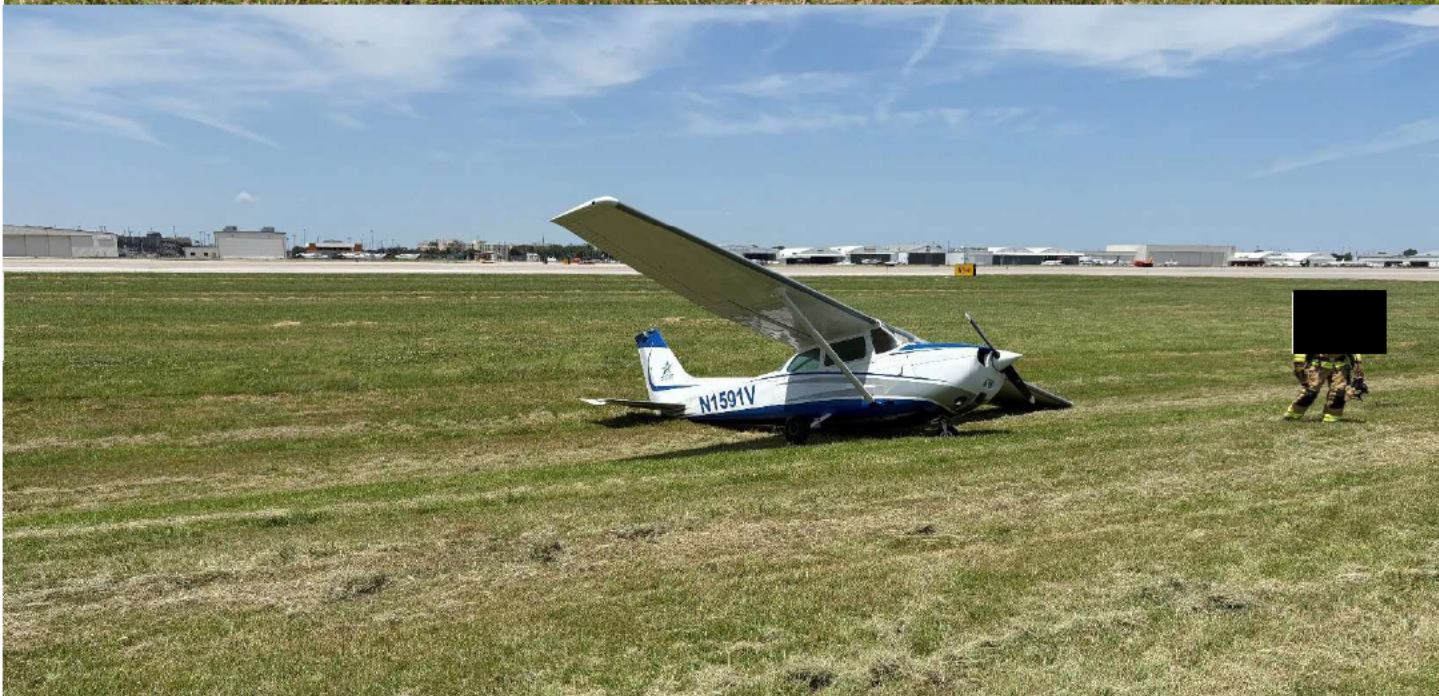
Images at the final location facing east.

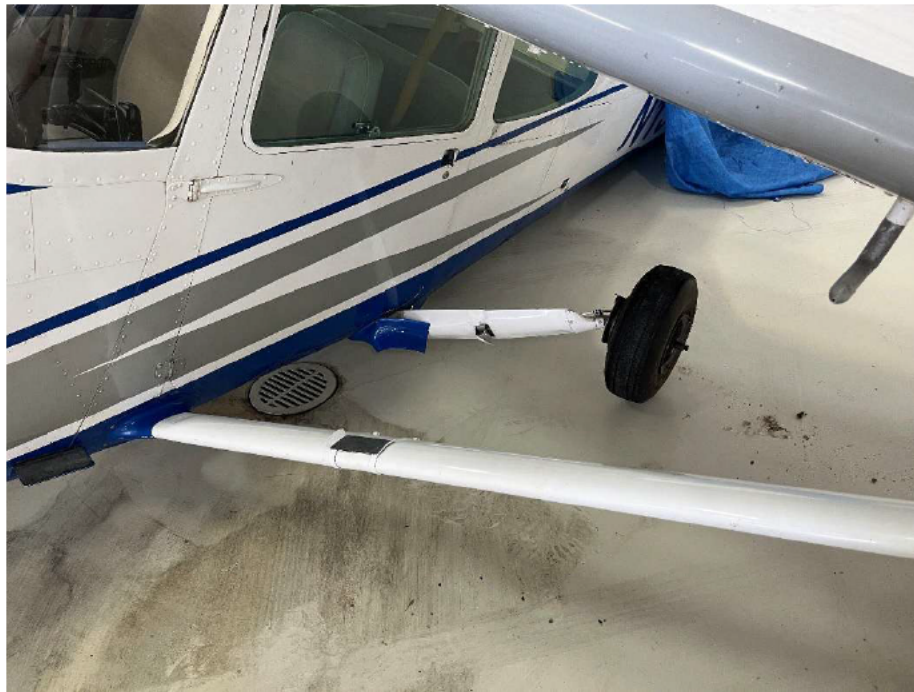
Left gear leg swept back due to the shearing of the gear leg attachment bolt.

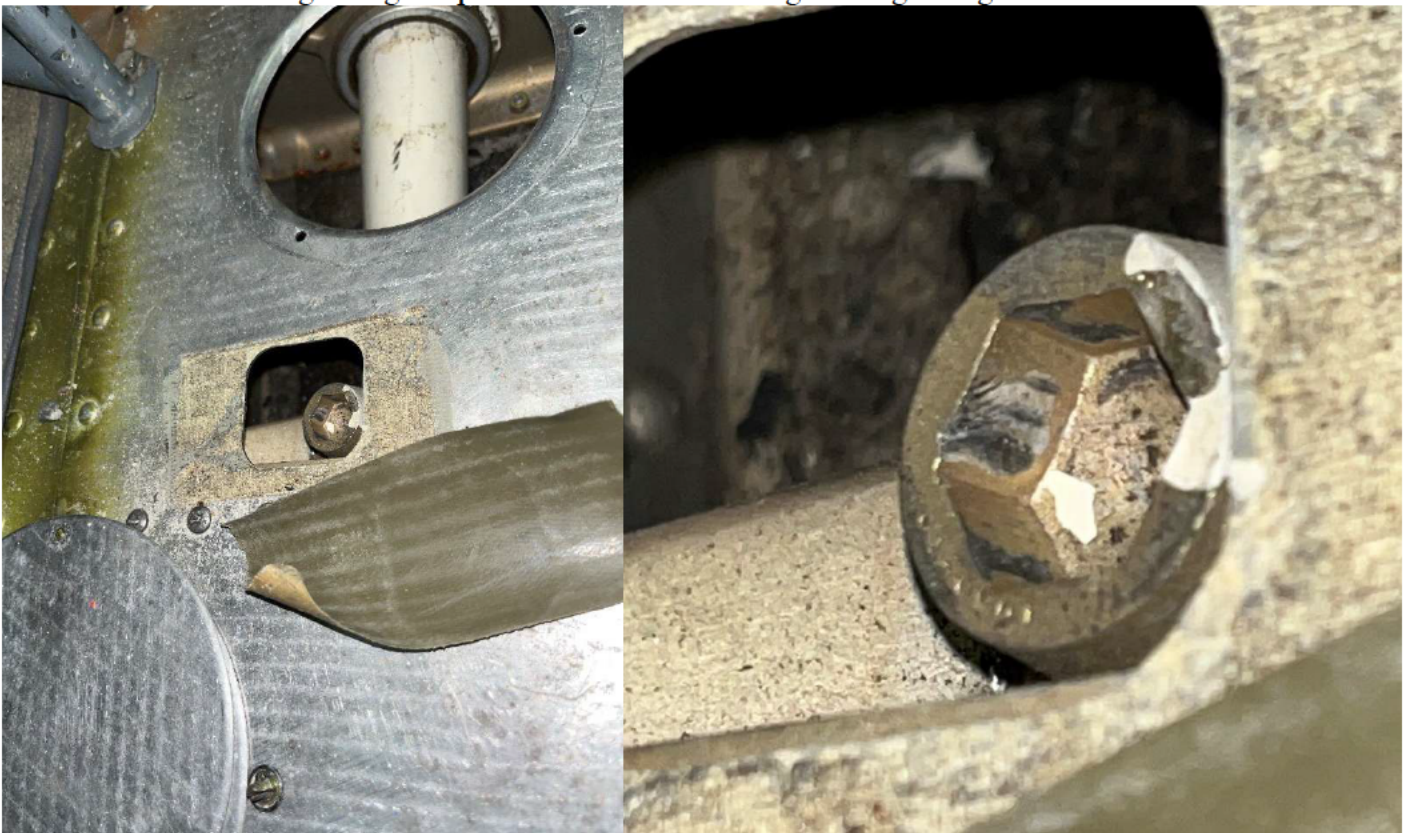
of the bolt was pulled from the inboard landing gear support housing. The bolt head has only tool mark indications of tightening, and none of losing.

Photos of left gear leg attaching bolt. Note tool marks on inside of bolt indicate it was never removed, time in service 5570 hours.

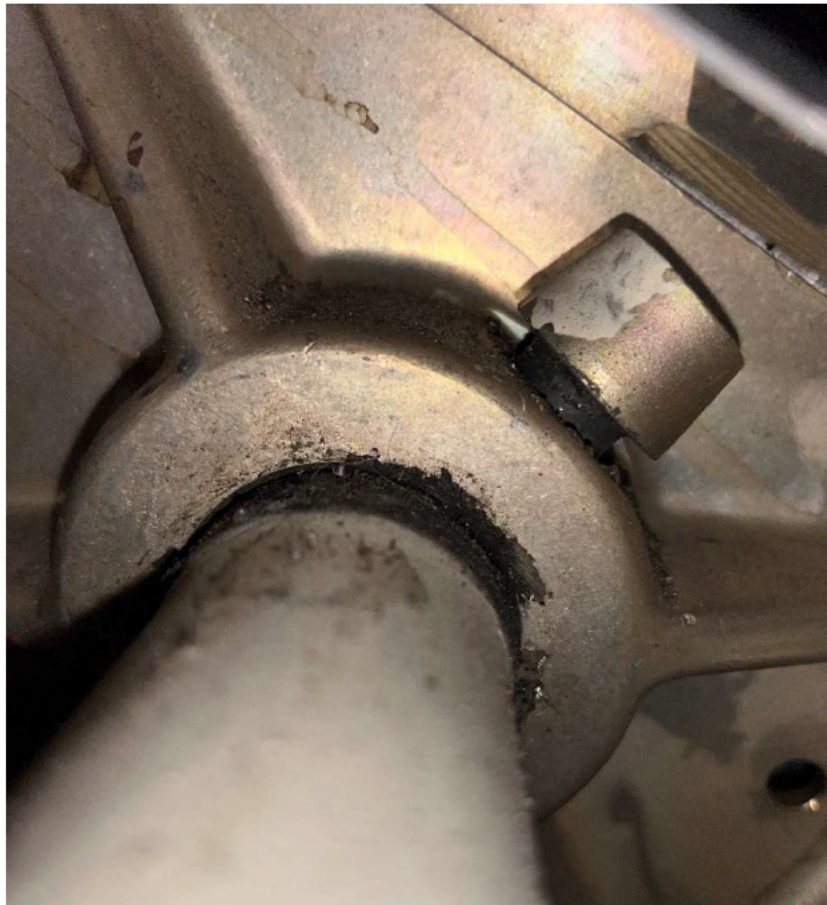
Left gear leg bolt as found.

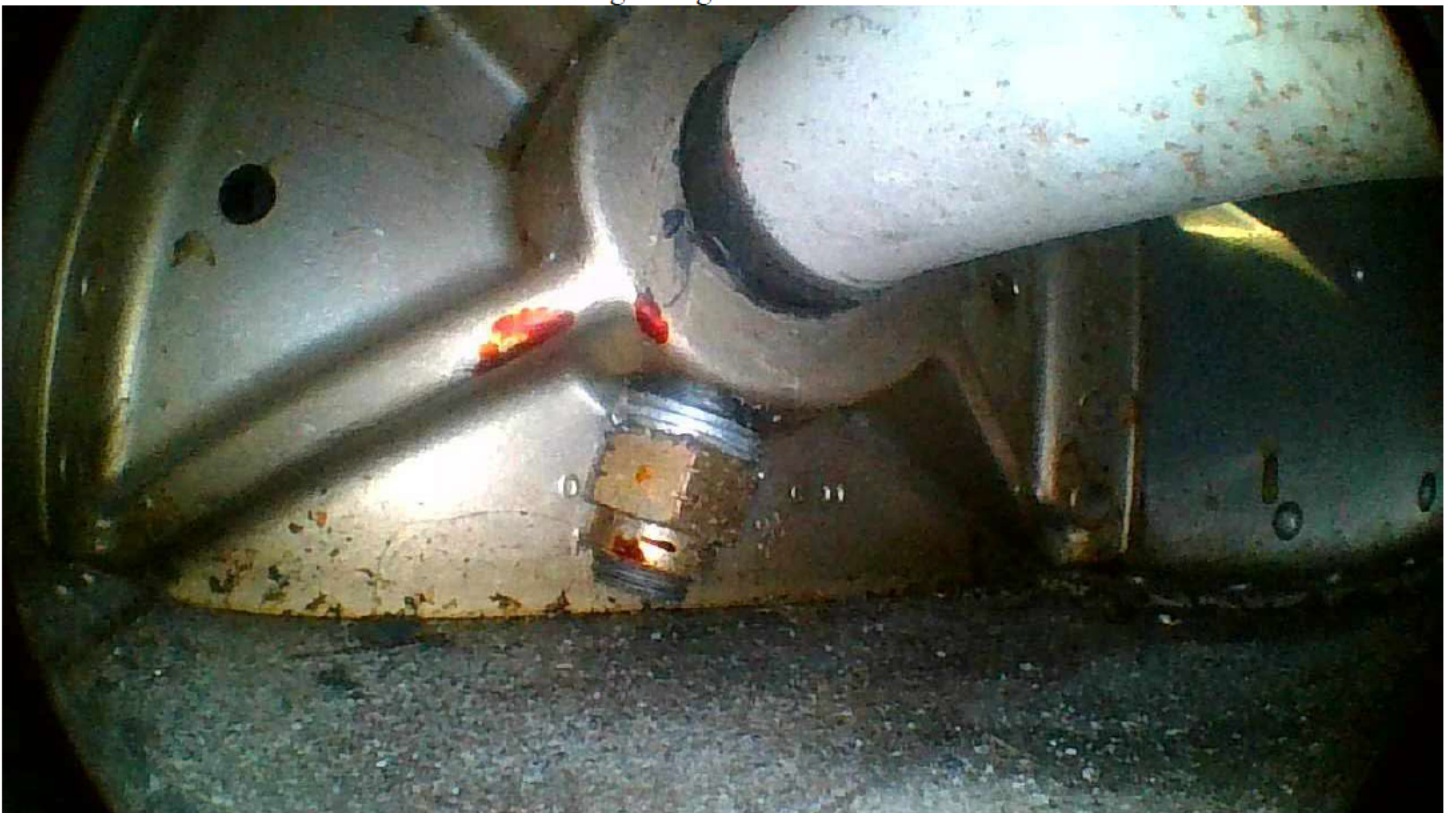
Nut end of the sheared left gear attach bolt.

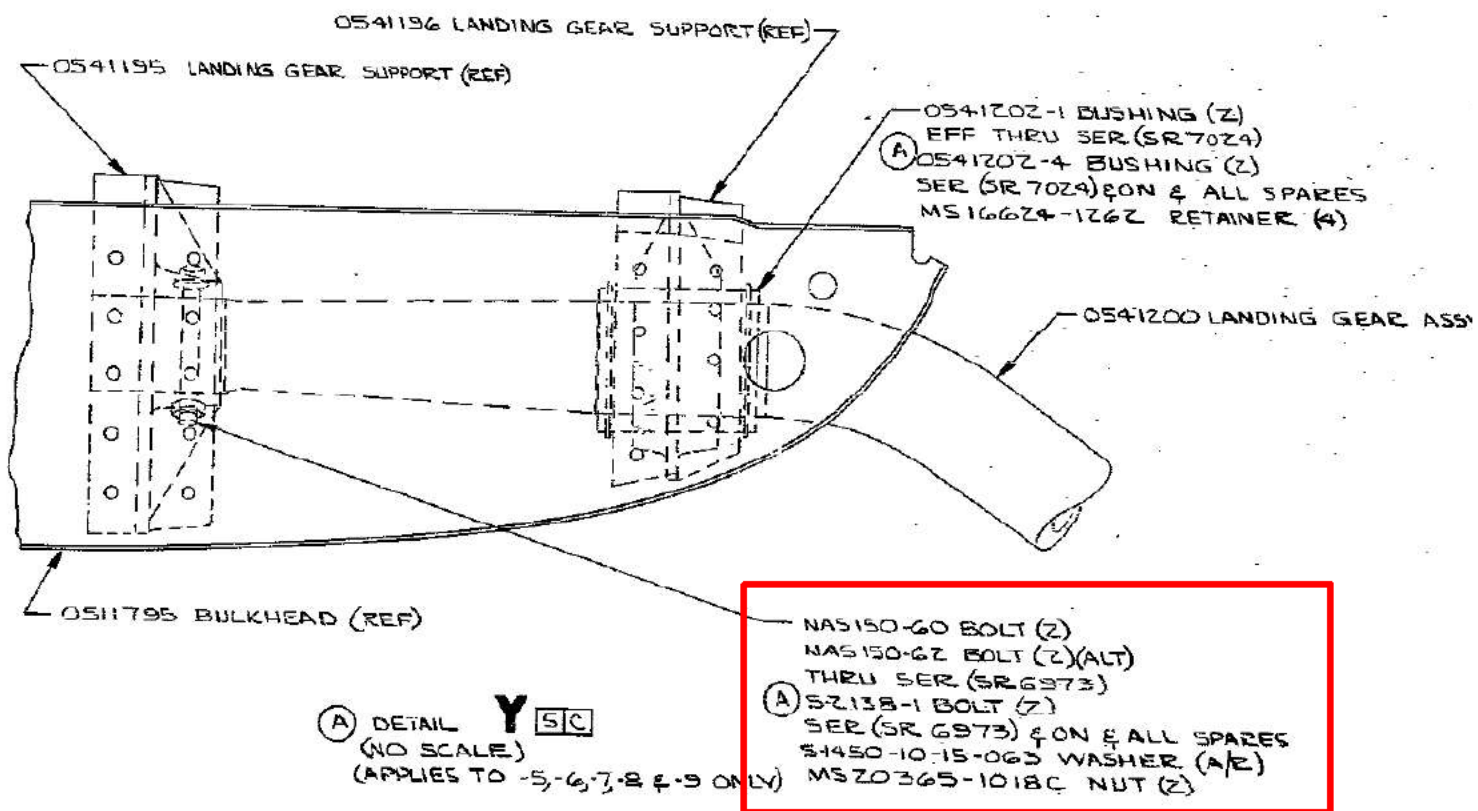
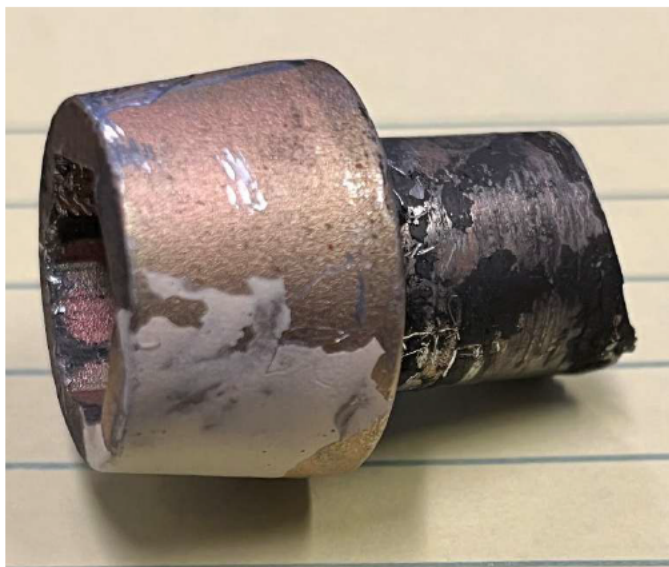
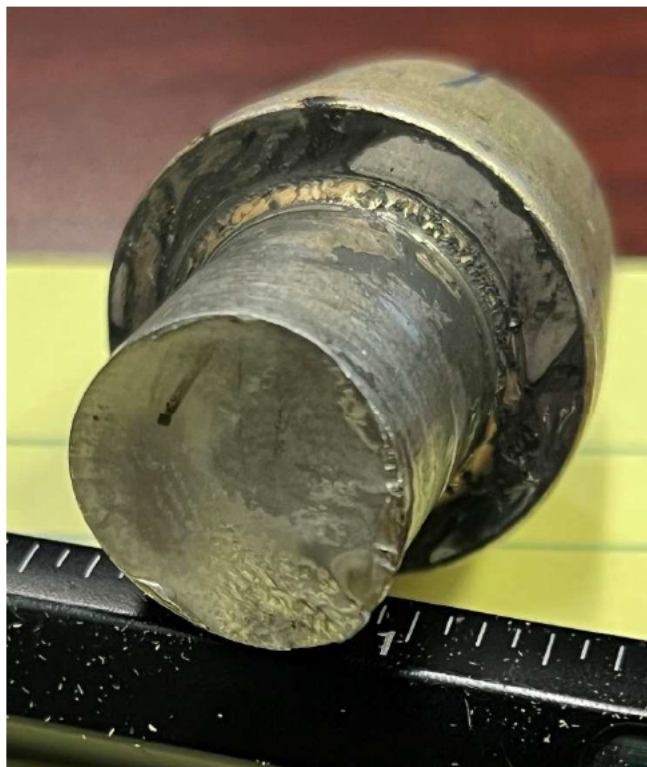
The 1975-year model (based on serial number) had approximately 5570.7 hours. Review of the photos and compares to Textron Aviation new parts and Cessna engineering drawings indicate that the original factory hardware was installed on this aircraft.

As removed bolt head. Note original Cessna factory witness paint. Metal shows signs of shear stress.
