# National Transportation Safety Board

CEN25LA231

## INVESTIGATION SUMMARY

Location: Lockport, Louisiana  
Date: July 1, 2025  
Time: 1145 central daylight time  
Airplane: Grumman G-164B, s/n 1B  
Registration: N8834H

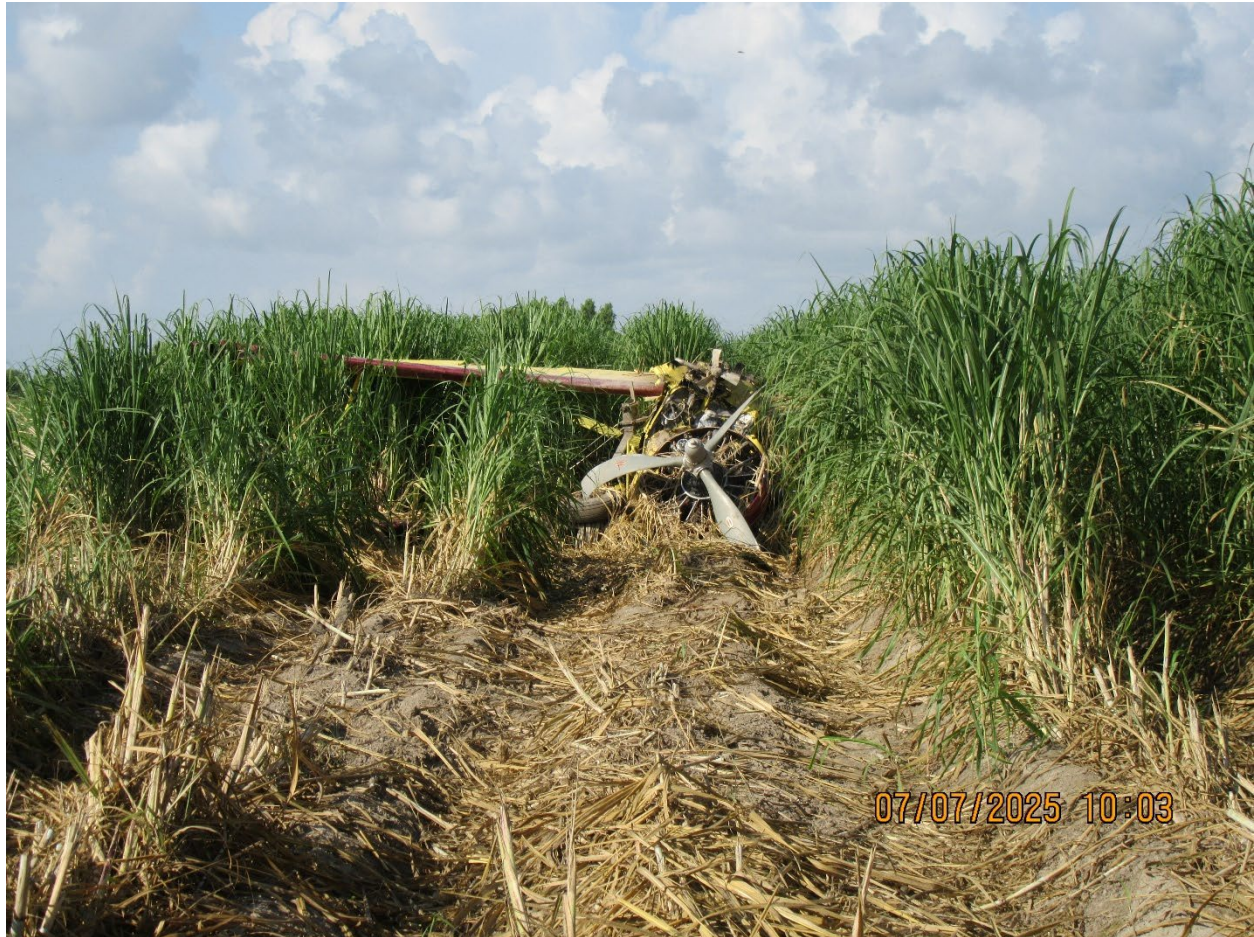
The responding FAA inspector reported that the airplane came to rest inverted in a field. The engine and propeller were mostly separated from the firewall. The upper and lower wings remained attached to the fuselage and sustained leading edge damage.

**Picture 1 - Accident Site**

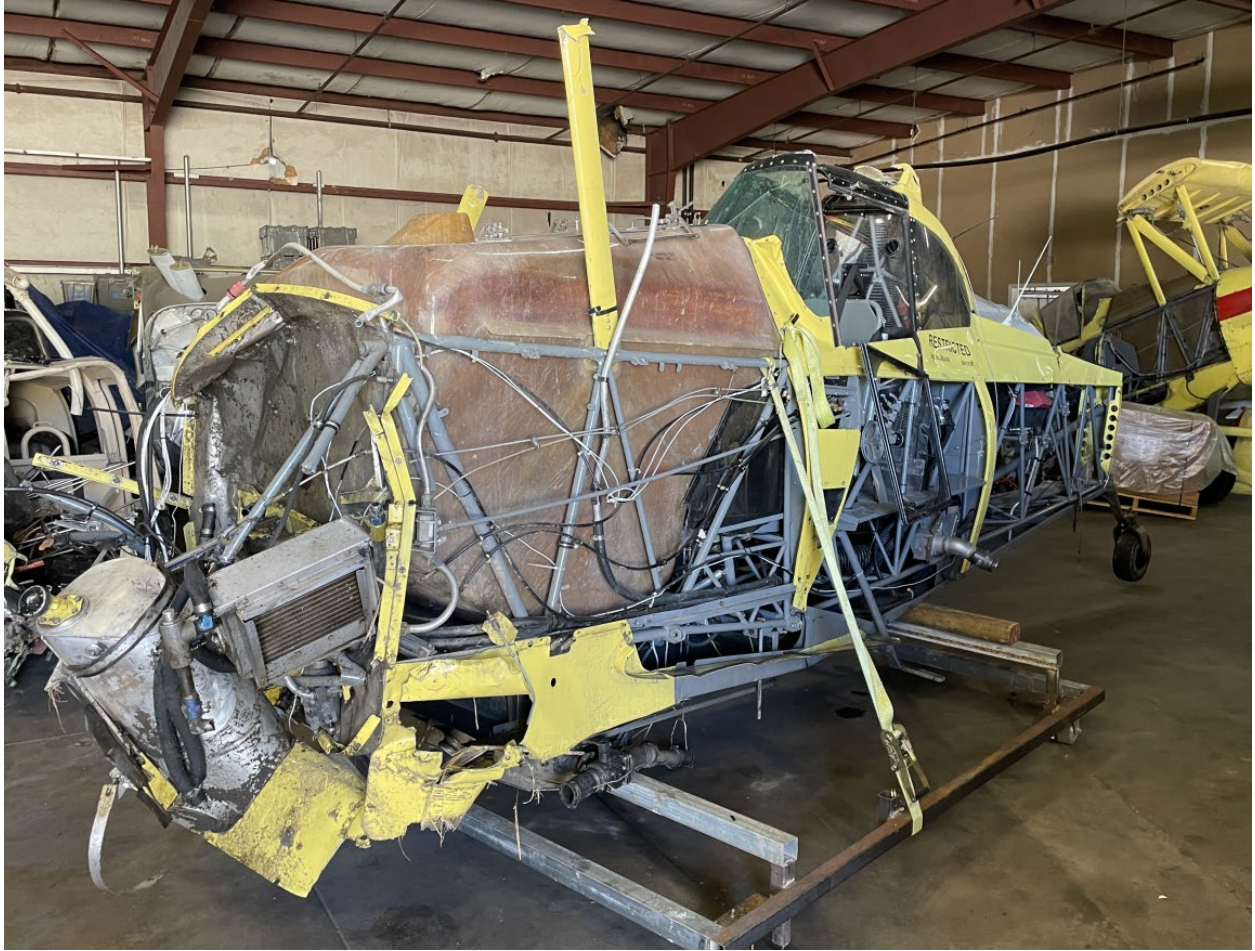
**Picture 2 - Airplane During Examination (left side)**

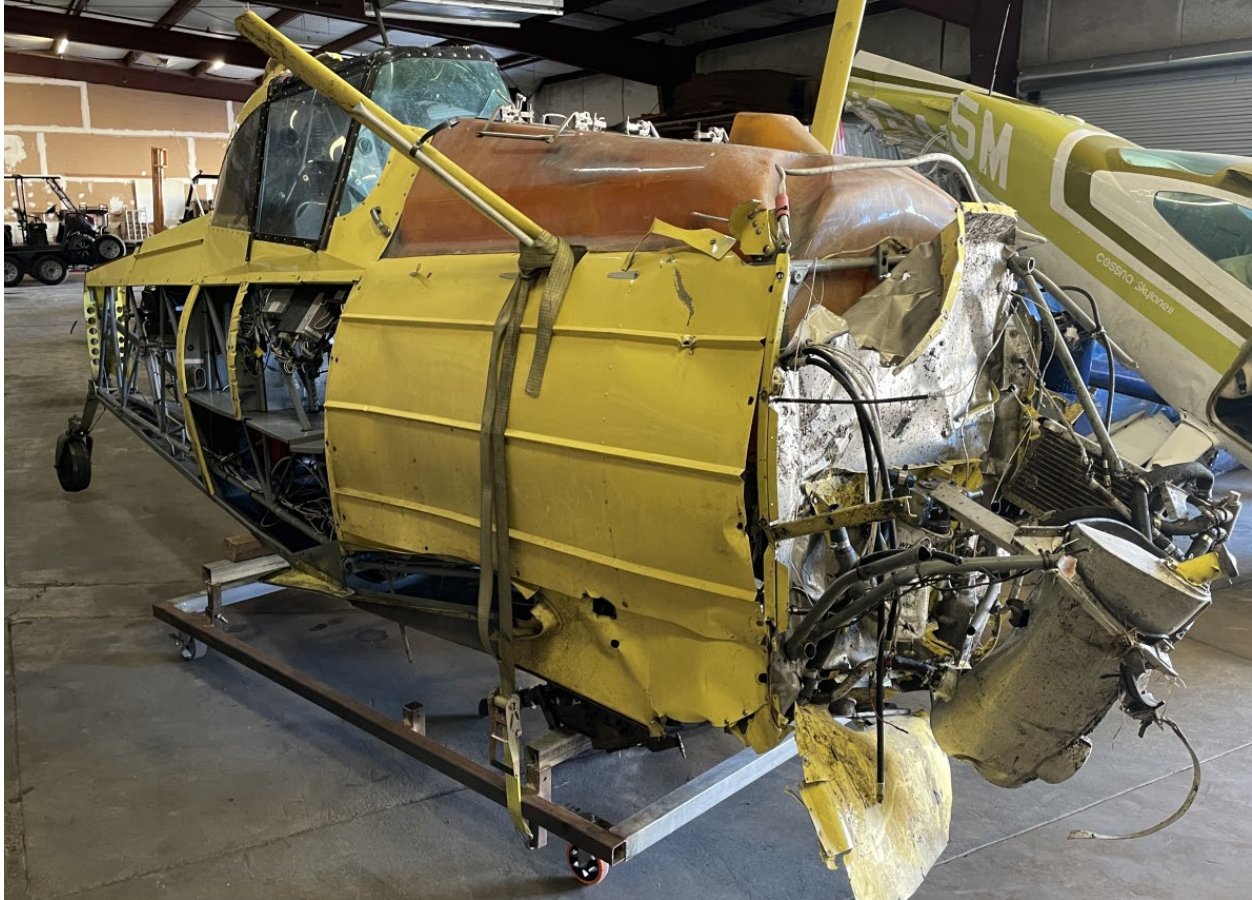
**Picture 3 - Airplane During Examination (right side)**

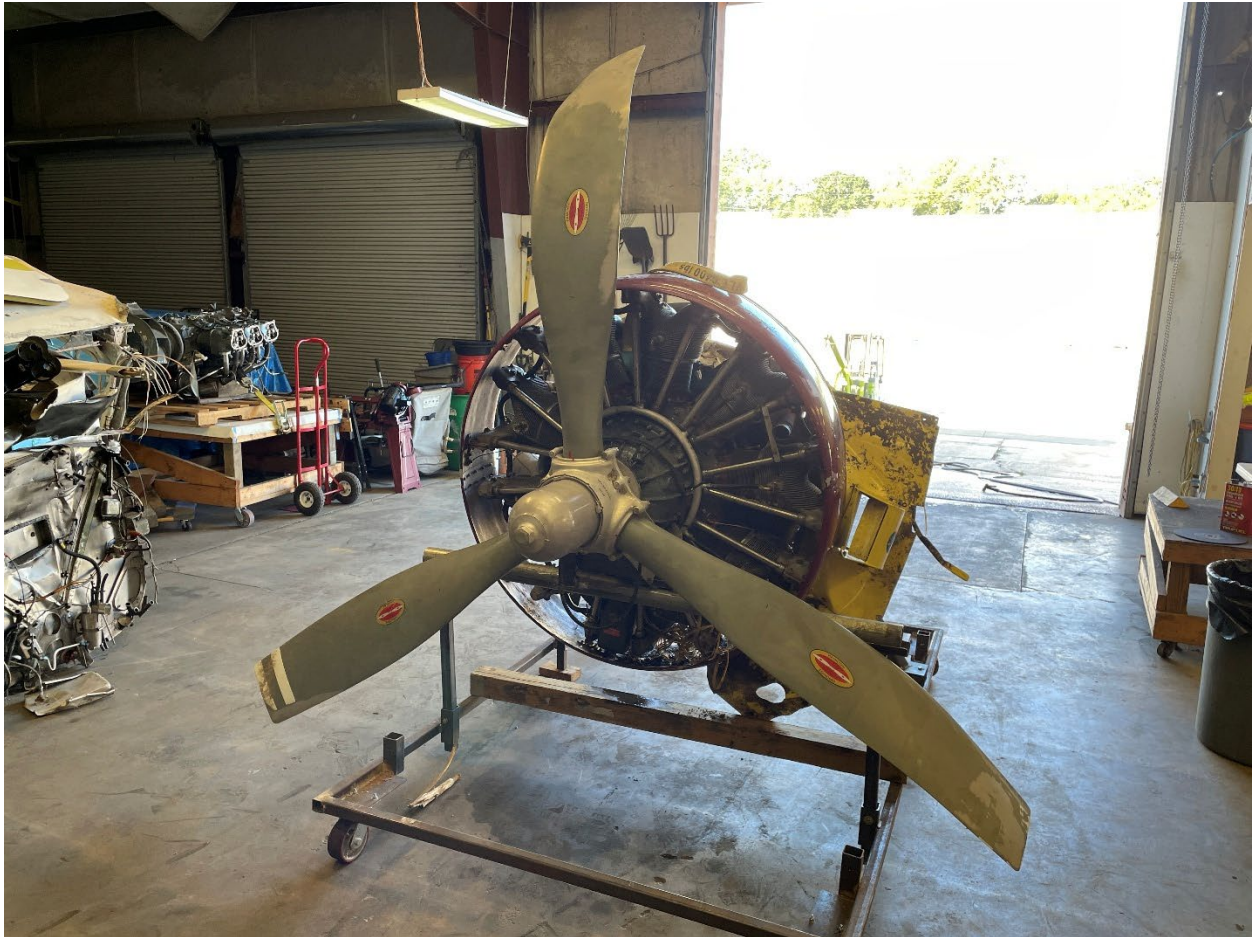
**Picture 4 - Engine and Propeller**

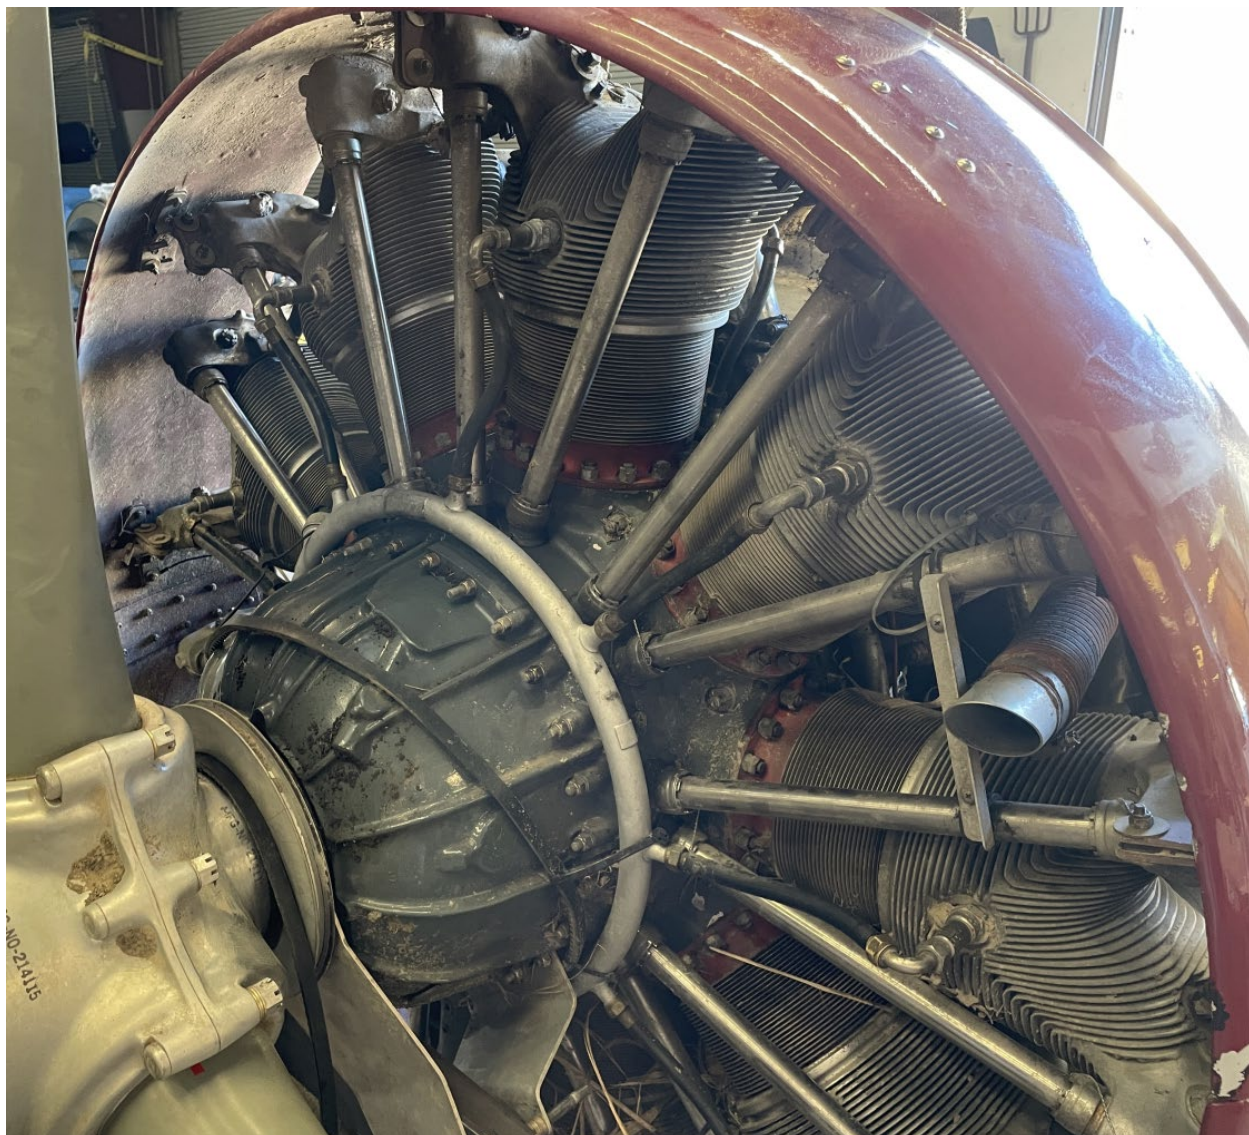
**Picture 5 - Engine Cylinders (front left)**

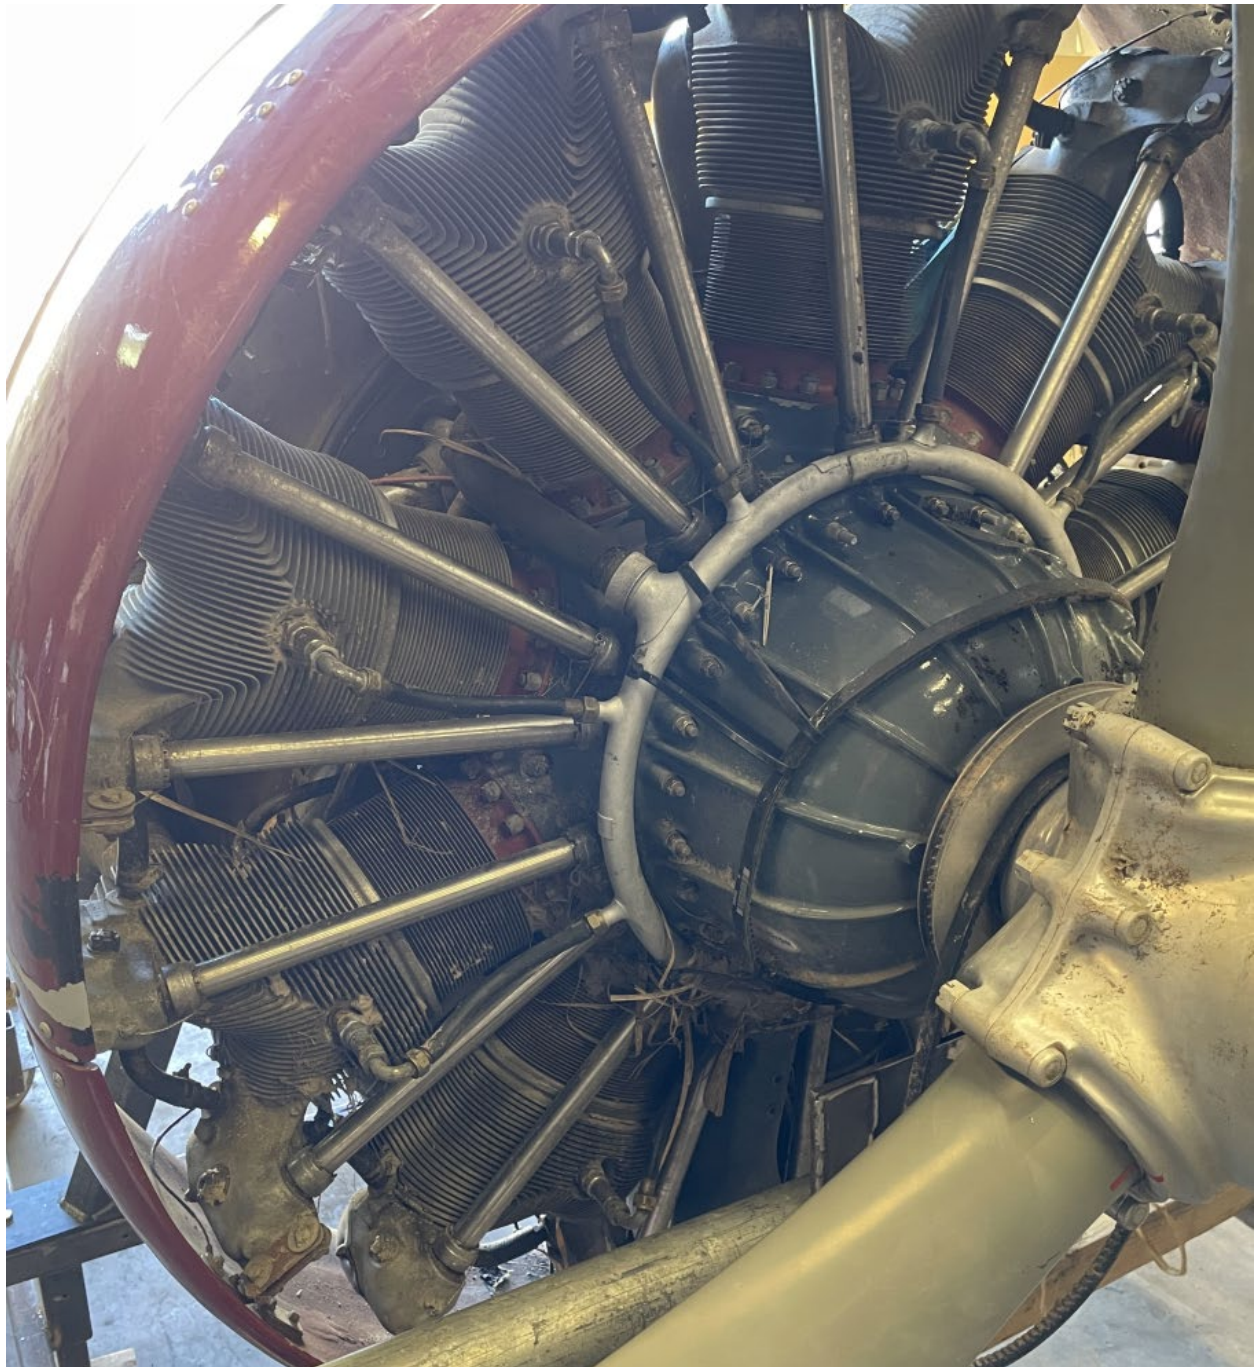
**Picture 6 - Engine Cylinders (front right)**

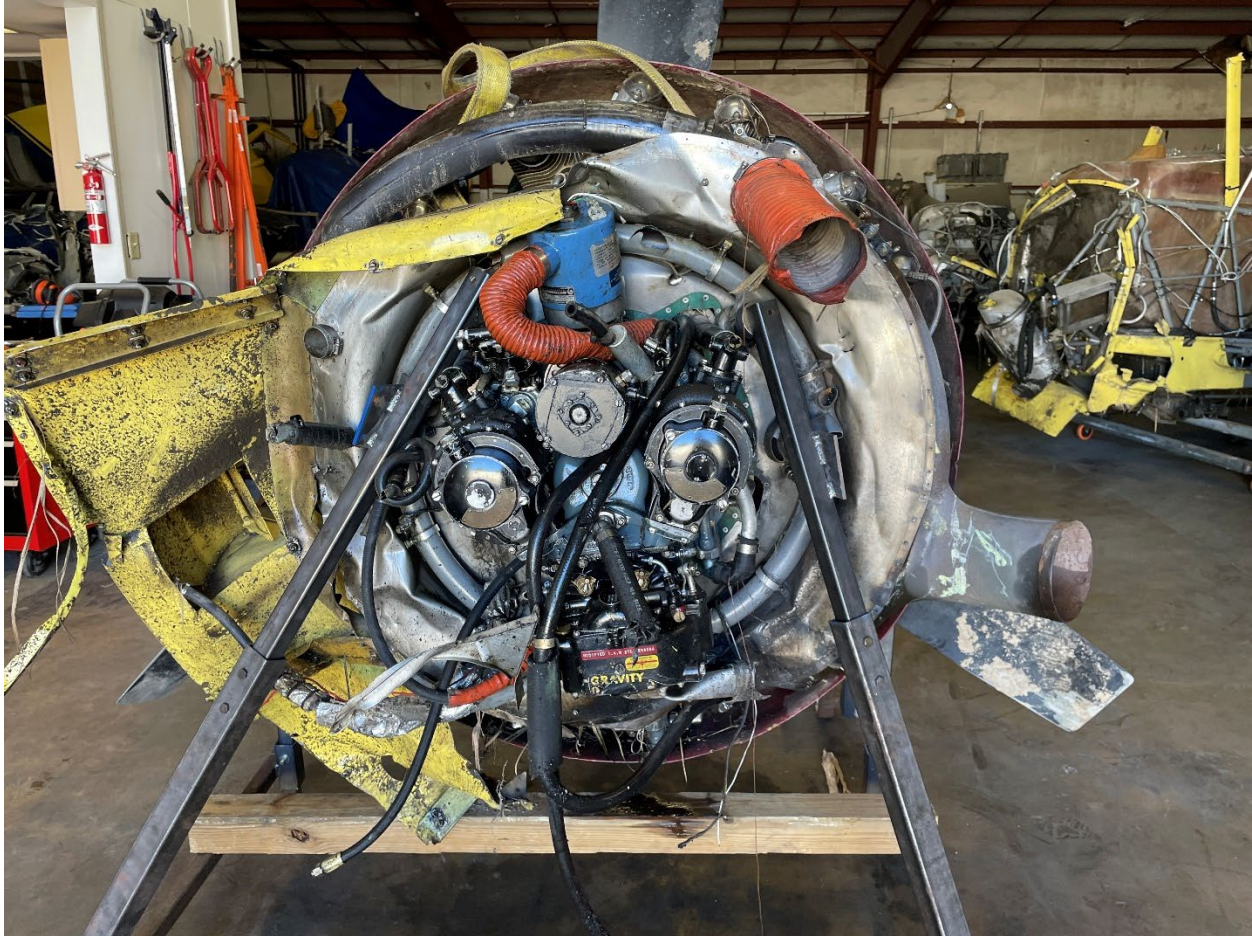
**Picture 7 - Engine Rear, Accessories**

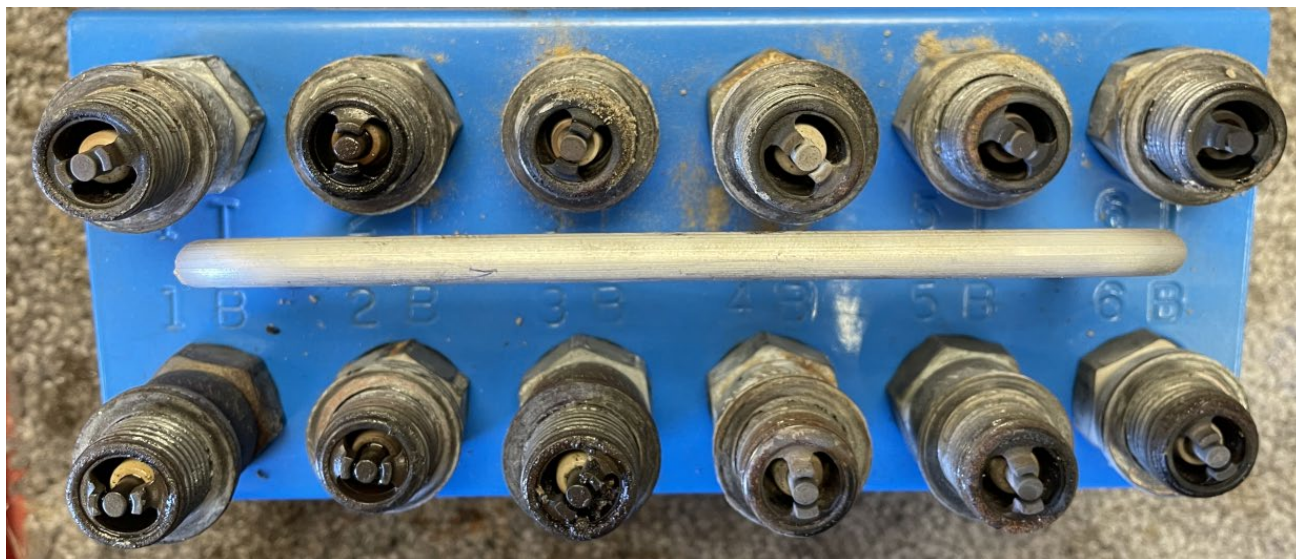
The front and back ignition harnesses were examined and found installed with no impact damage or anomalies noted. The spark plugs were removed and some were covered in oil due to the accident sequence and subsequent recovery. They were in normal condition when compared with the Champion Aerospace Check-A-Plug inspection chart.

**Picture 8 - Front and Back Spark Plugs Nos. 1-6**

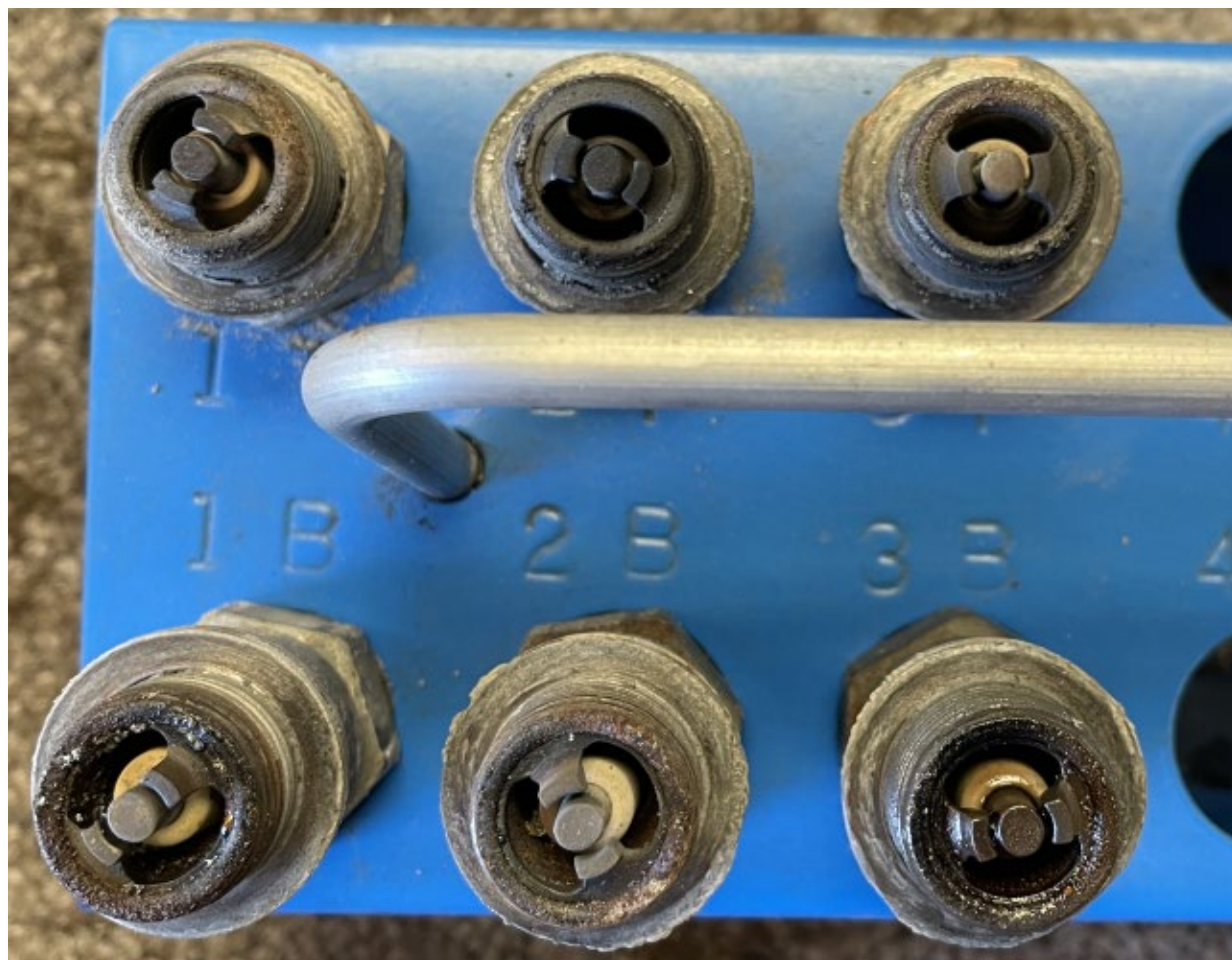
**Picture 9 - Front and Back Spark Plugs Nos. 7-9**

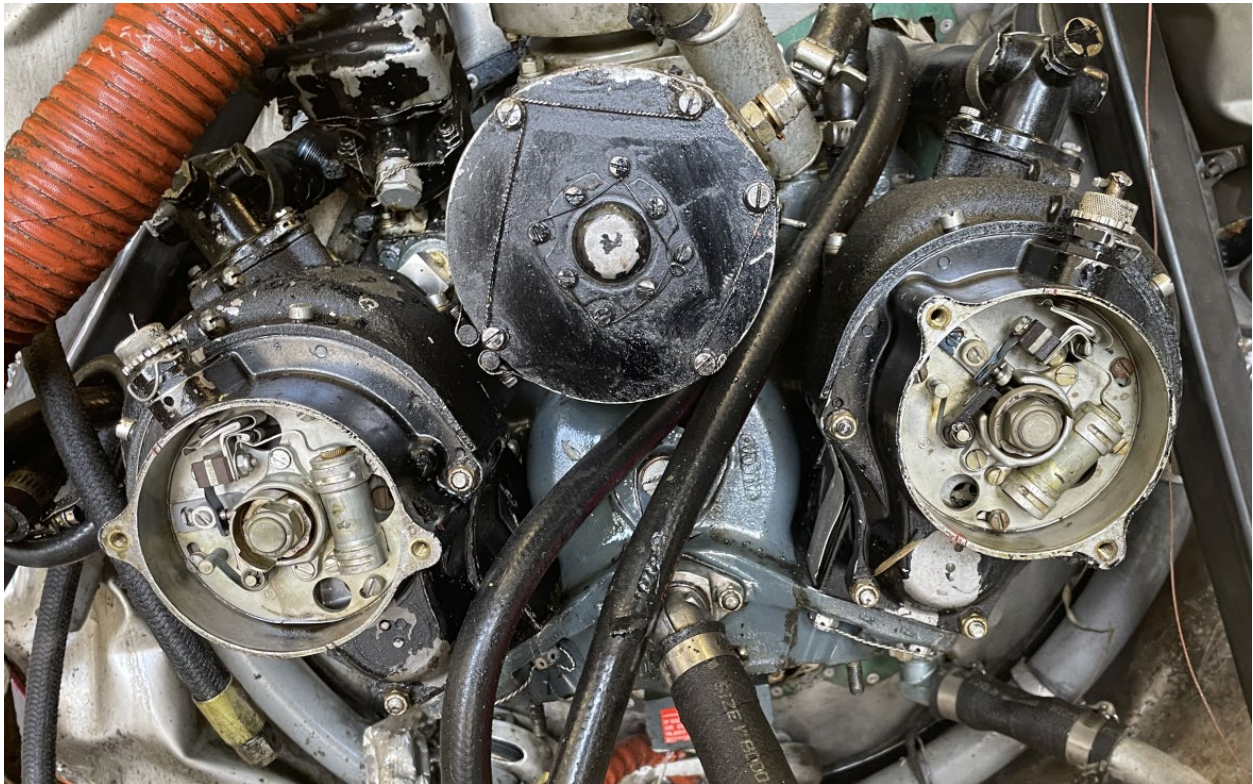
The magnetos were found secured to the engine and were both removed from their mounts to facilitate rotation and sparking. The ignition harnesses and spark plugs remained connected during this process. They were spark checked by spinning the drive nuts with a cordless drill; a spark was observed at each spark plug. The magnetos exhibited no issues that would prevent its normal operation.

**Picture 10 - Magnetos (caps removed)**

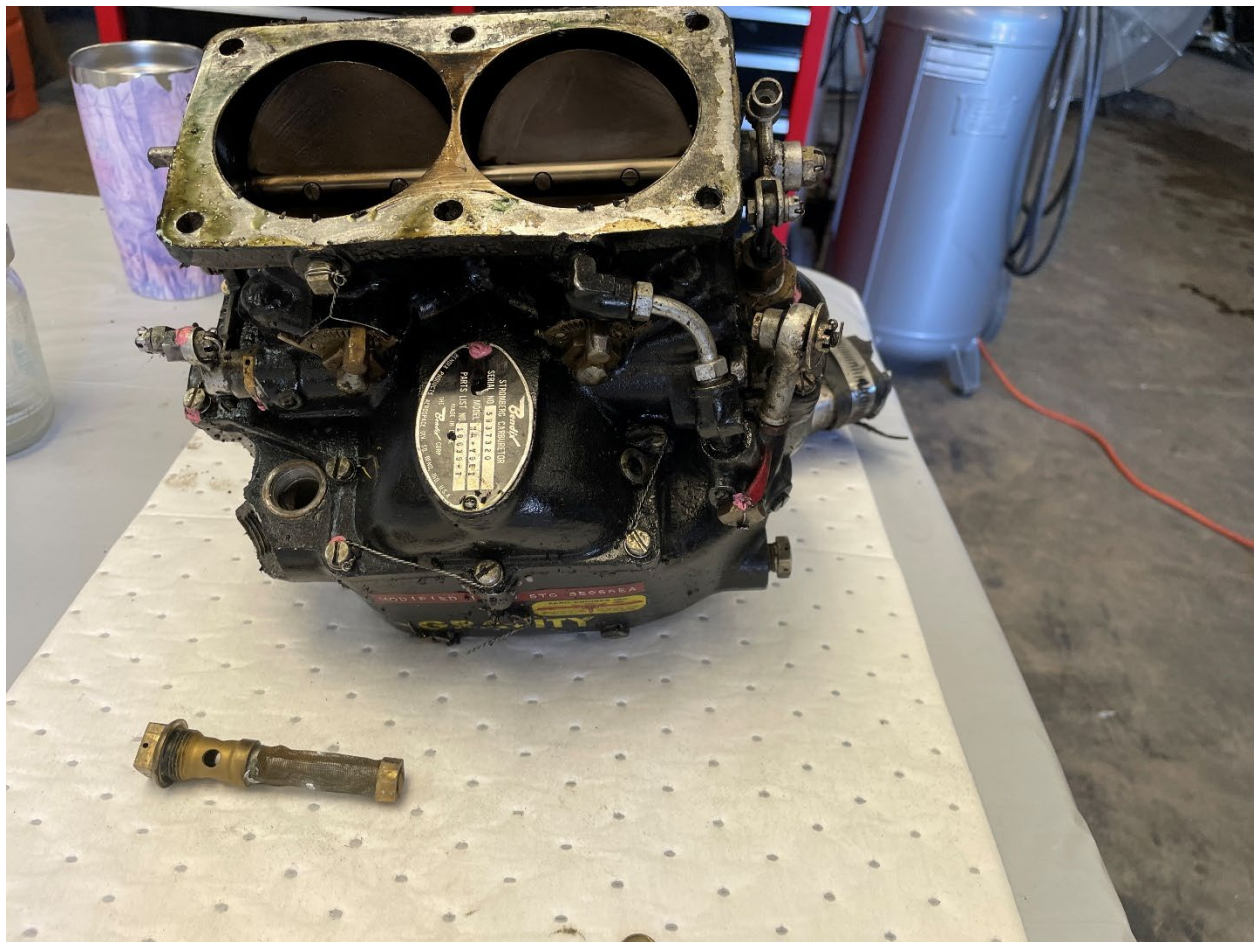
The carburetor was found securely mounted to the engine. The engine controls were impacted damaged and separated. Continuity could not be confirmed because of separation of the engine from the airframe during the accident sequence. The metering jet was free of obstructions. The accelerating pump was in good condition with no anomalies noted. The floats were intact with minor deformation from the impact sequence. The bowl contained a thick white substance from rain water entering the system during the recovery process, then sitting stagnant for 2 months. About 34 ounces of murky liquid was drained from the carburetor, which was likely rain water. The carburetor examination revealed no anomalies that would have prevented normal operation. The fuel screen was removed and examined and was free of debris. The fuel screen was found to be in a serviceable condition.

**Picture 11 - Carburetor and Fuel Screen**

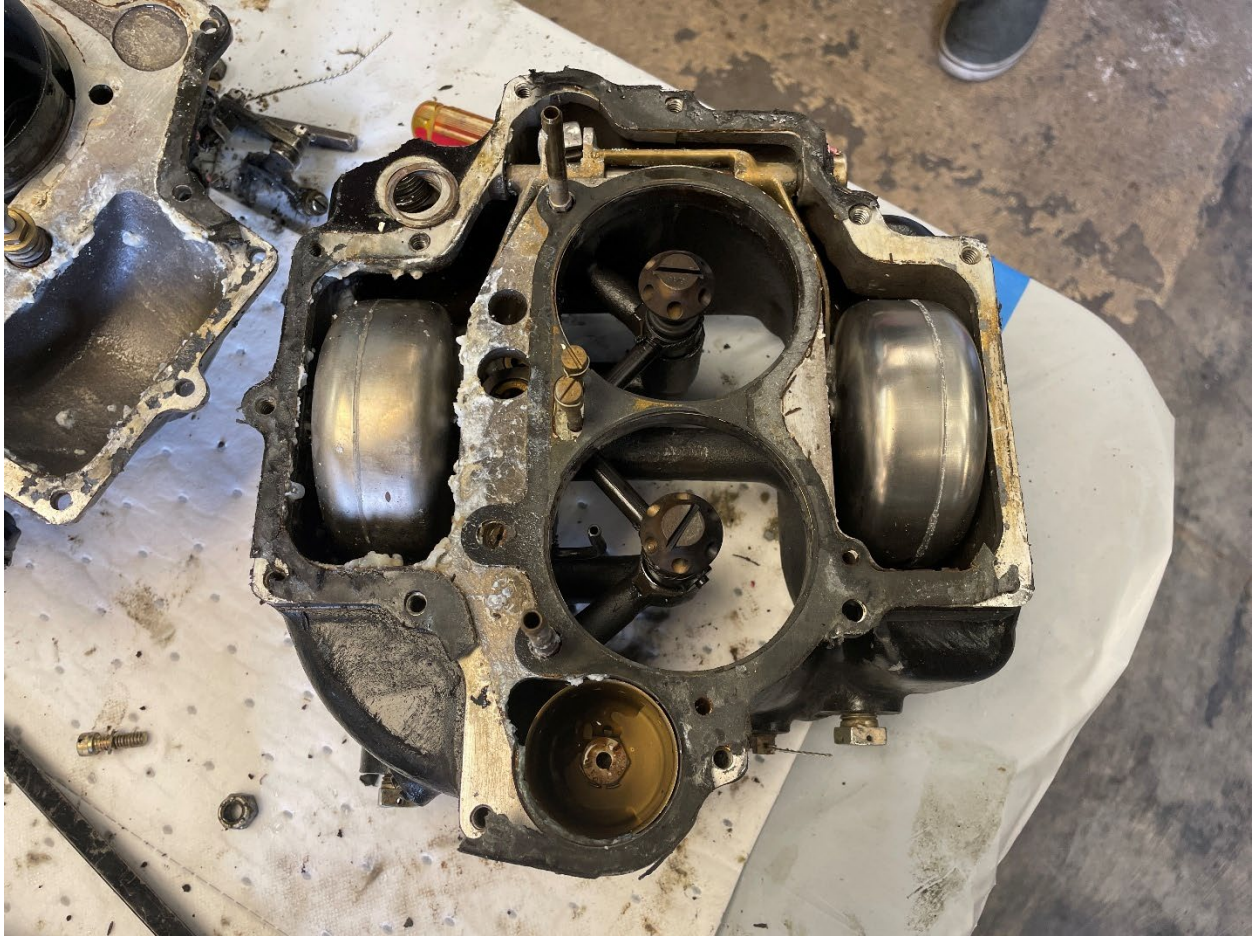
**Picture 12 - Carburetor floats**

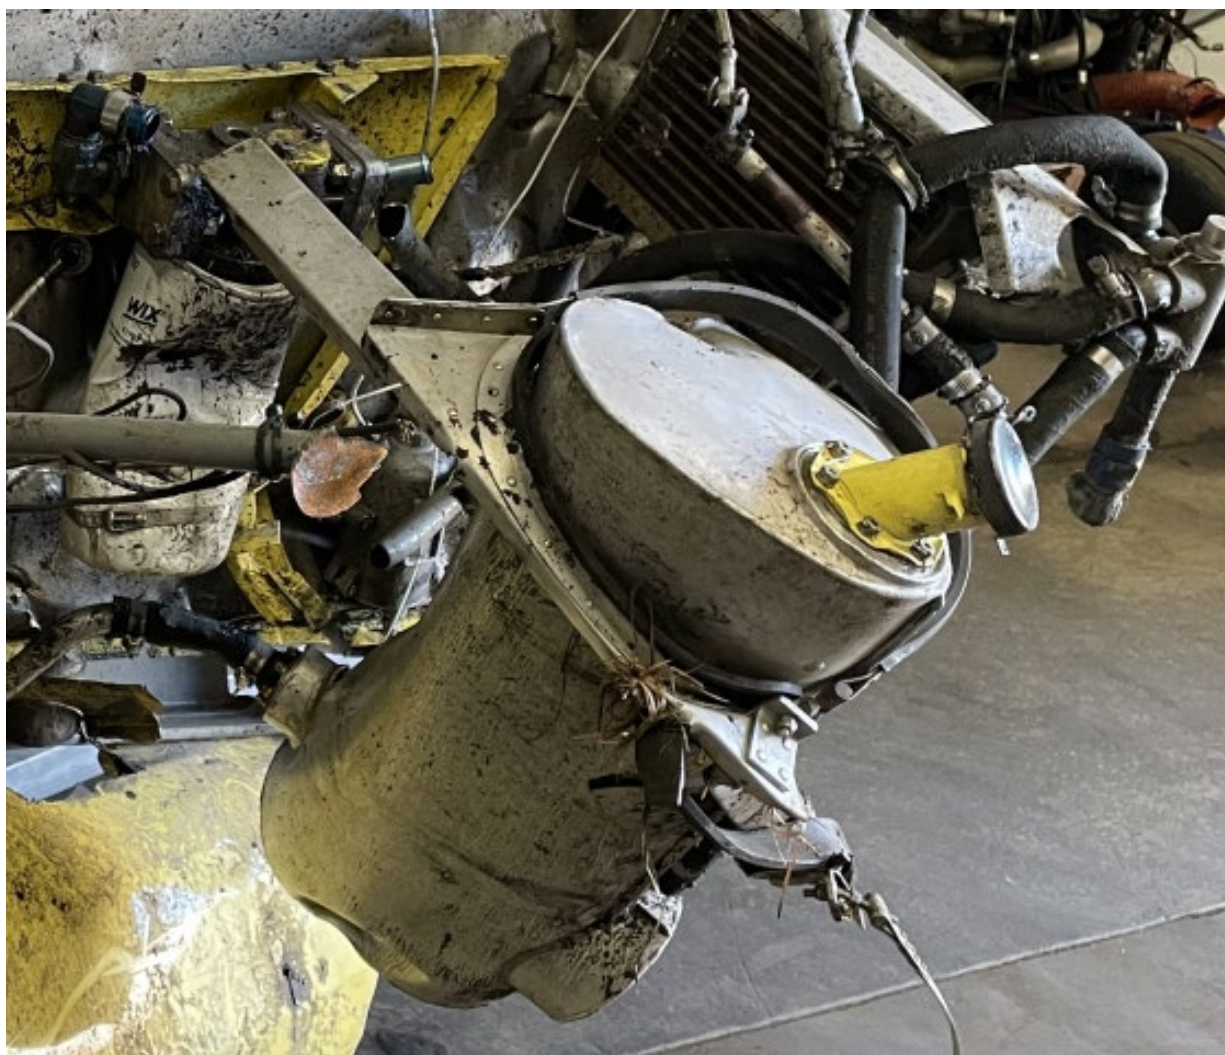
The oil level was not confirmed due to the separation of the engine from the airframe along with the oil tank and oil cooler. However, there was oil in the field at the accident site and was seen draining from the engine during the recovery. When the engine sump was drained, about 1-2 gallons of oil was captured. The oil was dark colored and mostly free of metallic debris.

**Picture 13 - Engine Oil Tank**

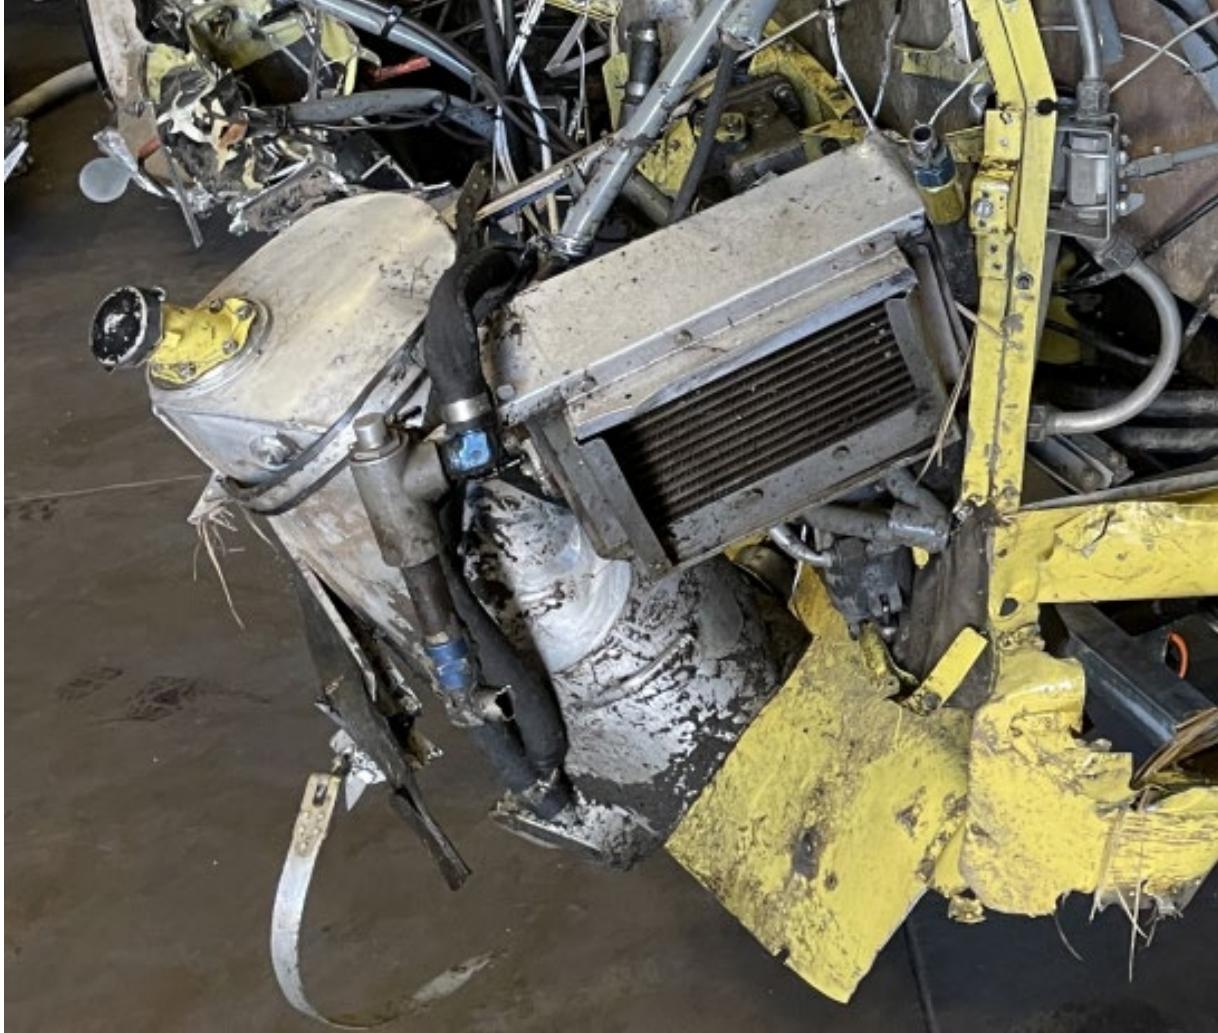
**Picture 14 - Engine Oil Cooler**

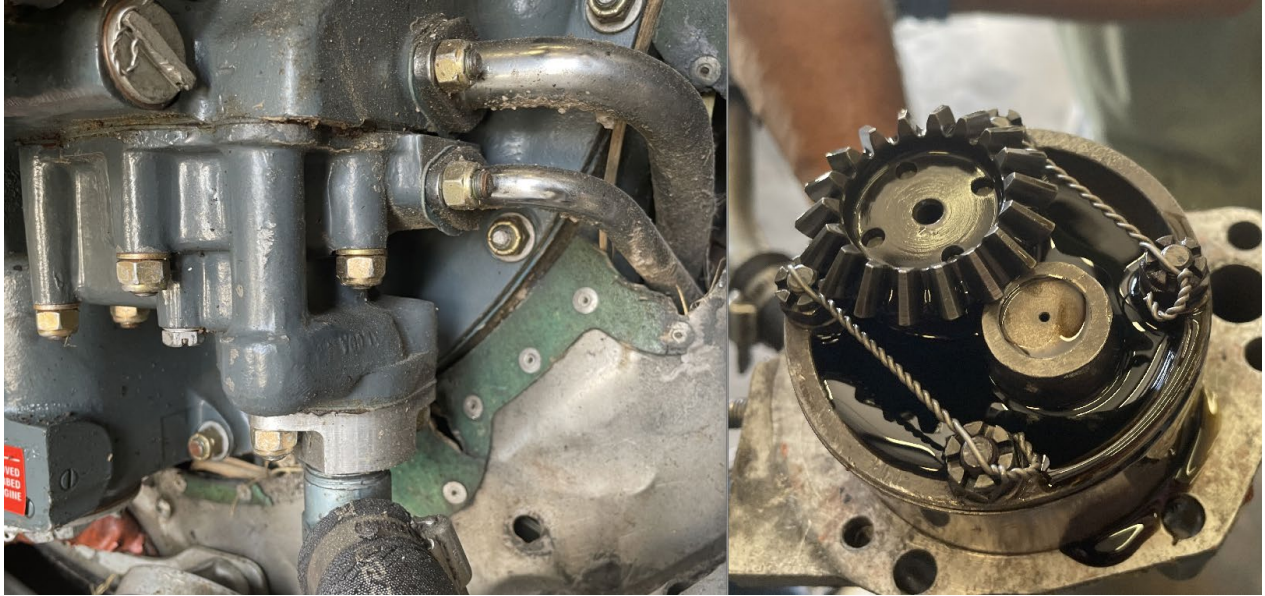
The oil pump was removed from its mount and found to be in good condition with no issues noted. The oil screen was removed and no contaminants were found. Very small pieces of ferrous metal were found on the chip detector.

**Picture 15/16 - Engine Oil Pump**

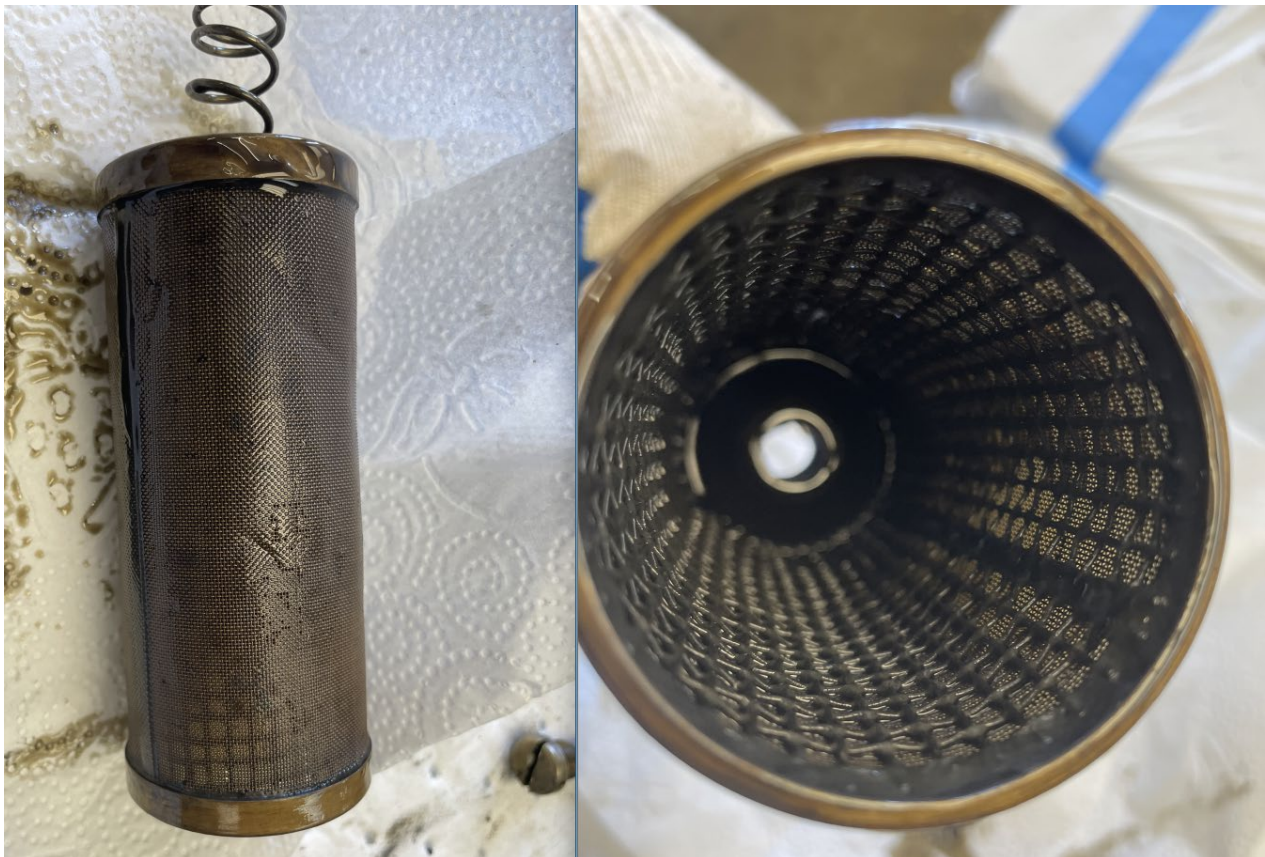
**Picture 17/18 - Engine Oil Screen**

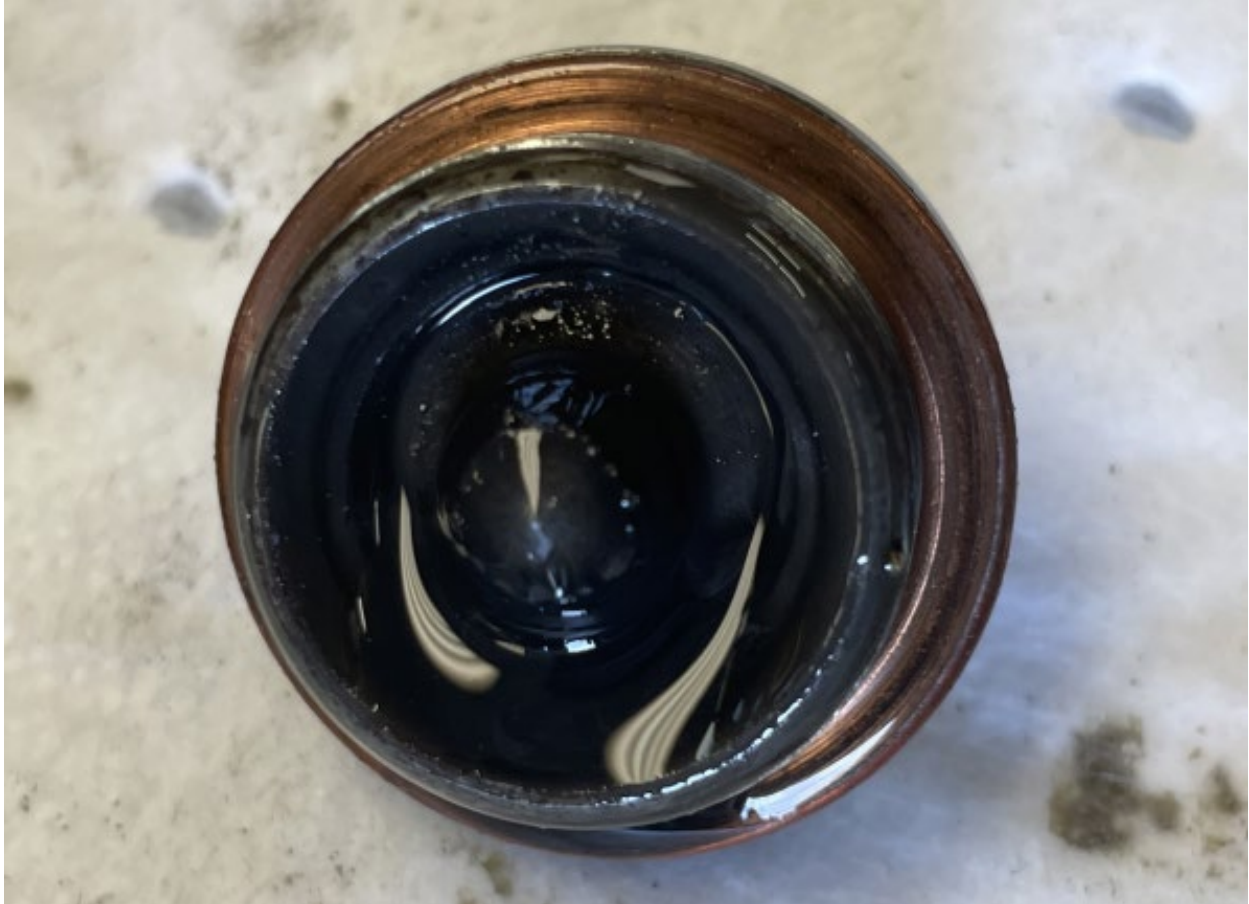
**Picture 19 - Oil Sump Magnetic Chip Detector**

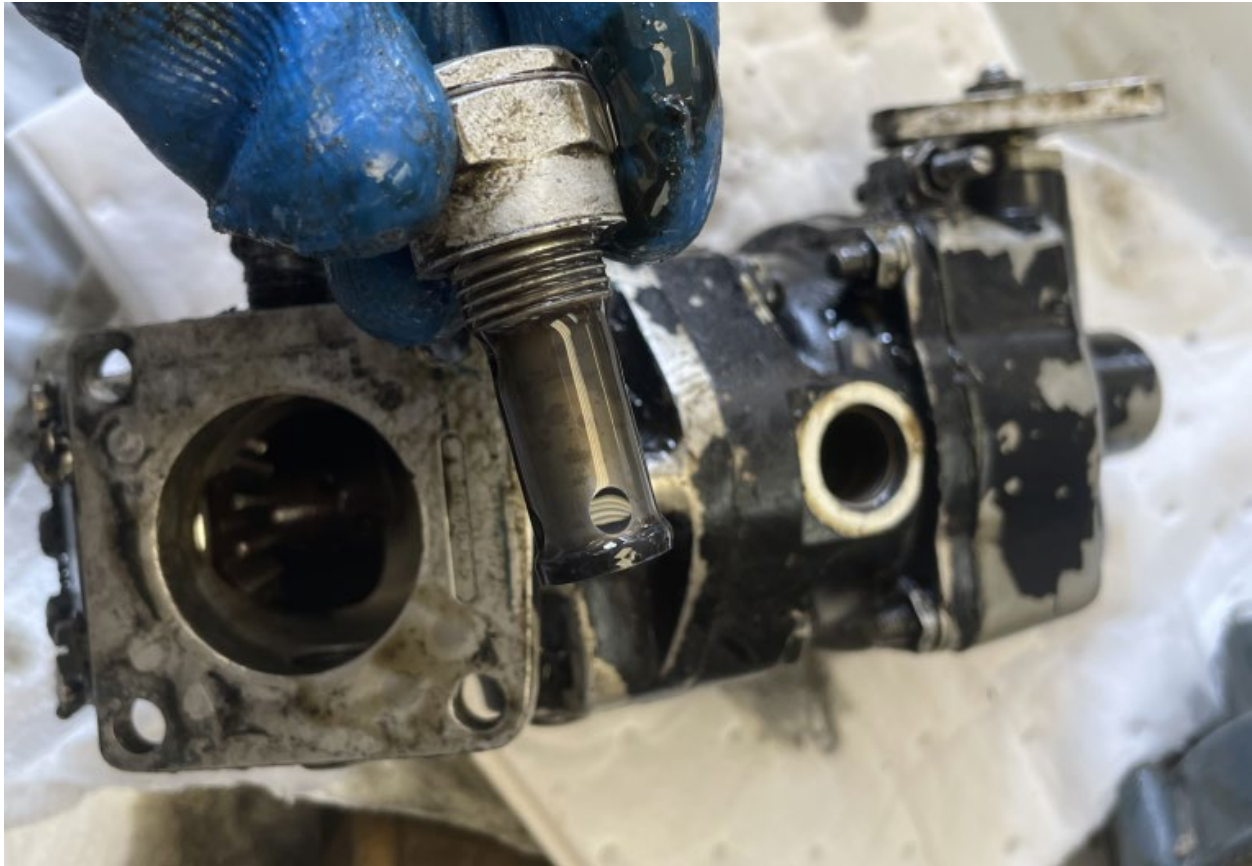
The propeller governor remained secure to the accessory case, but the control cable had been compromised from the accident sequence and was no longer attached. The damage appeared to be from impact with the ground. The governor was removed, and the screen was free of debris or foreign materials. No issues could be found with the propeller governor.

**Picture 20 - Propeller Governor**
