Fairchild 24 N81210 CEN25LA245

Greeley 07/09/2025 accident, ground loop with substantial damage to the left gear leg and left wing. No injuries.

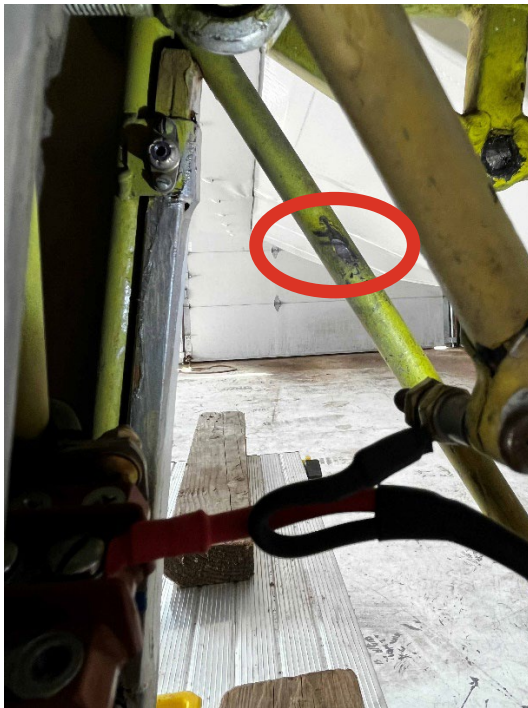
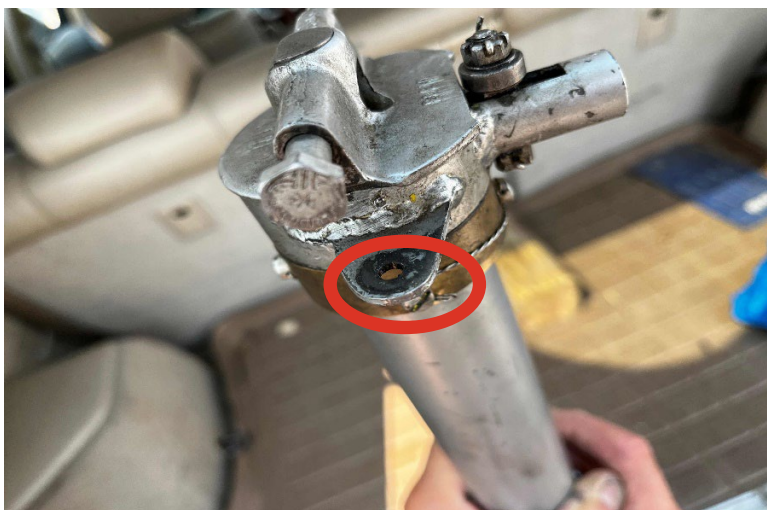
Rub marks were visible on the right diagonal steel tubing in the tail structure where the steering arm of the tailwheel assembly had been making contact.

These wear mark observations could only be made after the removal of the steering post and would not have been visible during a routine annual inspection.

The statements made by the pilot that he put in a correction to the right and the plane would not turn in that direction can be explained by the steering arm rubbing or getting caught behind the aircraft structure.

It is the opinion of this inspector that these tailwheel steering issues happened under load and likely could not be reproduced during maintenance inspections.
