CEN25LA278

## INVESTIGATION PHOTOGRAPHS

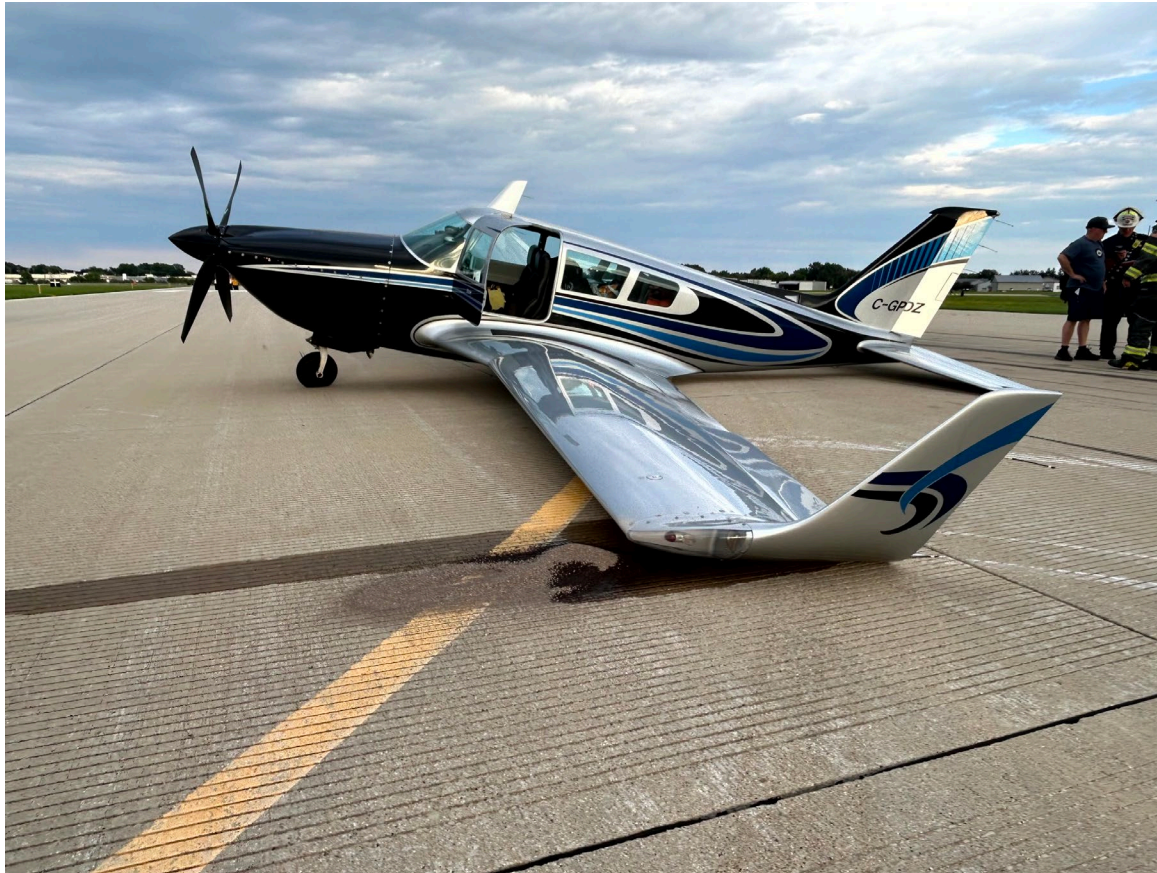
**Photograph 1 - Airplane on runway 9 (Courtesy of FAA)**

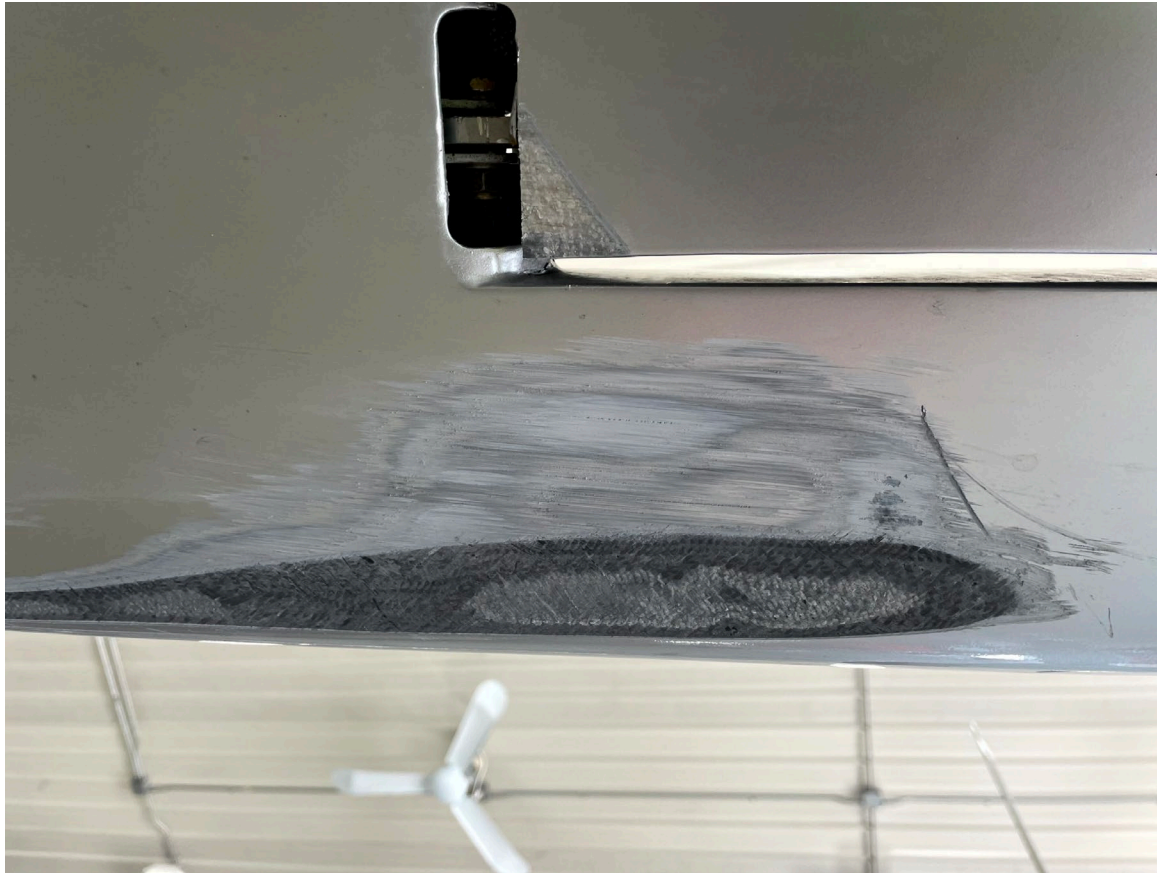
**Photograph 2 -Damage to left wing (Courtesy of FAA)**

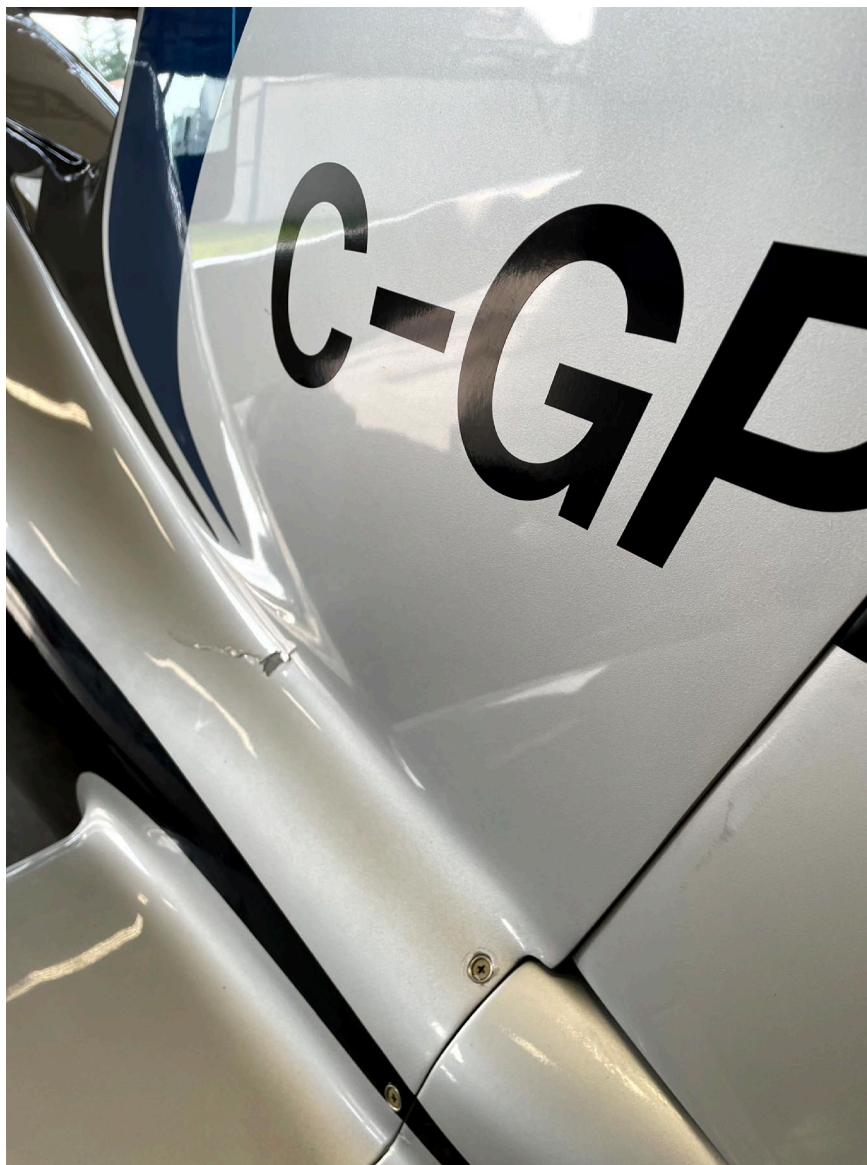
**Photograph 3 - Damage at aft fuselage/empennage (Courtesy of FAA)**

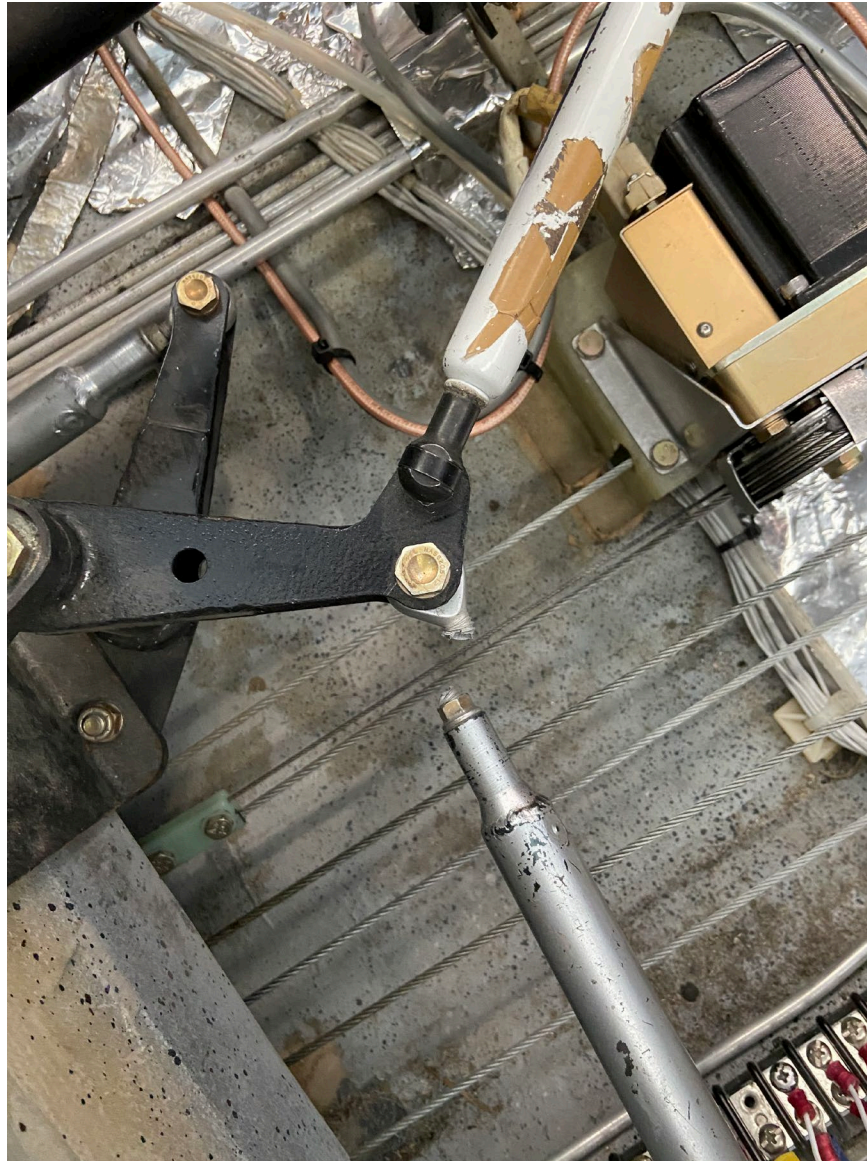
**Photograph 4 - Left main landing gear lateral pushrod (Courtesy of FAA)**
