**From:** [REDACTED]  
**Sent:** Wednesday, September 3, 2025 3:44 PM  
**To:** Joshua Lindberg  
**Subject:** RE: N83PS New Holstein WI

On July 26, 2025, at 1533z / 1033 CDT, an Aerotek Pitts S-2A, piloted by its owner from the back seat with a passenger in the front seat, diverted from Wittman Regional Airport (KOSH), WI, to new Holstein Municipal Airport (8d1), WI, due to an unlatched canopy. The aircraft ground looped after landing on a dry concrete runway 32, resulting in substantial damage to the right wing and empennage, and causing the collapse of the Right main and tail landing gears. The intended destination was Austin Straubel International Airport (KGRB), WI .

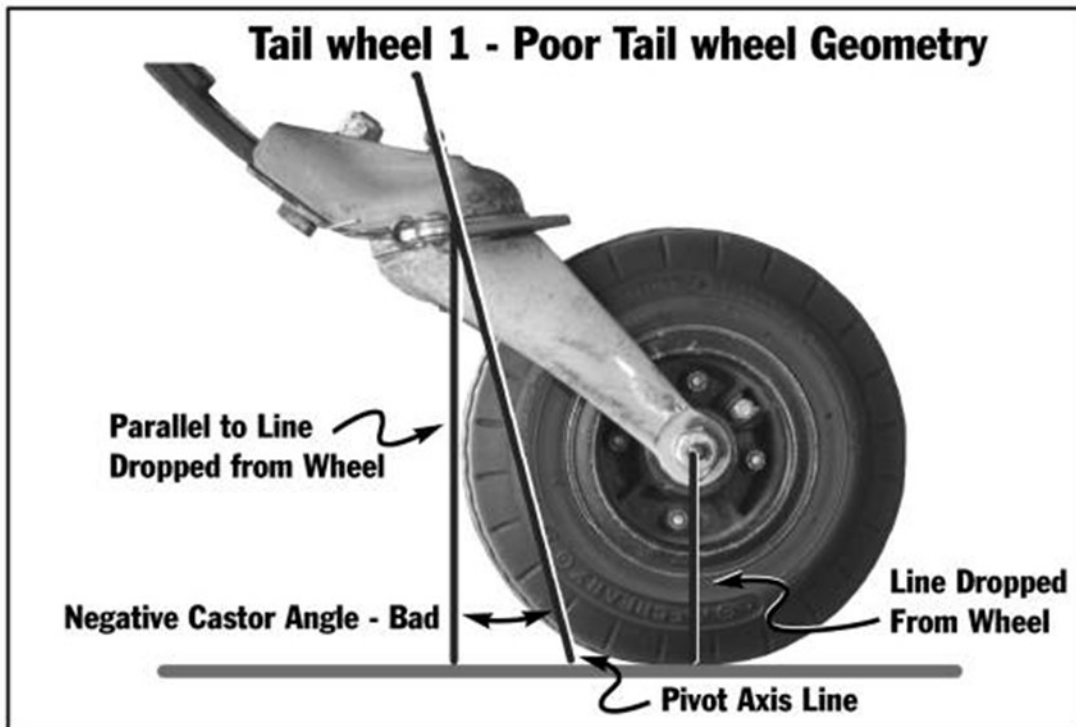
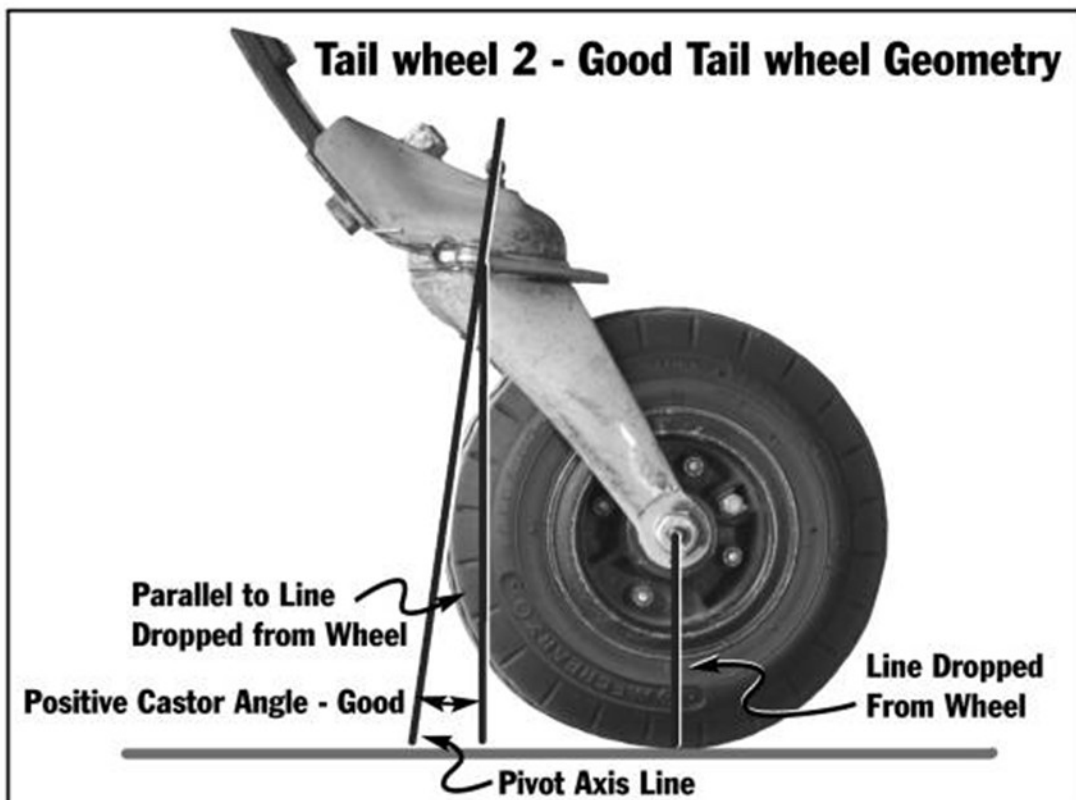
The installation of the unapproved tailwheel assembly and tail spring contributed directly to the tailwheel's oscillating skid marks observed upon landing, heightening the risk of a ground loop. An incorrect tailwheel or tail spring assembly can create a negative caster angle, further exacerbated by the additional weight of a passenger, leading to reduced trail and increased shimmying. Moreover, rudder springs that were connected but not

I have been off work [REDACTED] the last two days but saw your email I do plan to get the -23 complete by next week. Anyway, what I discovered so far as to the aircraft [REDACTED] is that the tailwheel assembly was replaced three times with a different model. The original Maule Tailwheel SFS-1-14 replaced by a Scott 2000 series, the Scott 2000 series tailwheel replaced by a Maule tailwheel model SFSA, the Maule tailwheel model SFSA replaced by the Aviation Products 6134, The only approved change was via the FAA Form 337 Major Repair and Alteration - Airframe, Powerplant, Propeller, or Appliance on 06 January 1978. The Aviation Products tailwheel is utilized on experimental aircraft (at least would need field approval to be installed on this, N93PS, certified Standard/ Acrobatic aircraft). The Aviation Products tailwheel has a much longer tail spring, than the Maule & the Scott....this can change a lot of things....impact the fail-limit of the aircraft airframe (that square extruded frame member – see attached picture 6158c). Also, but not verified, creating a negative castor, especially with more weight in the aircraft (during the accident the aircraft was flown with the pilot in the aft seat, and passenger in the front seat...that is the pilot was not the sole occupant in this flight). A negative castor will create a shimmy.

Tail wheel with positive and negative castor angles—exaggerated.  
 The terms positive and negative are simply the naming convention I choose to use, as they agree with my textbook references.
