CEN25LA294

## INVESTIGATION PHOTOGRAPHS

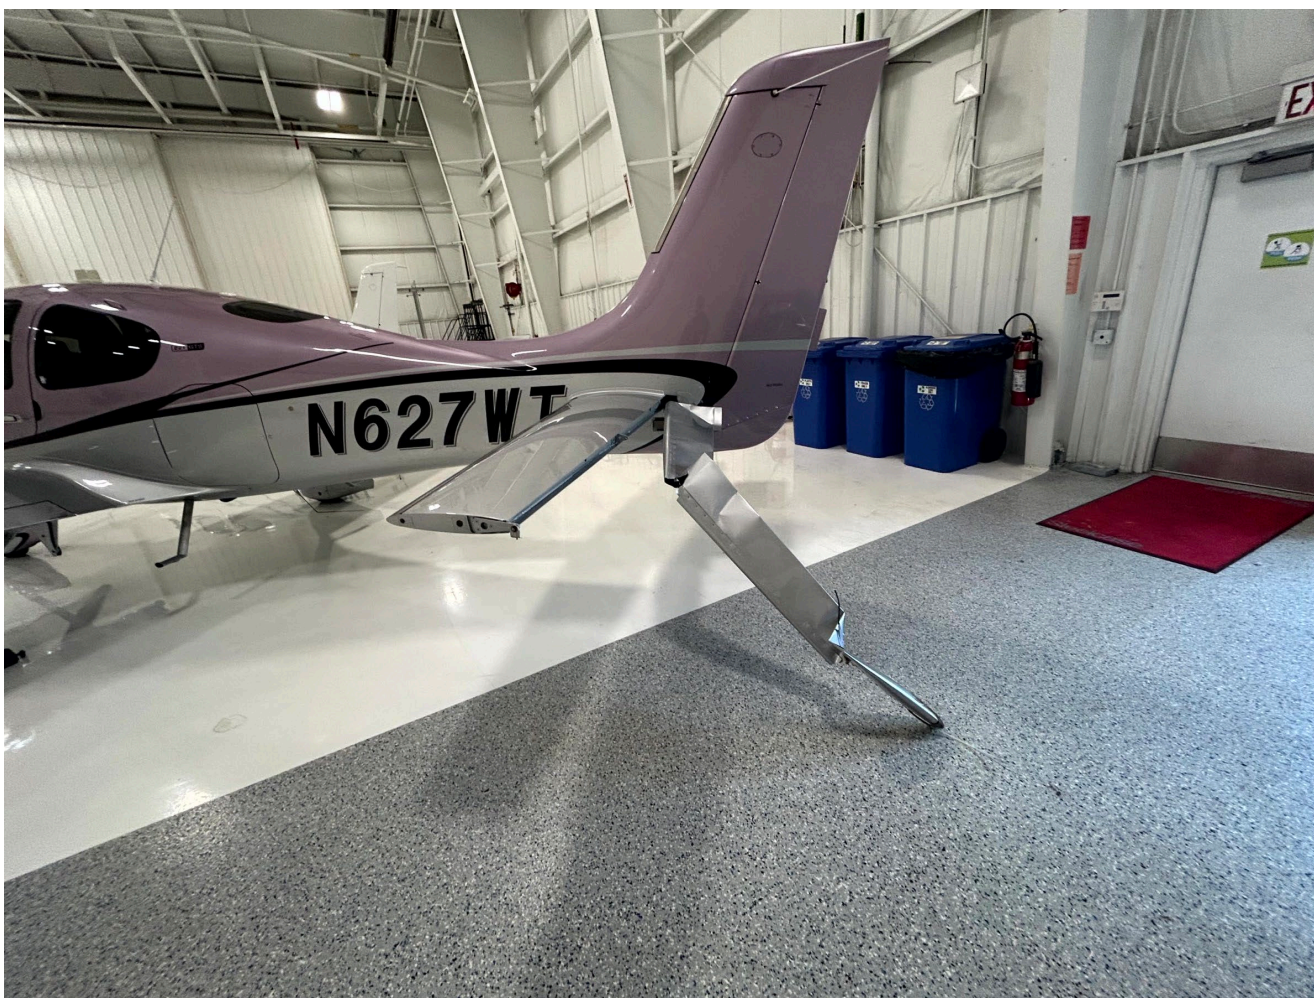
**Photograph 1 - Left Elevator Damage (Courtesy of FAA)**

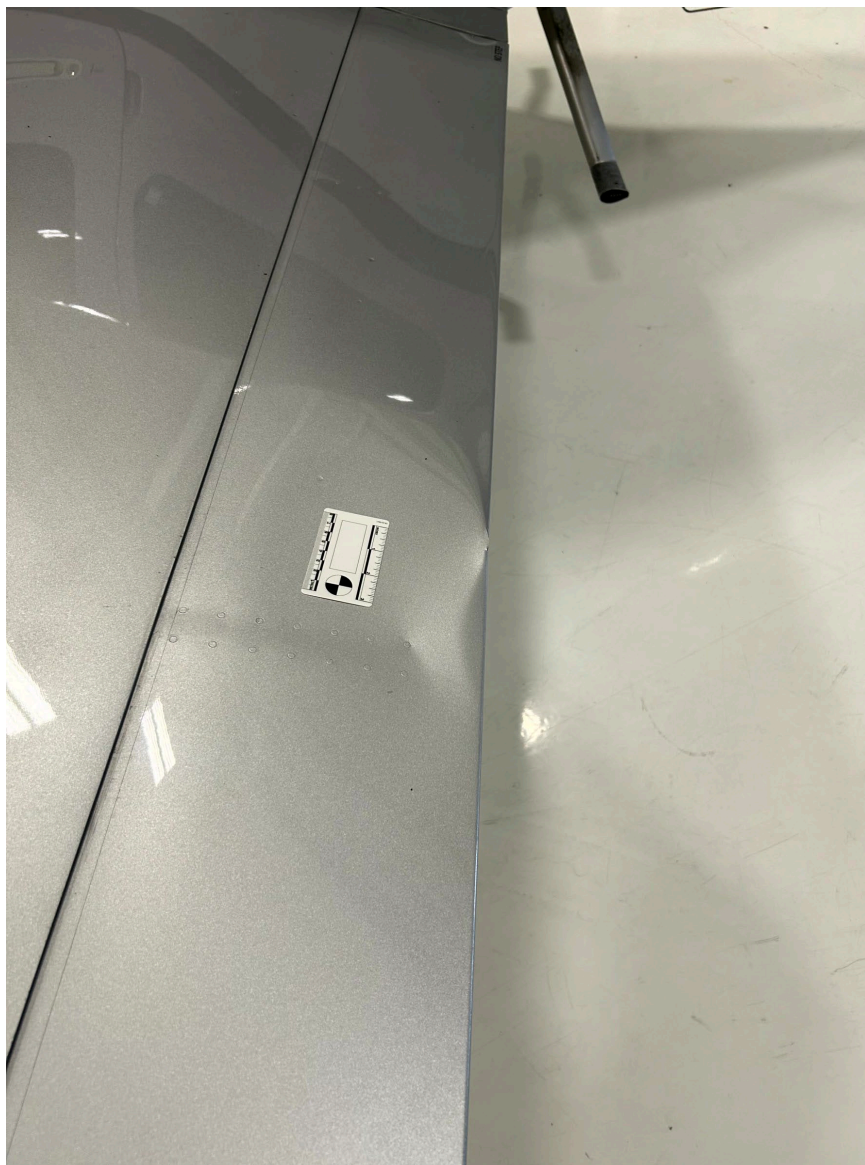
**Photograph 2 - Left Flap Damage (Courtesy of FAA)**
