National Transportation Safety Board

CEN25LA299

## INVESTIGATION PHOTOGRAPHS

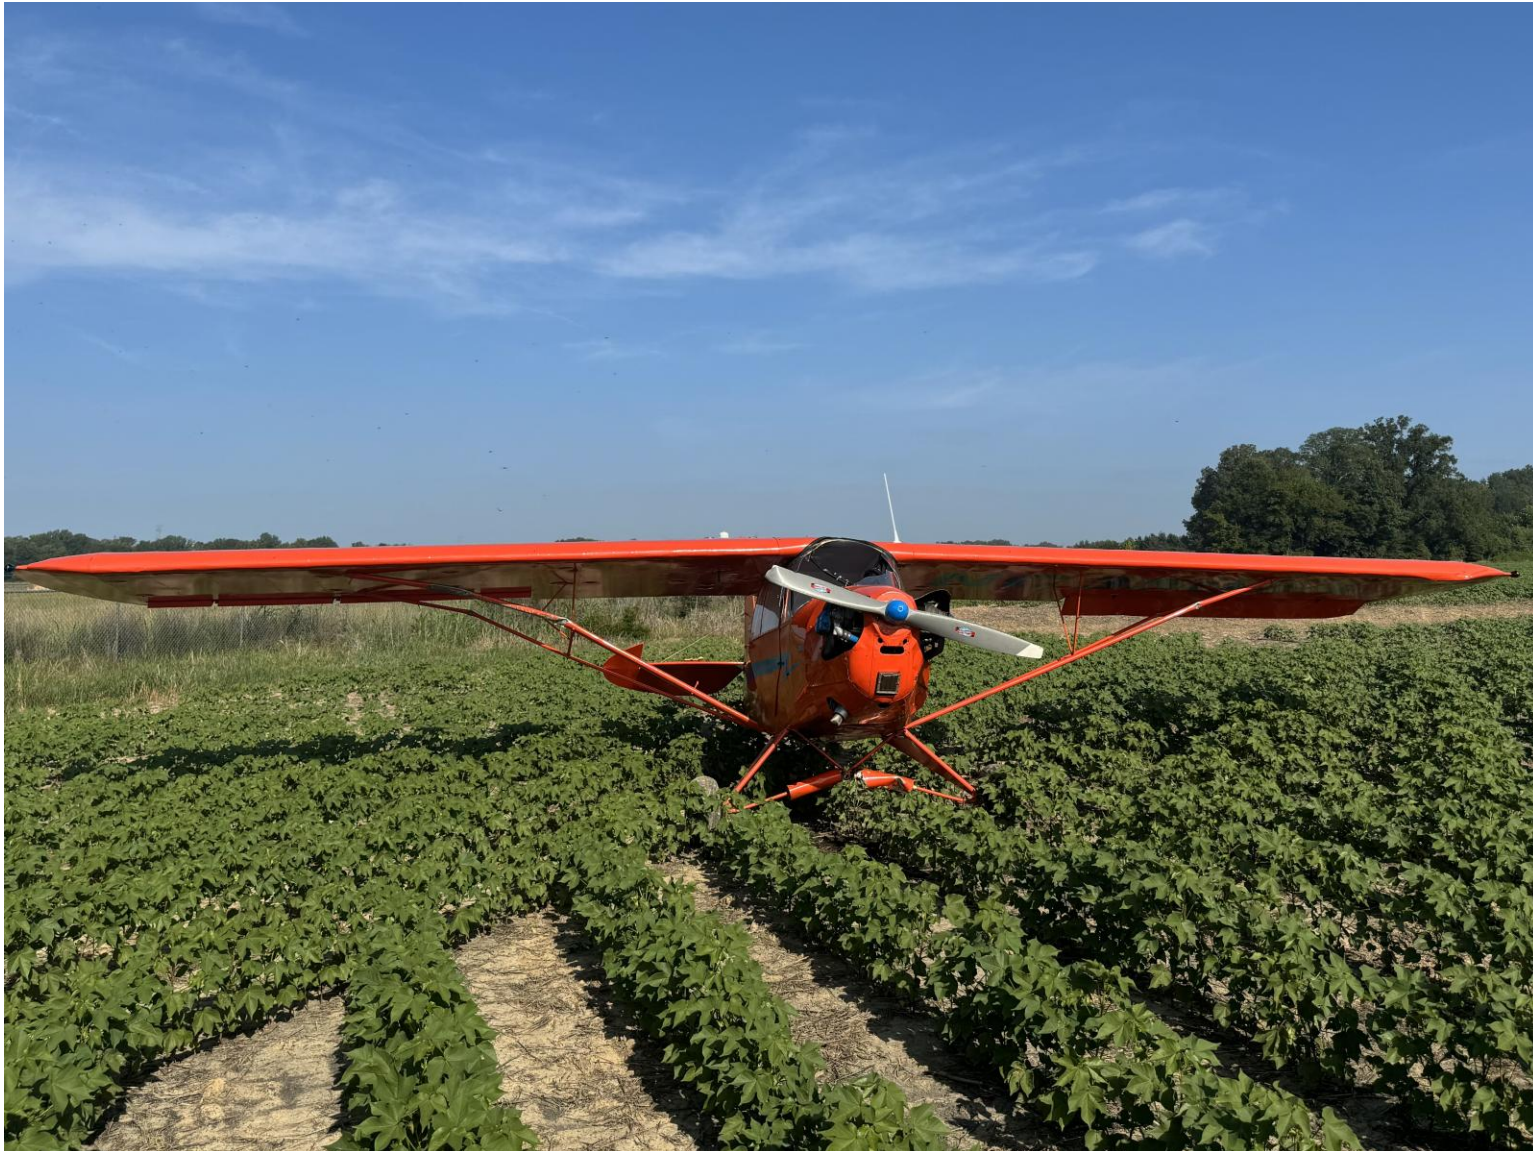
**Photograph 1 - Airplane at accident Site (Courtesy of FAA)**

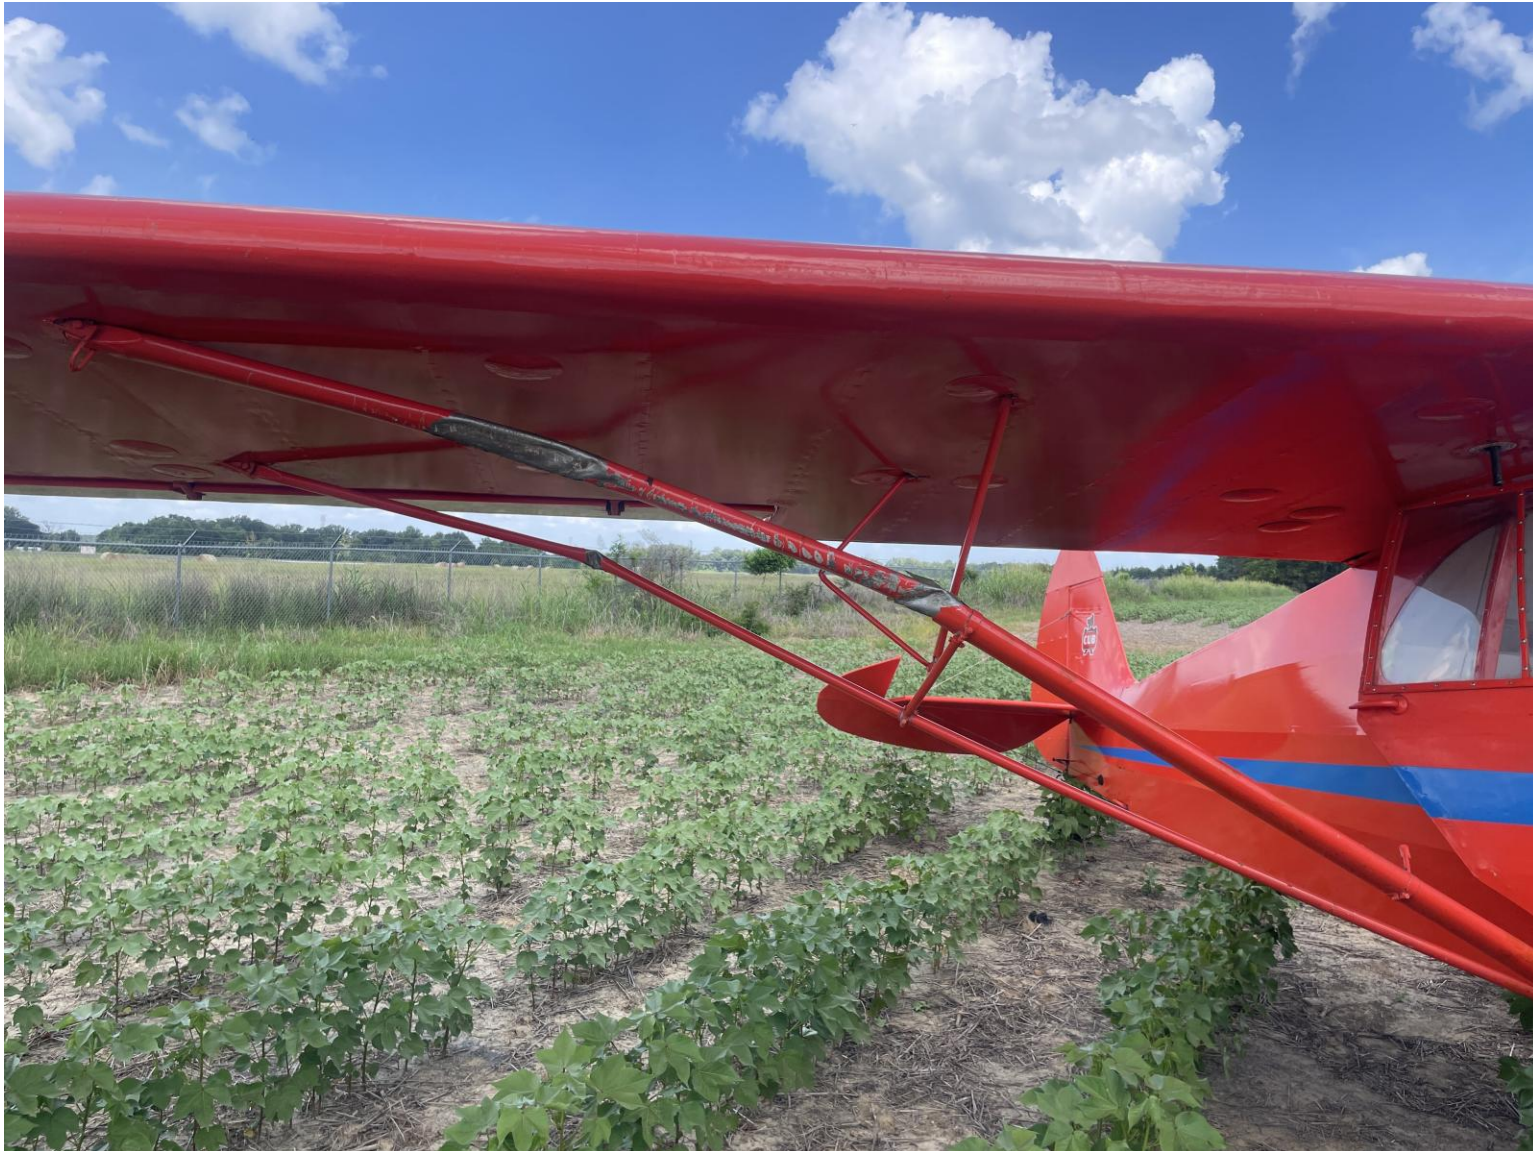
**Photograph 2 - Right wing strut damage (Courtesy of FAA)**

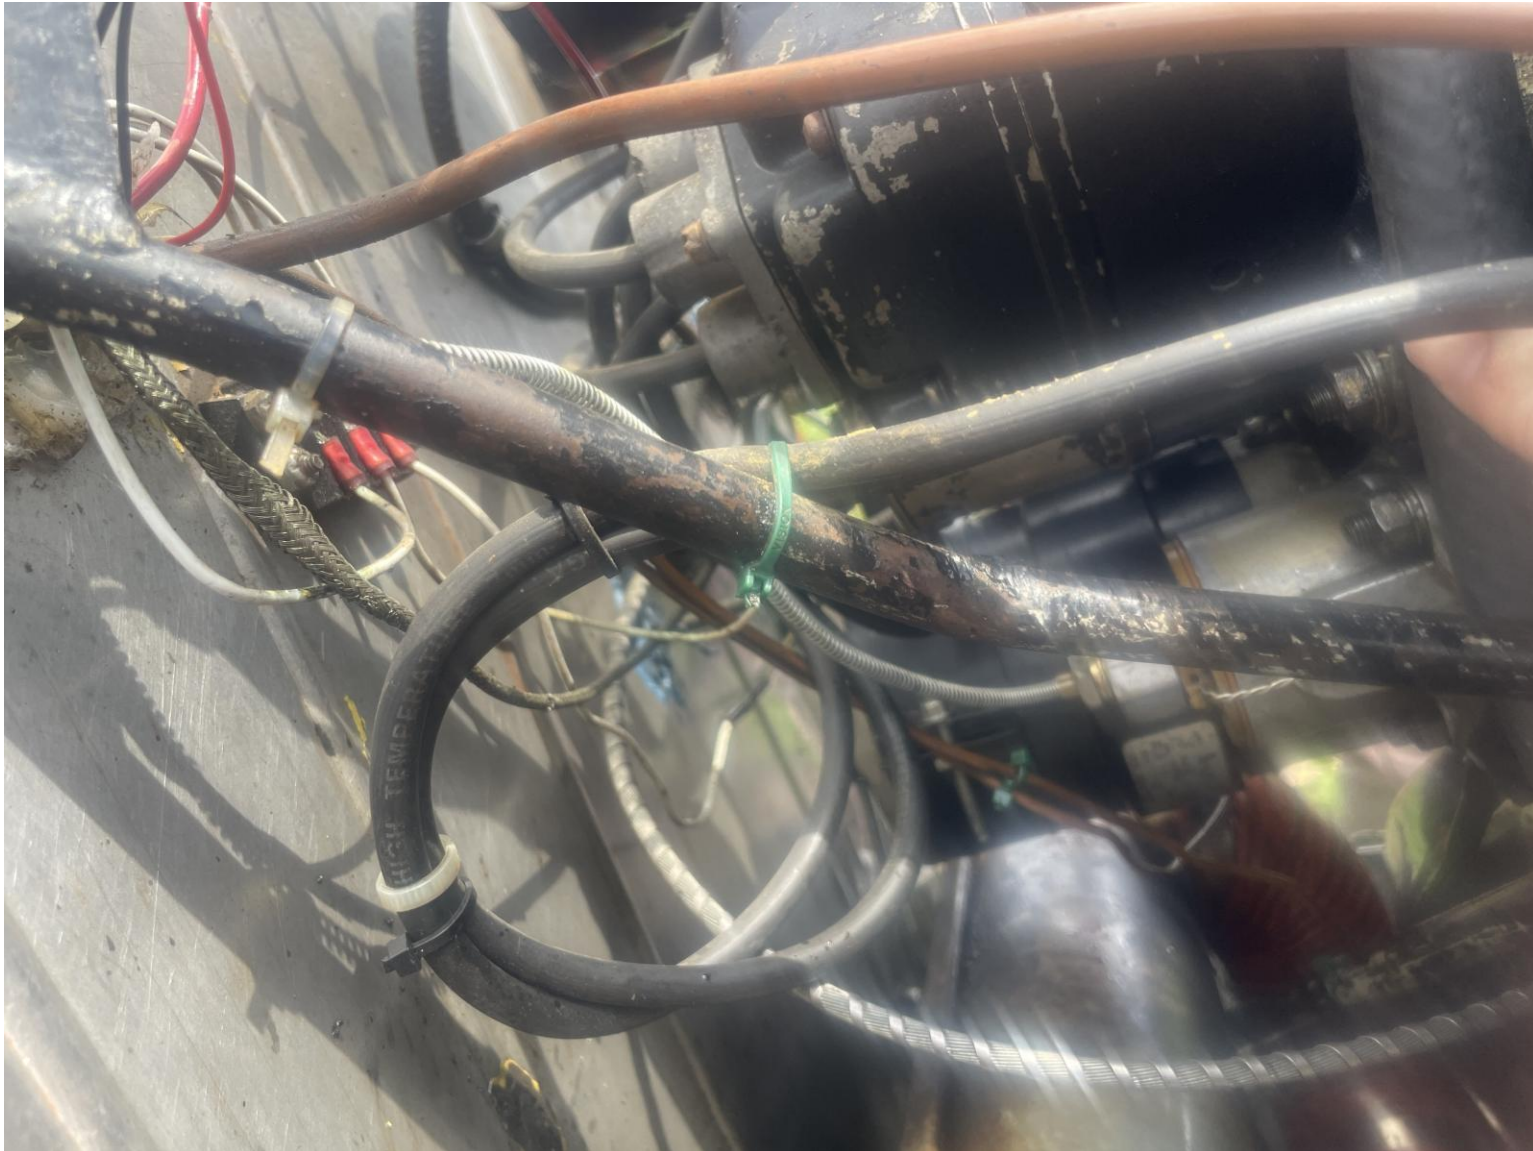
**Photograph 3 - Engine mount tube damage (Courtesy of FAA)**
