CEN25LA322

## INVESTIGATION PHOTOGRAPHS

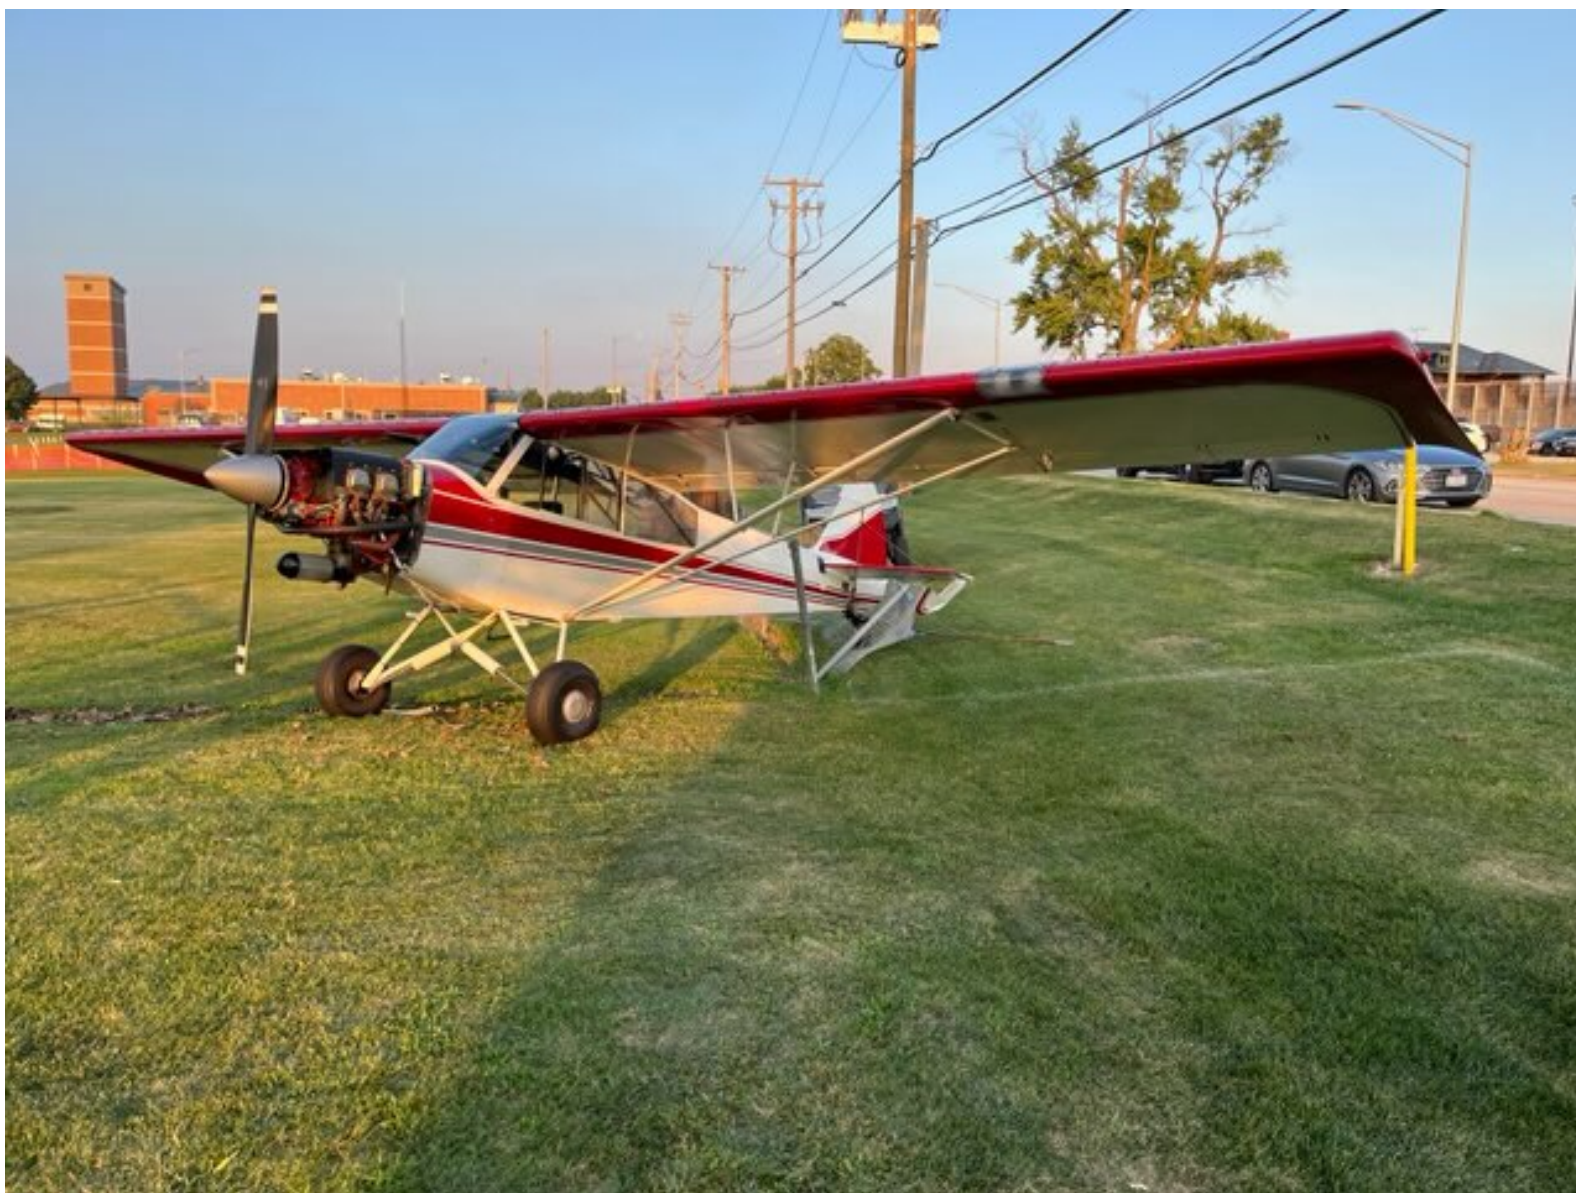
**Photograph 1 - Accident site (Courtesy of FAA)**

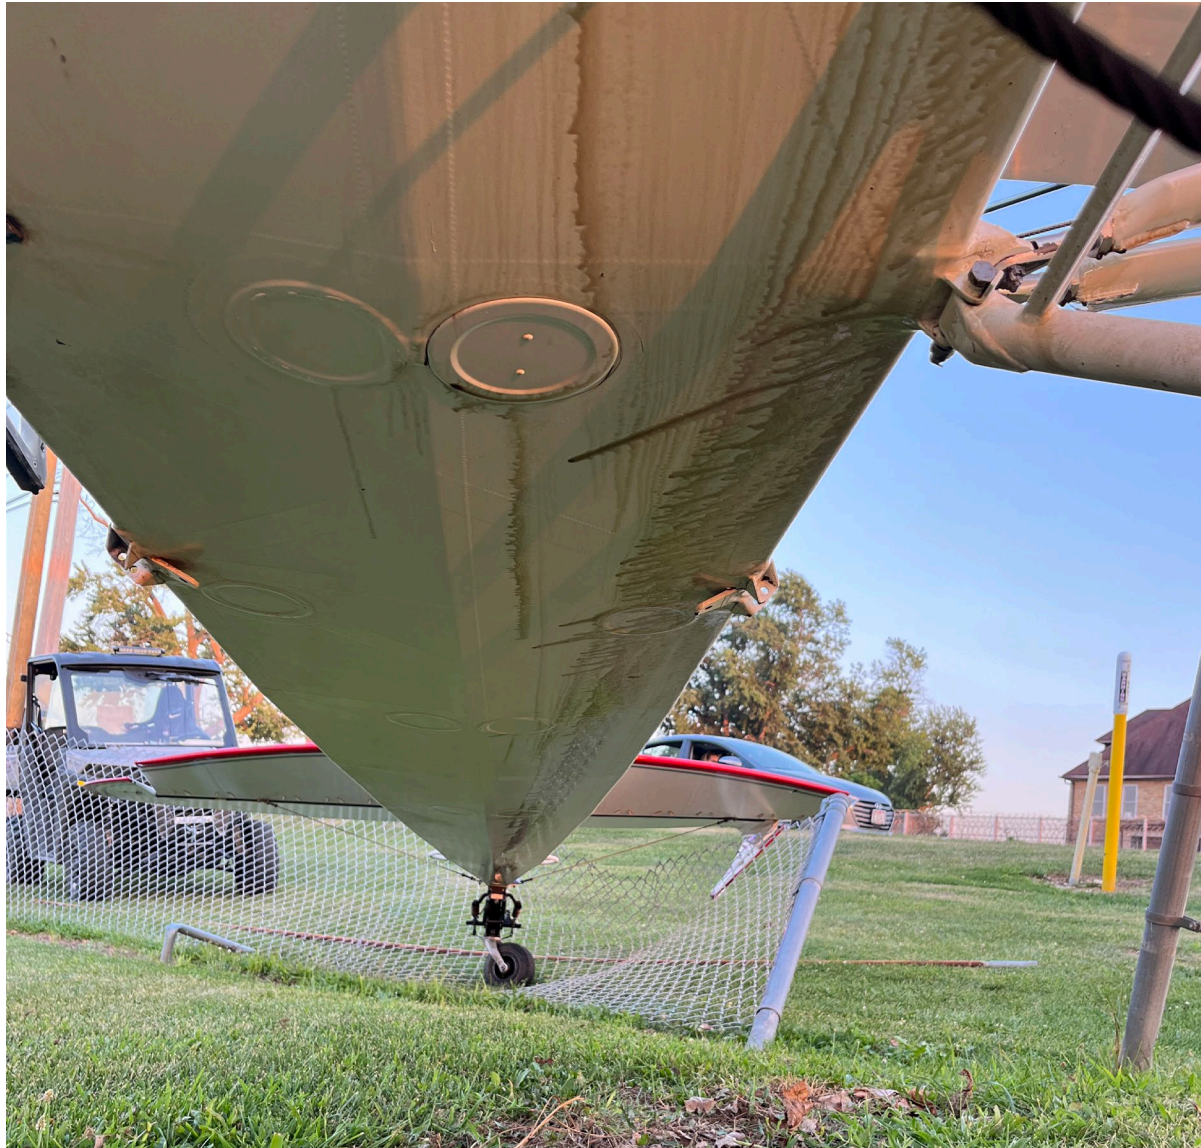
**Photograph 2 - Oil under fuselage (Courtesy of FAA)**

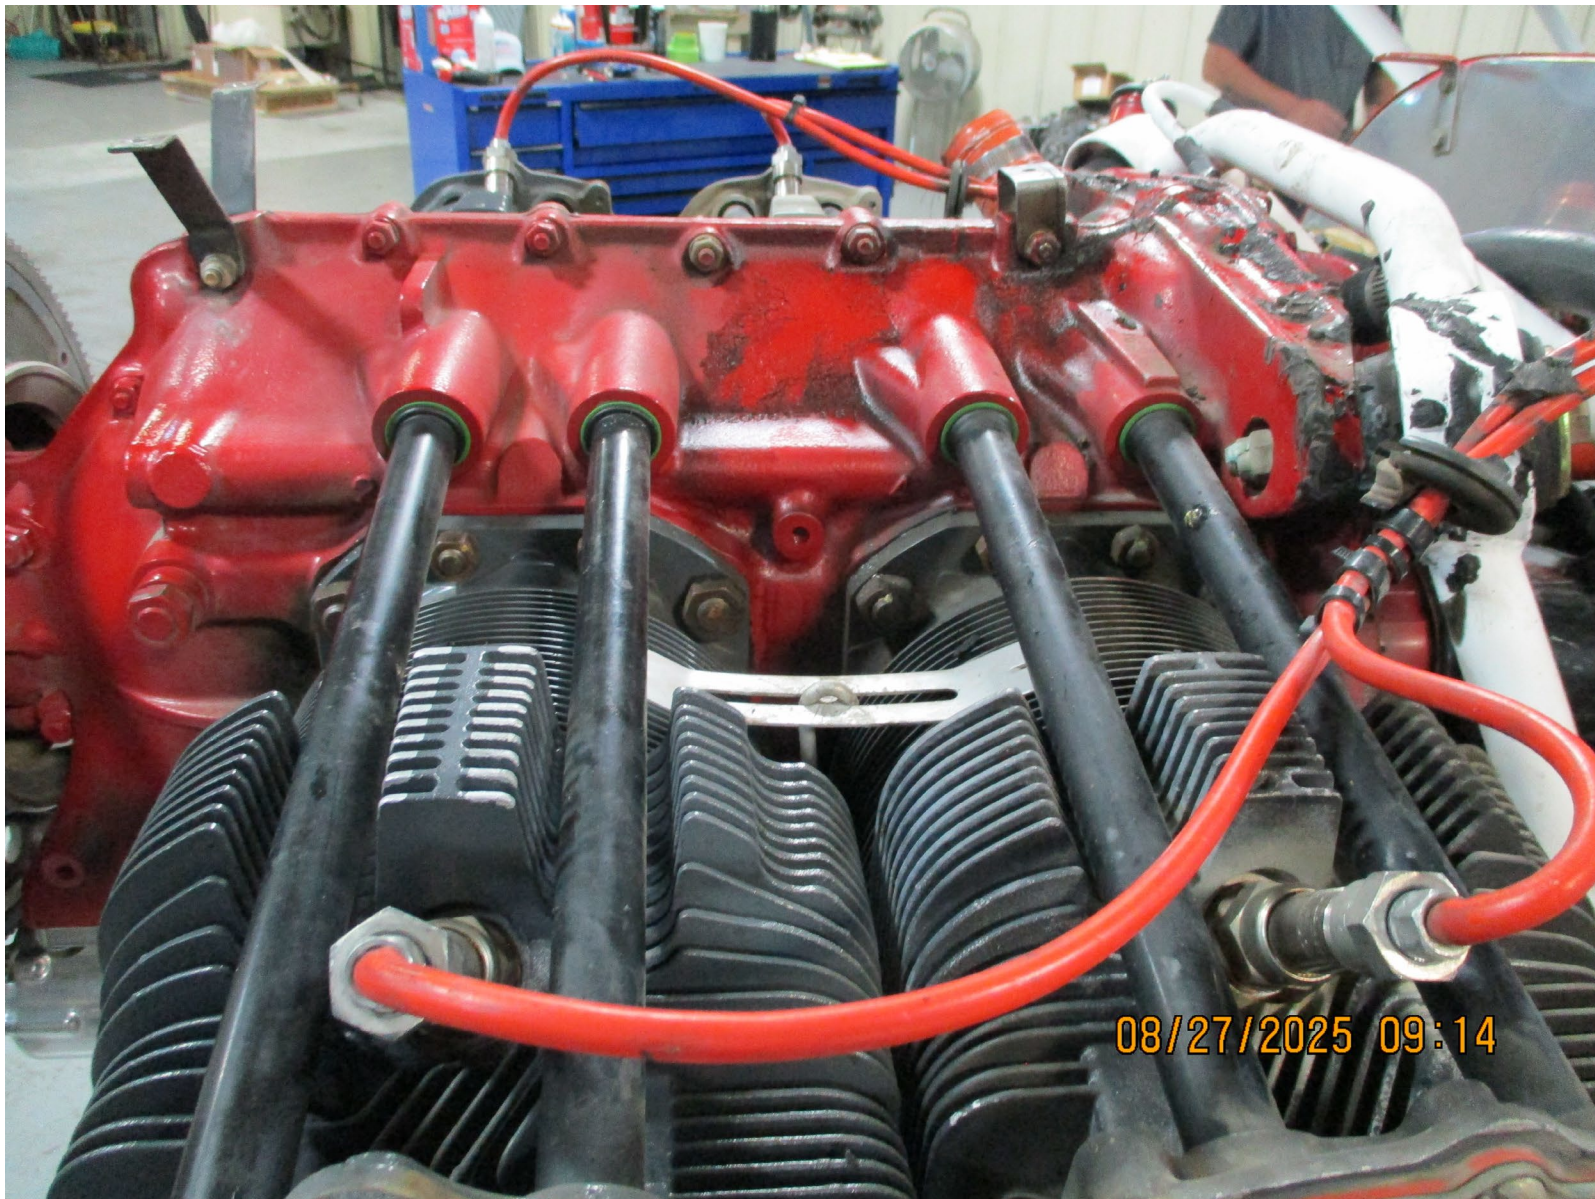
**Photograph 3 - Engine left side (Courtesy of FAA)**

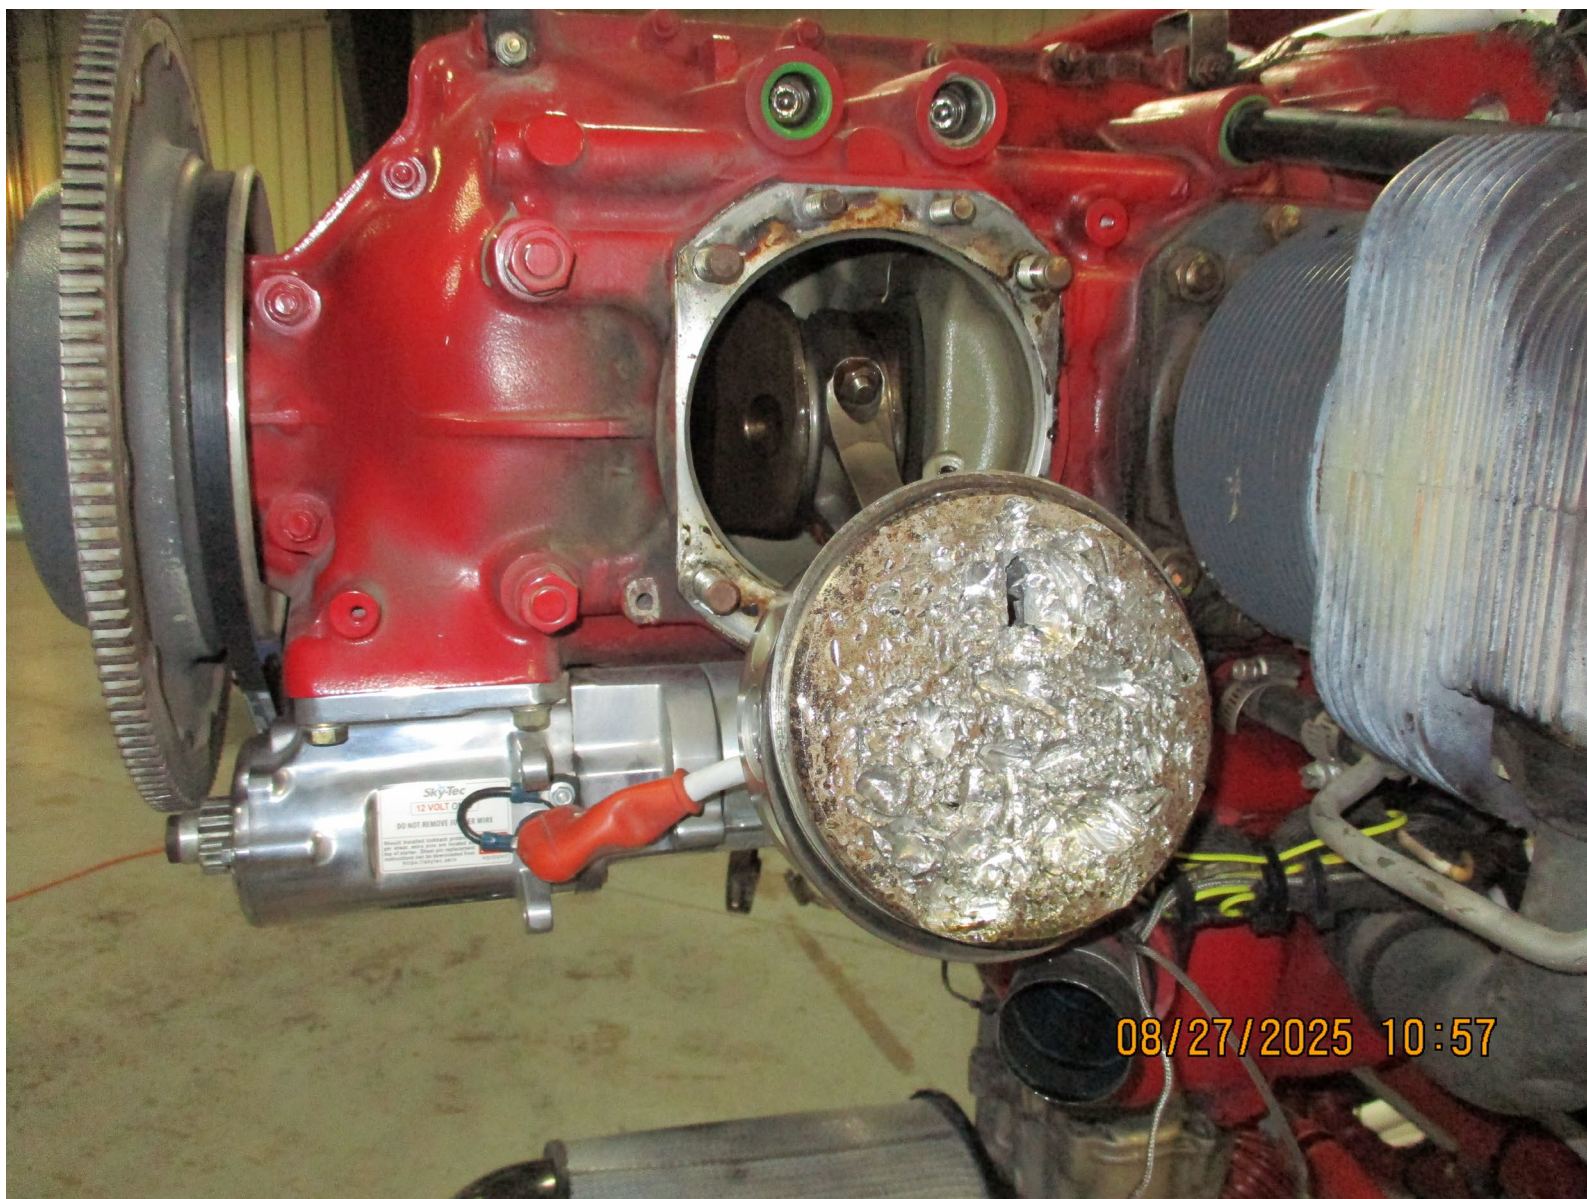
**Photograph 4 - No. 2 piston (Courtesy of FAA)**

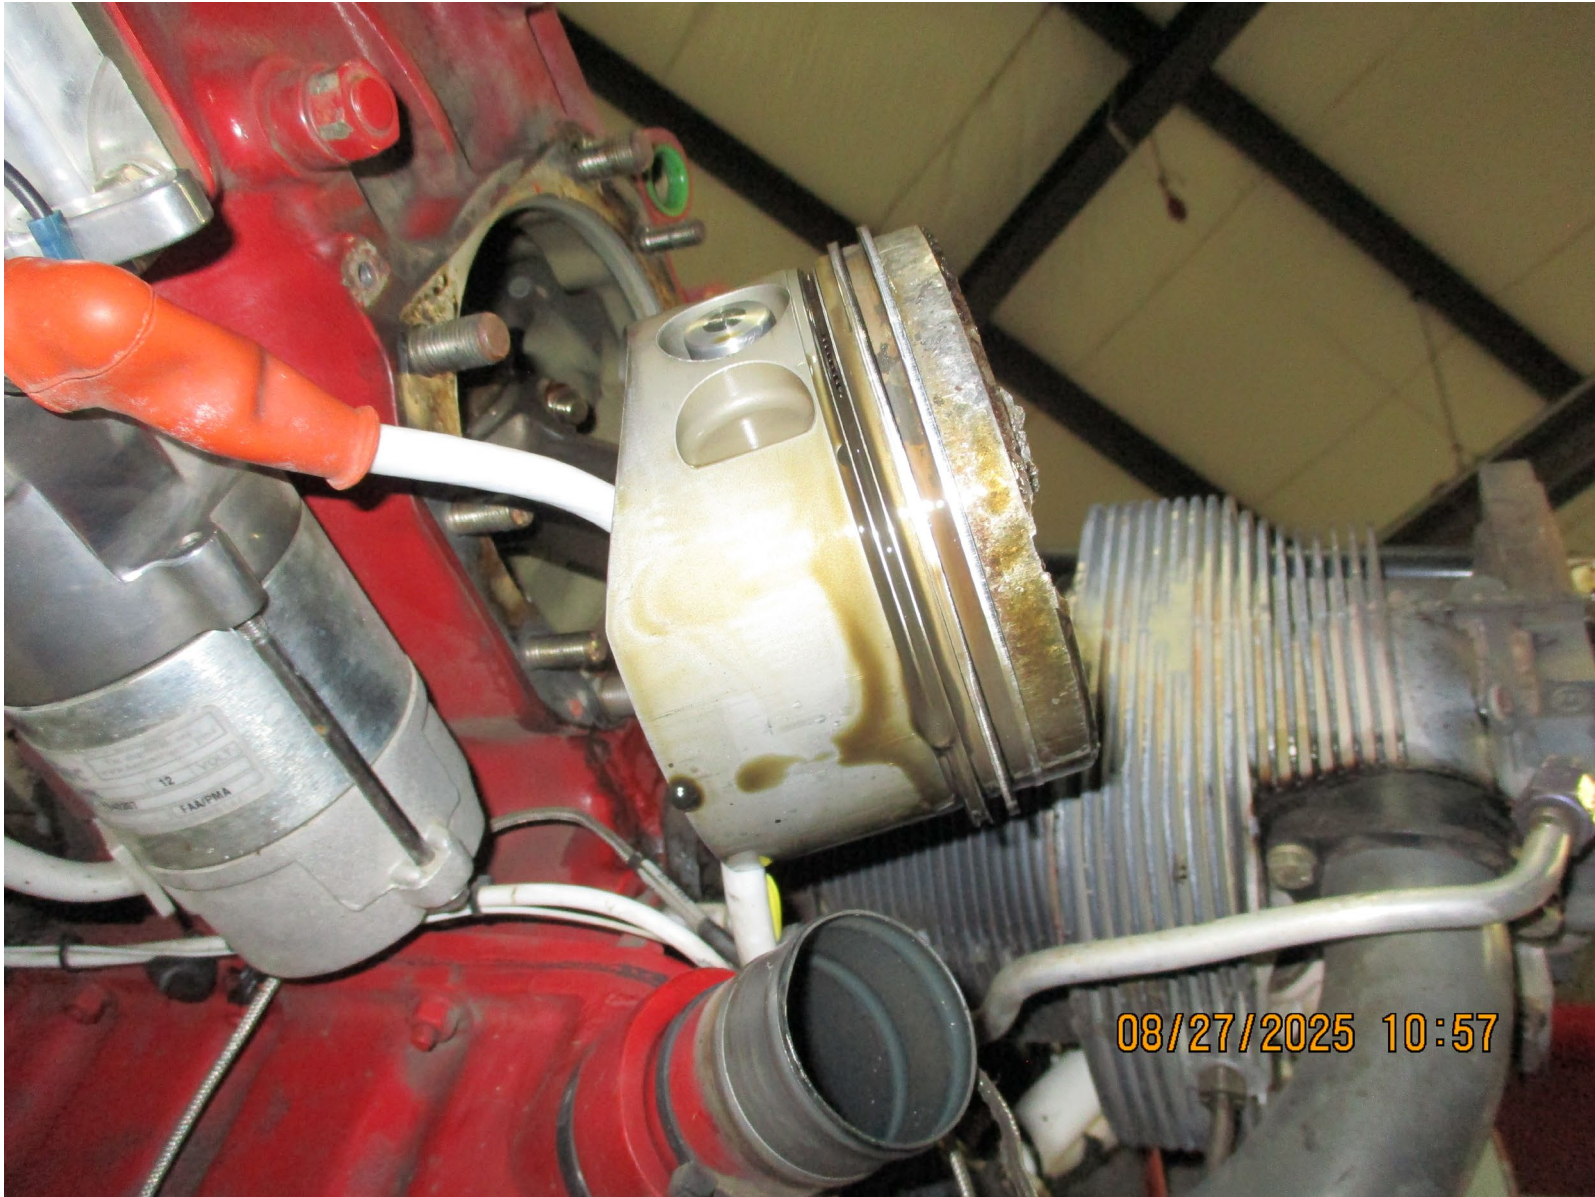
**Photograph 5 - No. 2 piston (Courtesy of FAA)**

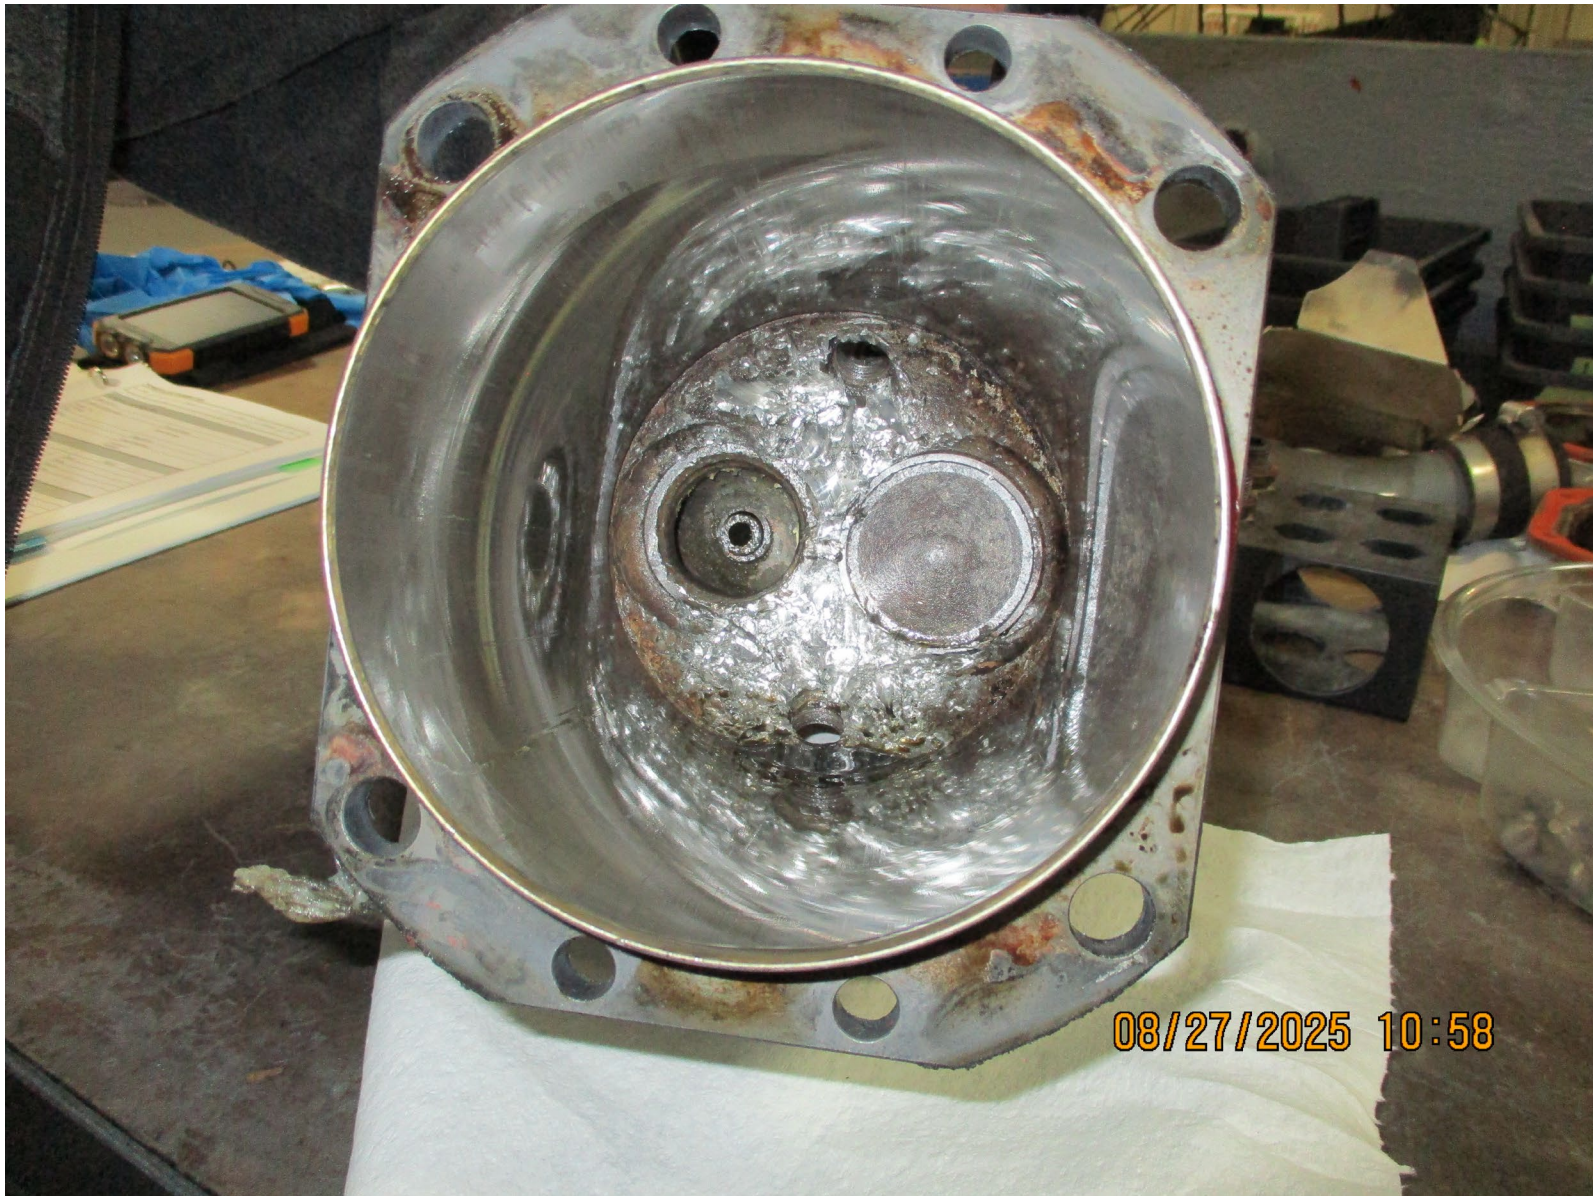
**Photograph 6 - No. 2 cylinder (Courtesy of FAA)**

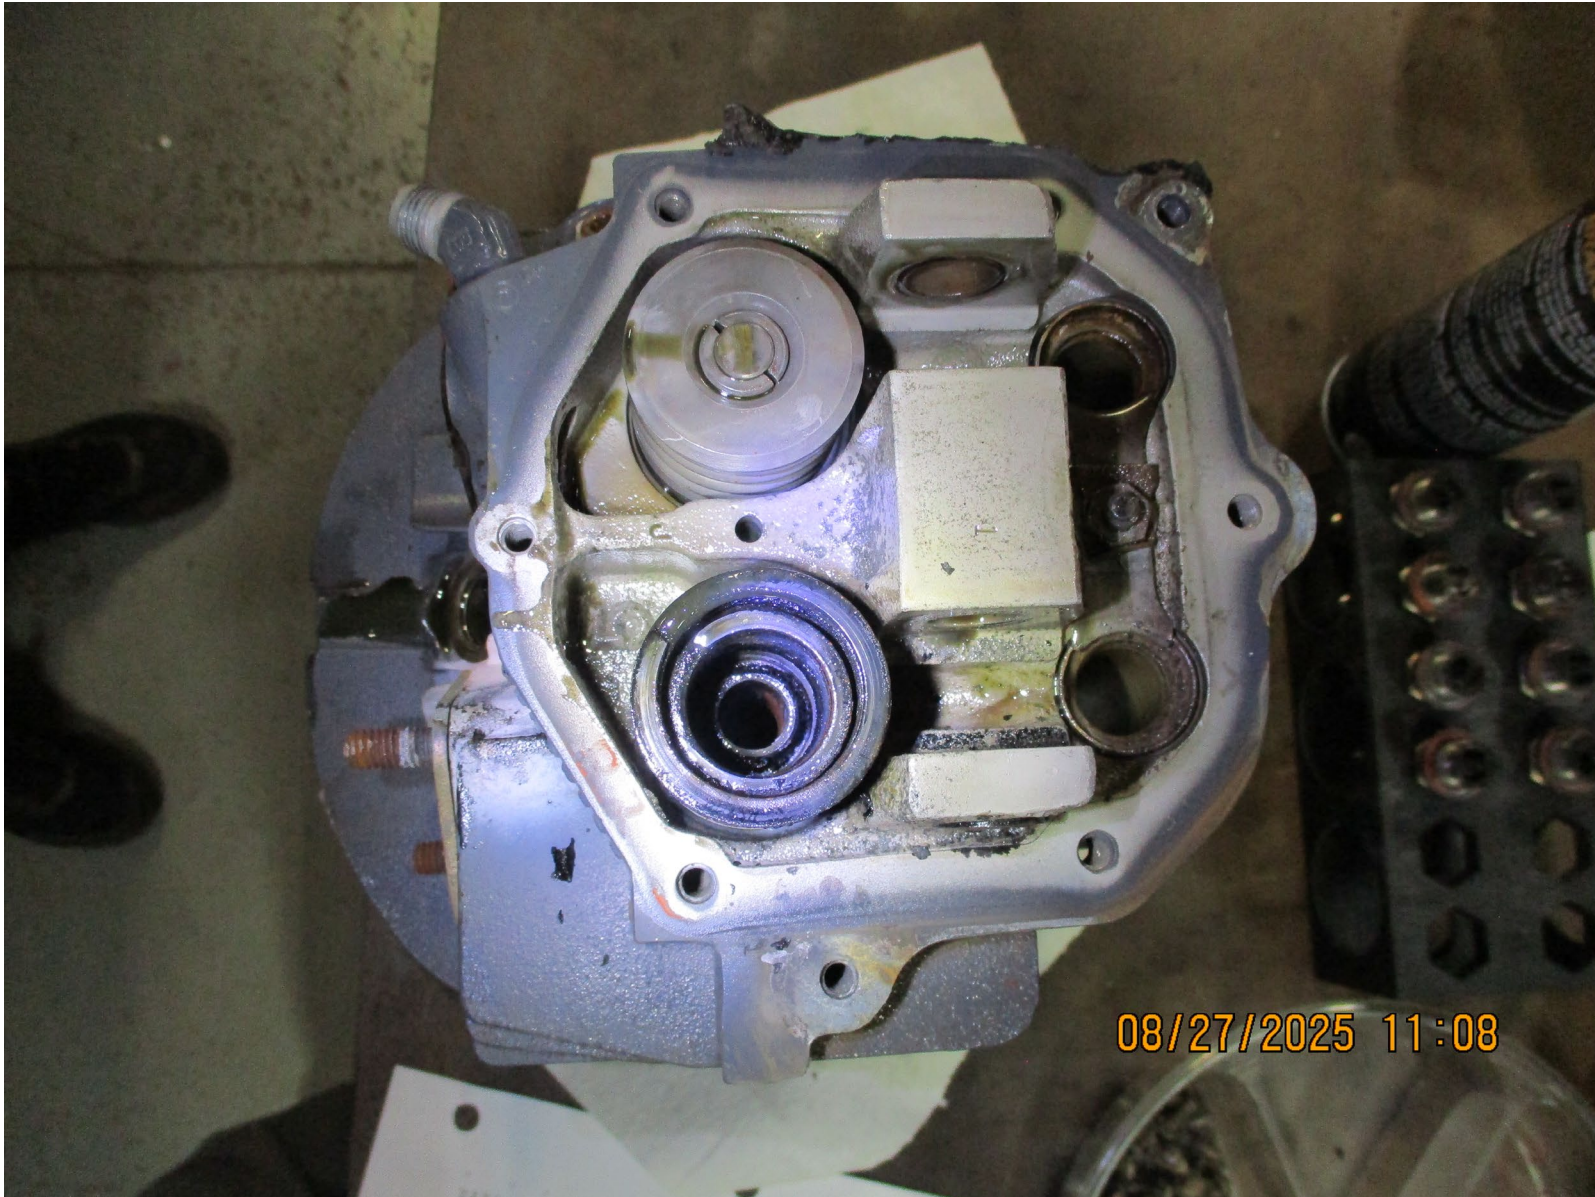
**Photograph 7 - No. 2 cylinder (Courtesy of FAA)**

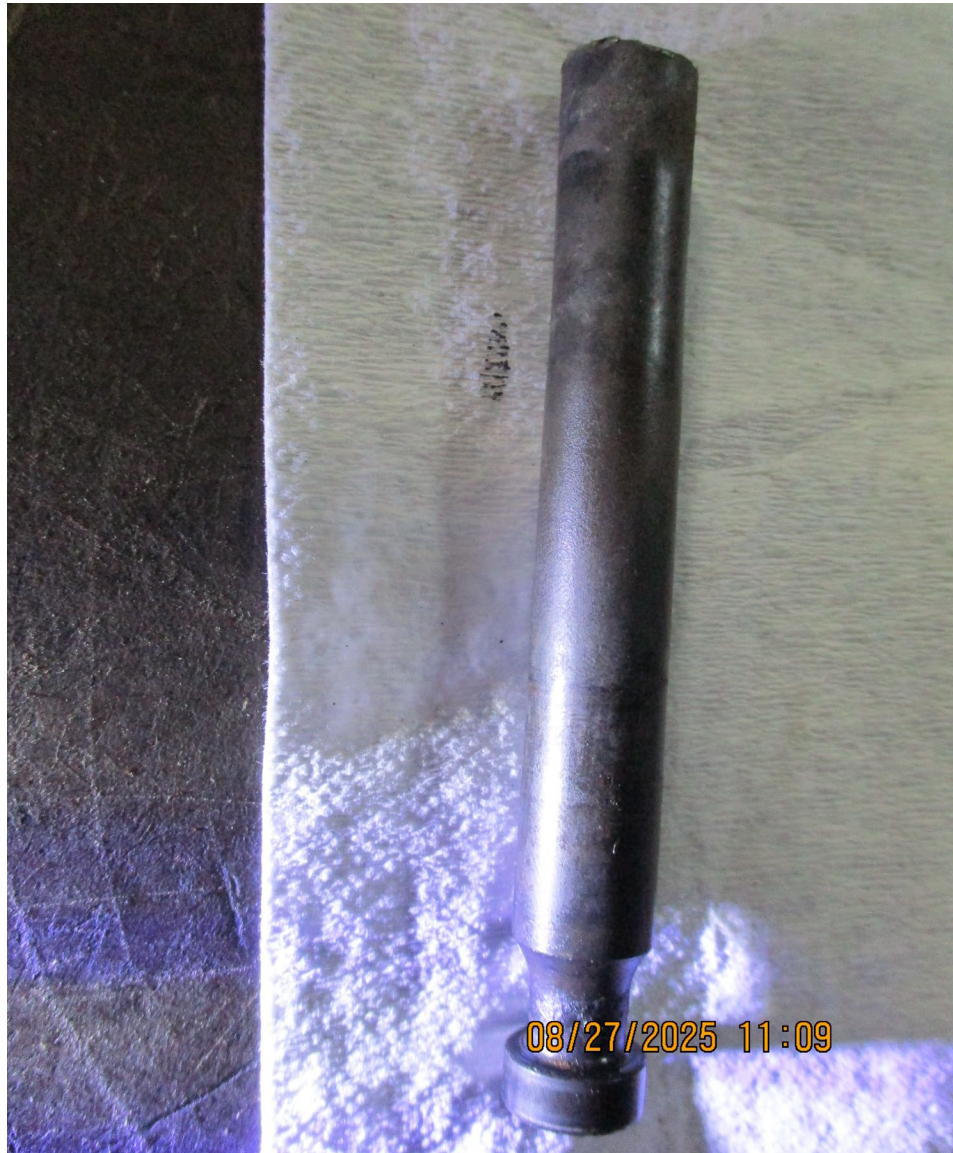
**Photograph 8 - No. 2 exhaust valve stem (Courtesy of FAA)**

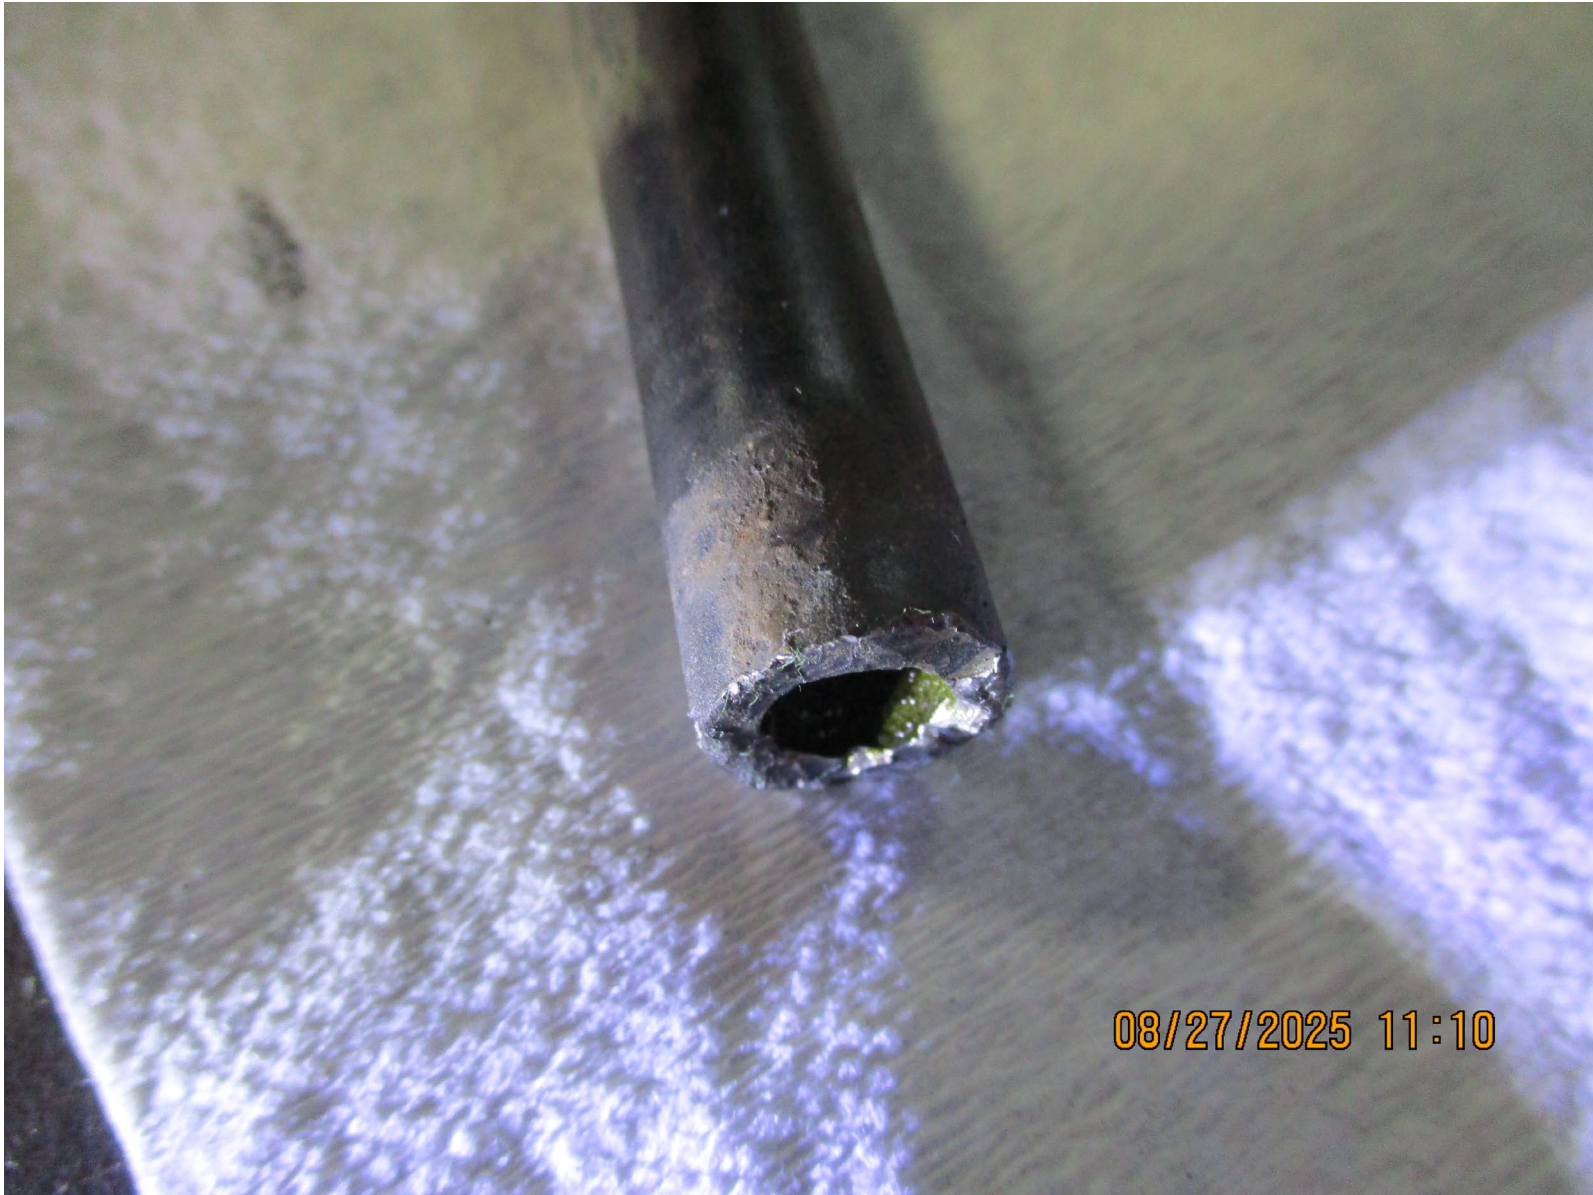
**Photograph 9 - No. 2 exhaust valve stem (Courtesy of FAA)**

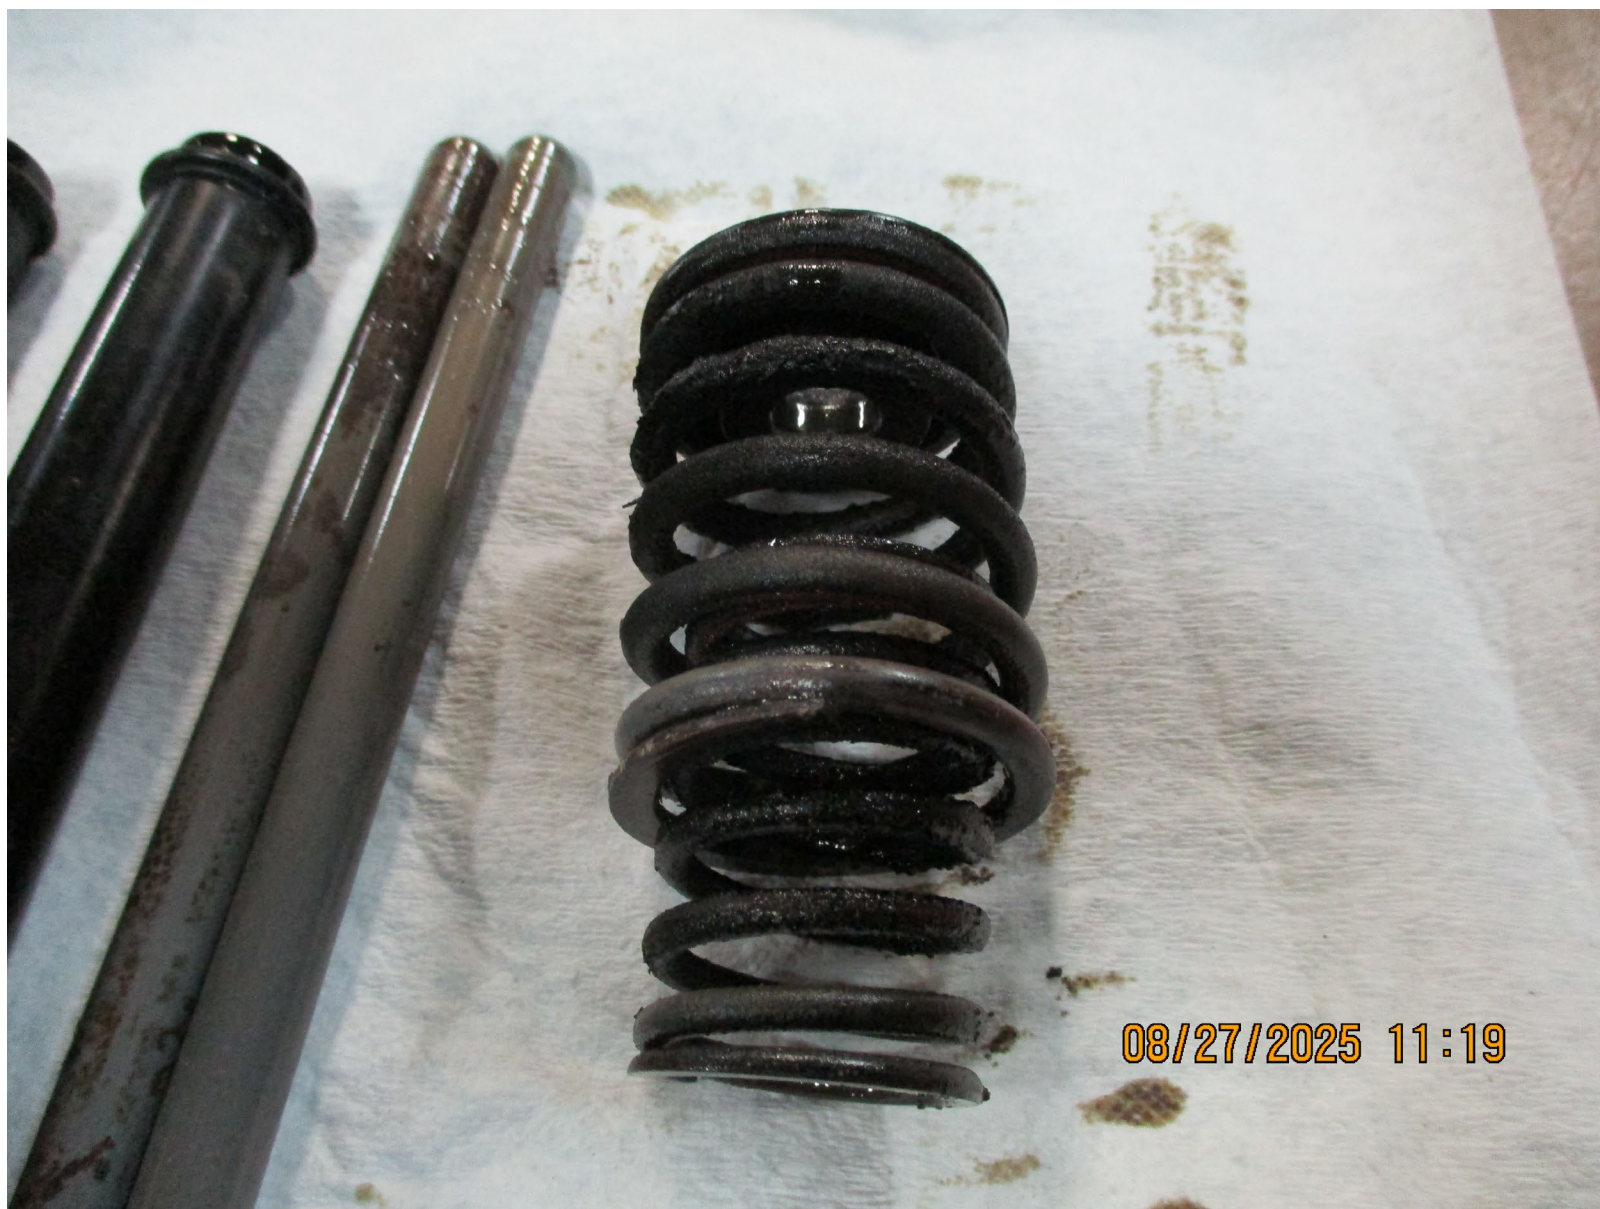
**Photograph 10 - No. 2 exhaust valve springs and push rods (Courtesy of FAA)**
