CEN25LA332

## INVESTIGATION PHOTOGRAPHS

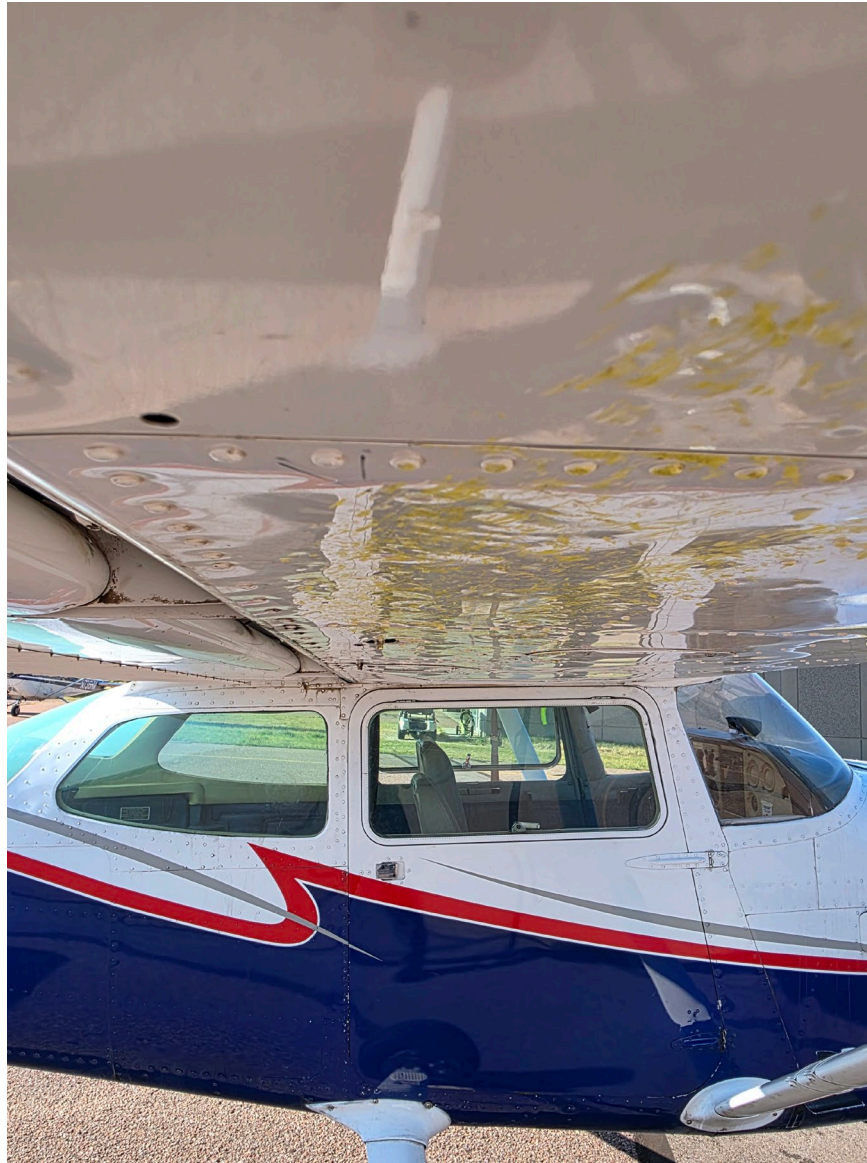
**Photograph 1 - Right Wing Damage (Courtesy of USAFA Aero Club)**

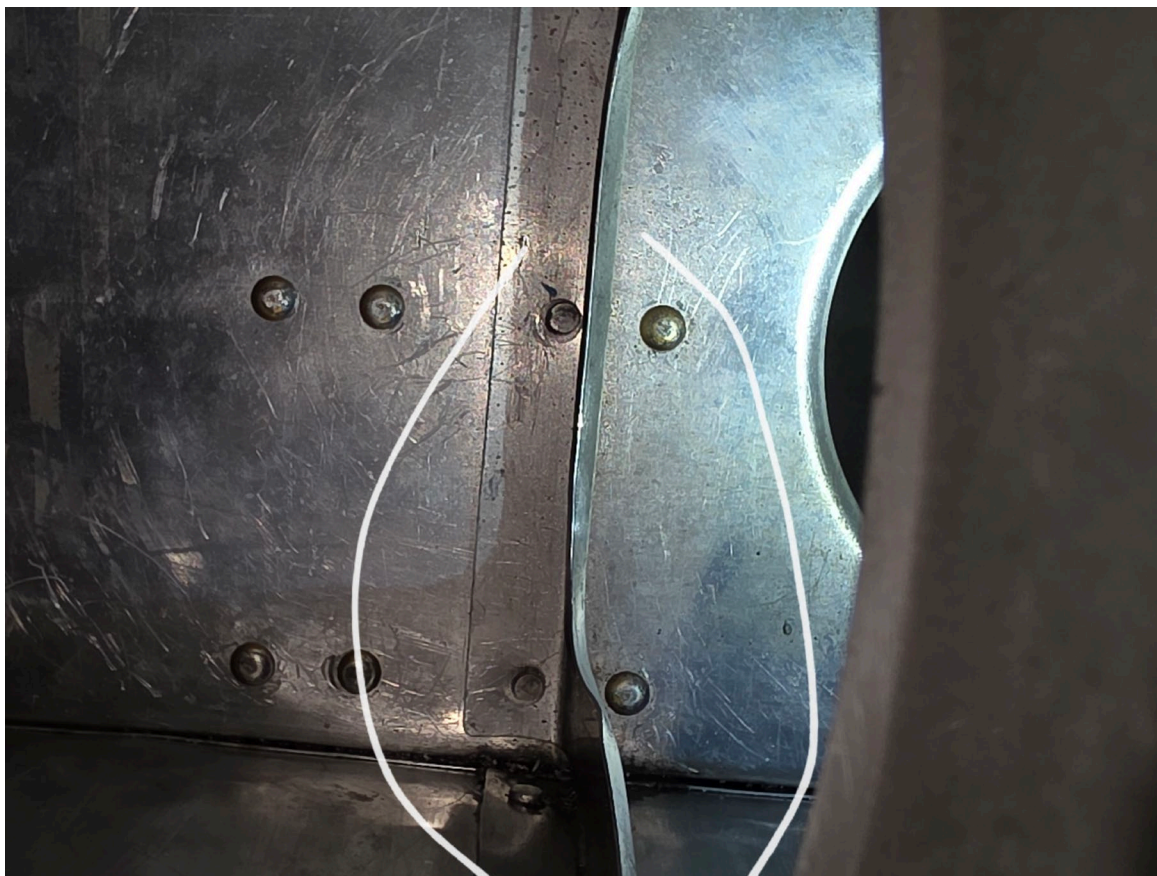
**Photograph 2 - Rib Damage - Emphasis Added (Courtesy of USAFA Aero Club)**
