CEN25LA333

## INVESTIGATION PHOTOGRAPHS

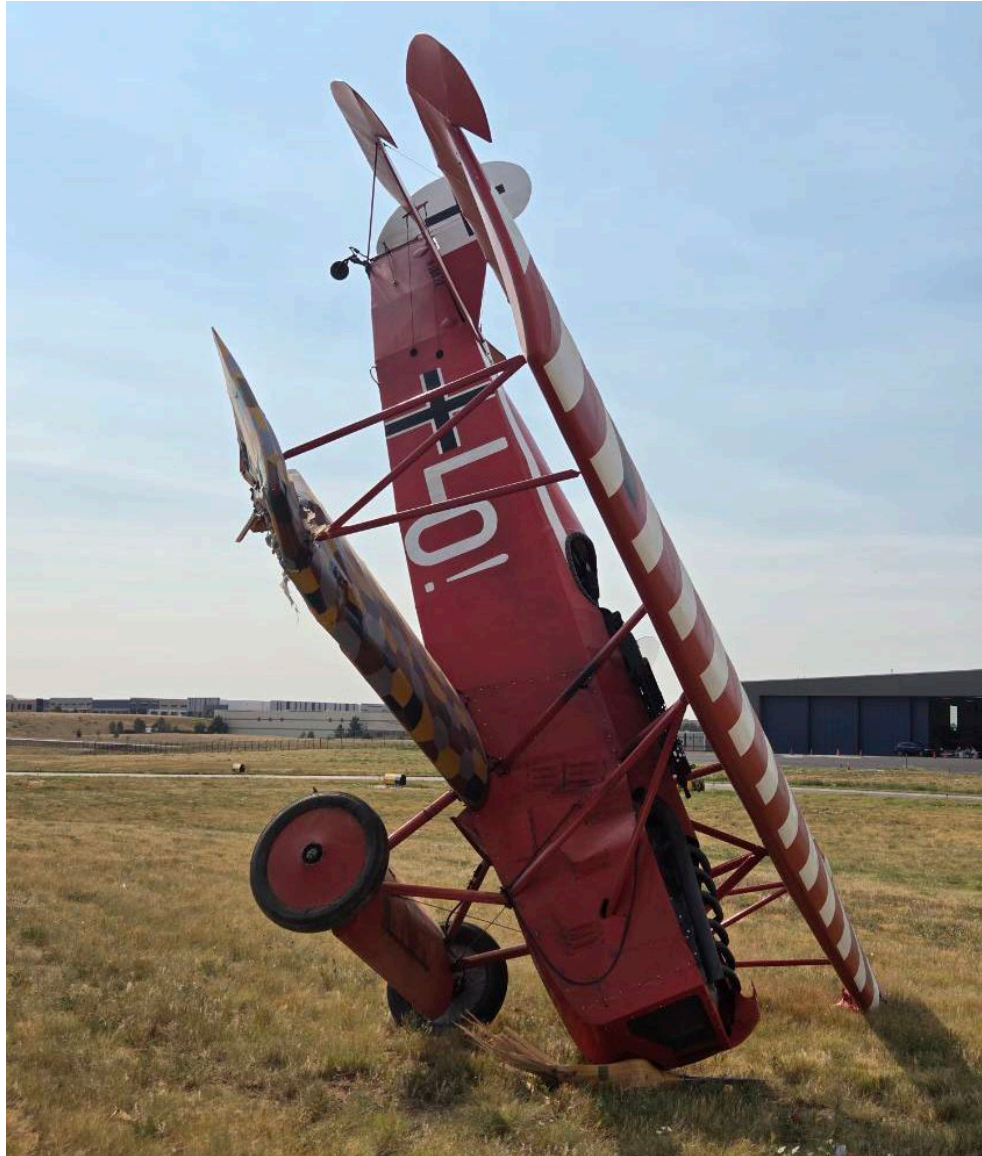
**Photograph 1 - Accident site (Courtesy of APA Airport Ops)**

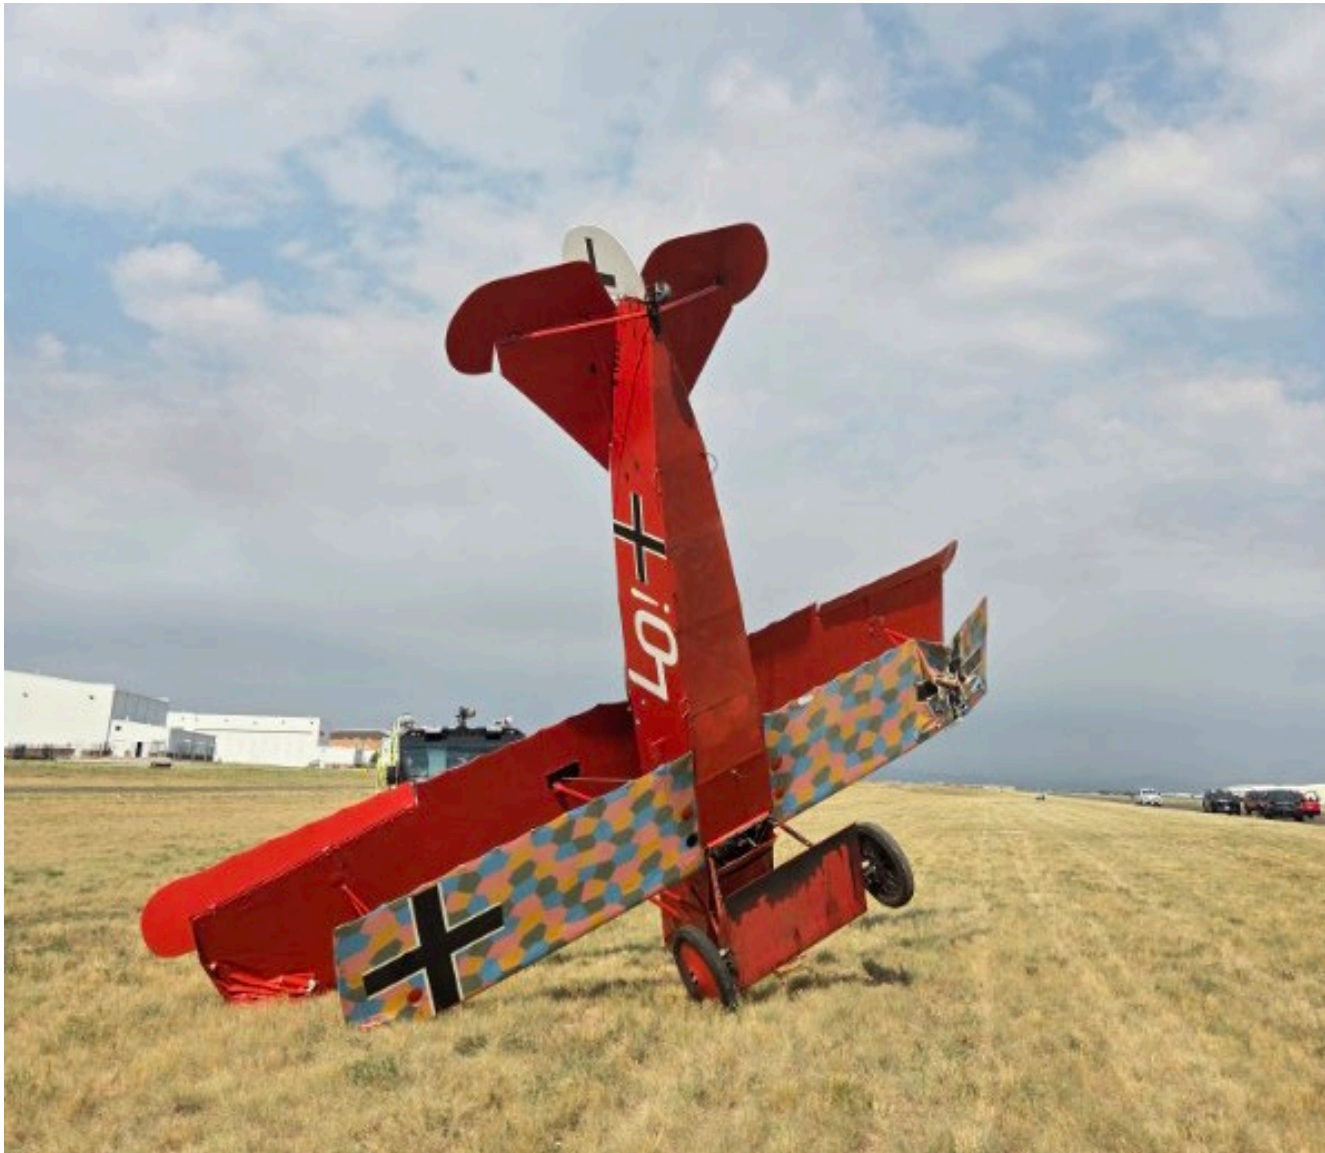
**Photograph 2 - Accident site (Courtesy of APA Airport Ops)**

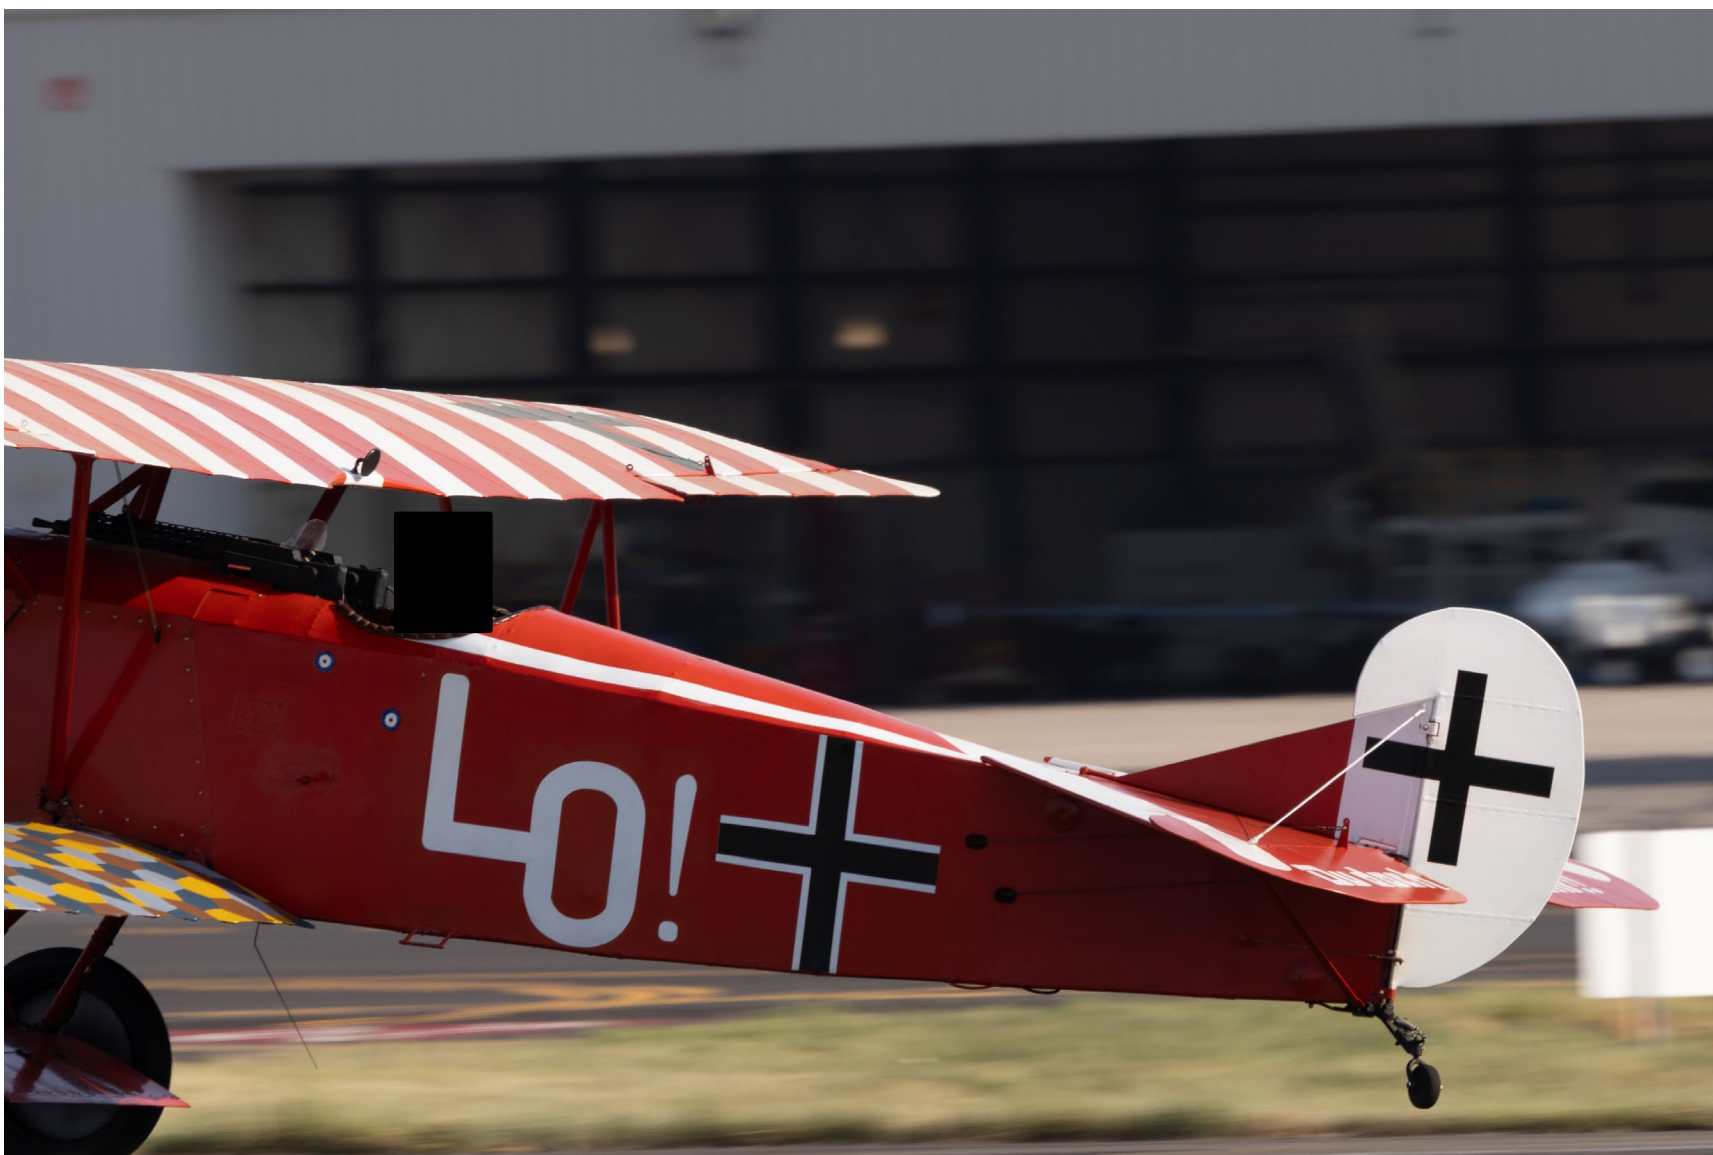
**Photograph 3 - Tailwheel position before landing (Courtesy of pilot)**
