CEN25LA342

## INVESTIGATION PHOTOGRAPHS

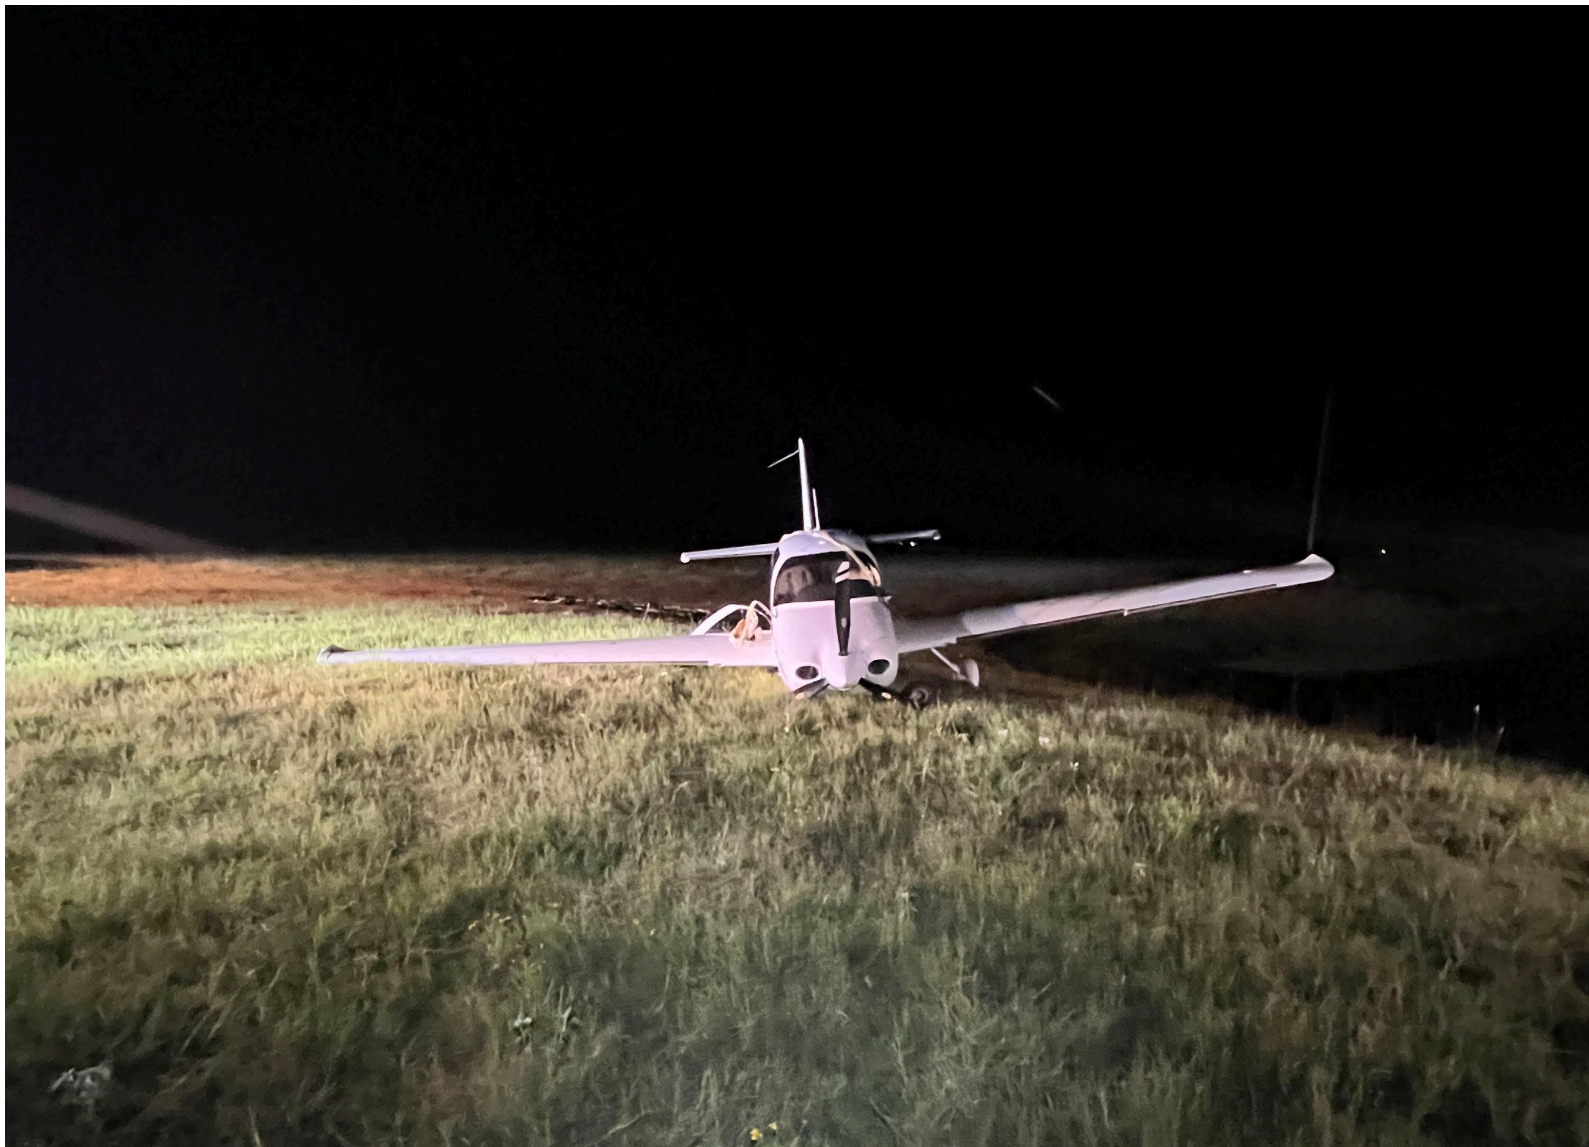
**Photograph 1 - Accident site (Courtesy of FAA)**

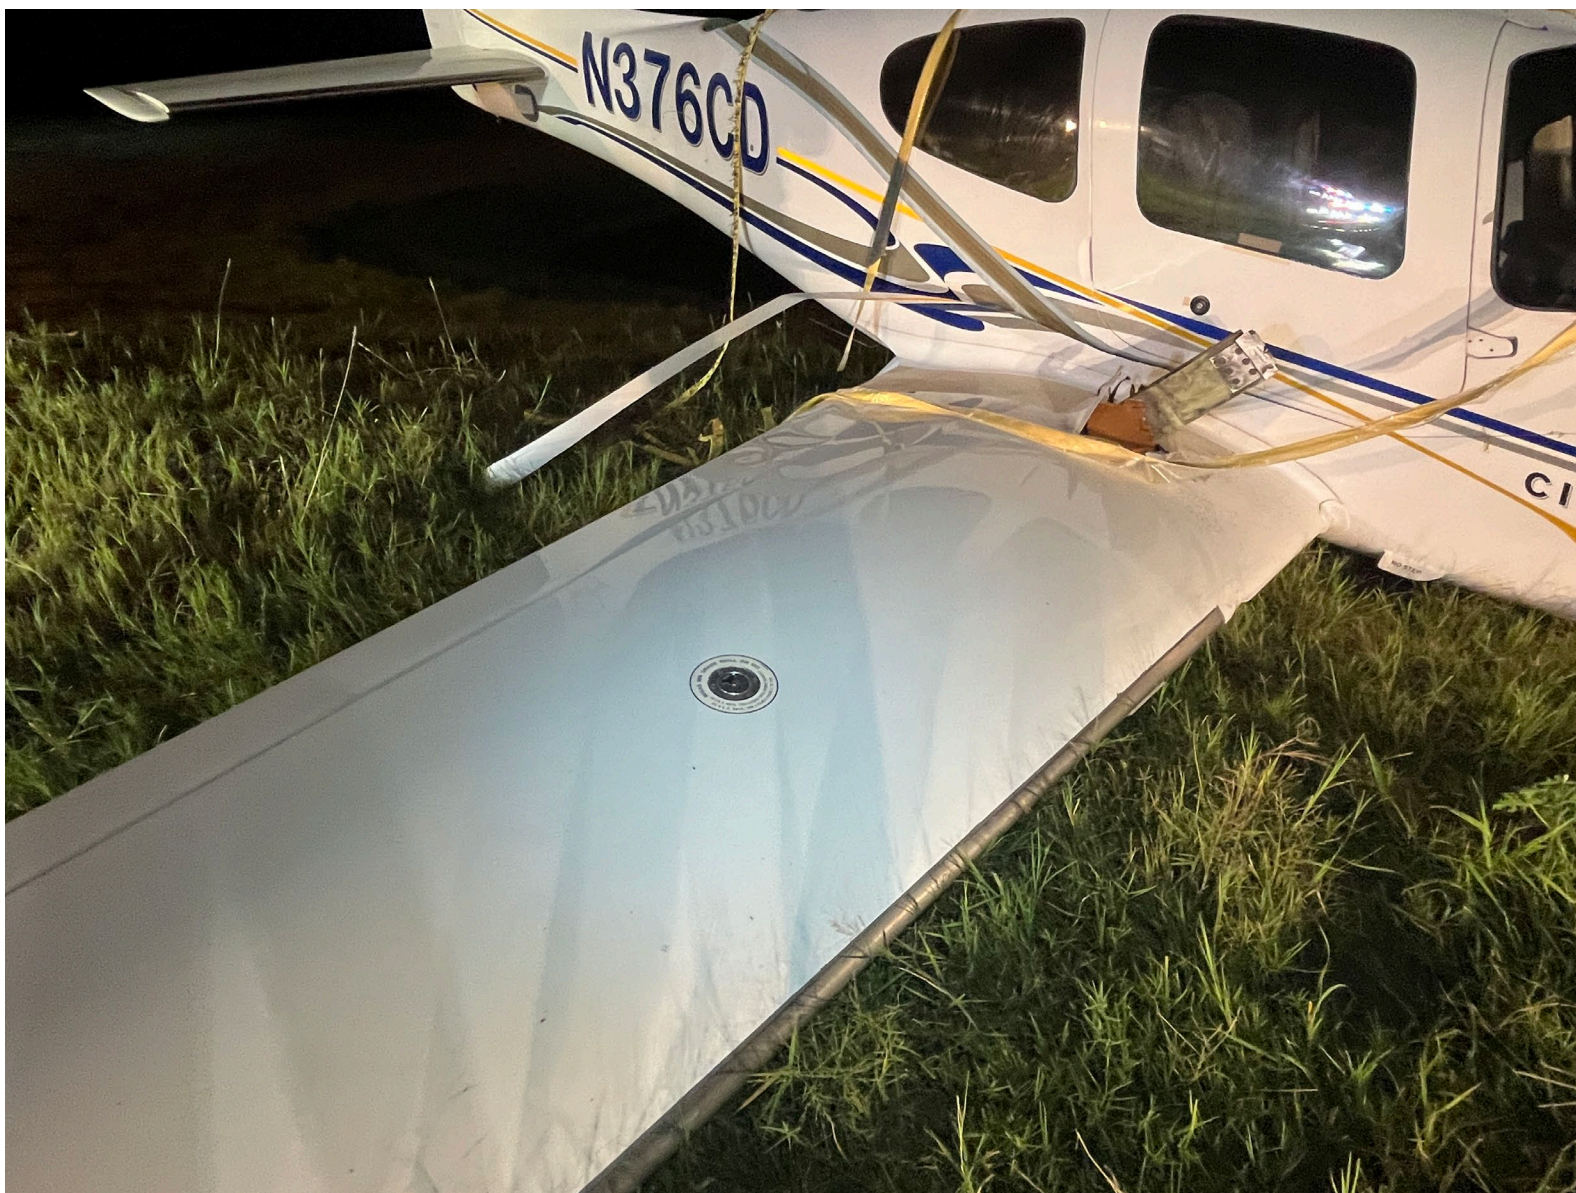
**Photograph 2 - Right wing damage (Courtesy of FAA)**
