National Transportation Safety Board

CEN25LA375

## INVESTIGATION PHOTOGRAPHS

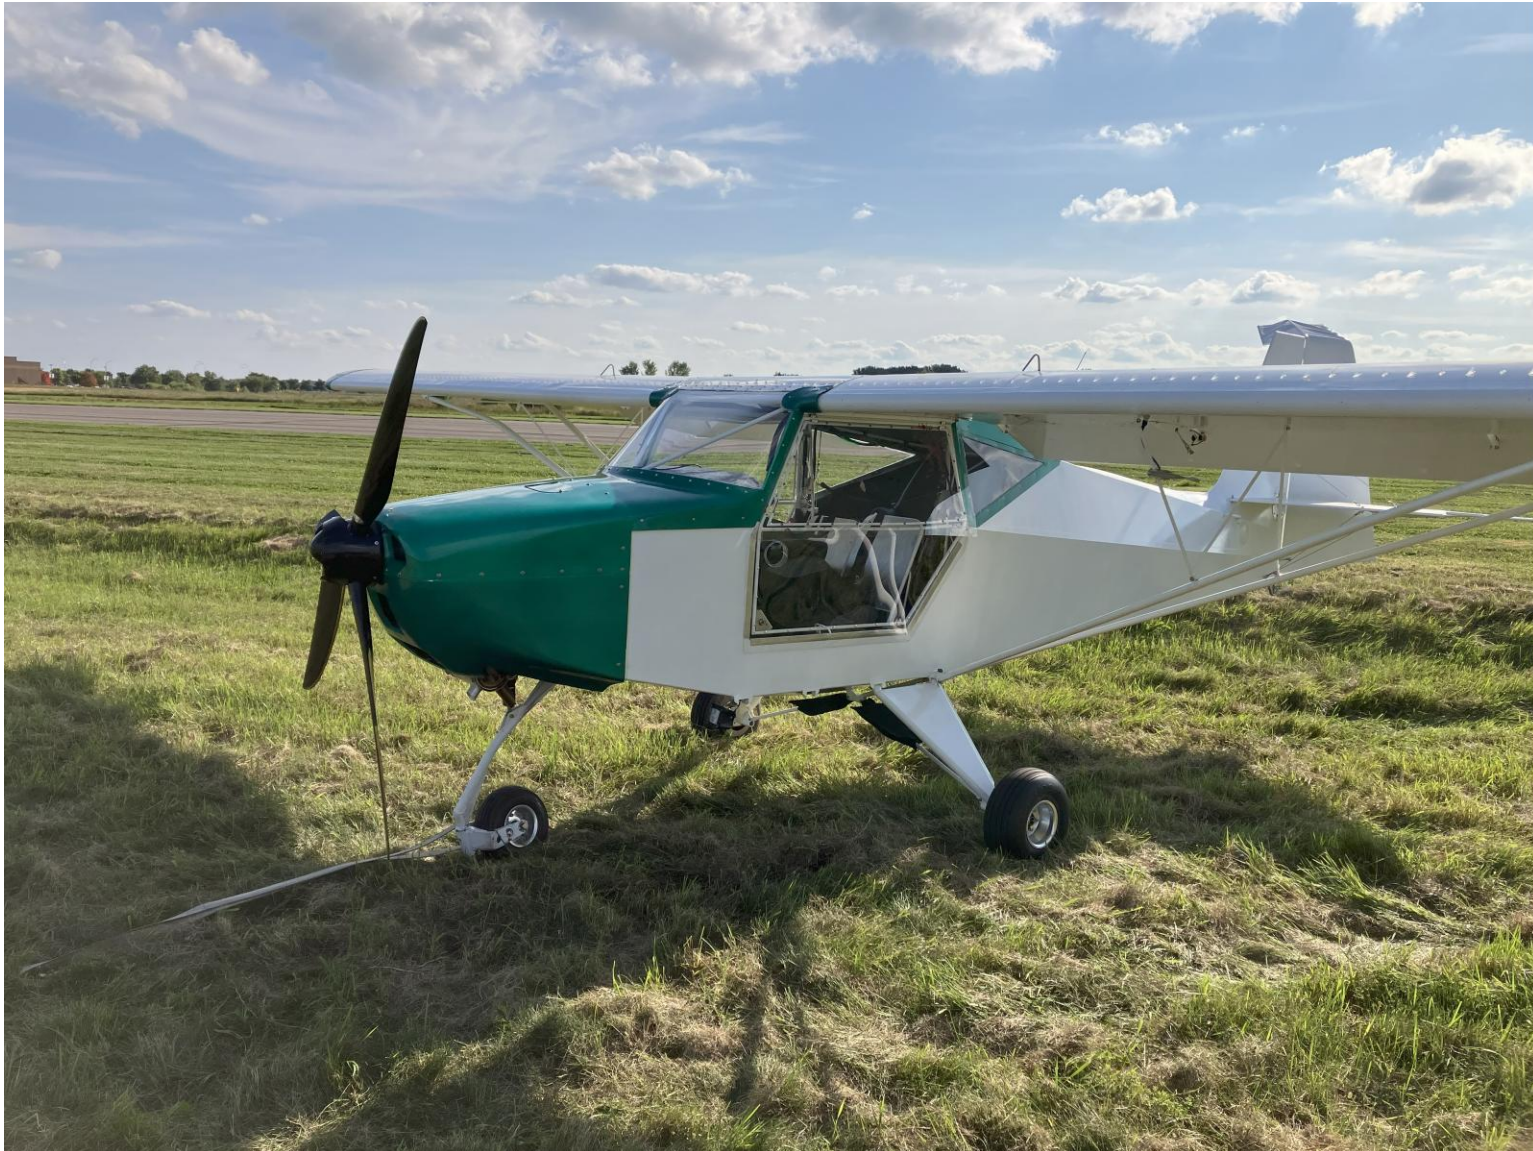
**Photograph 1 - Airplane after it was recovered to an upright position at the accident site.  
(Courtesy of Local Law Enforcement)**

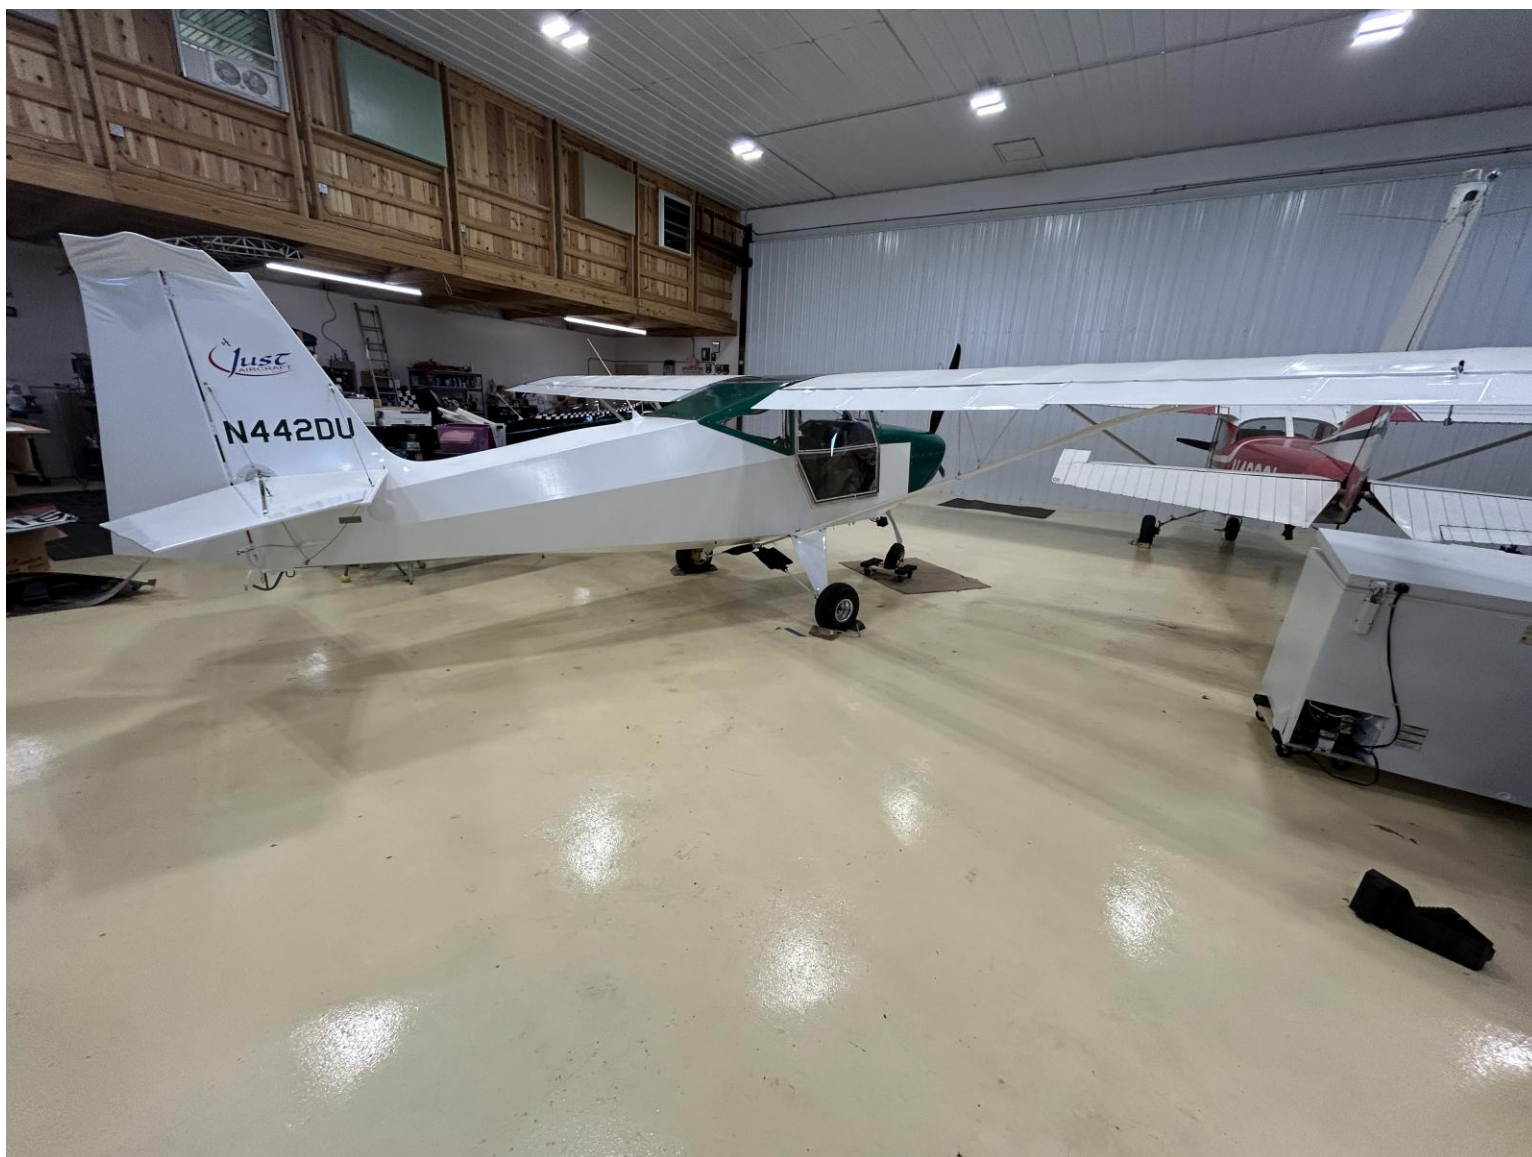
**Photograph 2 - Rudder Damage (Courtesy of FAA)**

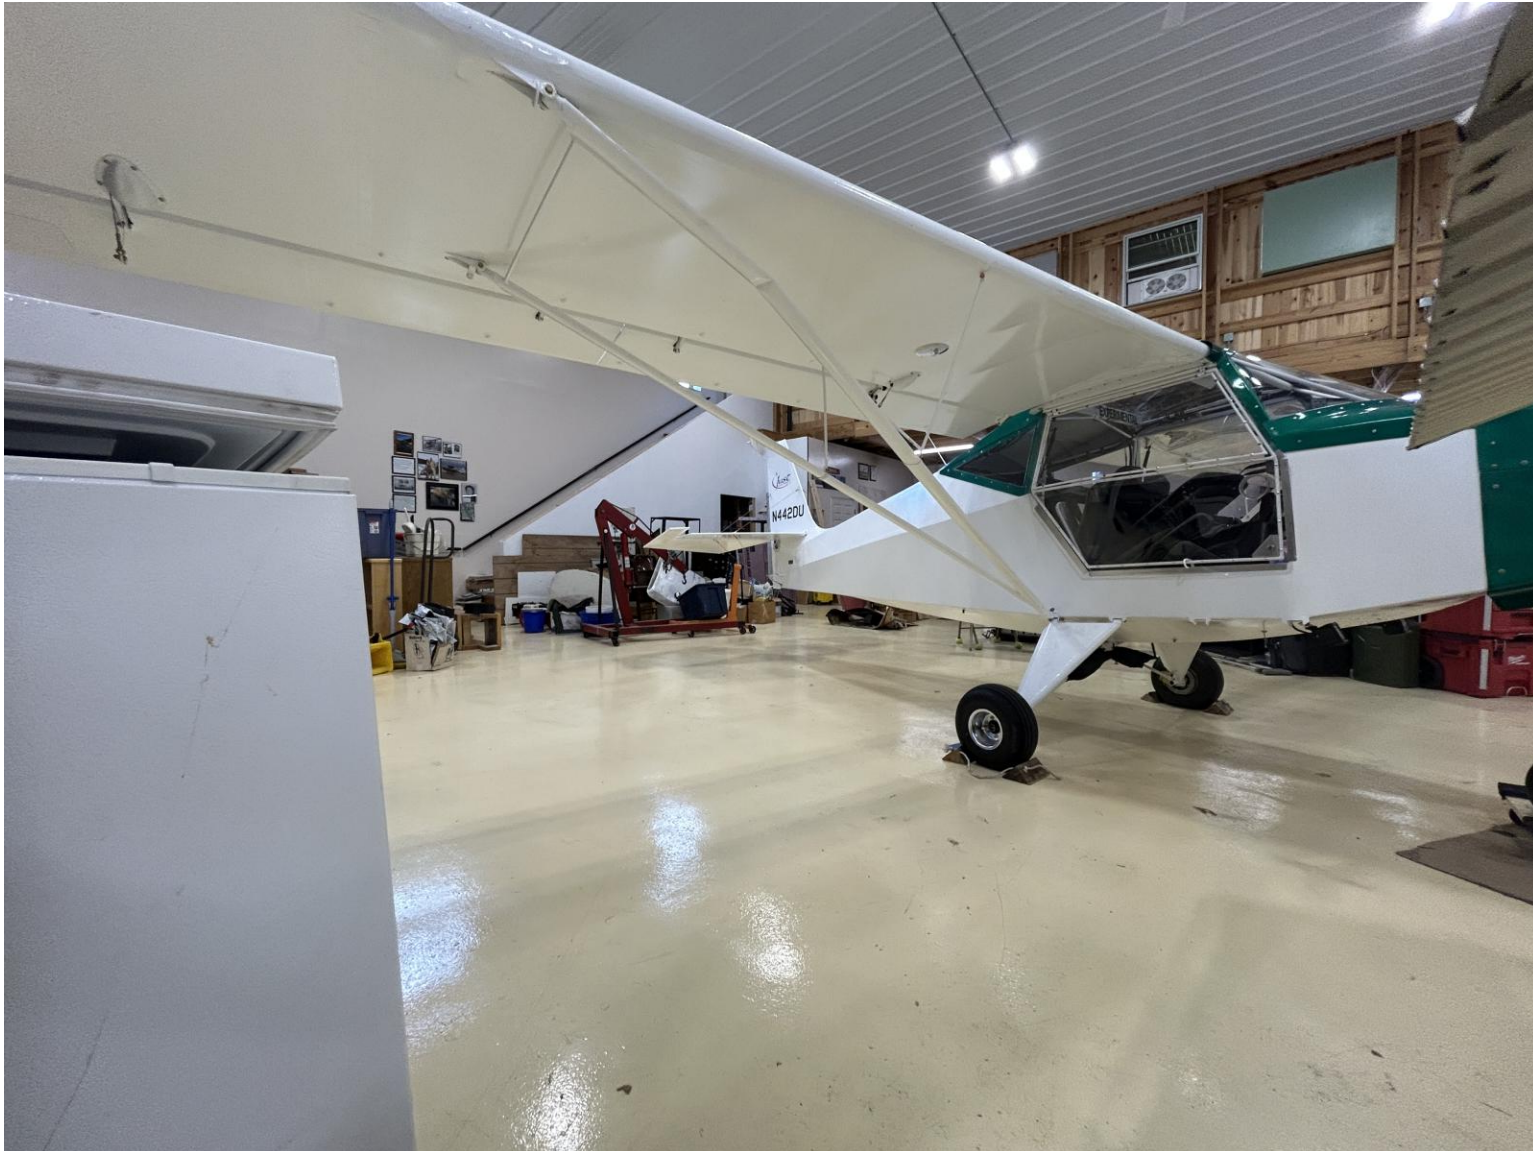
**Photograph 3 - Right-Wing Lift Strut Damage (Courtesy of FAA)**
