CEN25LA389

## INVESTIGATION PHOTOGRAPHS

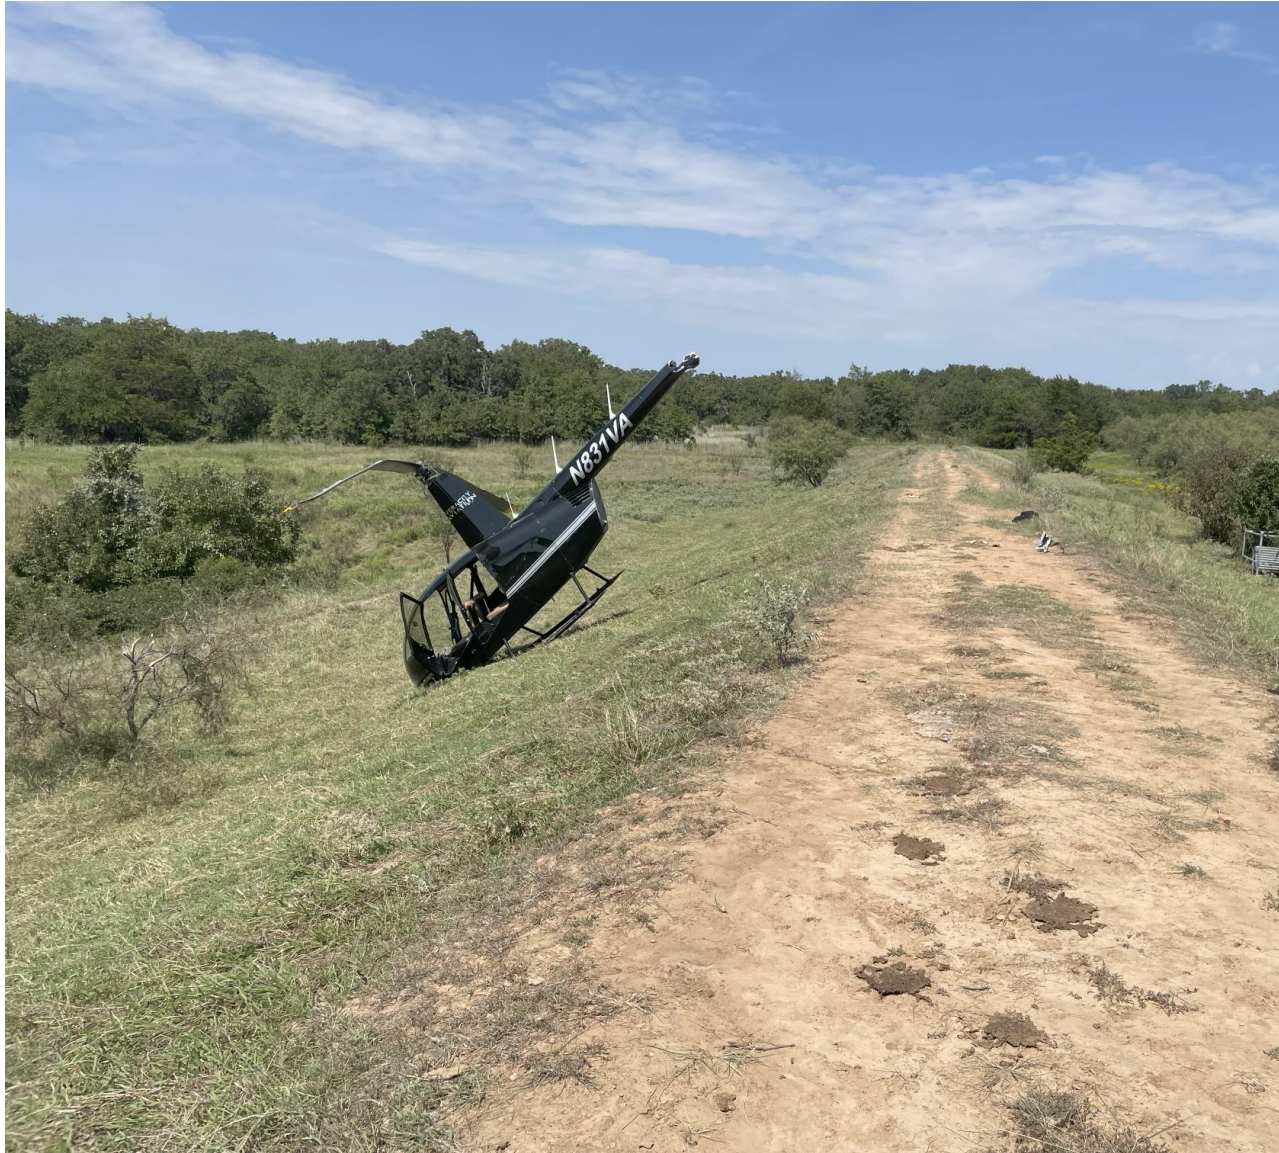
**Photograph 1 - Helicopter at accident site (FAA photo)**

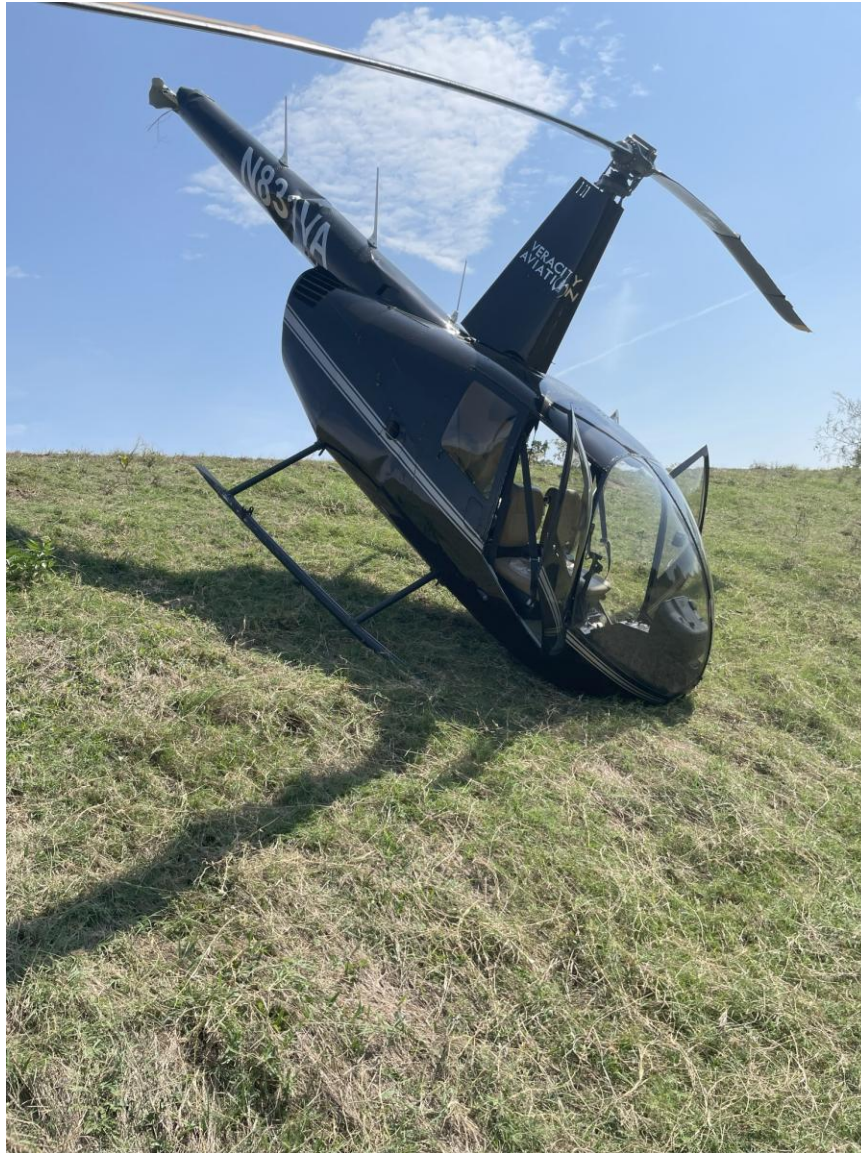
**Photograph 2 - Helicopter at accident site (FAA photo)**

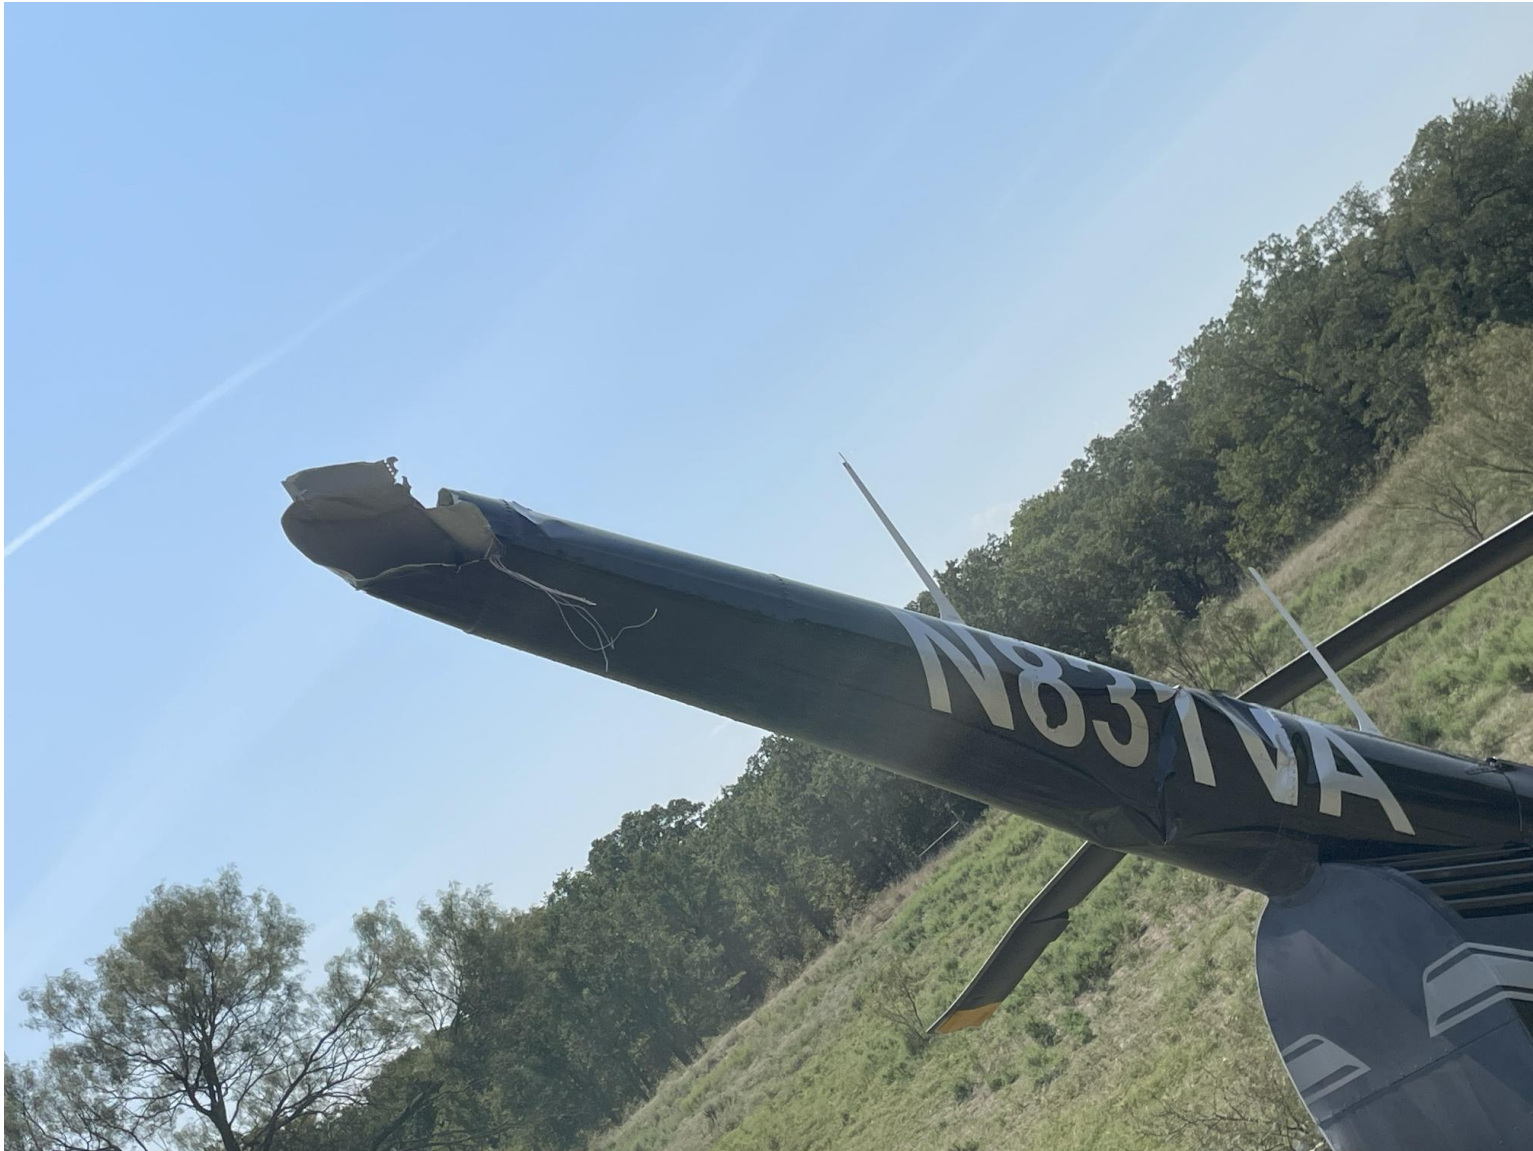
**Photograph 3 - Tail boom (FAA photo)**

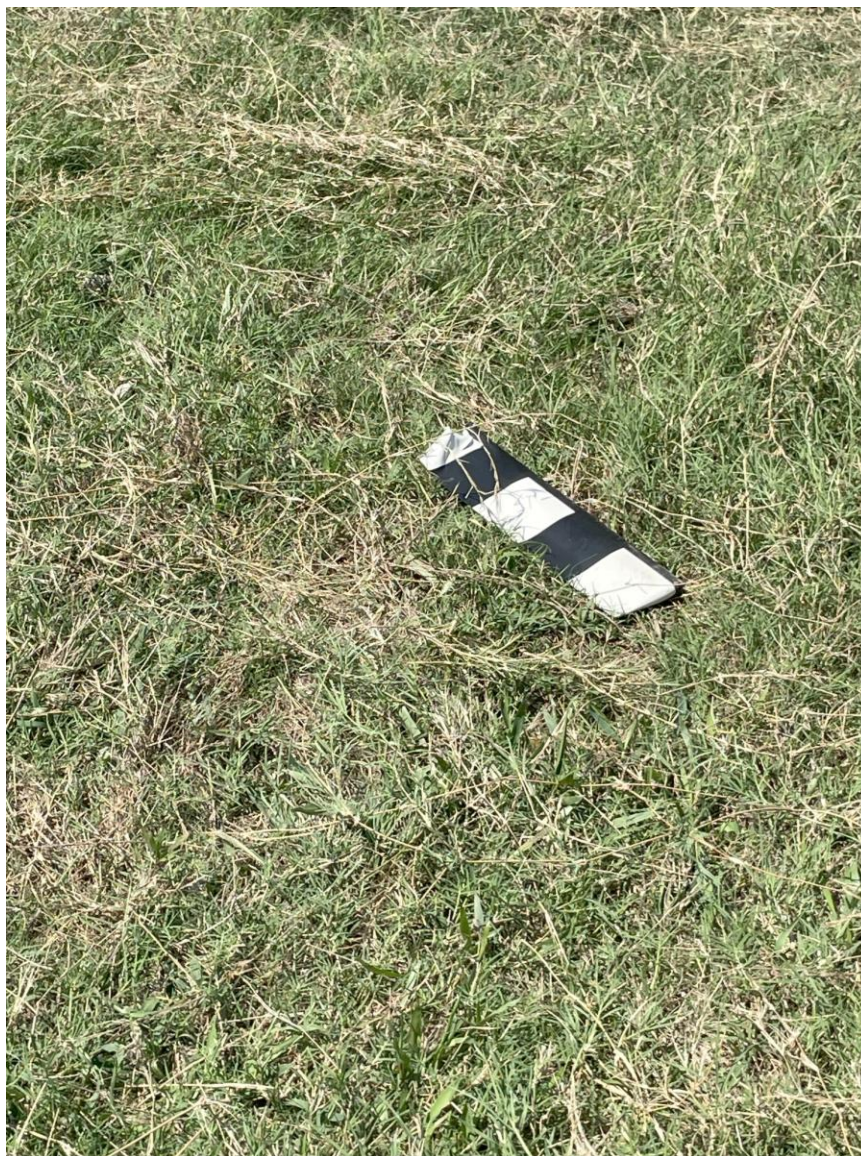
**Photograph 4 - Tail rotor blade fragment (FAA photo)**

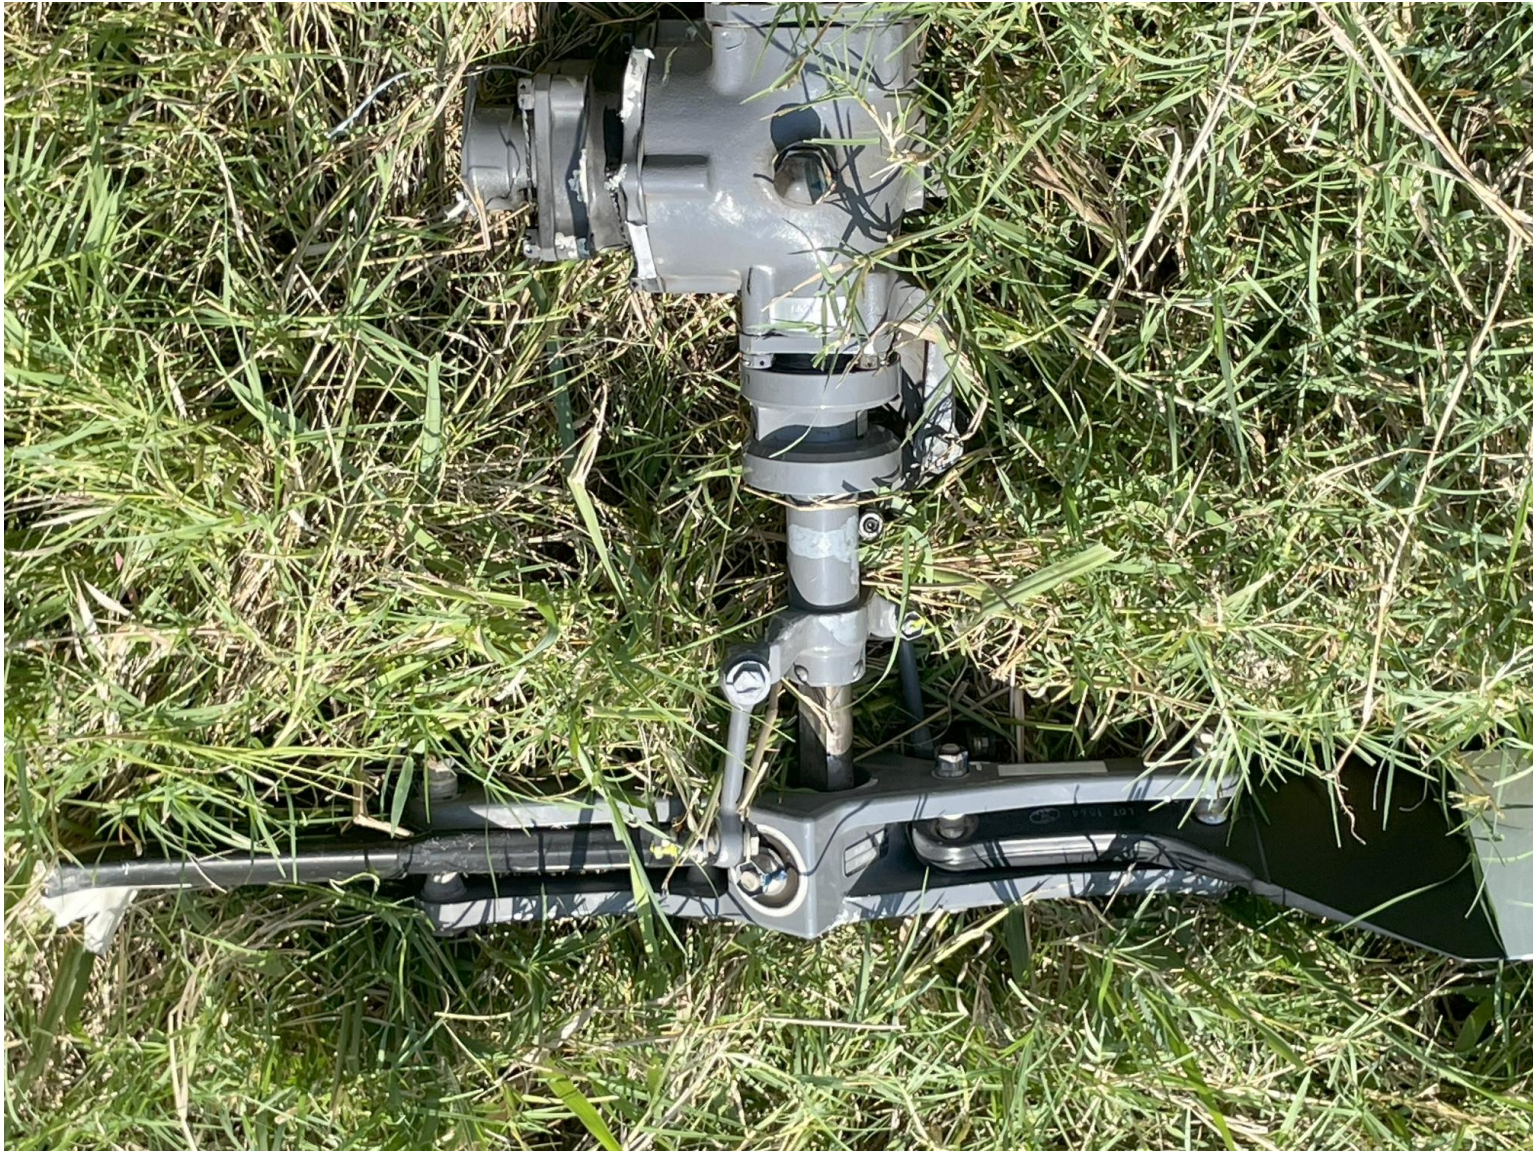
**Photograph 5 - Tail rotor assembly (FAA photo)**

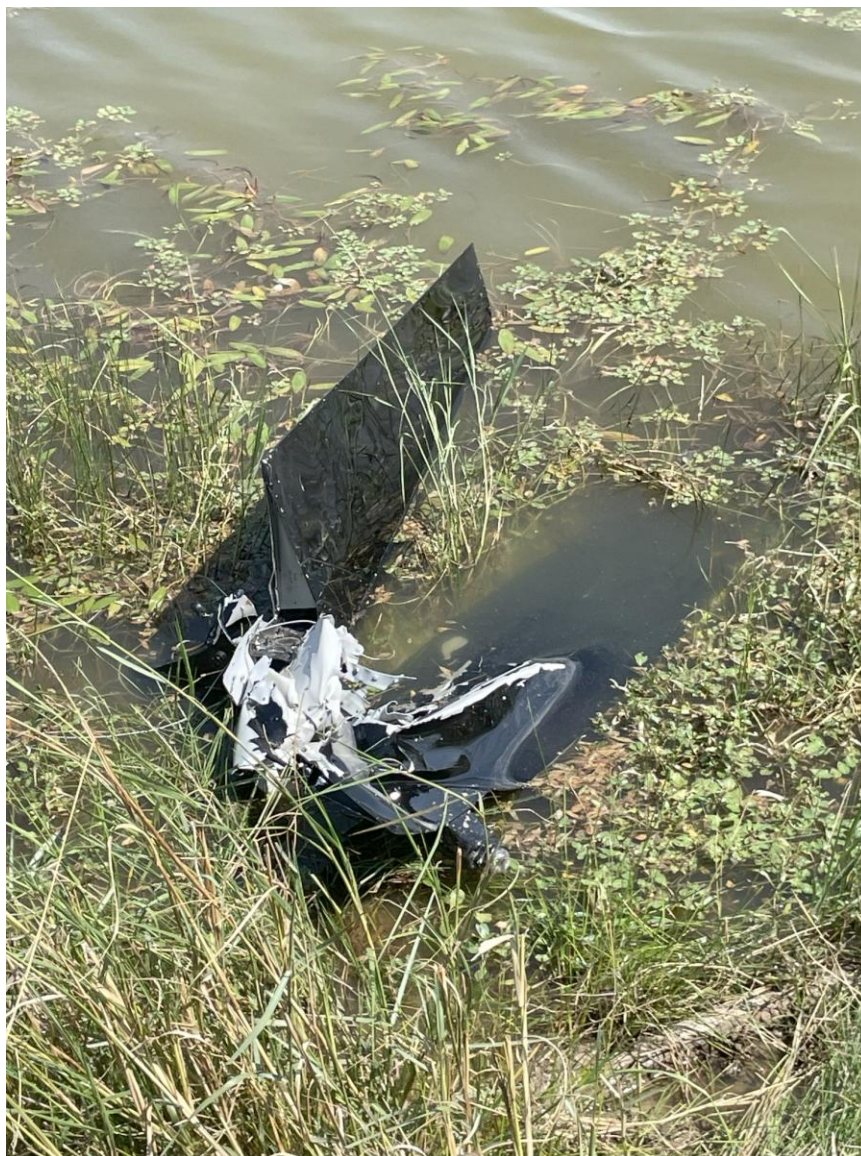
**Photograph 6 - Tail boom / vertical stabilizers (FAA photo)**
