CEN25LA399

## INVESTIGATION PHOTOGRAPHS

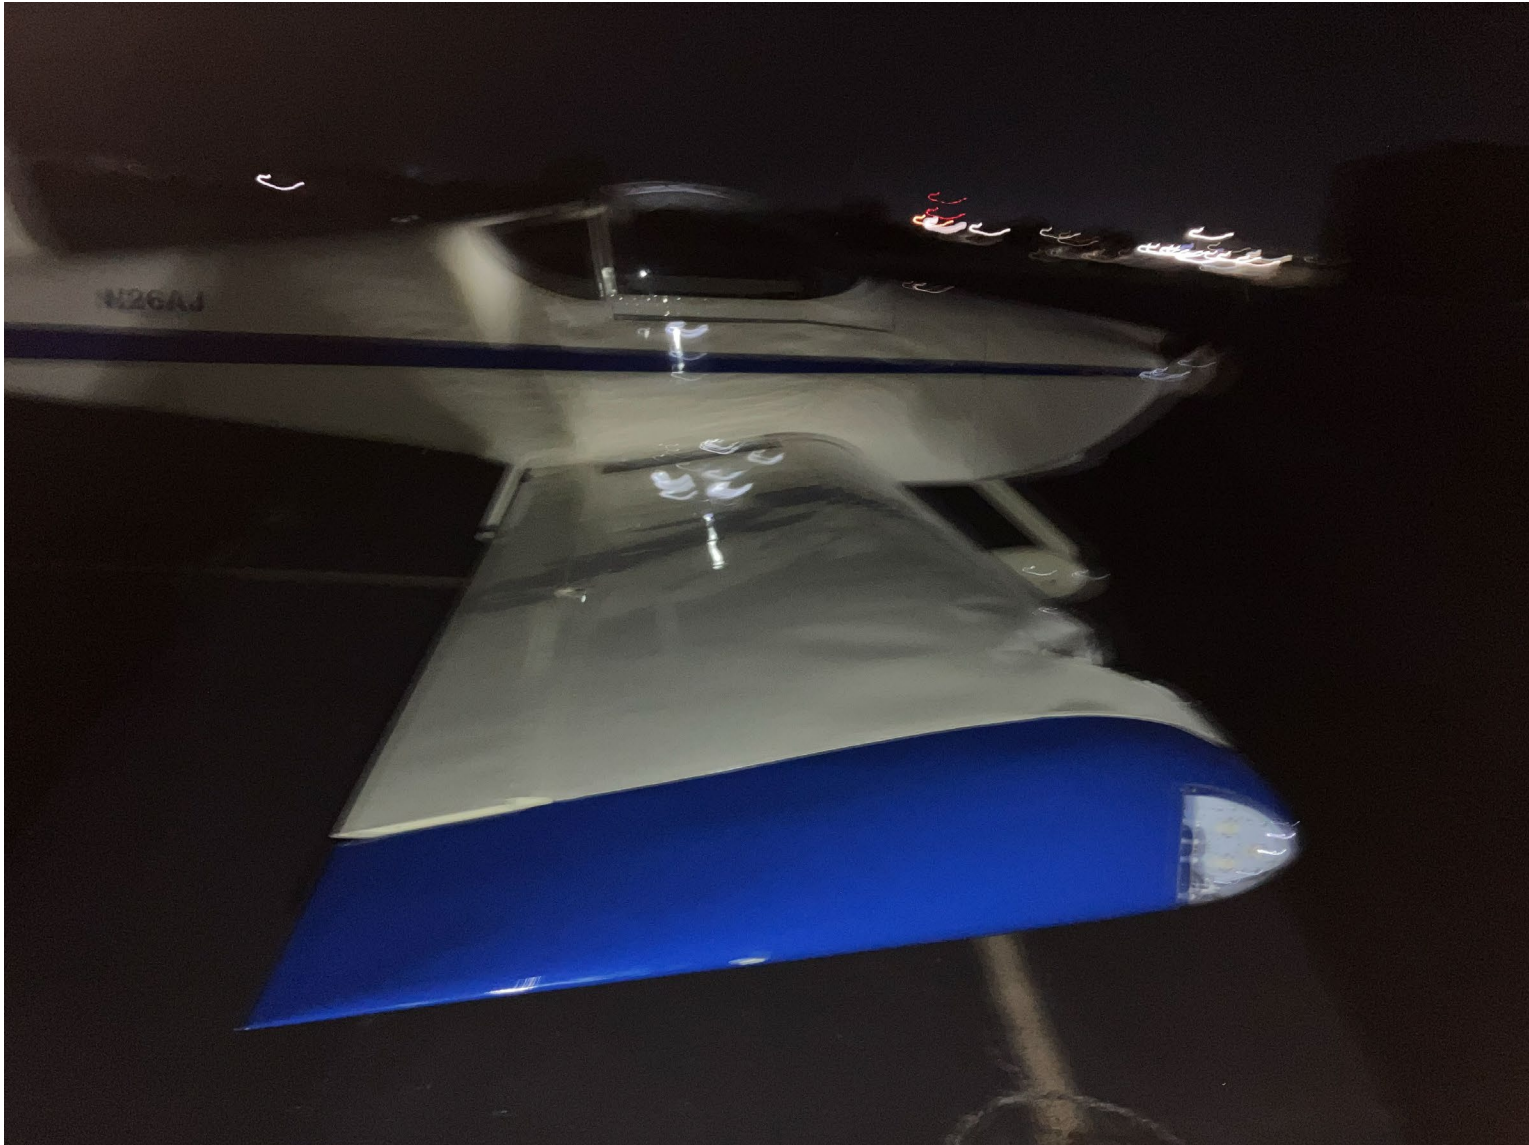
**Photograph 1 - Accident Airplane Overview (Courtesy of Federal Aviation Administration)**

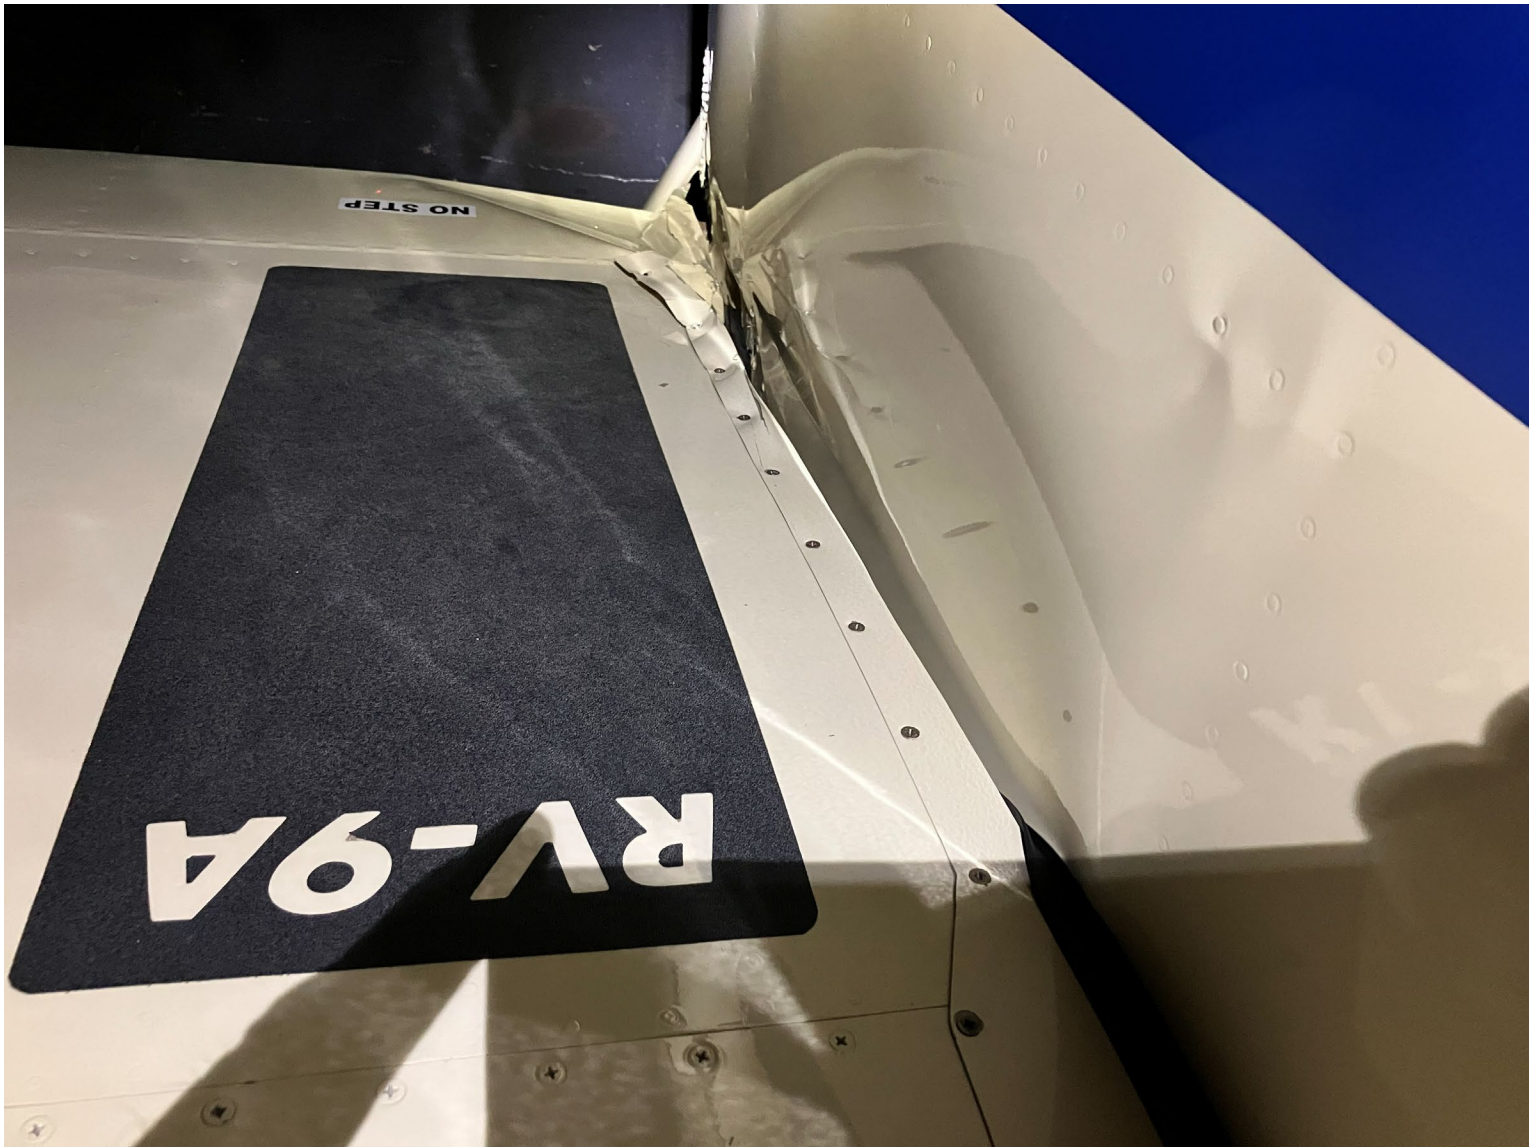
**Photograph 2 - Right Wing Root Damage (Courtesy of Federal Aviation Administration)**

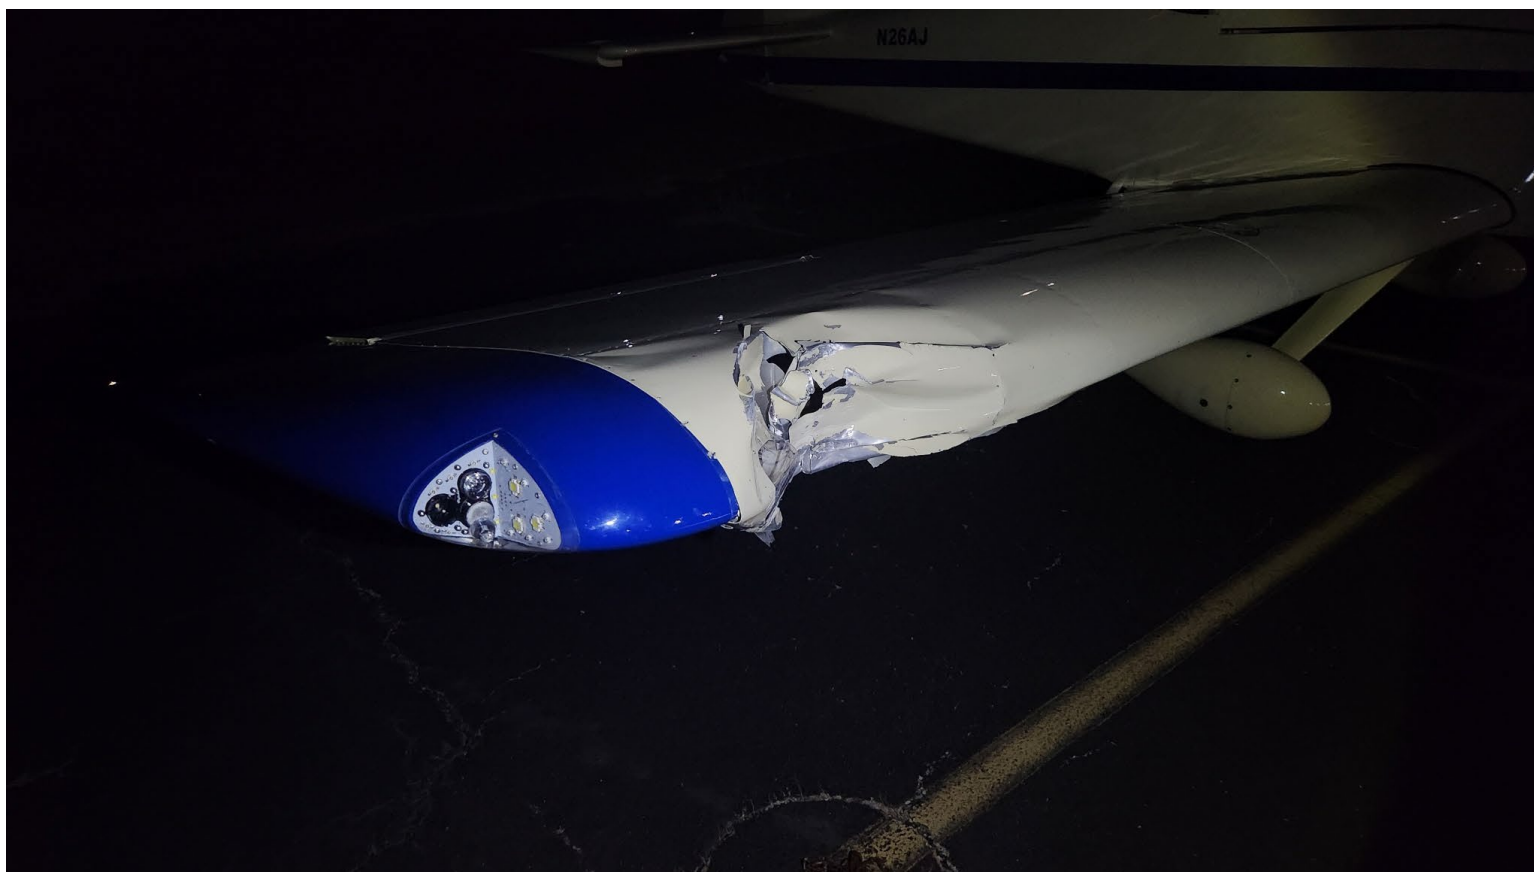
**Photograph 3 - Right Wing Leading Edge Damage (Courtesy of Airport Manager)**

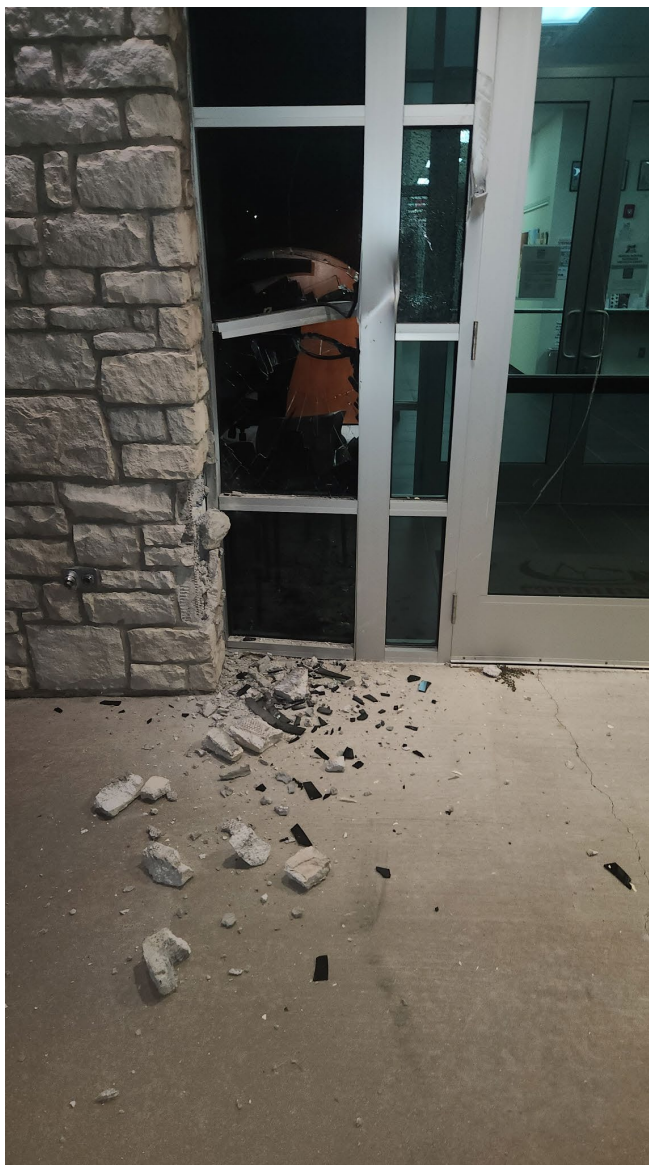
**Photograph 4 - Terminal Building Damage (Courtesy of Airport Manager)**

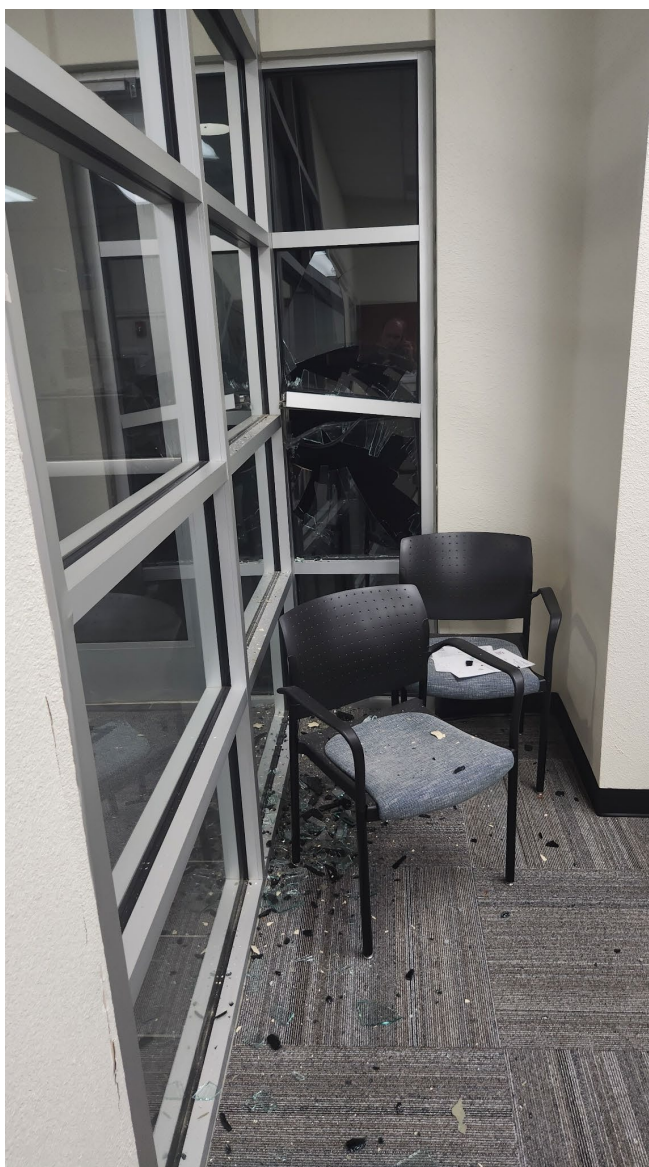
**Photograph 5 - Terminal Building Damage (Courtesy of Airport Manager)**
