CEN25LA403

## INVESTIGATION PHOTOGRAPHS

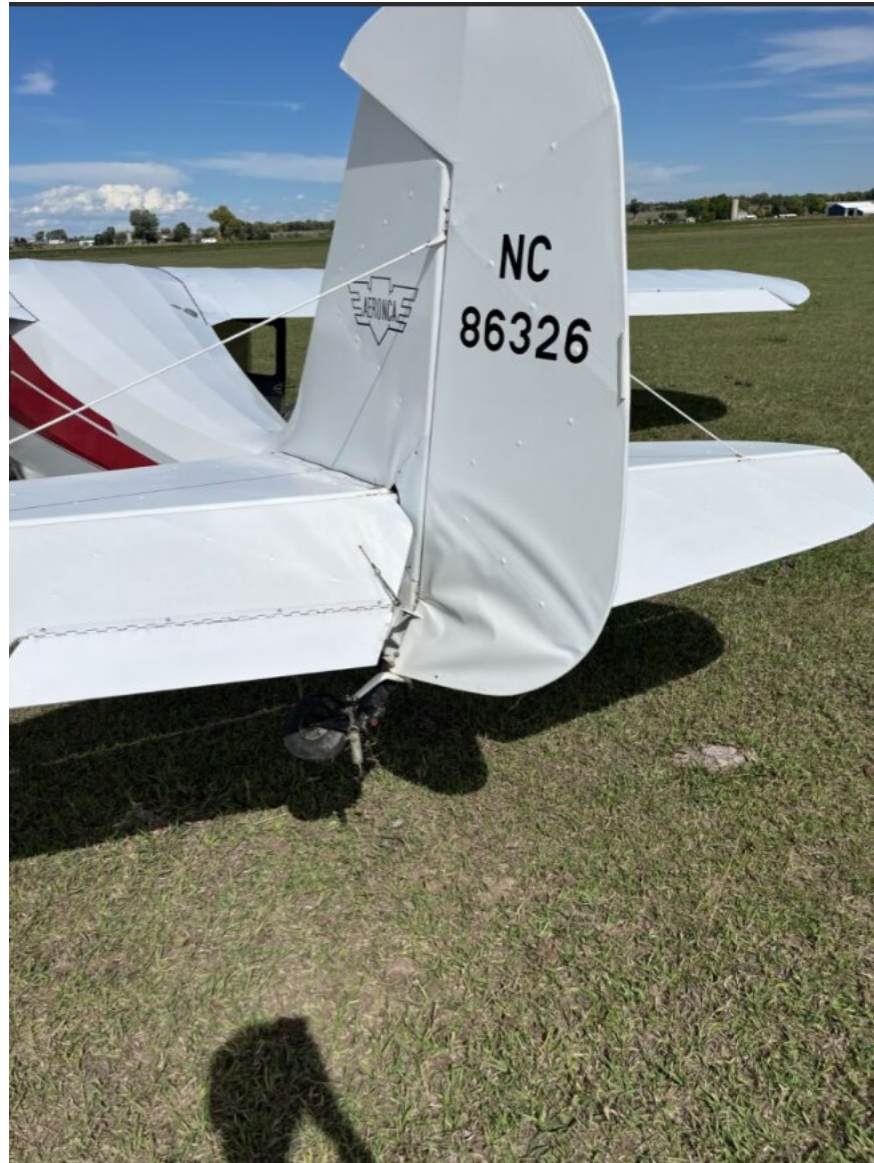
**Photograph 1 - Substantial damage to rudder (Courtesy of FAA)**
