CEN25LA406

## INVESTIGATION PHOTOGRAPHS

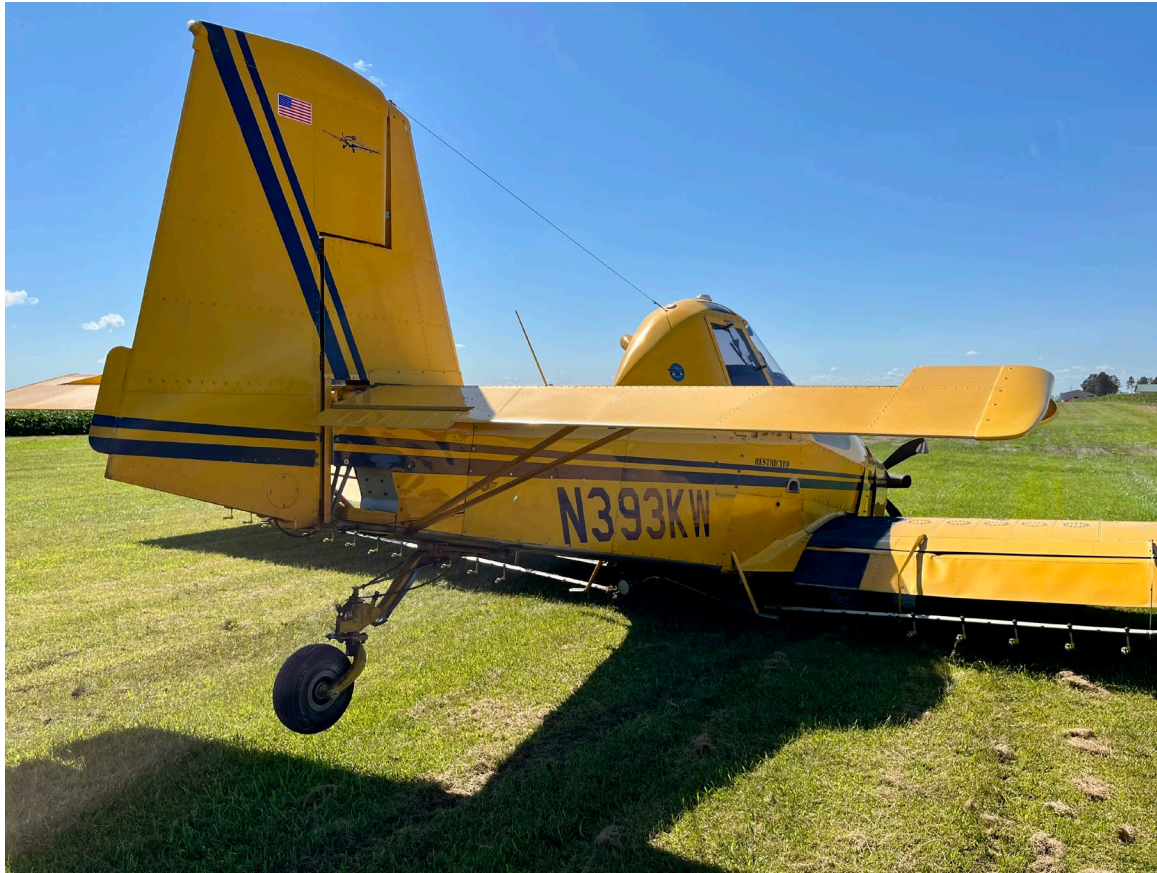
**Photograph 1 - Airplane at accident site (Courtesy of FAA)**

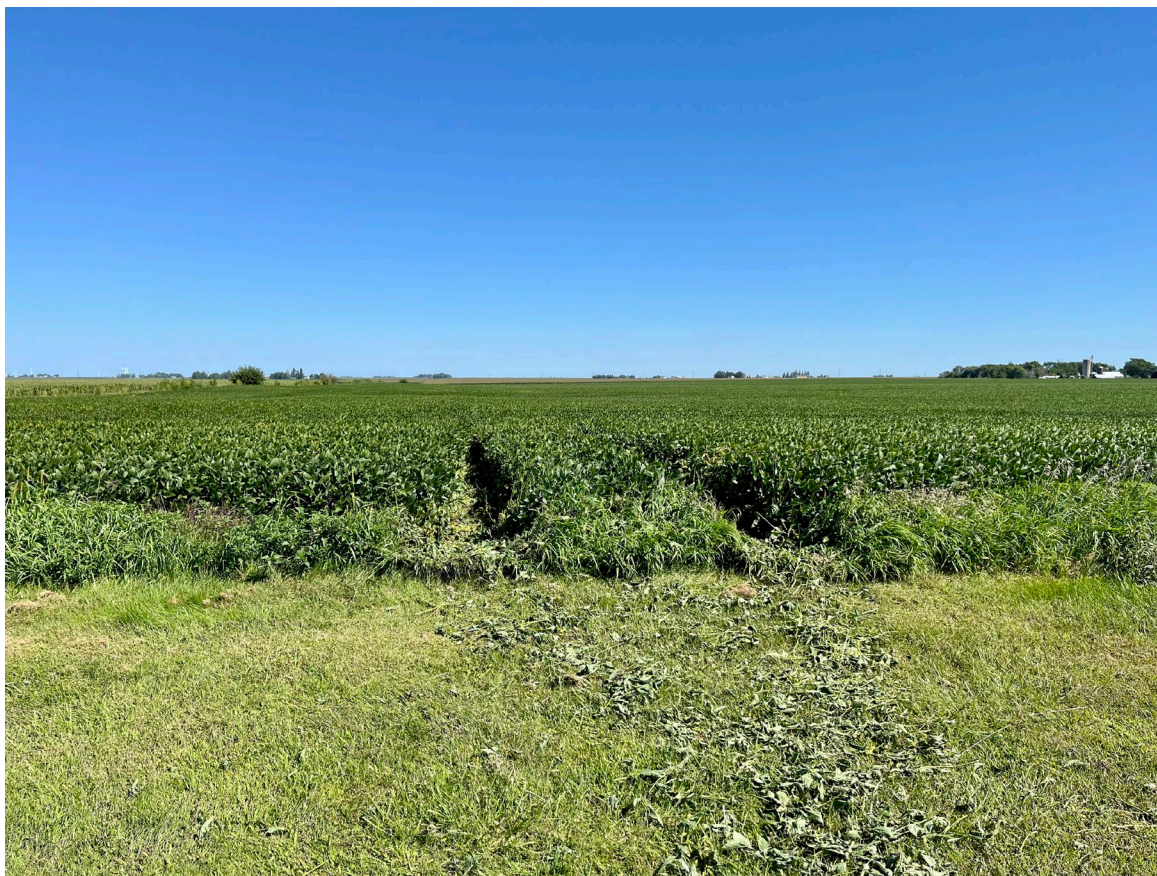
**Photograph 2 - Approach end of airstrip (Courtesy of FAA)**

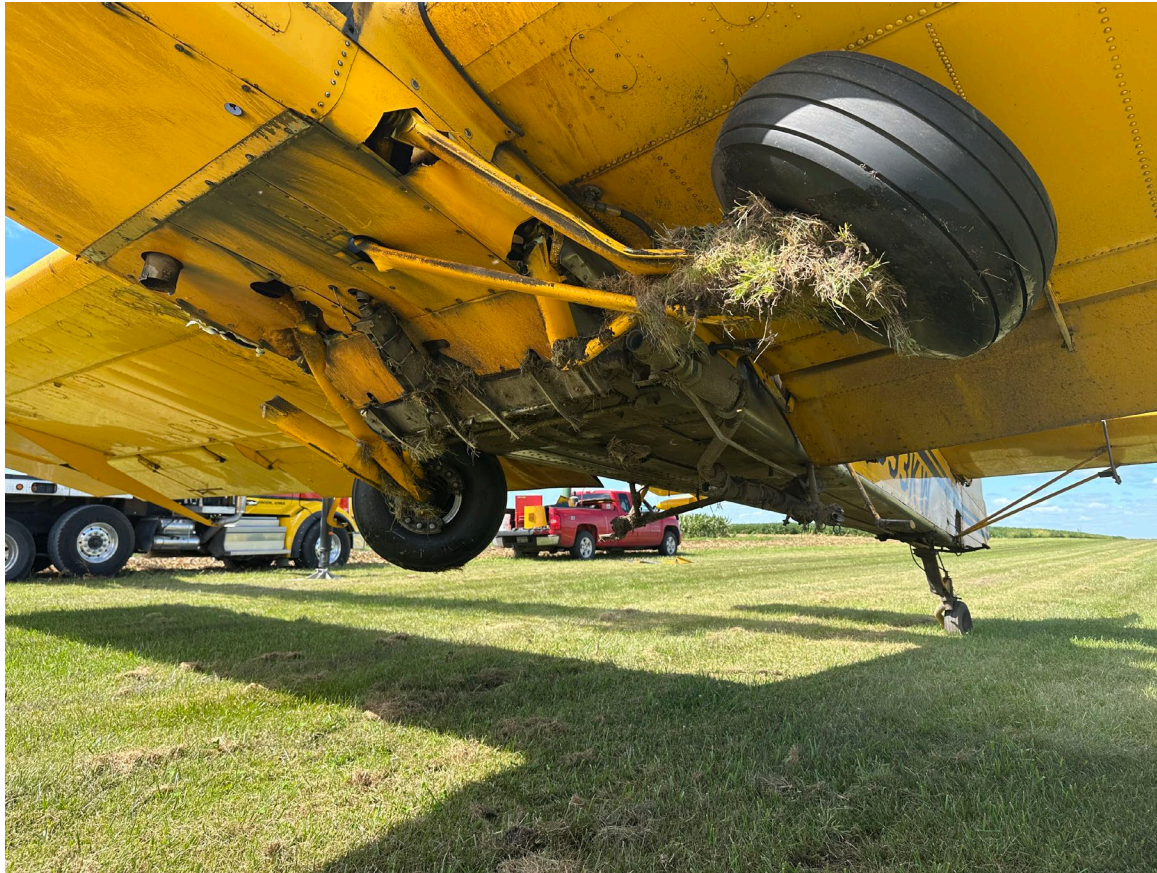
**Photograph 3 - Underside of airplane during recovery (Courtesy of FAA)**

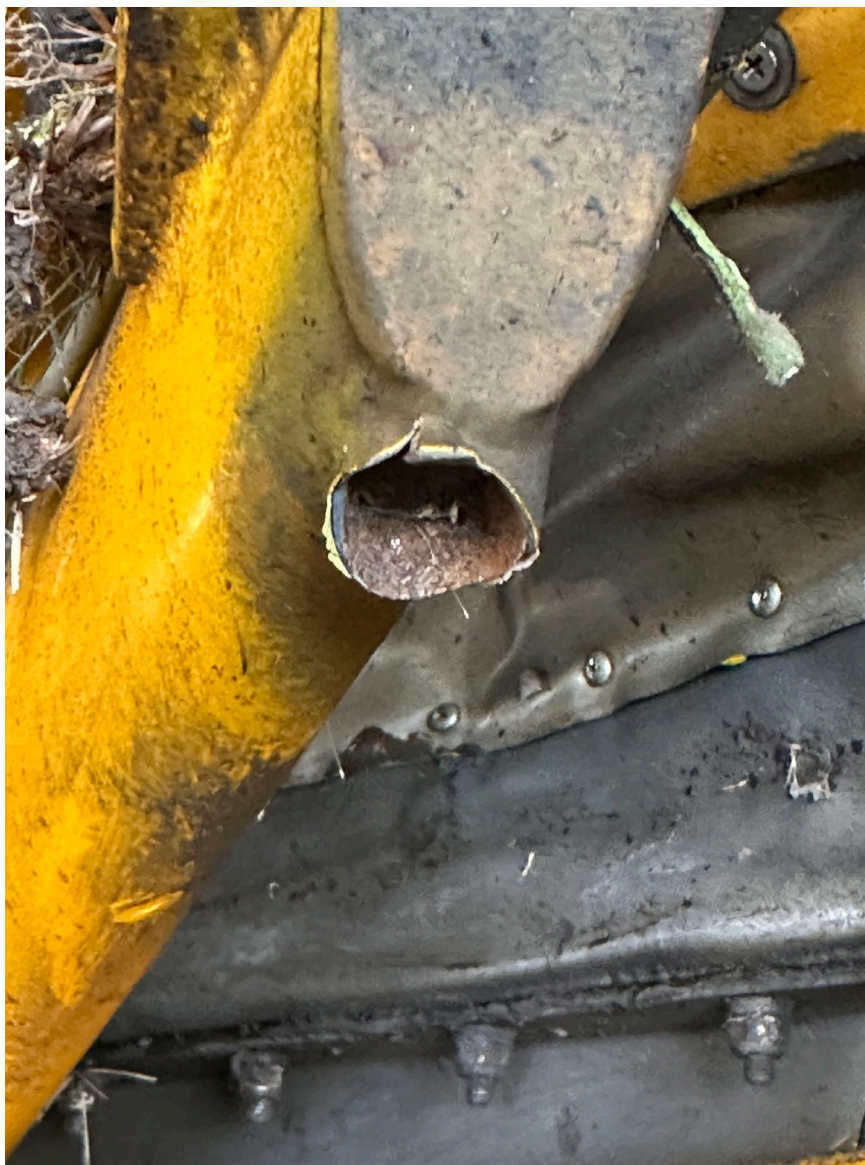
**Photograph 4 - Broken structural tube (Courtesy of FAA)**
