Jason Aguilera  
Senior Aviation Safety Investigator  
Aviation Safety - Central Region

**Subject:** CEN26LA003

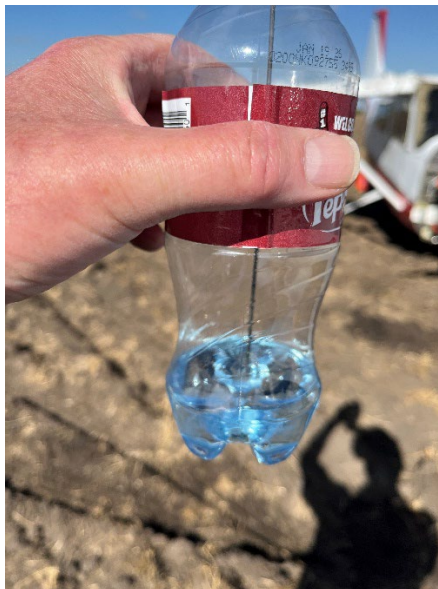
On October 10, the field was finally dry enough to allow for removal of the airplane by the recovery team. Neither tank appeared to be breached or compromised. The fuel drained out the left fuel tank was photographed.

Figure 1 Fuel From the Left Fuel Tank

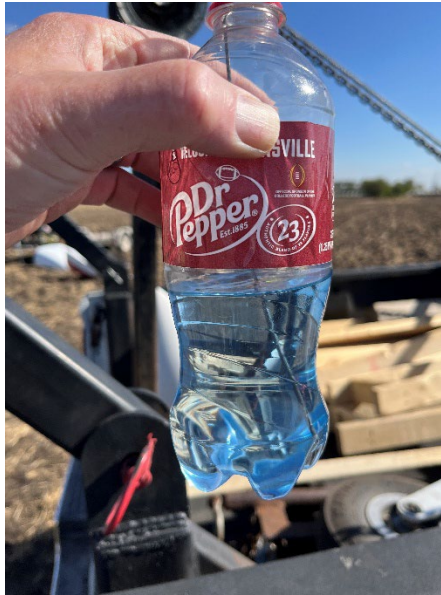
The fuel from the right wing was added to the same container and photographed.

Figure 2 Fuel From Both Fuel Tanks
