CEN26LA003

## INVESTIGATION PHOTOGRAPHS

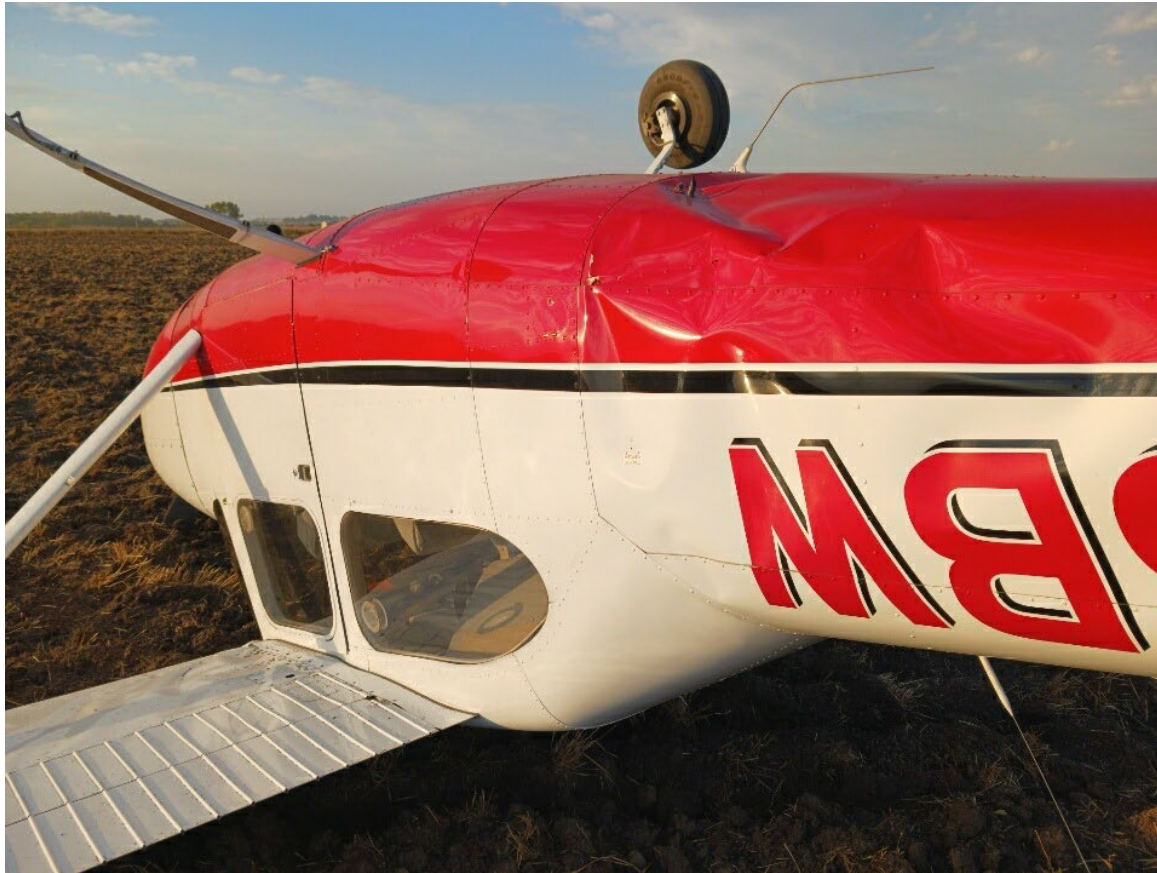
**Photograph 1 - Empennage Damage (Courtesy of FAA)**
