CEN26LA047

## INVESTIGATION PHOTOGRAPHS

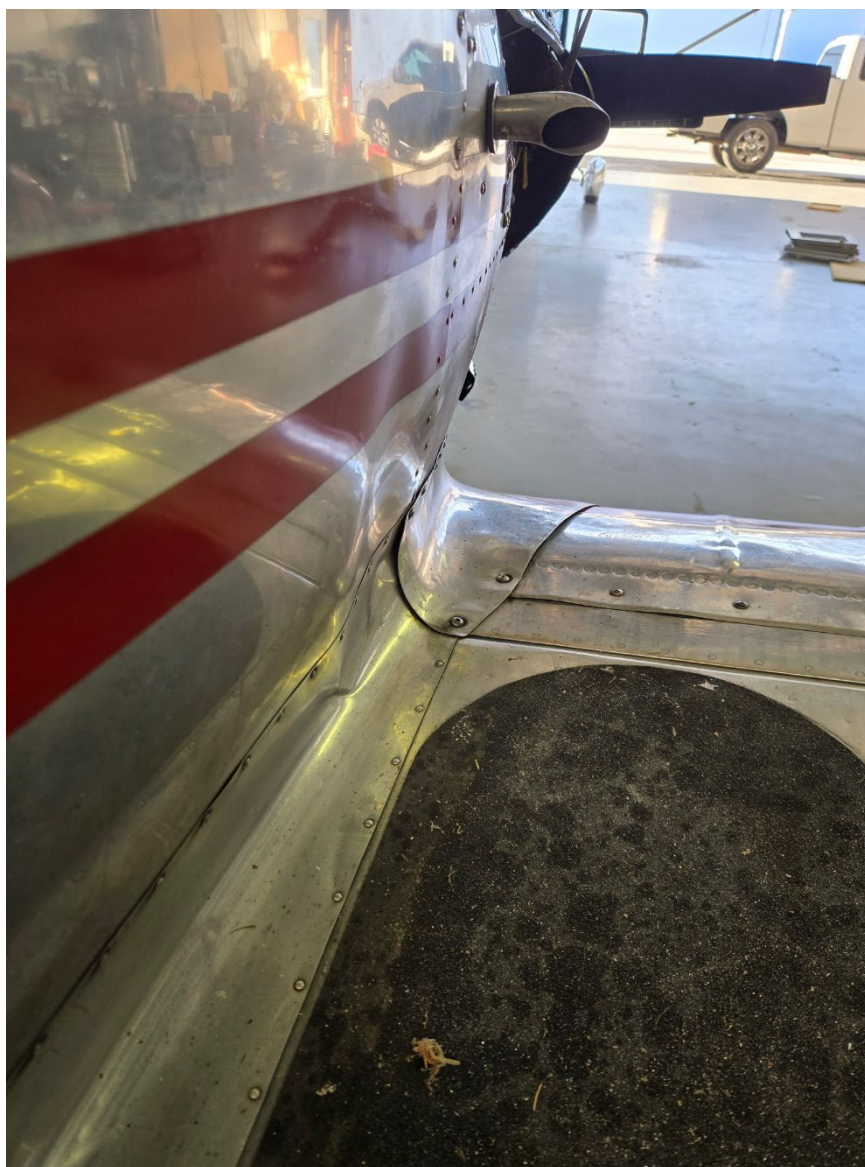
**Photograph 1 - Fuselage and Wing Damage (Courtesy of Owner)**

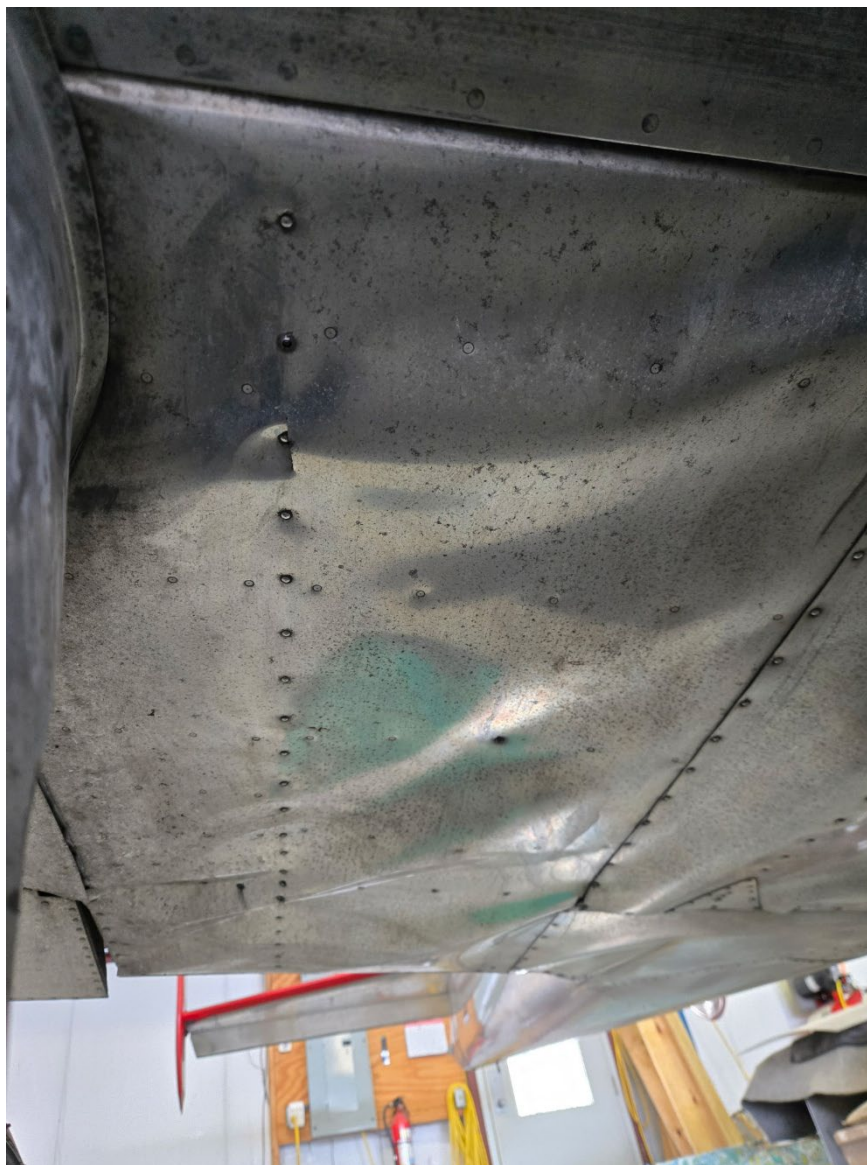
**Photograph 2 - Lower Right Wing (Courtesy of Owner)**
