CEN26LA055

## INVESTIGATION PHOTOGRAPHS

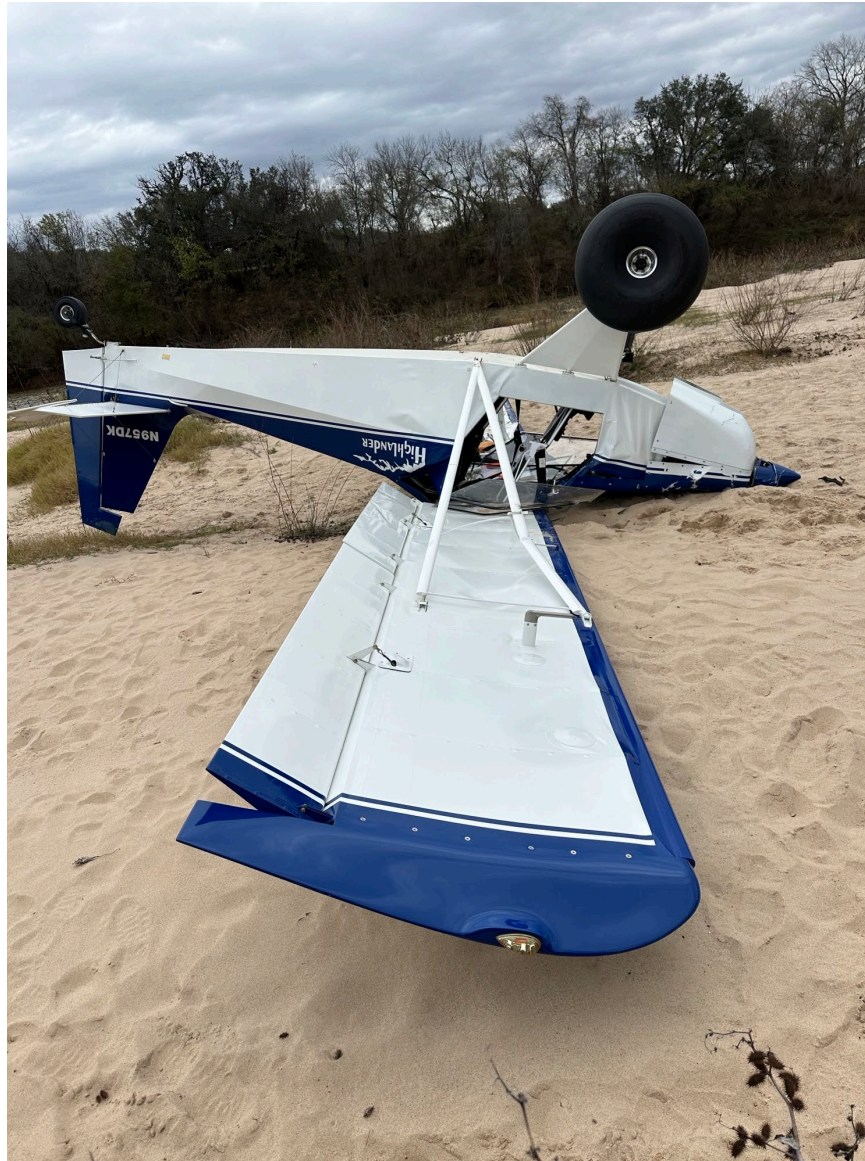
**Photograph 1 - Accident airplane (Courtesy of FAA)**

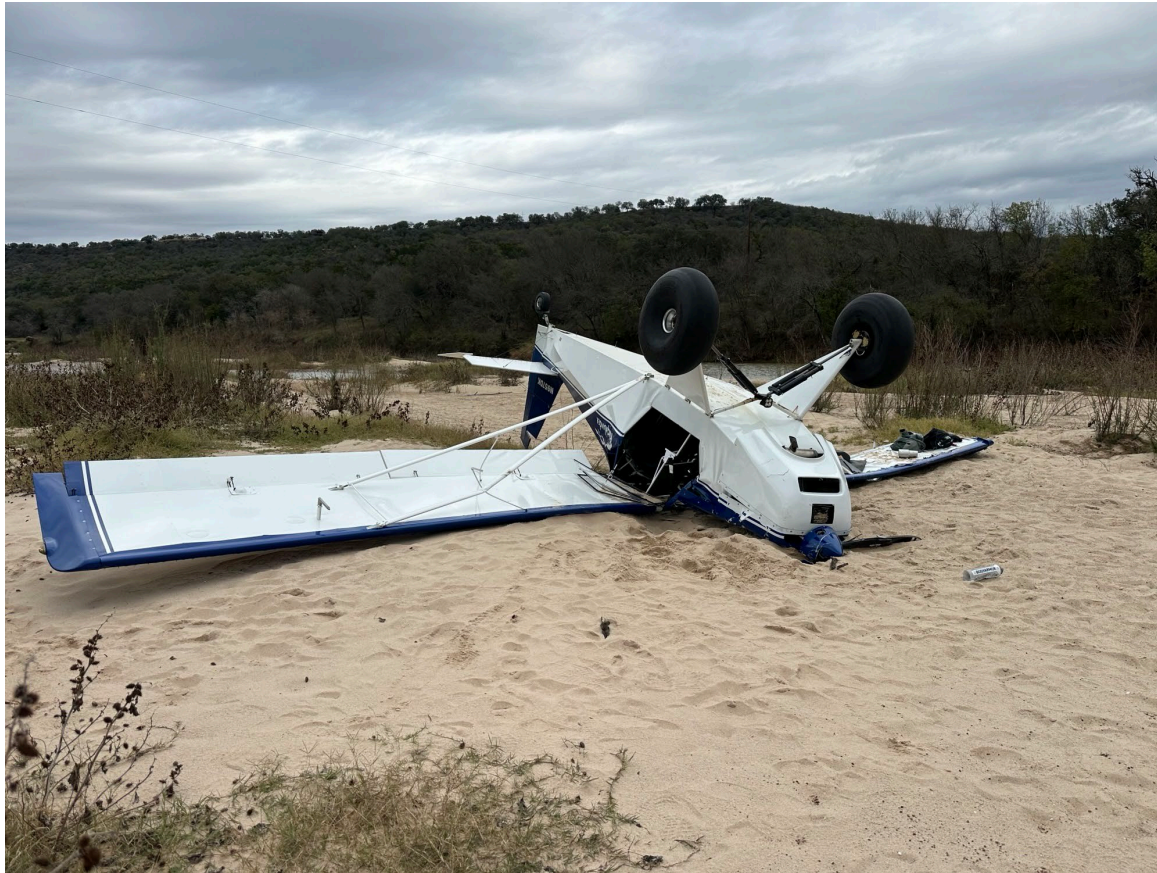
**Photograph 2 - Accident airplane (Courtesy of FAA)**

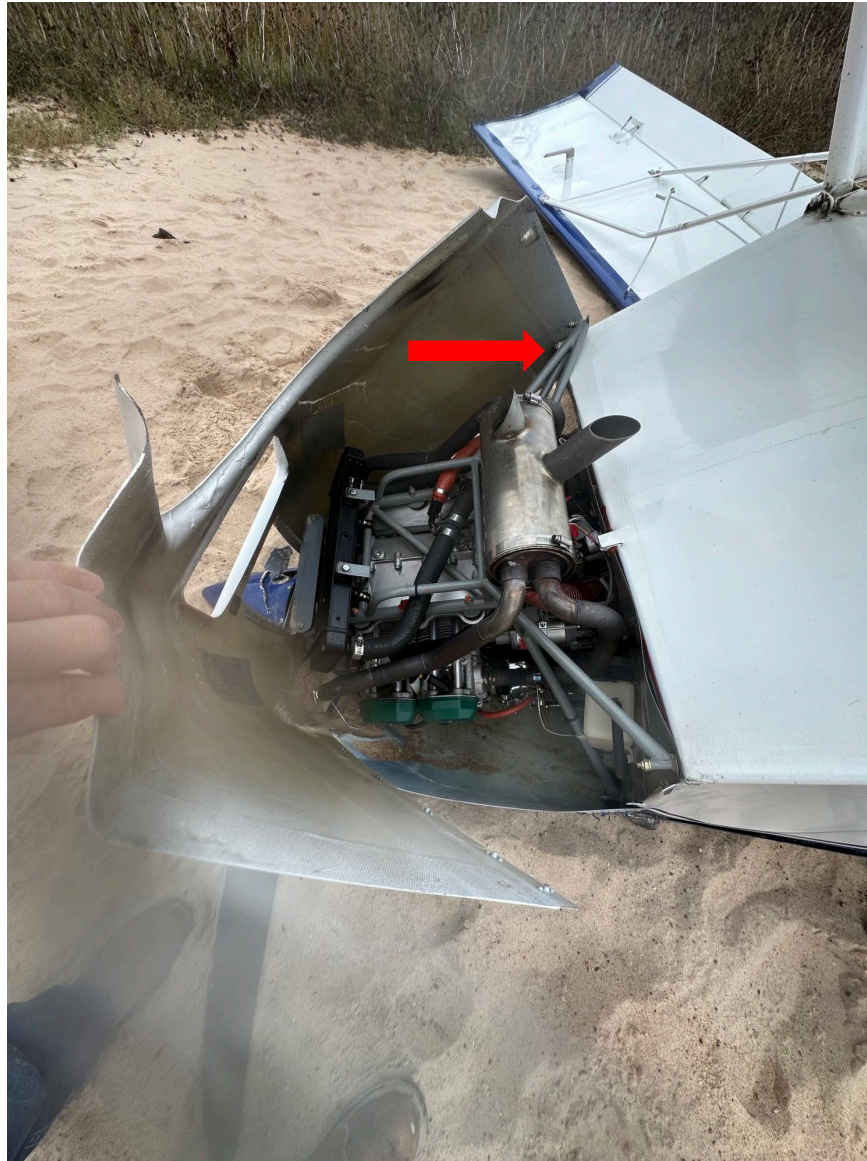
**Photograph 3 - Broken engine mount (Courtesy of FAA)**

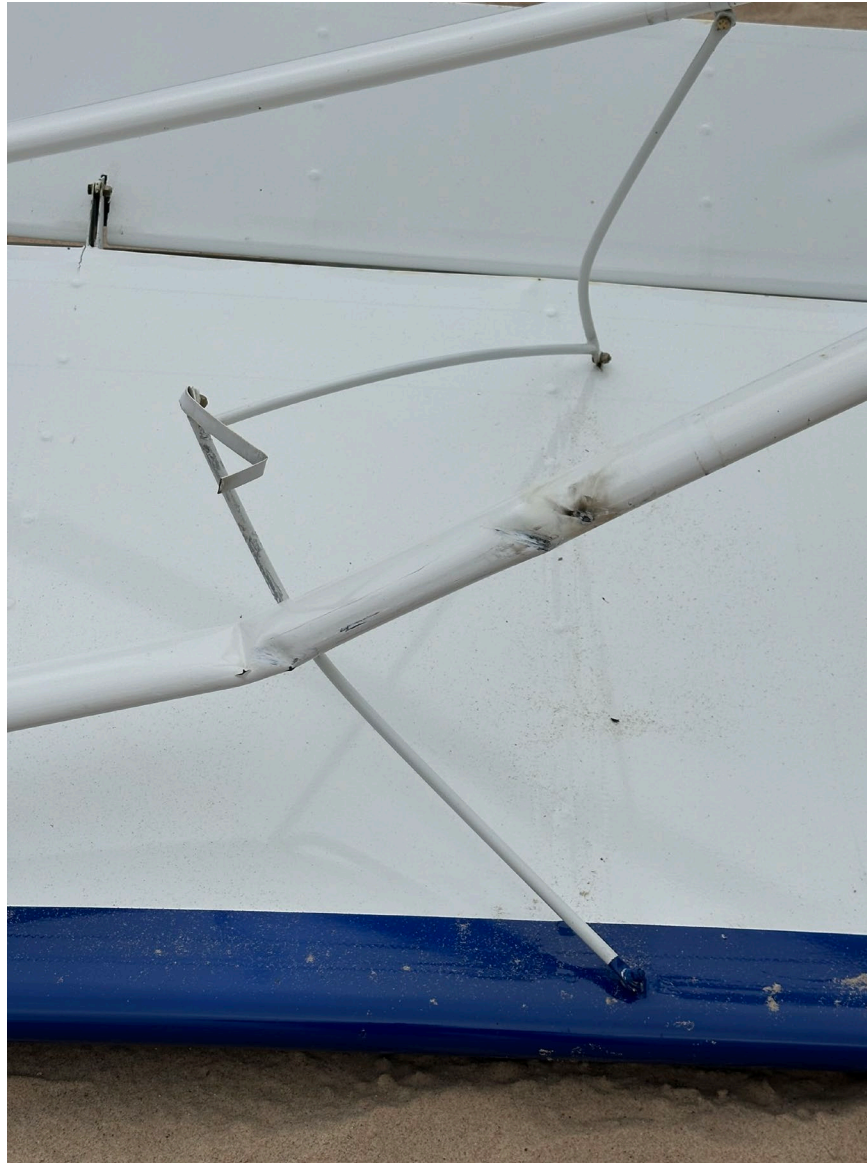
**Photograph 4 - Bent wing strut (Courtesy of FAA)**

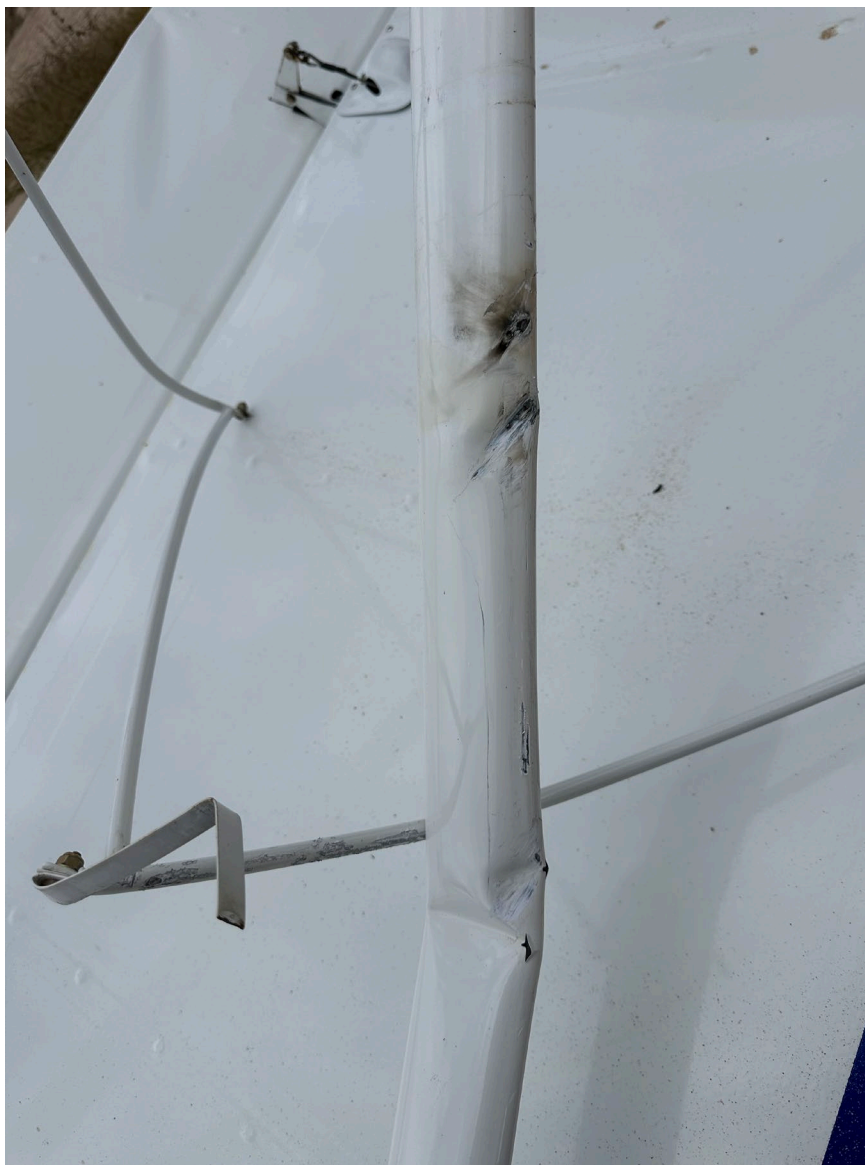
**Photograph 5 - Bent wing strut (Courtesy of FAA)**
