CEN26LA069

## INVESTIGATION PHOTOGRAPHS

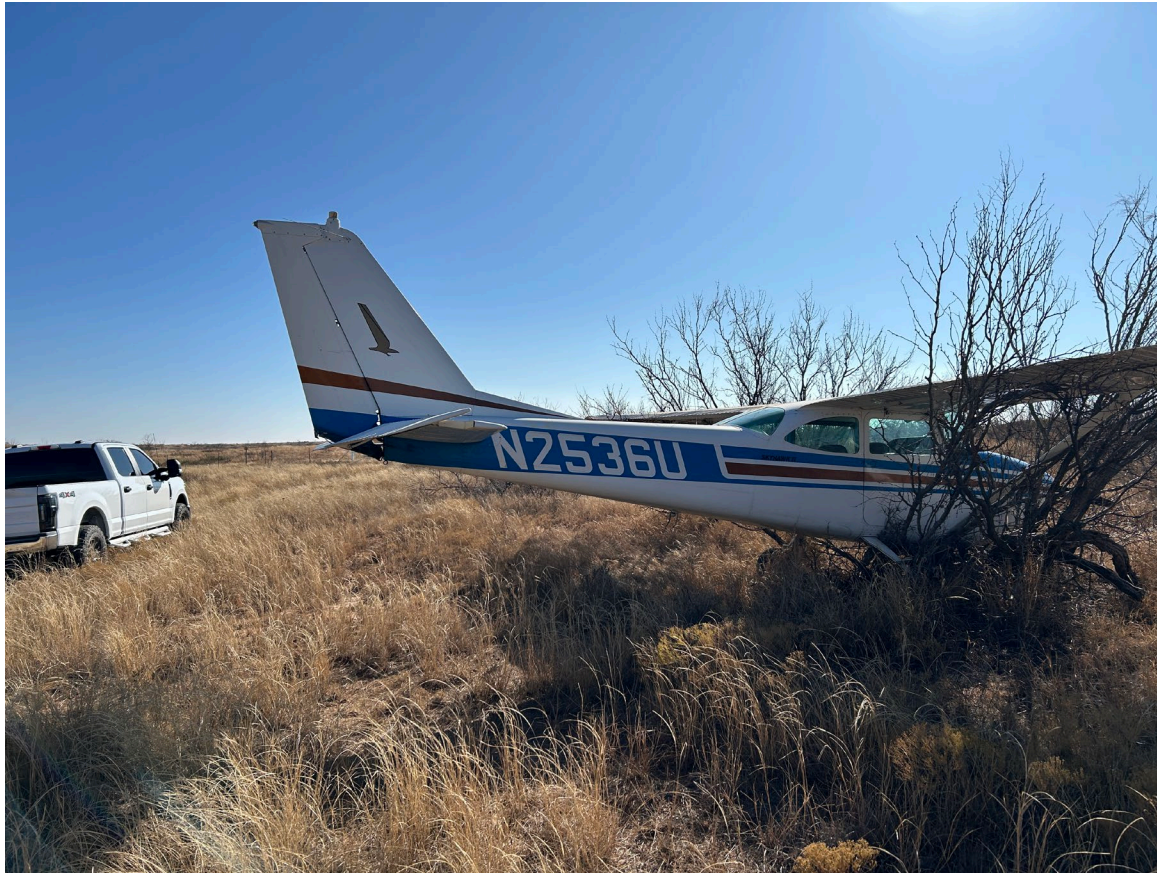
**Picture 1 Airplane at Rest in Brush (Courtesy of the FAA)**

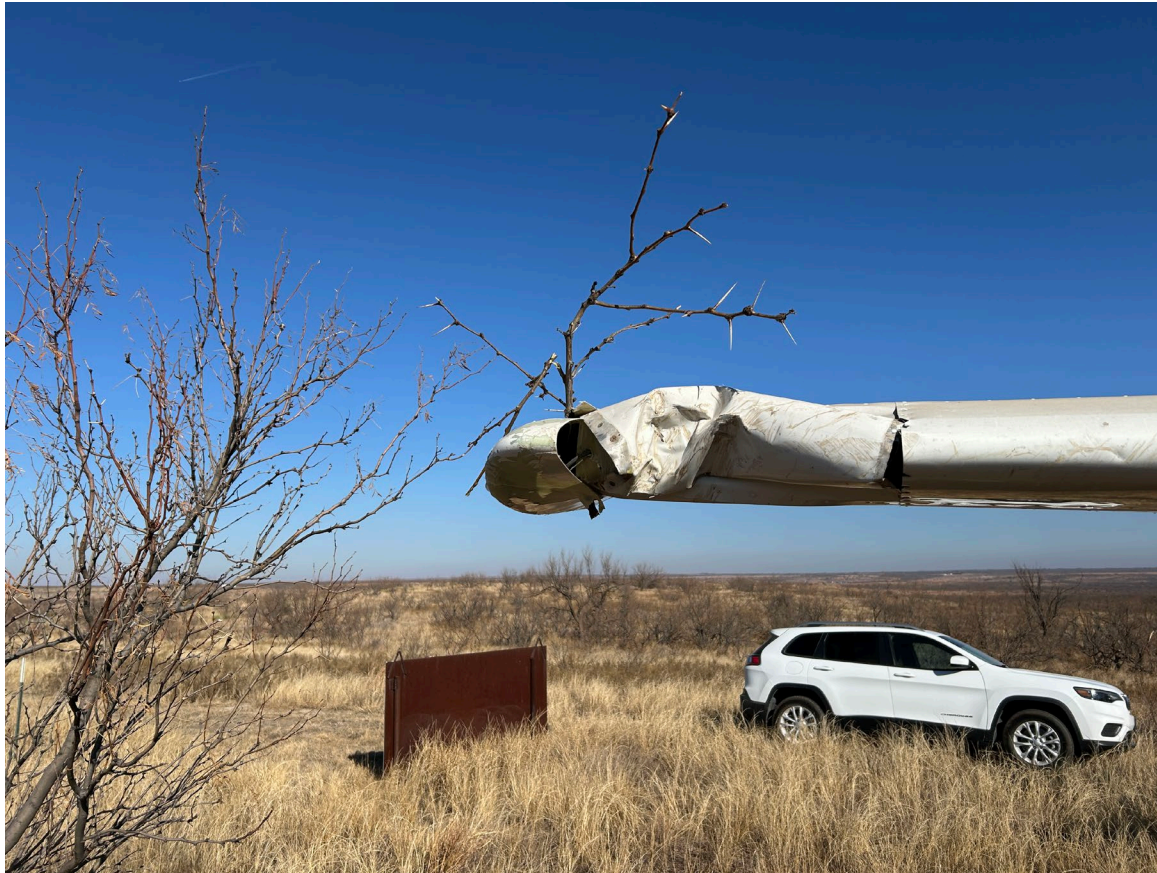
**Picture 2 Damage to Outer Right Wing (Courtesy of the FAA)**

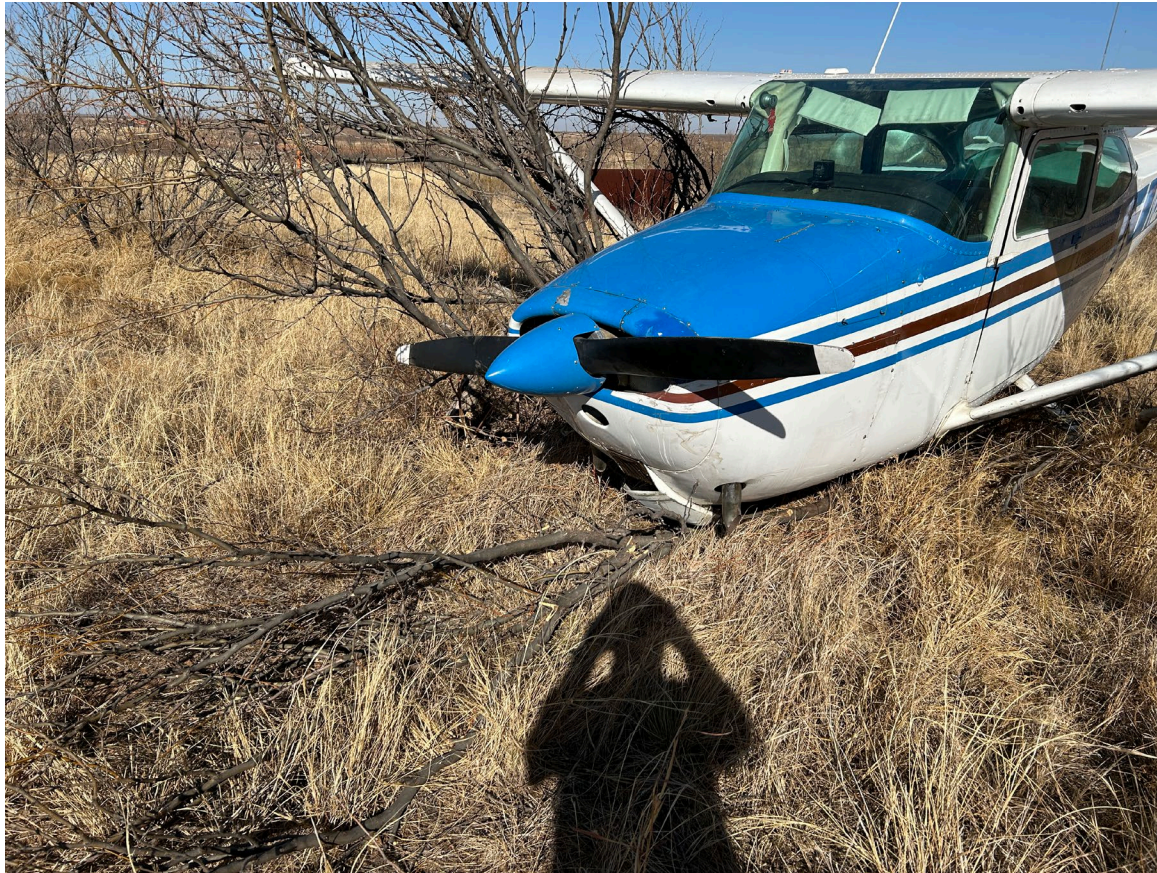
**Picture 3 Collapsed Nose Landing Gear (Courtesy of the FAA)**

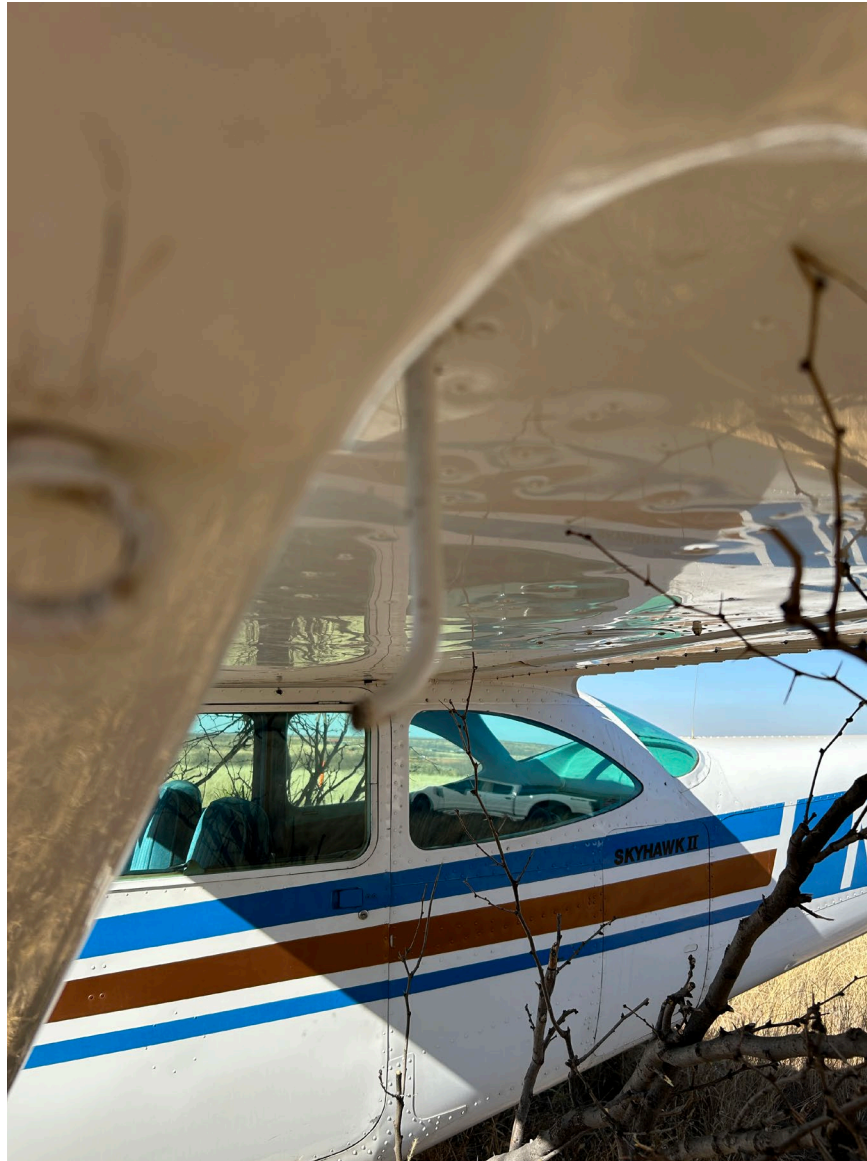
**Picture 4 Fuel Vent (Courtesy of the FAA)**

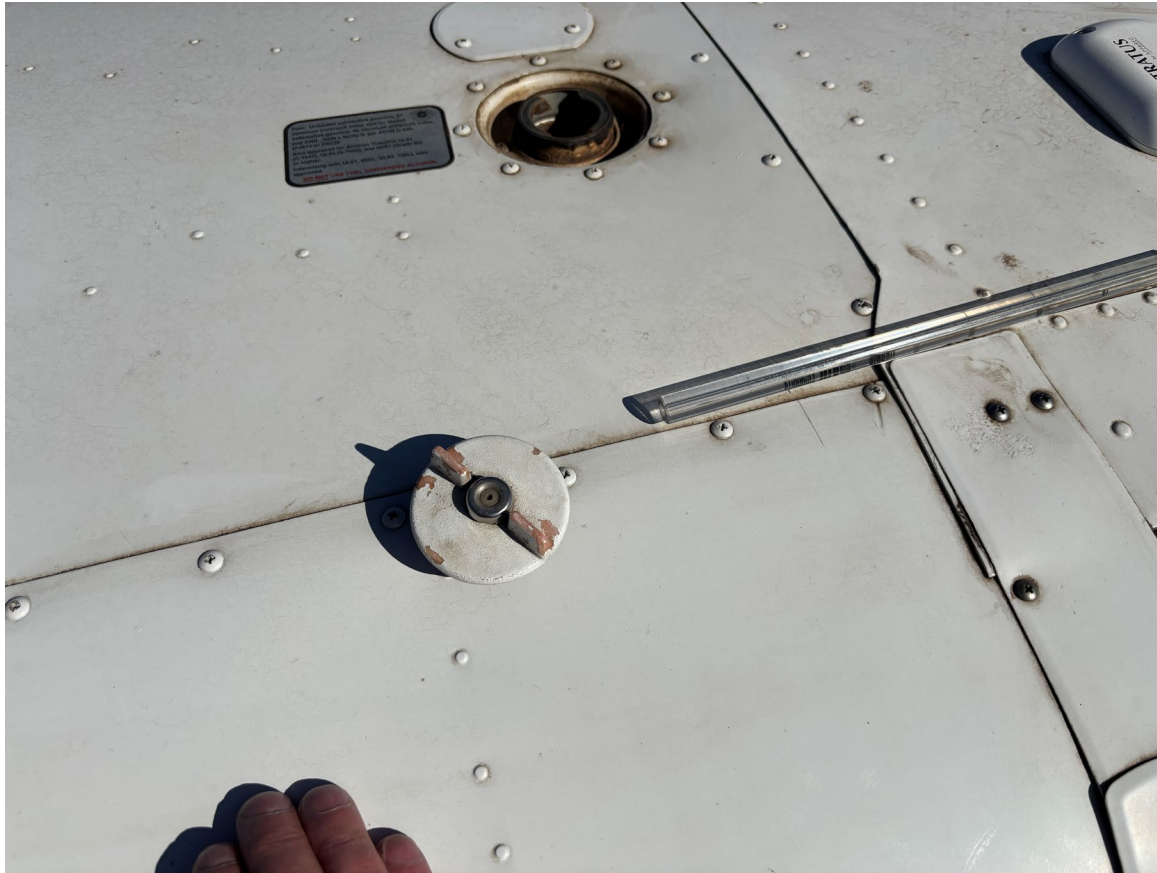
**Picture 5 Right Fuel Tank Vented Fuel Cap (Courtesy of the FAA)**
