# National Transportation Safety Board

CEN26LA074

## **EXAMINATION SUMMARY**

Location: Carbondale, Illinois  
Date: 12/31/2025  
Time: 1603 CST  
2203 UTC  
Airplane: N 401MS, Pitts S1S

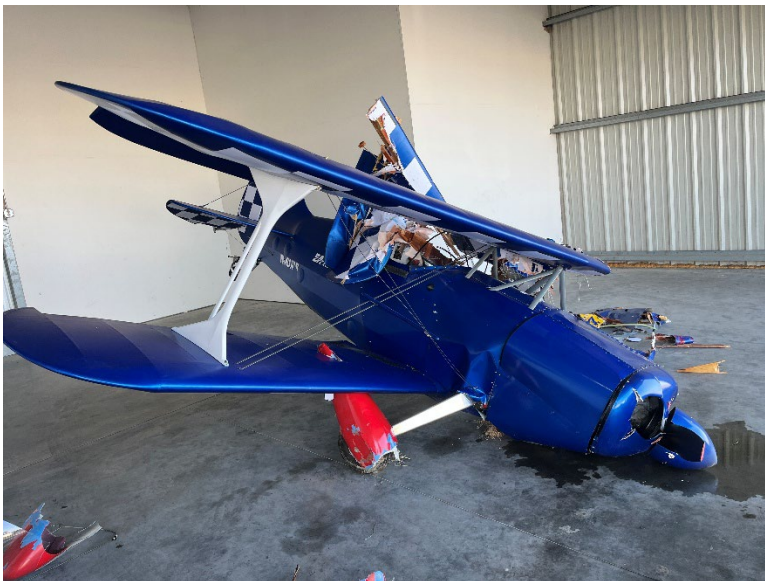
The steel tube fuselage was predominately intact. The forward lower portion of the fuselage, including the area where the main landing gear attached was bent upward and rearward. The tail surfaces were still attached and undamaged. Control system continuity was established by actuating the cockpit controls. The elevator and rudder controls were intact, as were the controls to the right wings and ailerons. The left upper and lower wings were fragmented, and complete left aileron control continuity could not be established; however, the pushrod exiting the left fuselage side moved with control stick movement. There were no pre-impact anomalies detected during examination of the fuselage or control system.

Figure 1. Airplane as recovered from accident site.

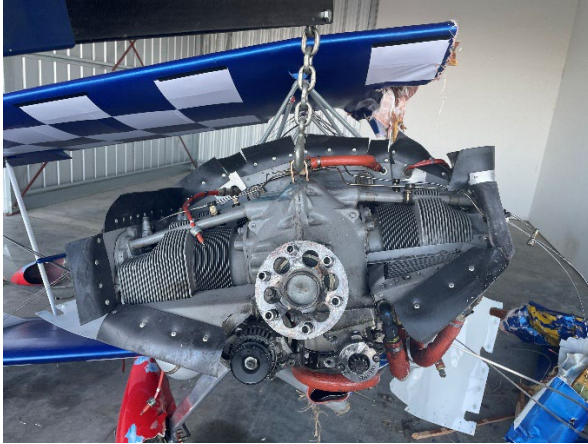
The engine was still securely attached to the airframe. During the examination an unknown quantity of oil was present beneath the airplane and on the floor of the hangar. The engine did not have a data plate but appeared to be a narrow-flange IO-320 engine. The crankshaft propeller flange was bent, preventing rotation of the engine with the propeller attached. An engine hoist connected to the engine's lifting strap was used to support the engine at working height. After removal of the propeller and starter ring support, the engine could be rotated using a short pry bar on the crankshaft flange.

Figure 2. Engine during examination.

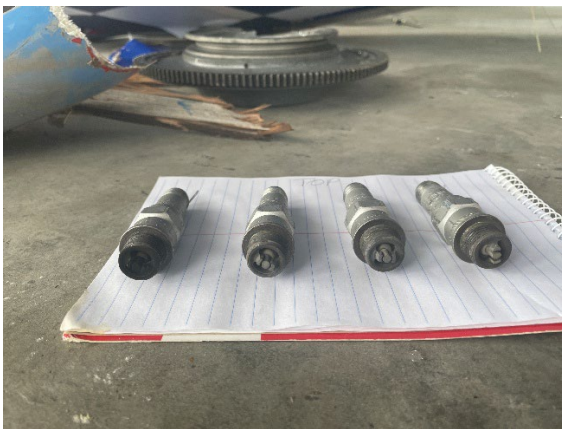
The upper spark plugs were removed. The No. 1 plug showed signatures consistent with rich combustion. The remaining three plugs showed normal burn signatures.

Figure 3. Upper spark plugs as removed.

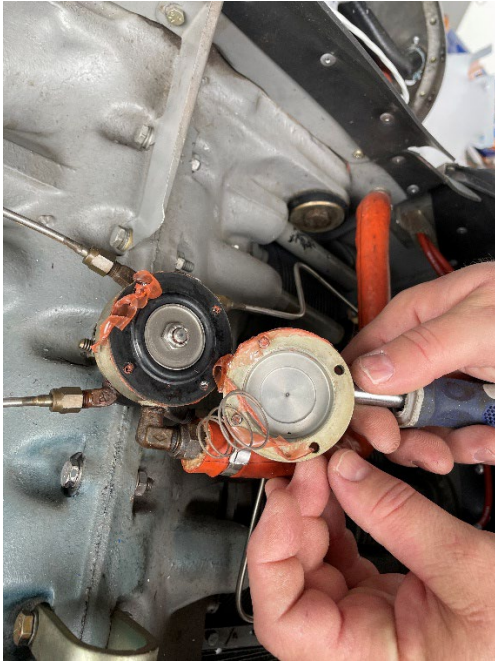
The fuel distribution manifold "spider" was disassembled. The four screws securing the cover did not have safety wire. All four screws were loose and required almost no breakout force to remove. The diaphragm had been coated with red silicone on both sides. The diaphragm was stiff and had cracks, although none of the cracks extended through the full thickness of the diaphragm. There was no fuel within manifold.

Figure 4. Fuel distribution manifold showing silicone sealant.

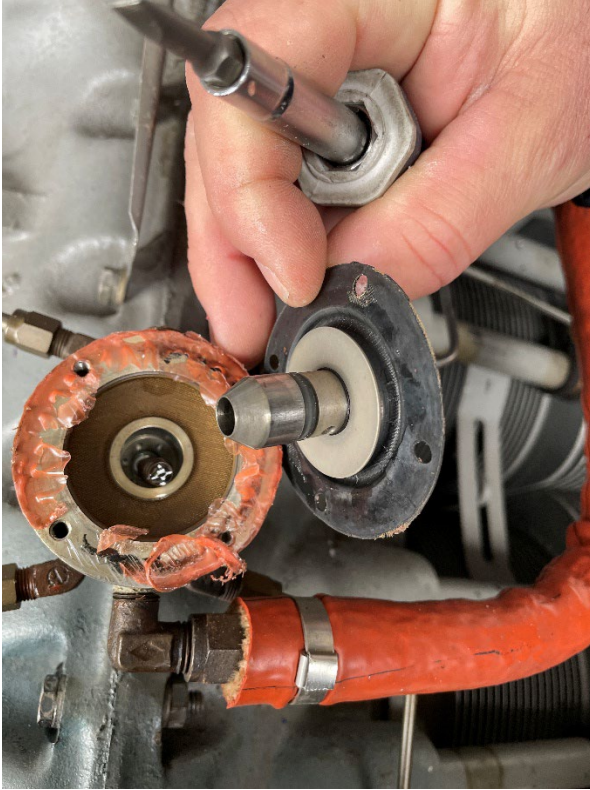
Figure 5. Fuel distribution manifold diaphragm.

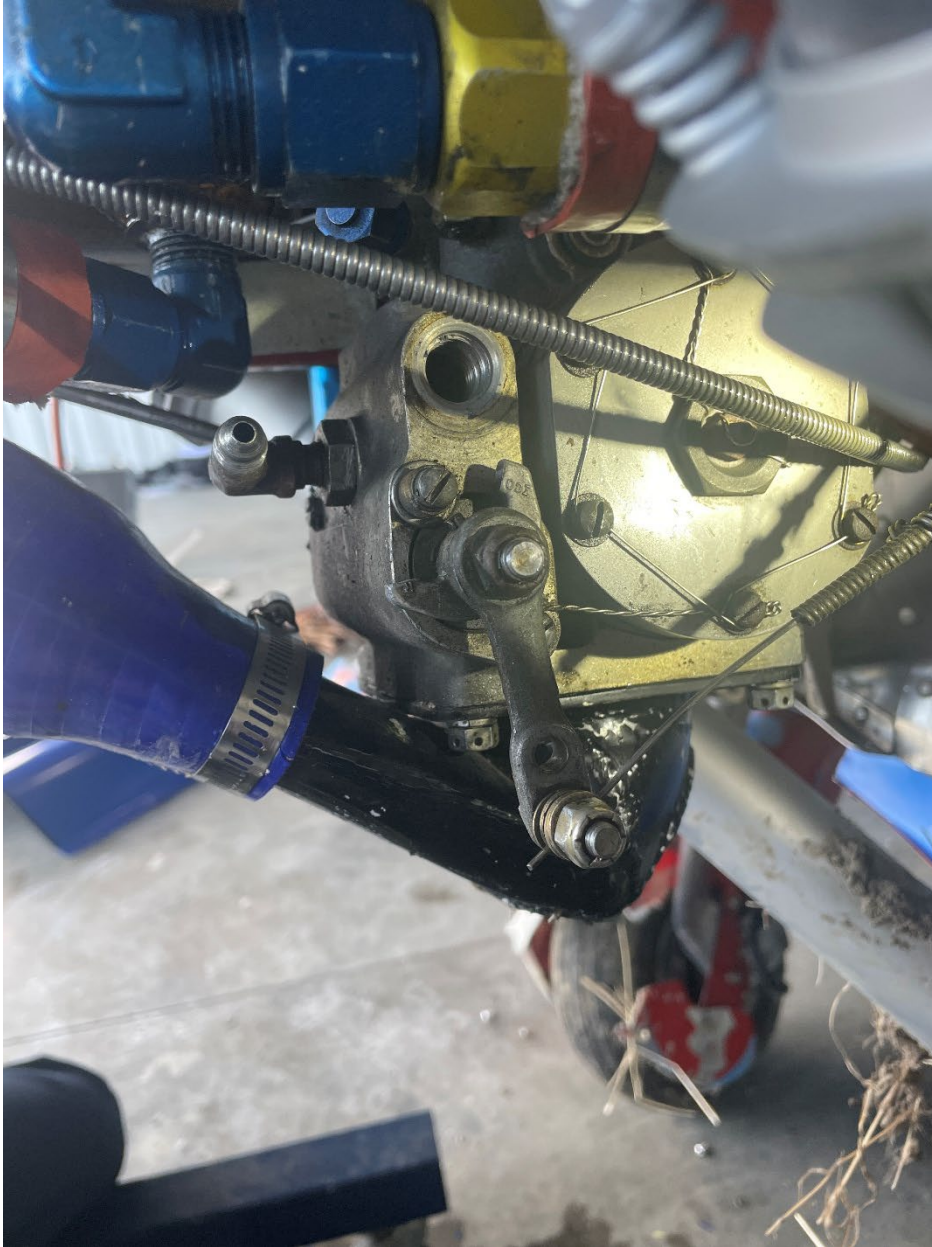
The fuel servo was securely attached to the engine sump. The fuel screen on the fuel servo was clean with no anomalies noted. The throttle cable was still attached and was secured. The mixture control cable inner wire was securely attached to the mixture arm, but the outer sheath was not installed on a bracket. The first support of the outer sheath aft of the fuel servo was where the cable was secured to the engine mount tube using adel clamps. This location was about 1 foot aft of the cable attachment to the mixture arm. The cable outer sheath had signatures consistent with it rubbing on the engine mount tube. The rub marks indicated that the outer sheath had moved aft about 1 inch. The mixture control arm was about mid-range with the cockpit control in the full rich position. There was safety wire wrapped around the outer sheath of the mixture control cable near its end, but the safety wire was not connected to anything except the cable itself.

Figure 5. Fuel servo mixture arm.

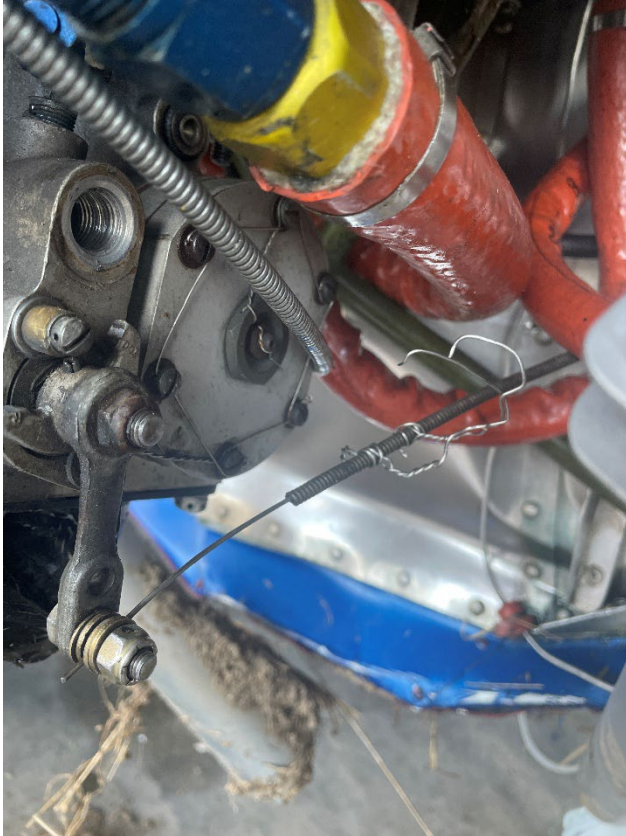
Figure 6. Mixture cable with safety wire.
