CEN26LA074

## INVESTIGATION PHOTOGRAPHS

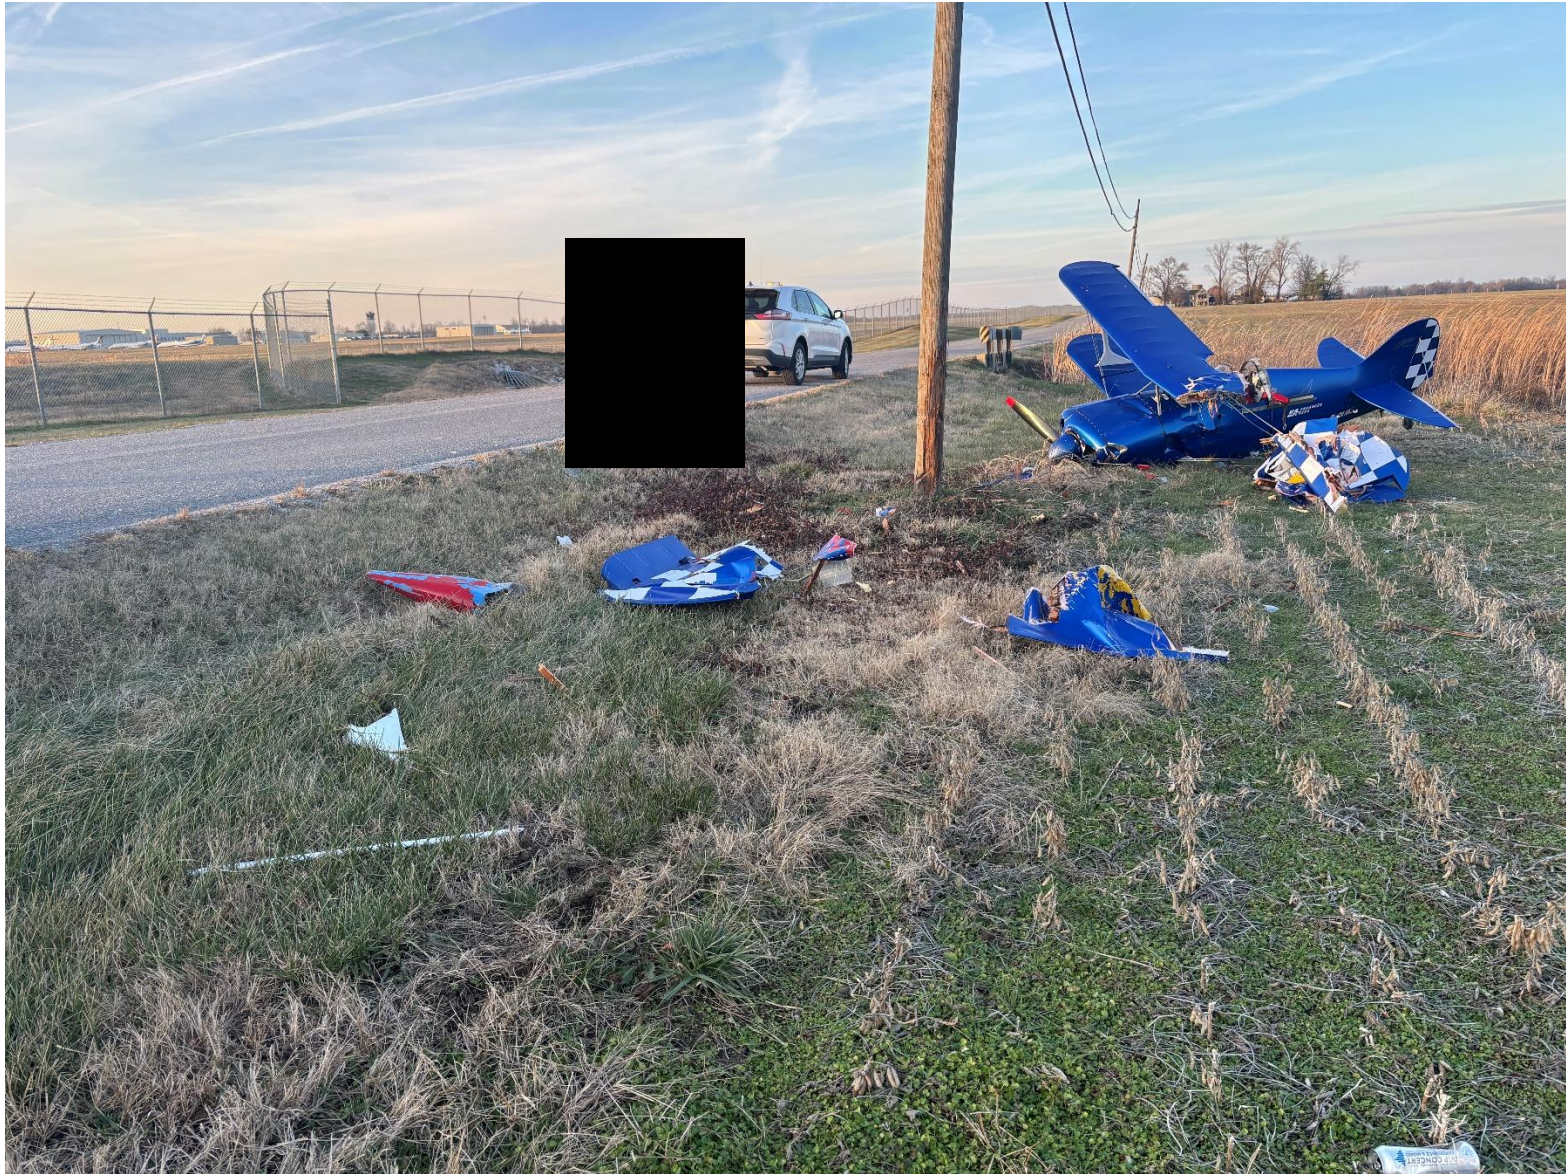
**Photograph 1 - Accident site (Courtesy of Airport Authority)**

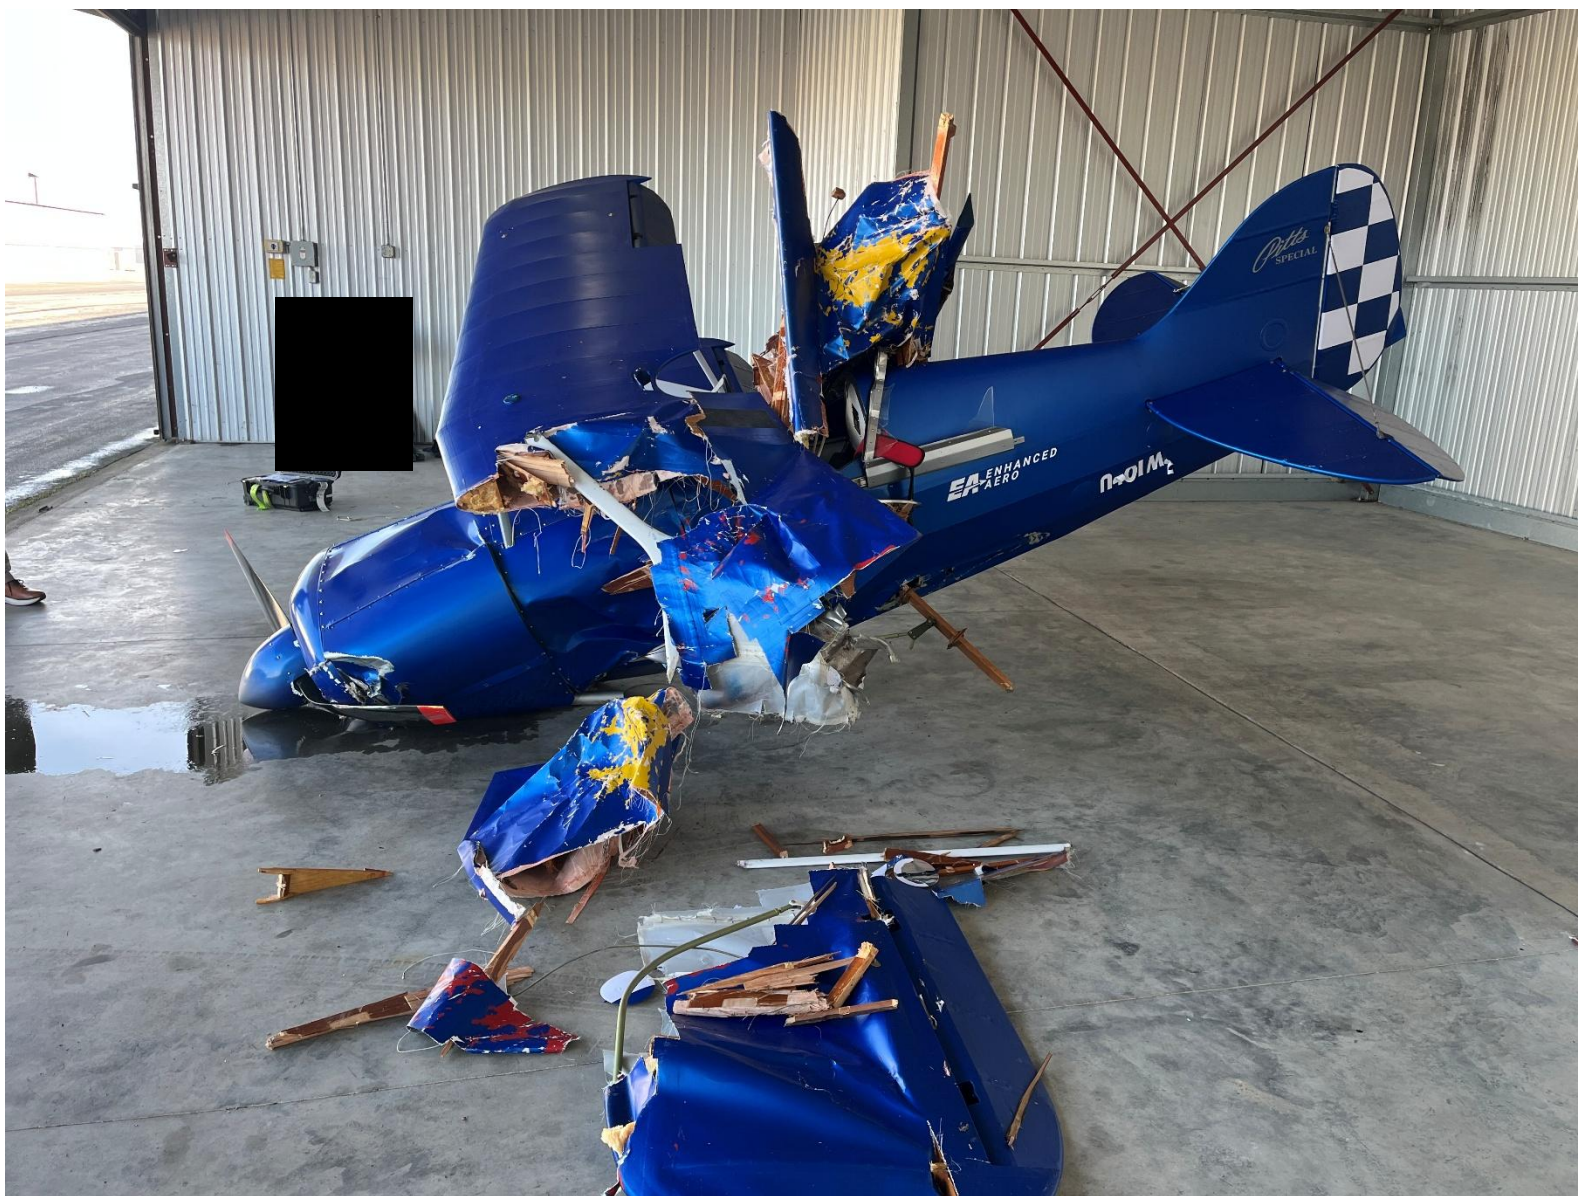
**Photograph 2 - Aircraft in hangar at examination time (Courtesy of NTSB)**

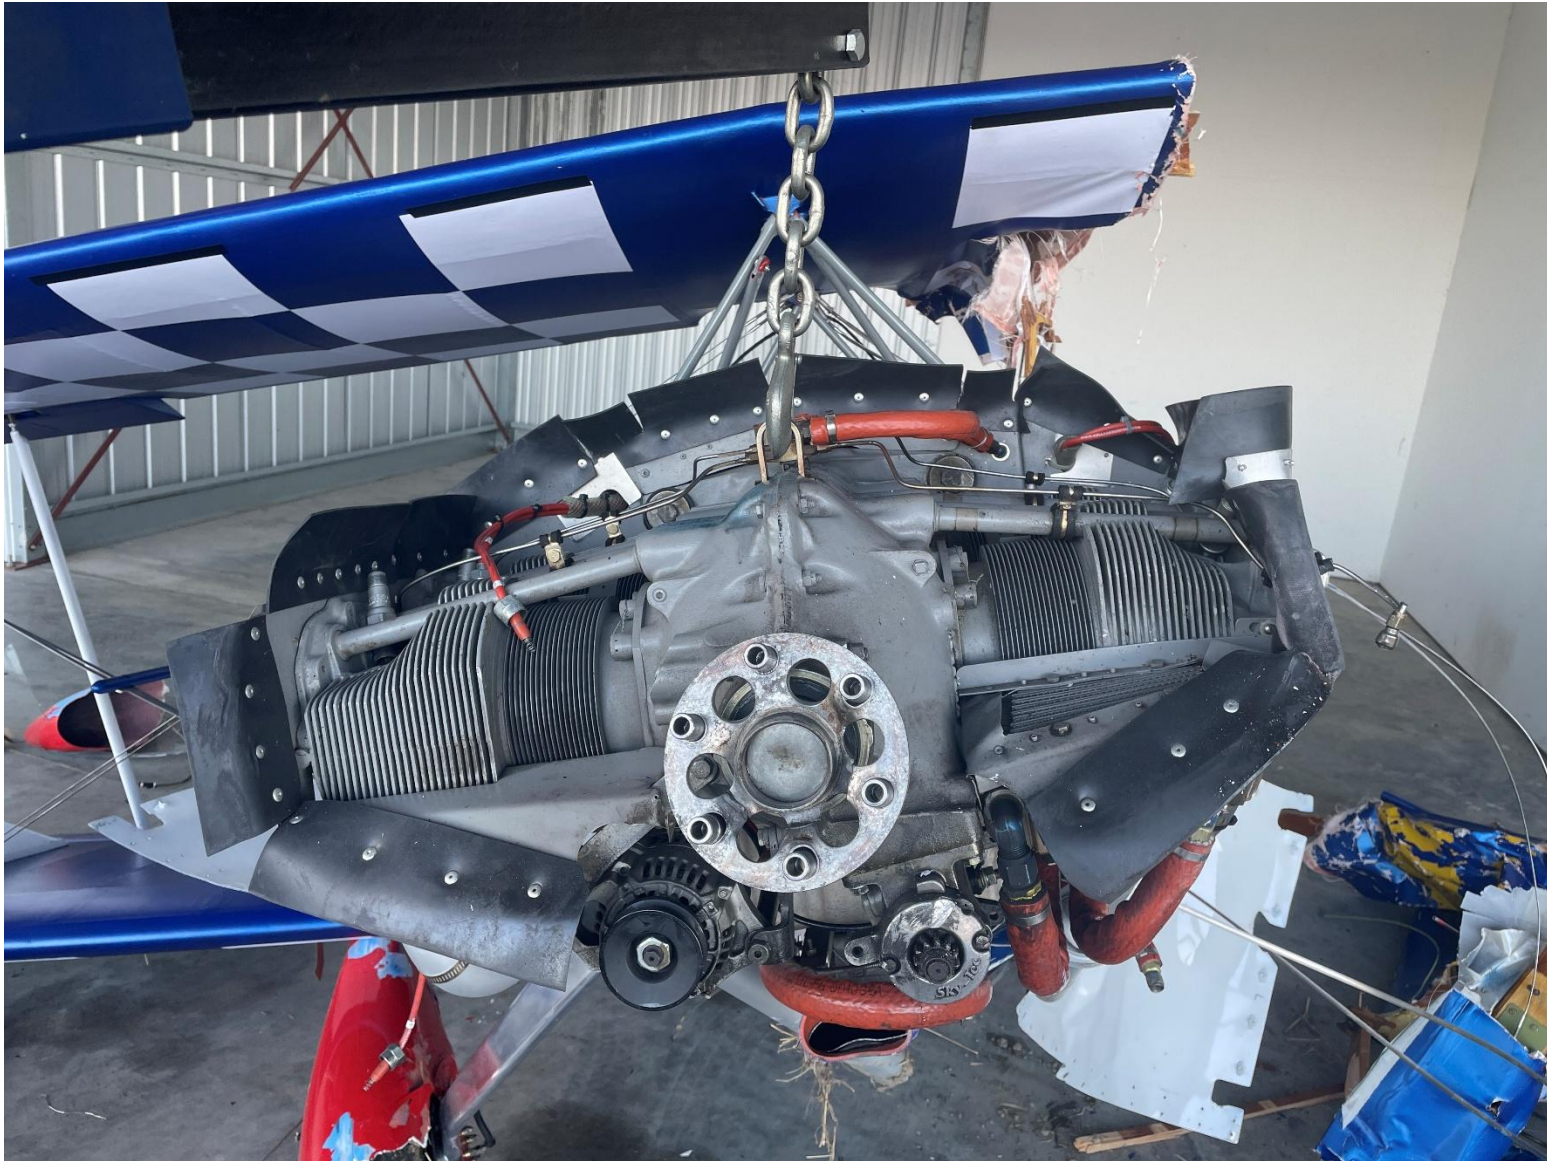
**Photograph 3 - Engine with cowling removed (Courtesy of NTSB)**

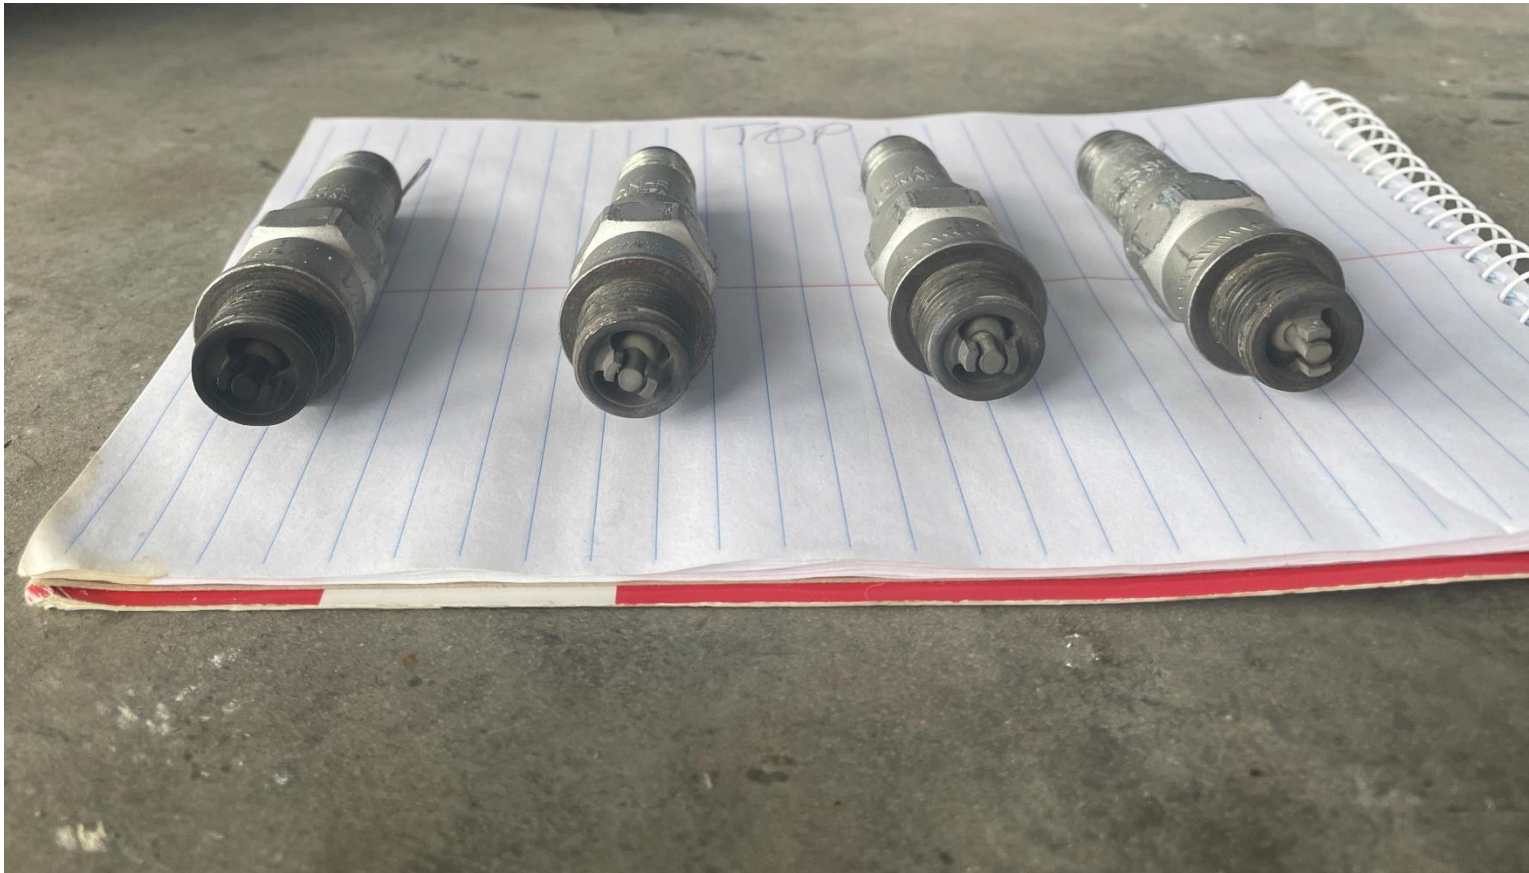
**Photograph 4 - Spark plugs (Courtesy of NTSB)**

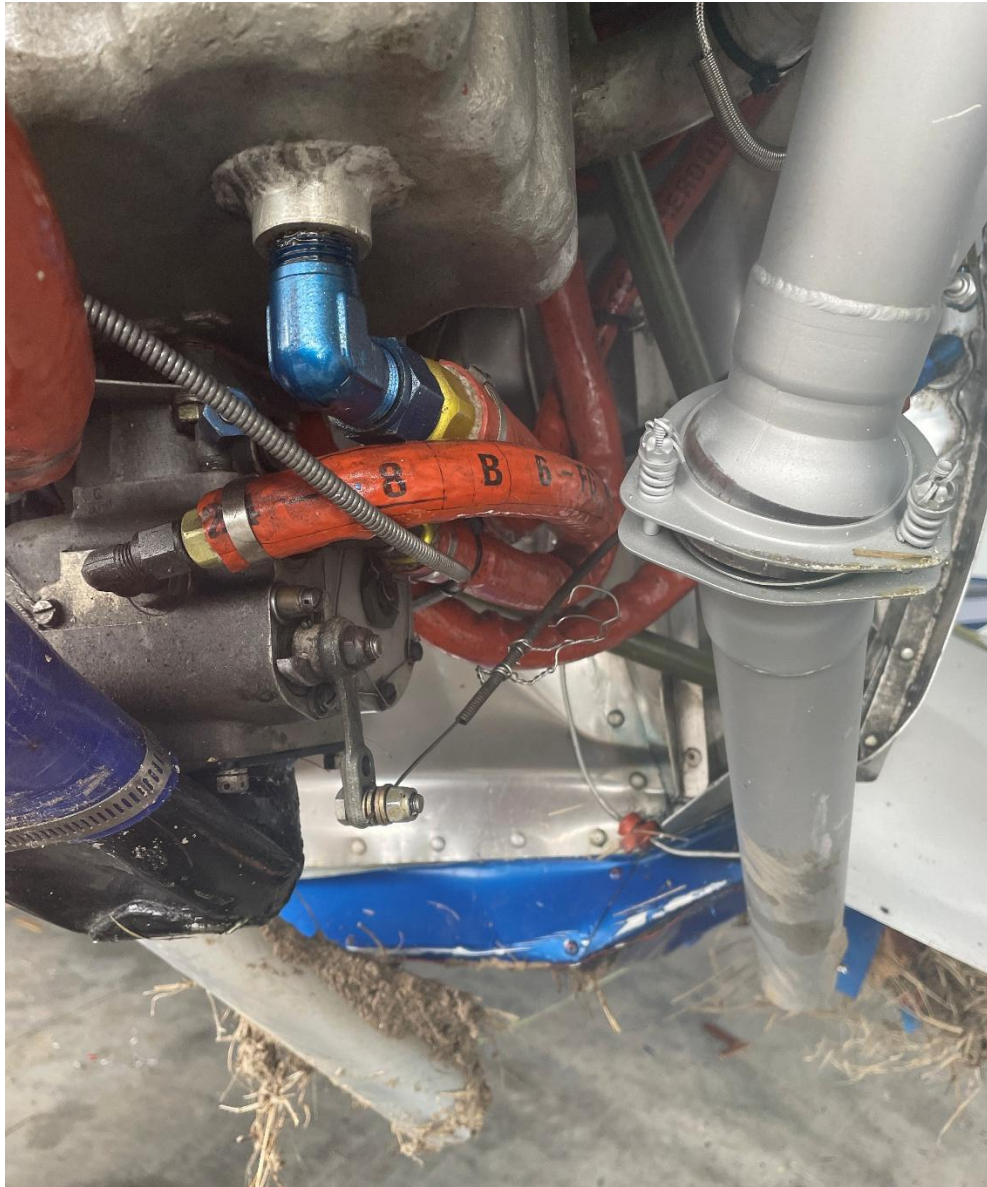
**Photograph 5 - Mixture linkage with severed safety wire (Courtesy of NTSB)**

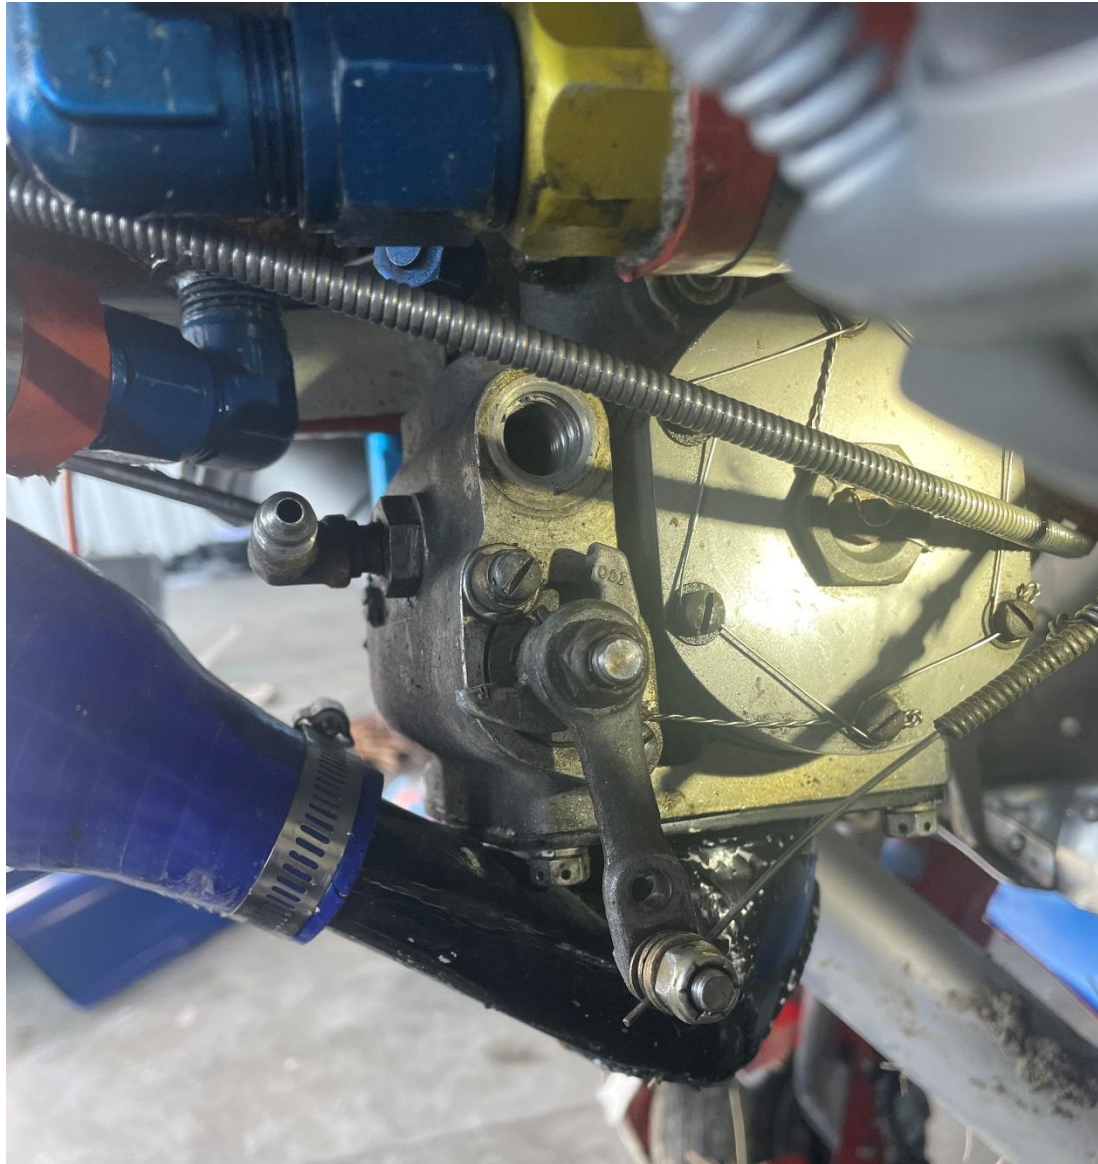
**Photograph 6 - Position of mixture arm with fuel screen removed (Courtesy of NTSB)**

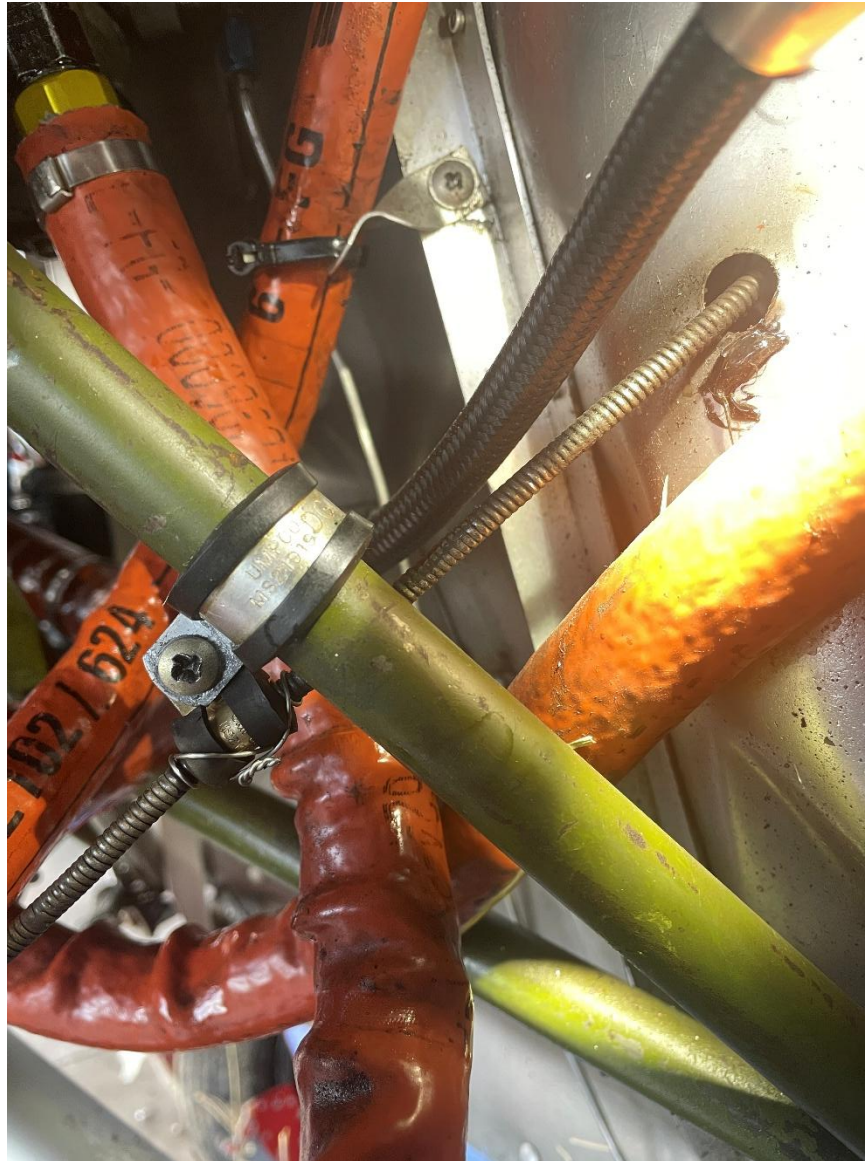
**Photograph 7 - Mixture cable slippage (Courtesy of NTSB)**

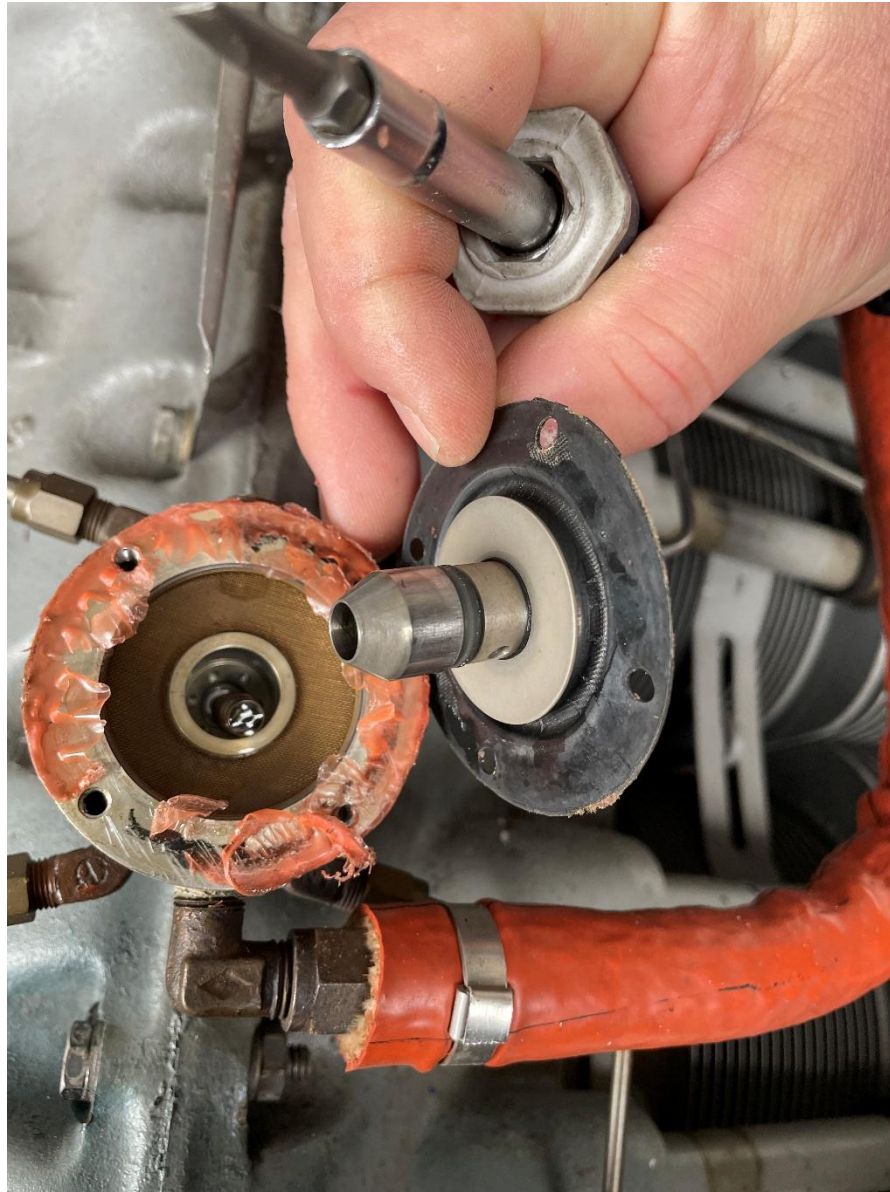
**Photograph 8 - Fuel manifold top removed, no fuel noted (Courtesy of NTSB)**
