CEN26LA081

## INVESTIGATION PHOTOGRAPHS

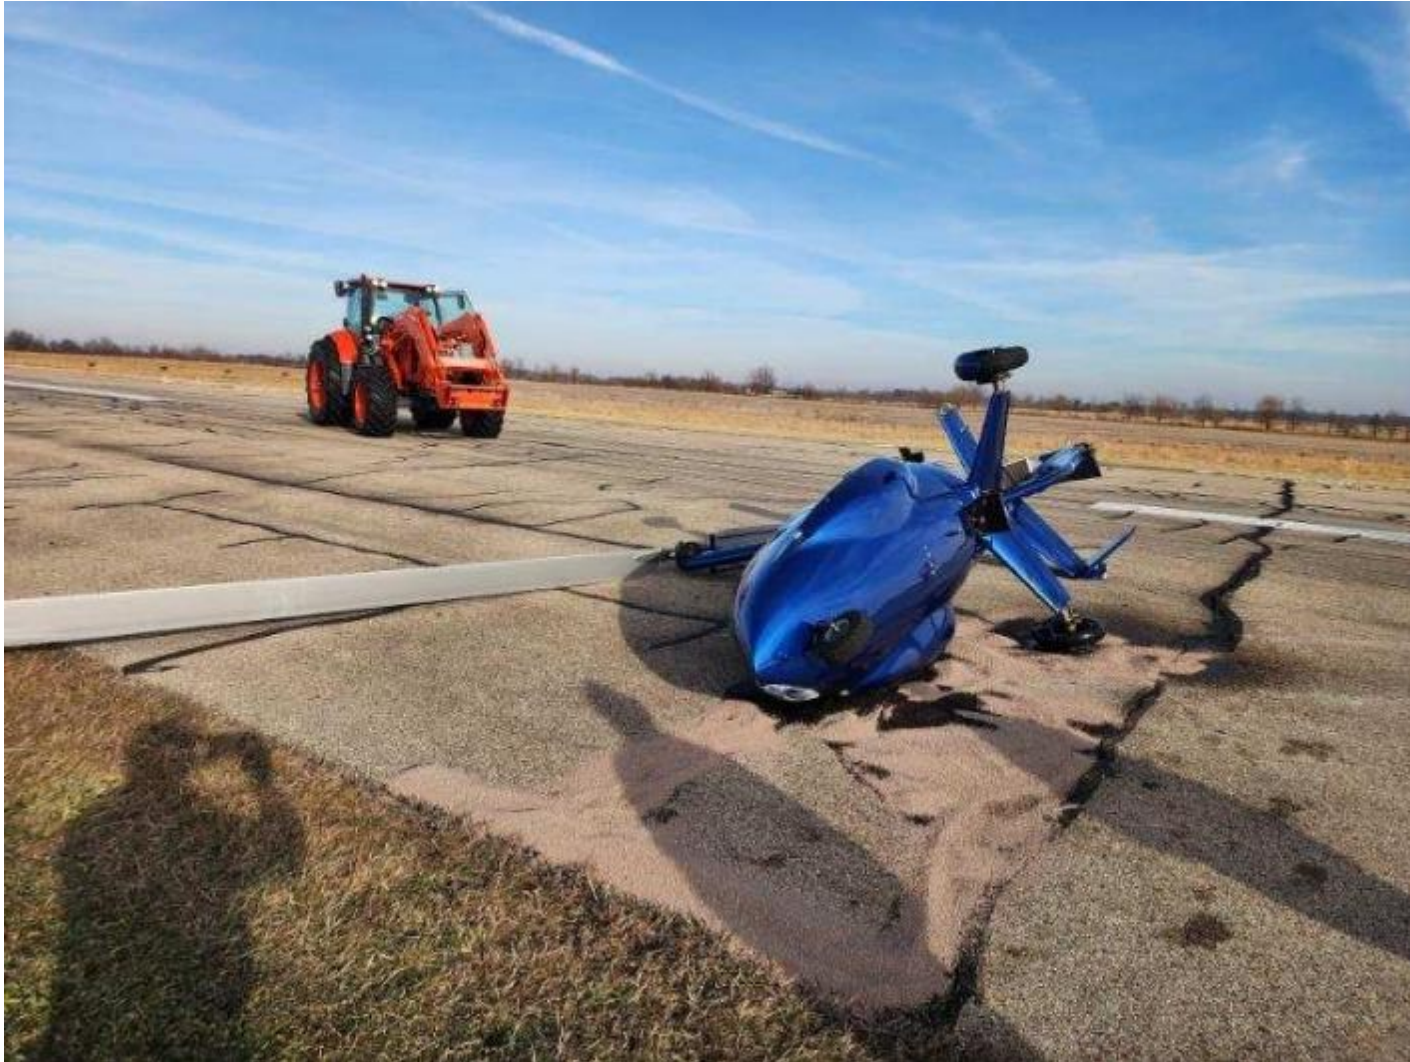
**Photograph 1 - Accident site (Courtesy of FAA)**

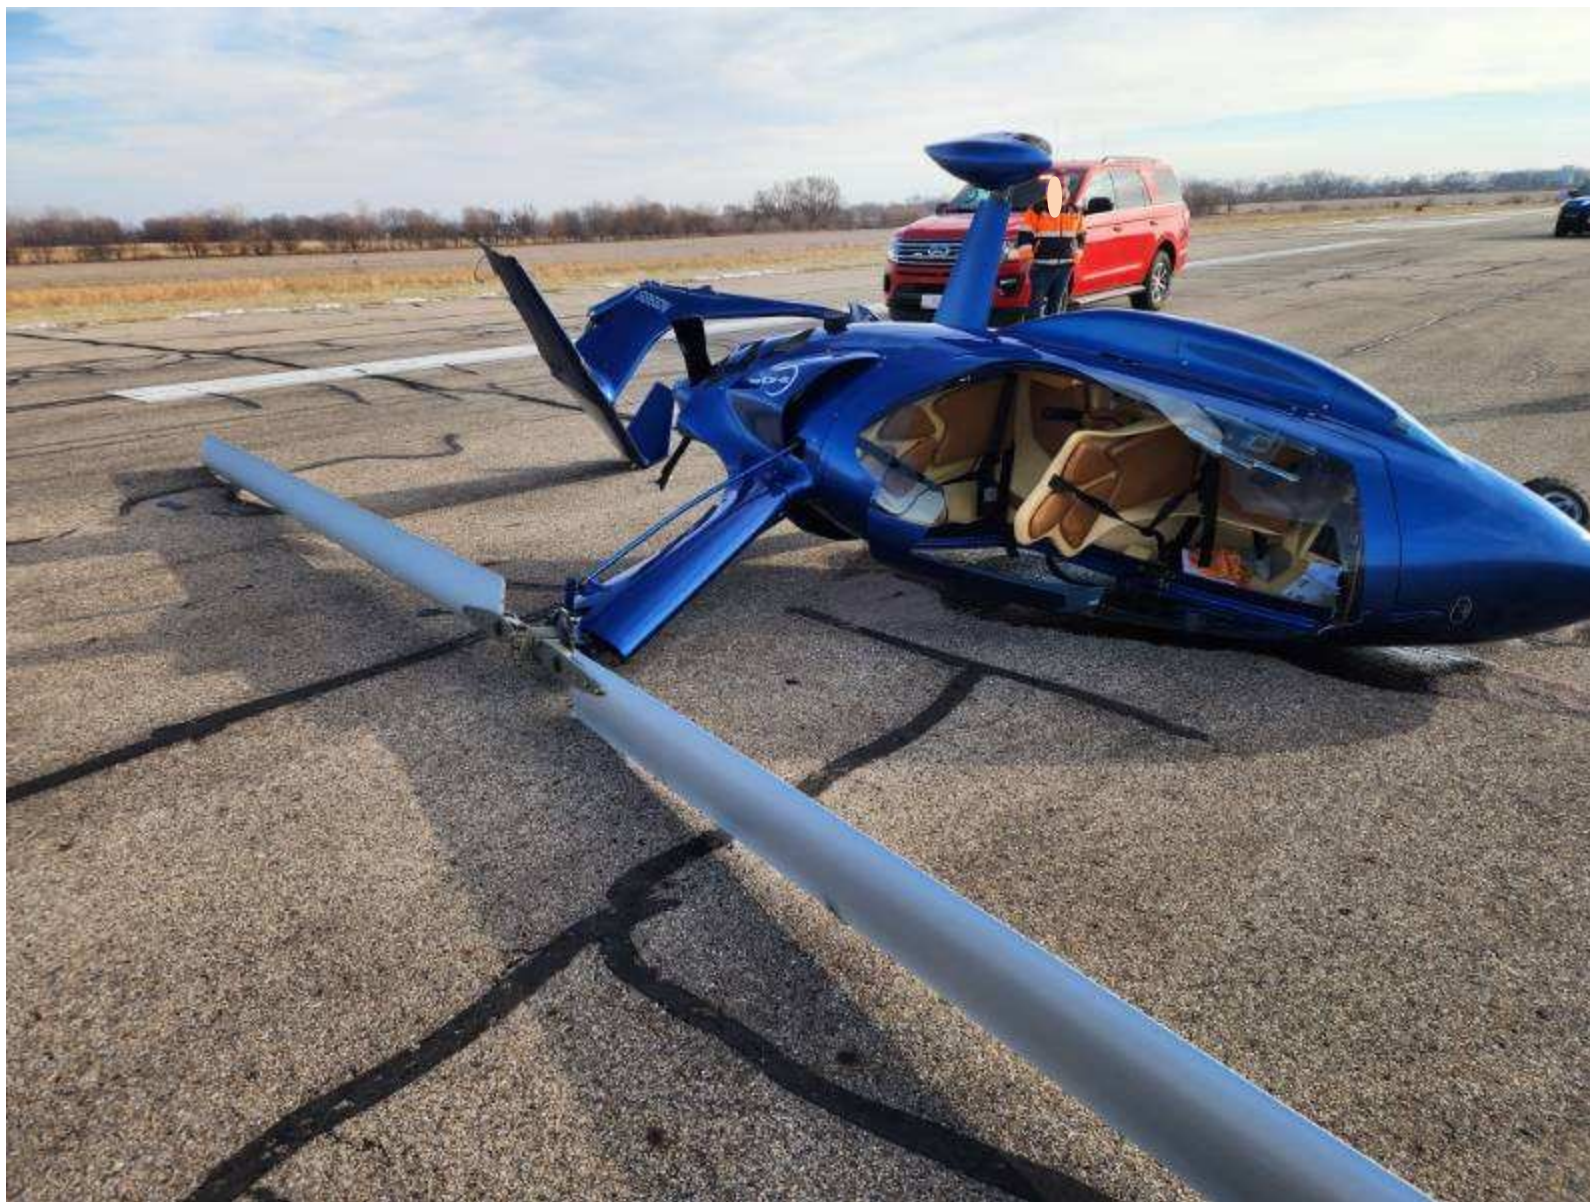
**Photograph 2 - Accident site (Courtesy of FAA)**

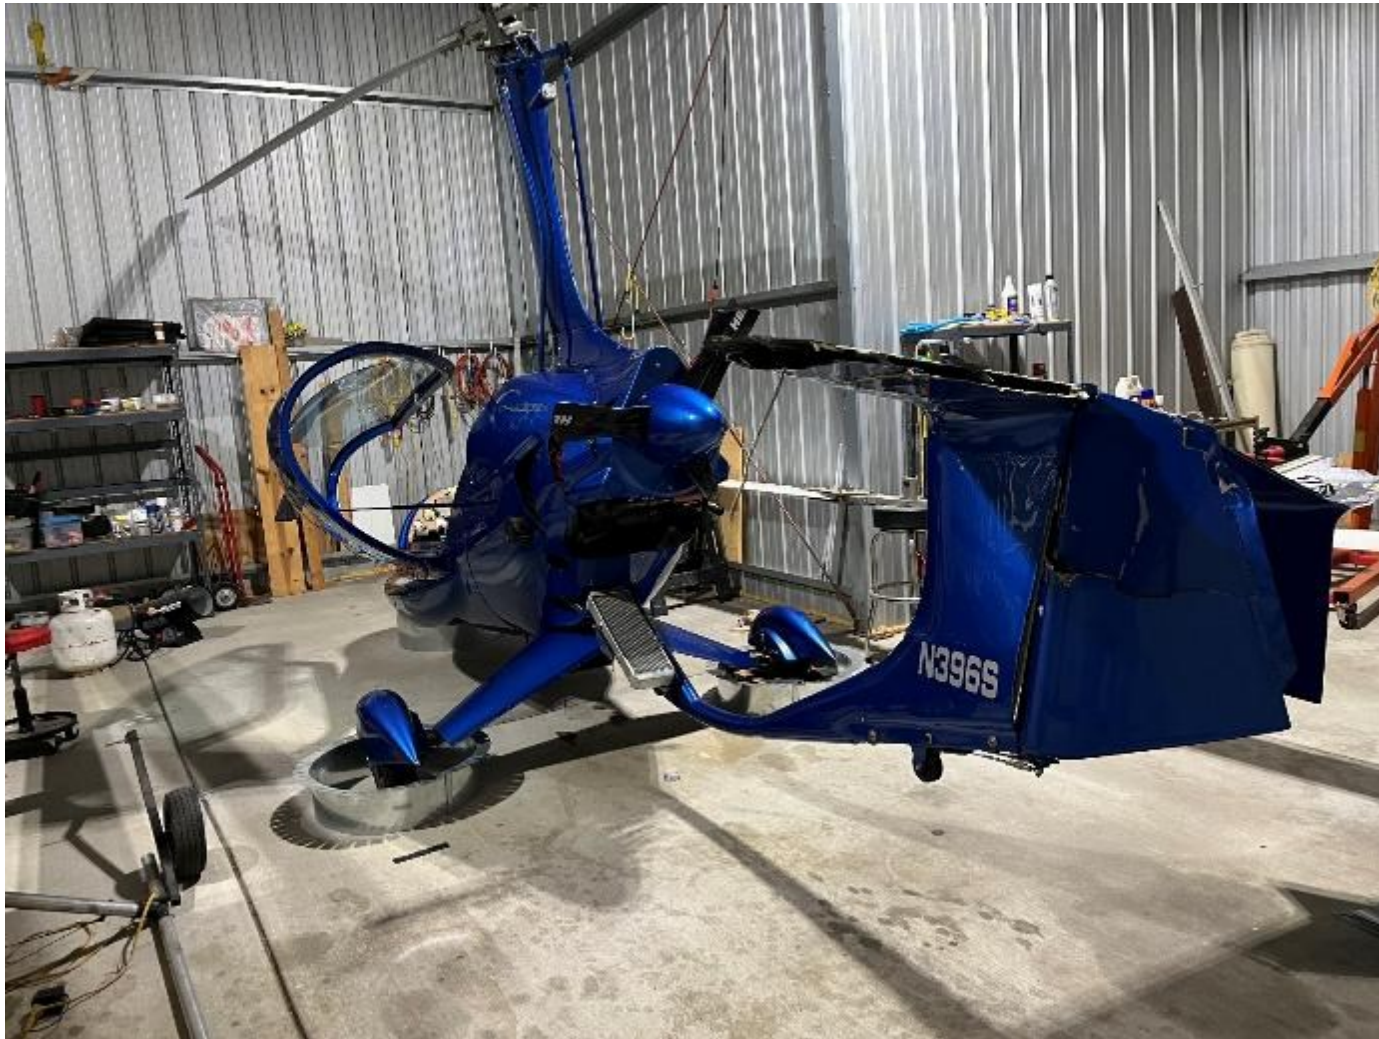
**Photograph 3 - Empennage damage (Courtesy of FAA)**
