CEN26LA084

## INVESTIGATION PHOTOGRAPHS

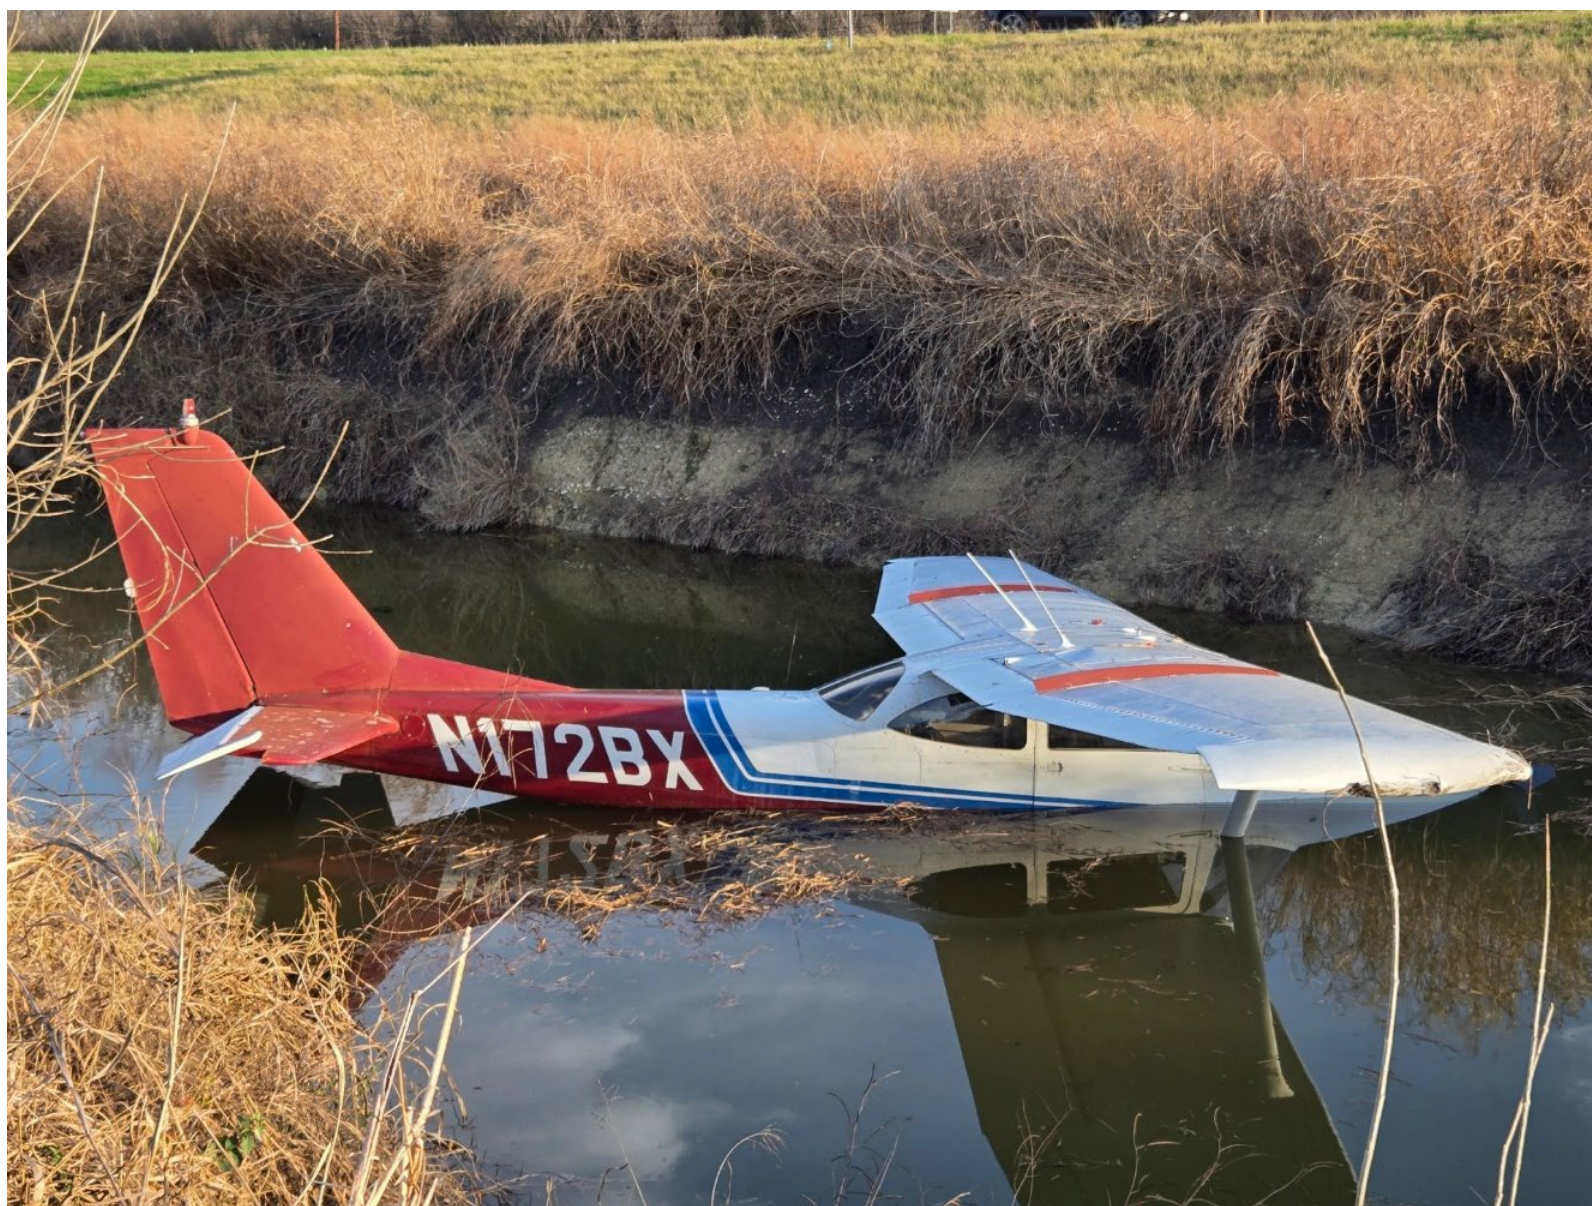
**Photograph 1 - View of the right side of the airplane in the water (courtesy of the pilot)**

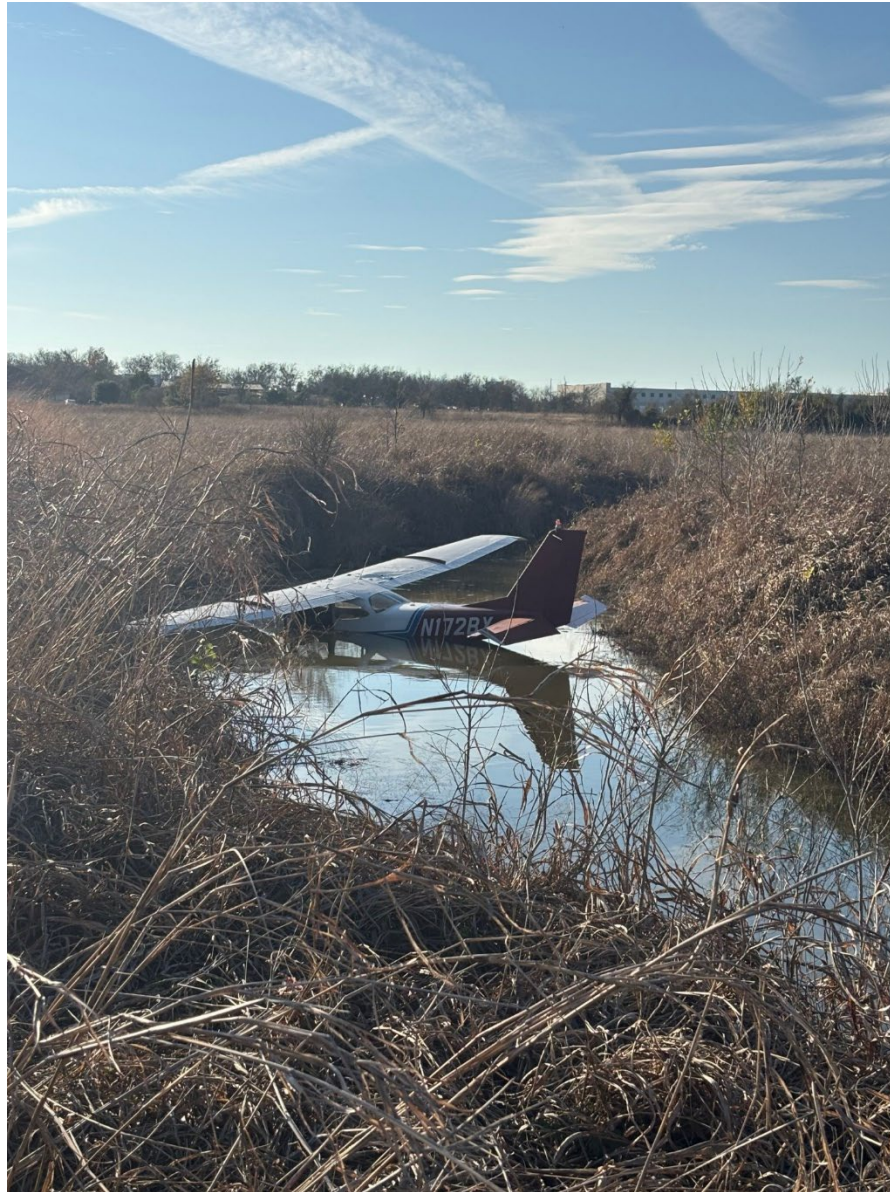
**Photograph 2 - View of the left side of the airplane in the water (courtesy of the pilot)**

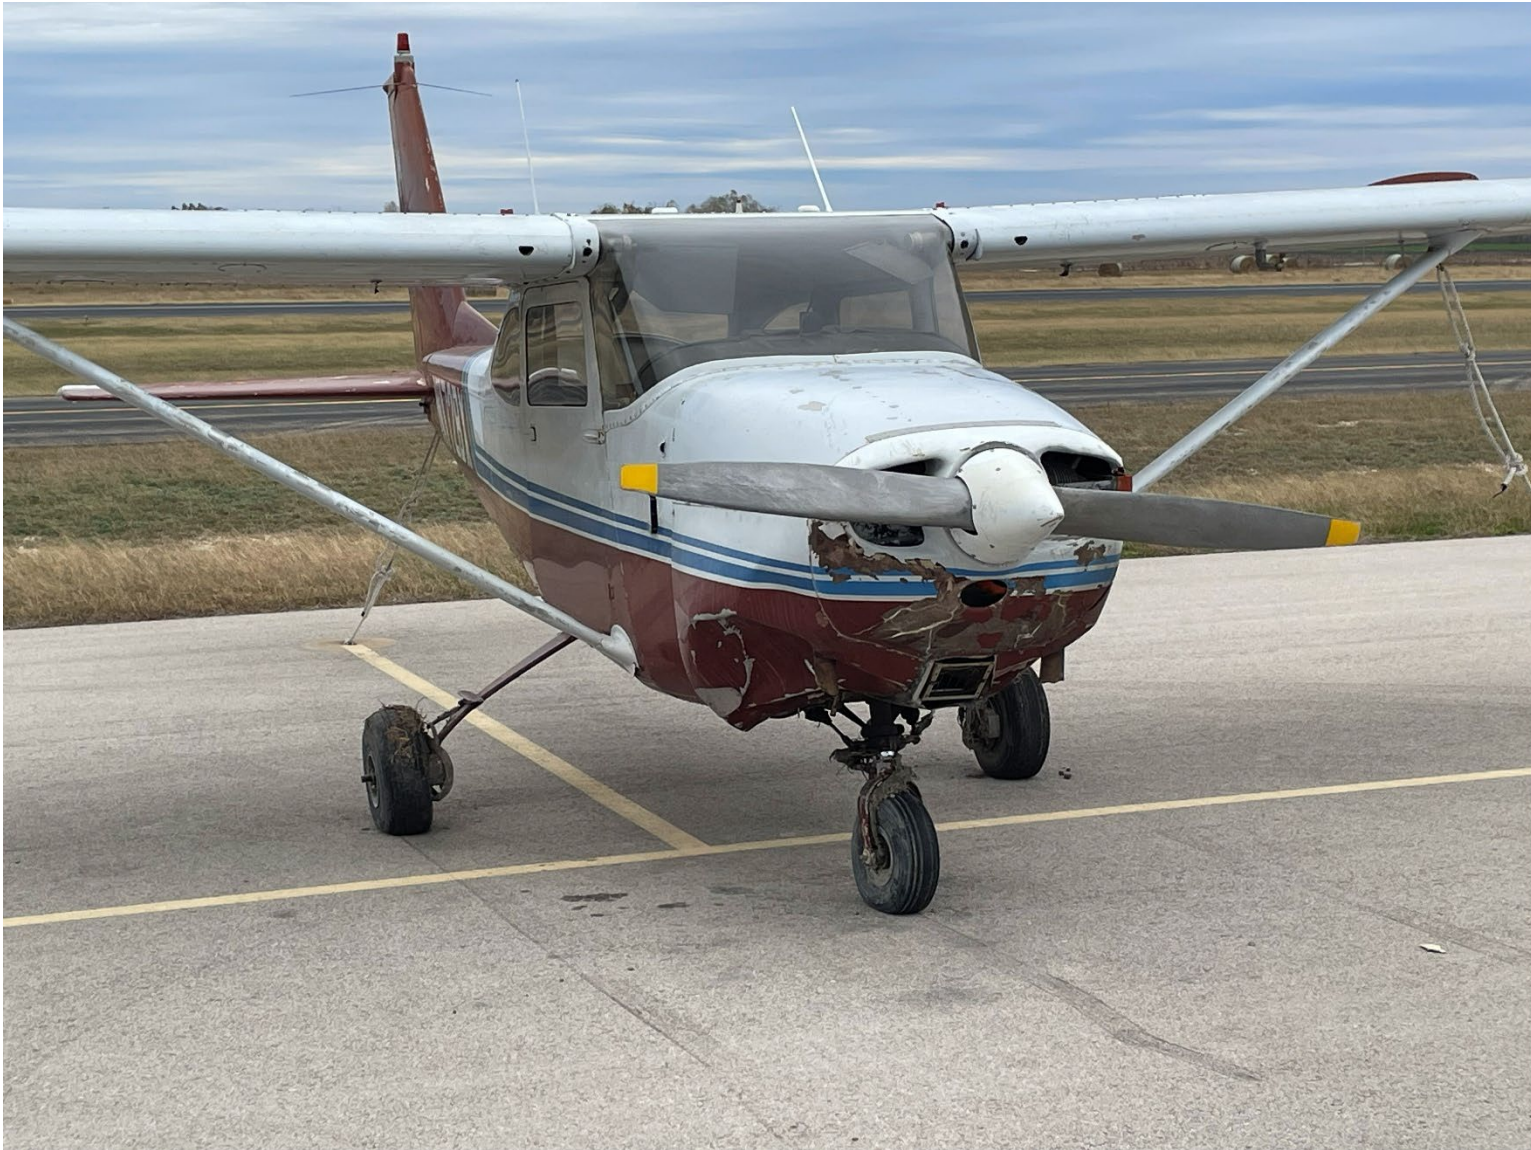
**Photograph 3 - Front view of the airplane on the ramp after it was recovered from the water  
(courtesy of the Federal Aviation Administration)**

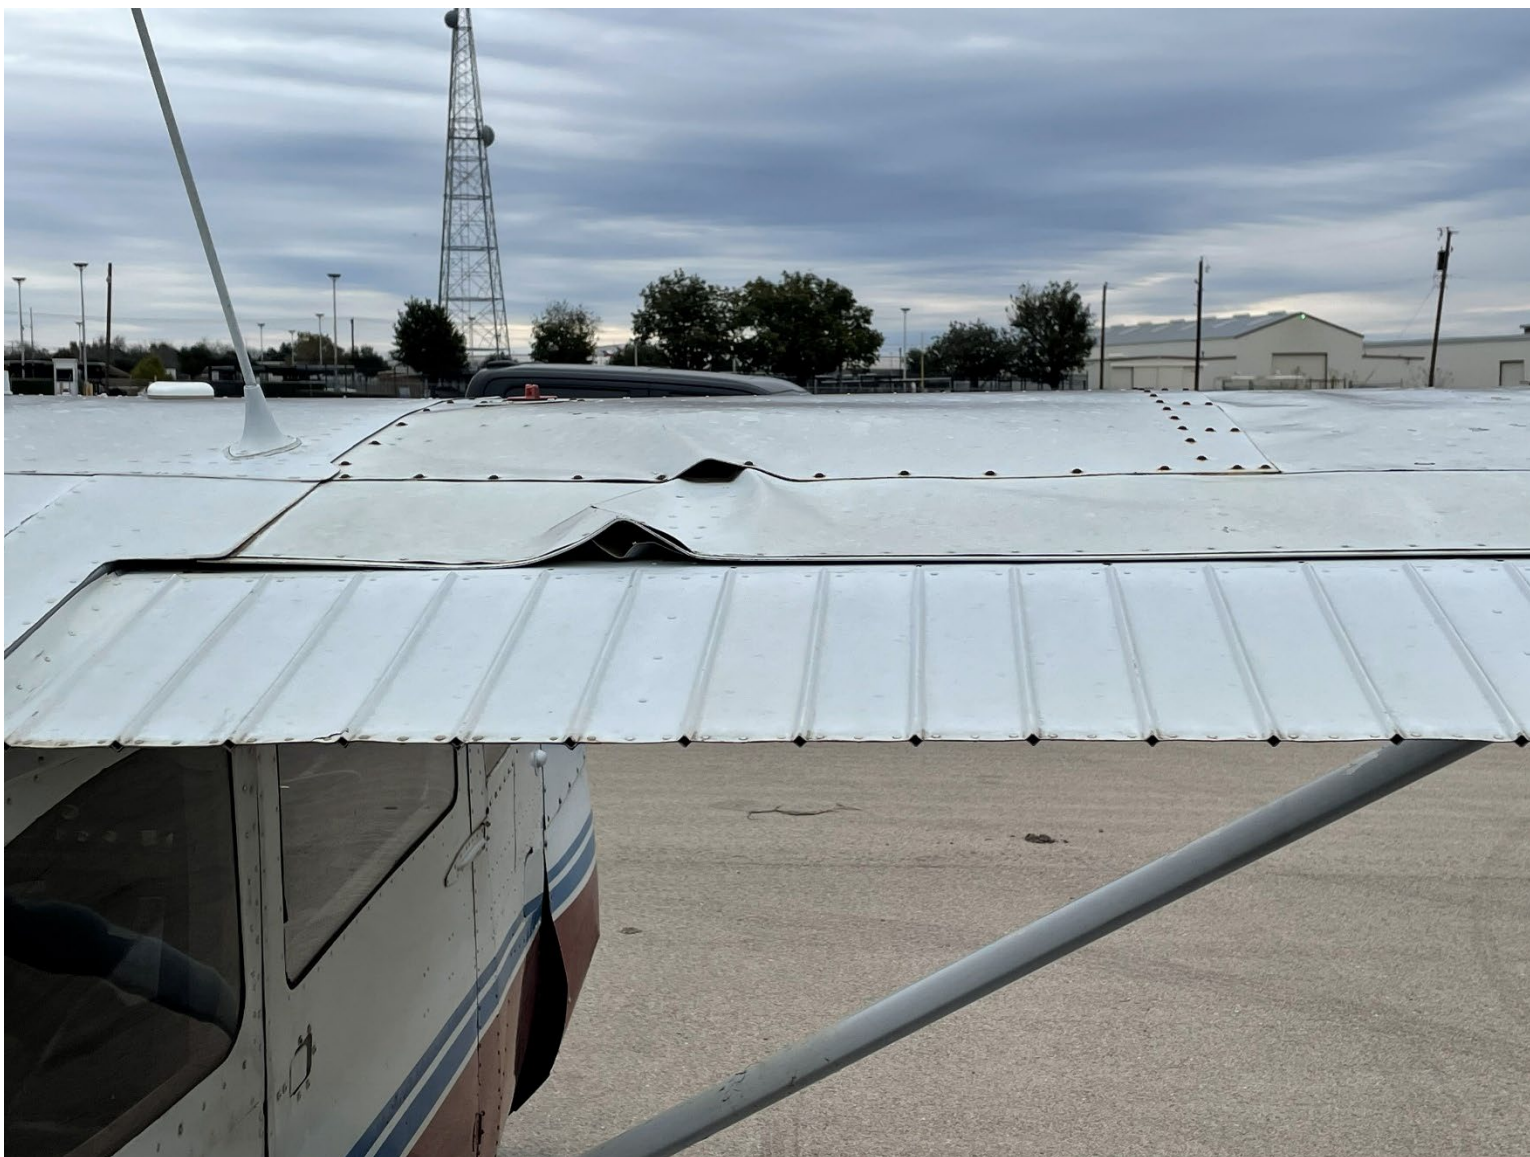
**Photograph 4 - View of the substantial damage sustained to the right wing (courtesy of the Federal Aviation Administration)**

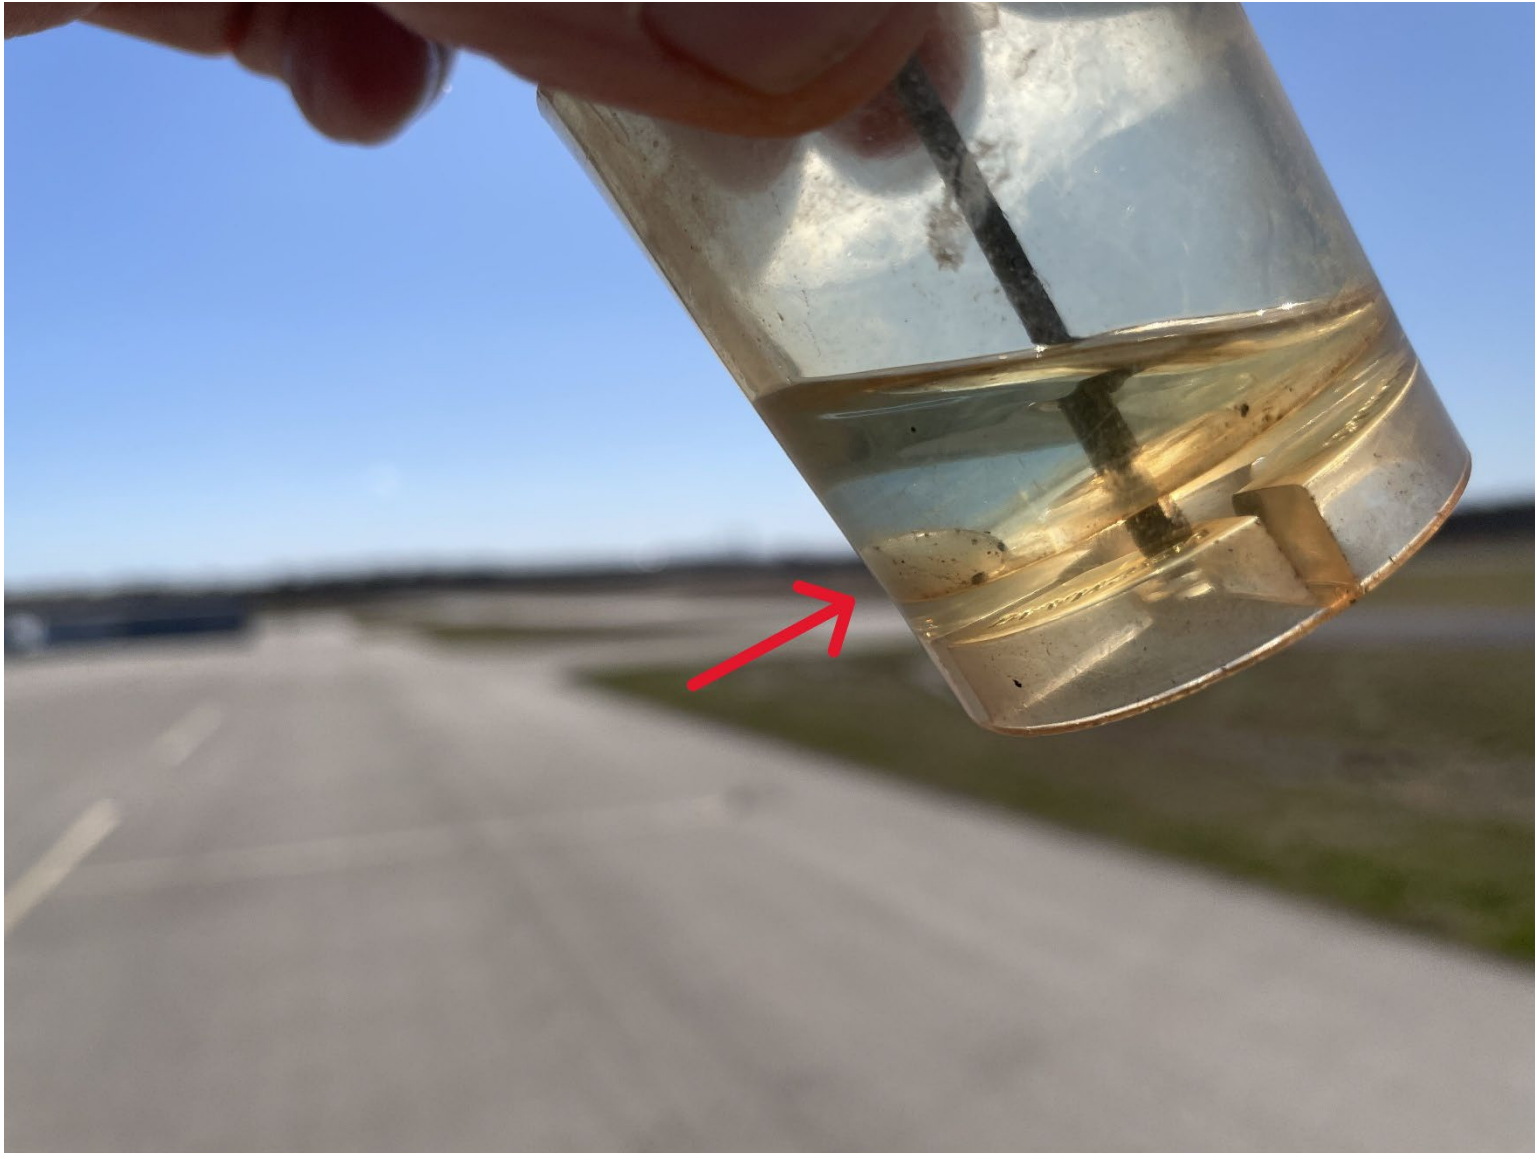
**Photograph 5 - View of the fuel sample obtained from the right wing fuel tank. The red arrow shows water contamination (courtesy of the Federal Aviation Administration)**
