## **N5136E Accident Investigation**

**FAA Accident Incident Report: ASW1726013**

**NTSB Report: CEN26LA092**

Cessna 172N, N5136E

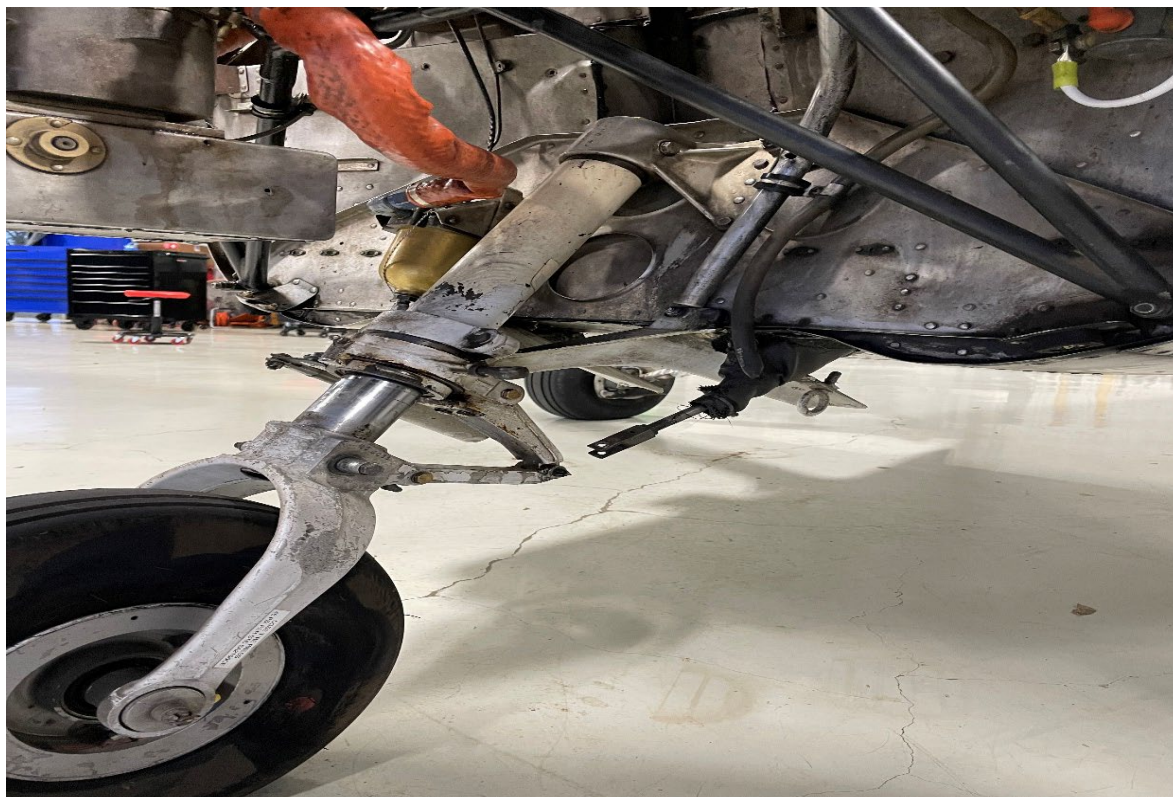
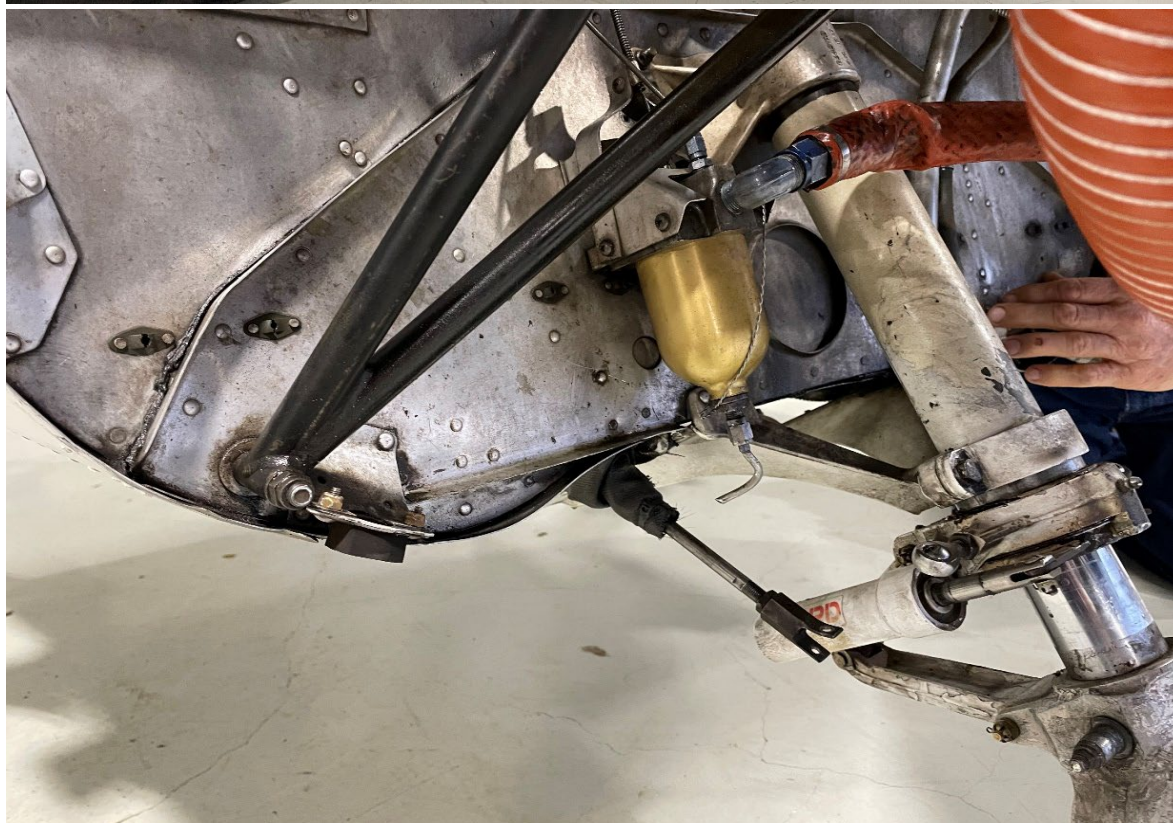
On 1/9/2026, we went to US Aviation Group's maintenance hangar to observe damage to aircraft N5136E that was a result of a hard landing. The nose landing gear assembly was observed to be bent forward. Measurements were taken from the firewall to the centerline of the nose wheel and compared to the same reference points on an undamaged Cessna 172. The comparison indicated that the damaged nose landing gear assembly was displaced forward by approximately seven inches. The upper strut mounting bolts were observed to be fully attached, with no visible cracking or bolt failure; however, deformation of the firewall was noted at the upper attachment location, with the structure displaced aft. The lower strut fitting attachment point exhibited a shear failure, with the fitting separated at that location. The mechanic reported disconnecting the steering arm attachments to facilitate towing the aircraft back to the hangar after the incident. An inspection of the propeller revealed no signs of prop strikes. Examination of the main landing gear showed no obvious damage. Performed flight control movement checks and flight controls moved freely with no signs of friction or binding. It was noted that the elevator trim was set to full nose down. Mechanic stated that they did not move the trim prior to relocating the aircraft to the hangar.
