CEN26LA113

## INVESTIGATION PHOTOGRAPHS

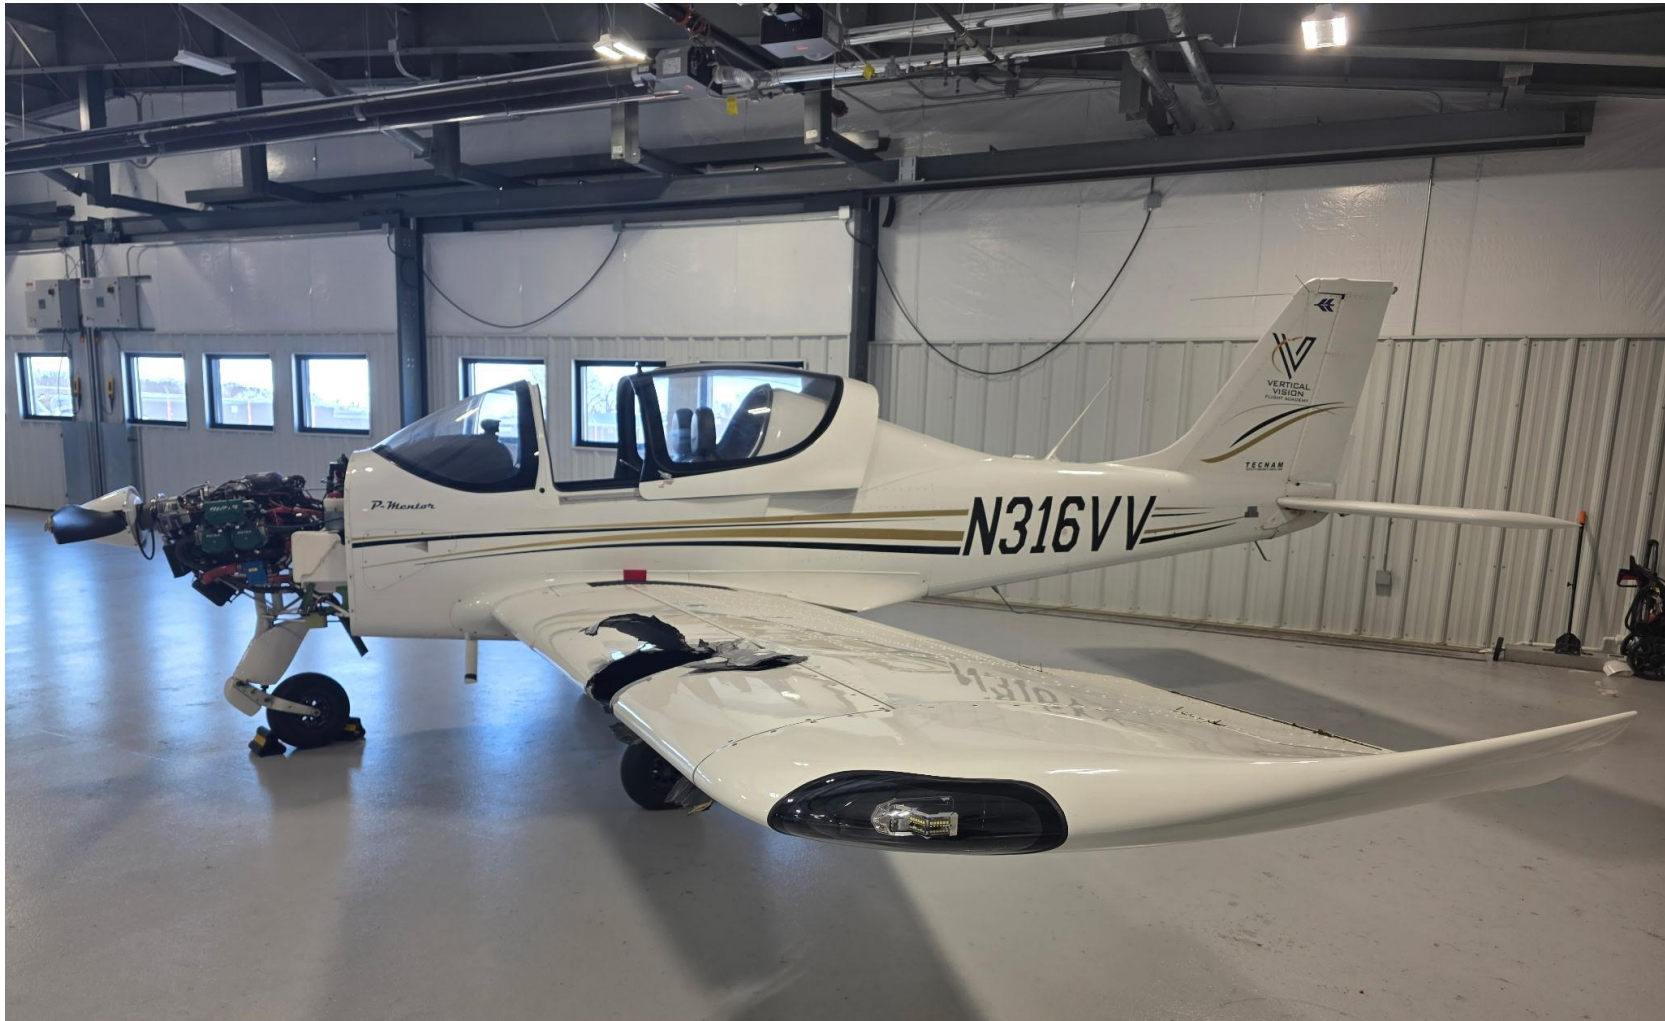
**Photograph 1 - Profile photo and nose gear swept aft (Courtesy of flight school)**

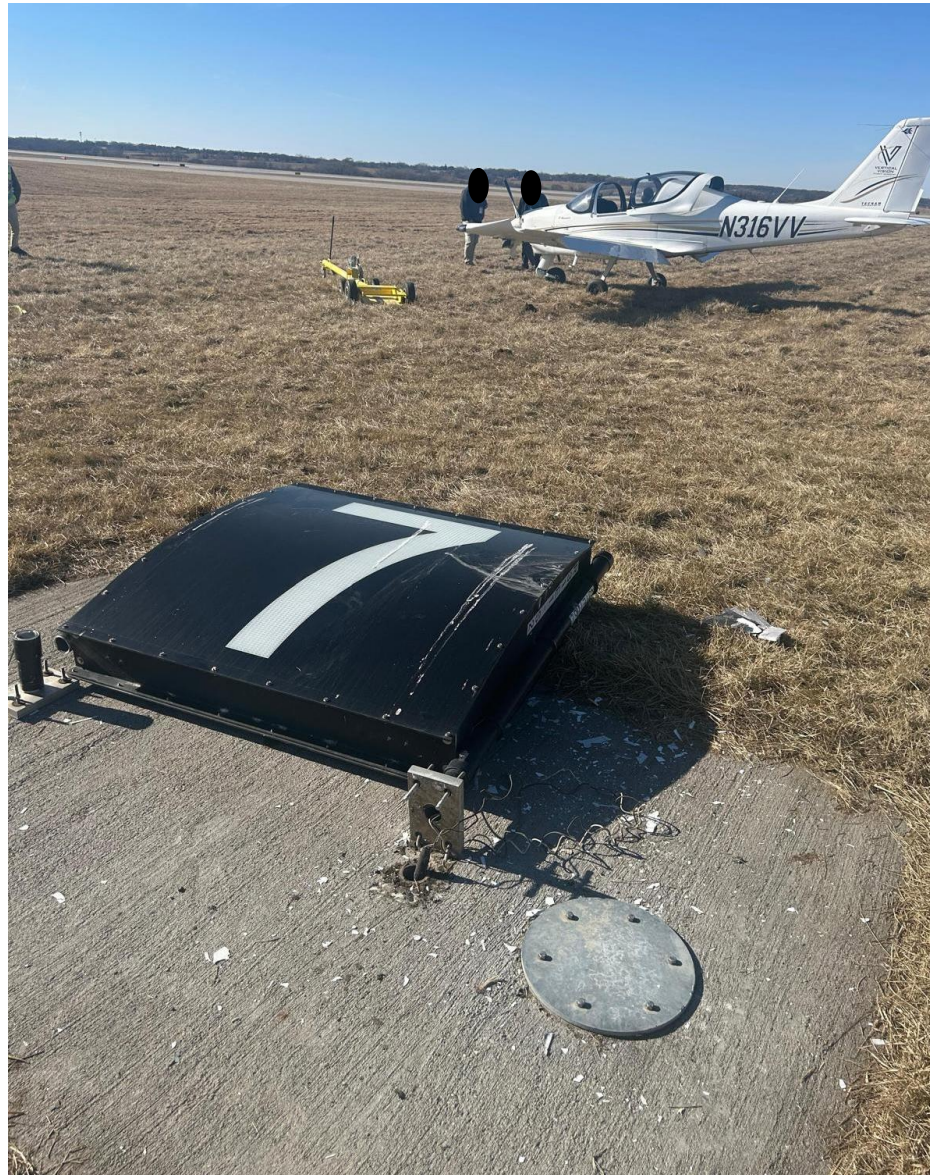
**Photograph 2 - Taxiway sign impacted by left wing (Courtesy of flight school)**

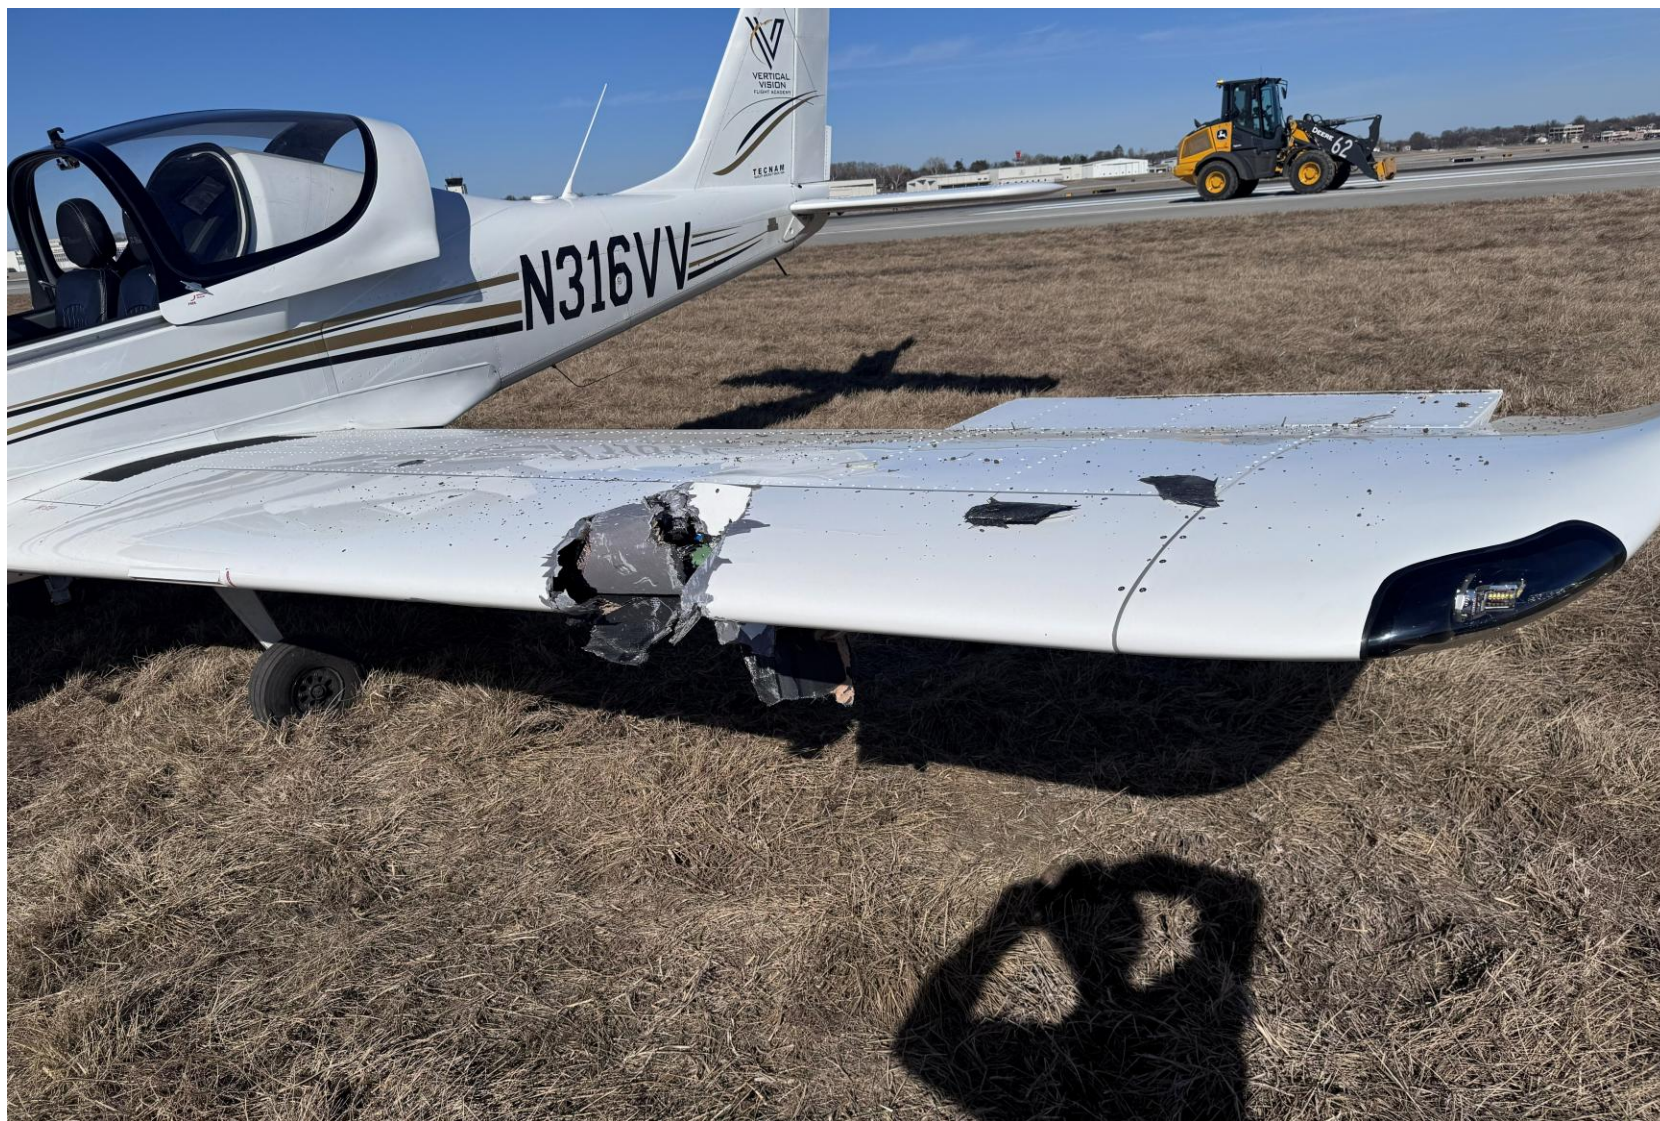
**Photograph 3 - Left wing damage (Courtesy of flight school)**

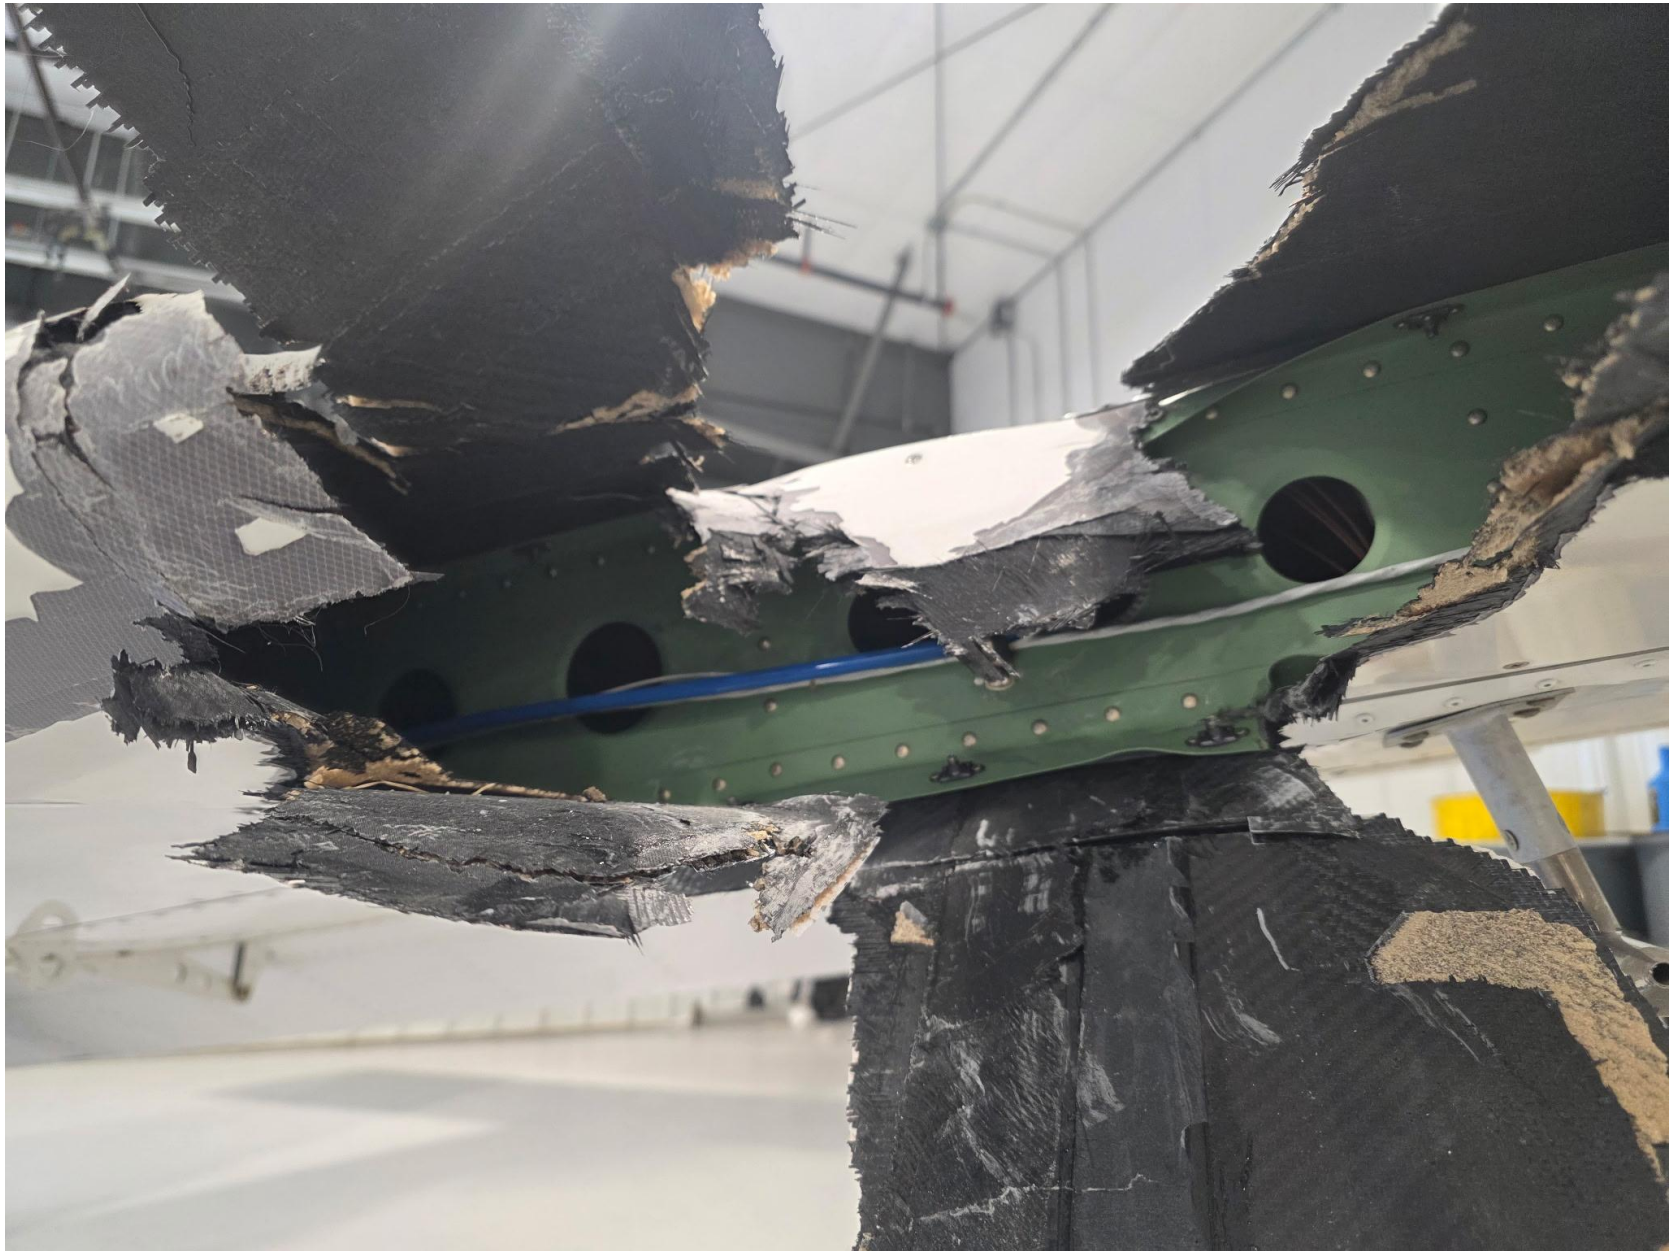
**Photograph 4 - Left wing spar damage (Courtesy of director of maintenance)**

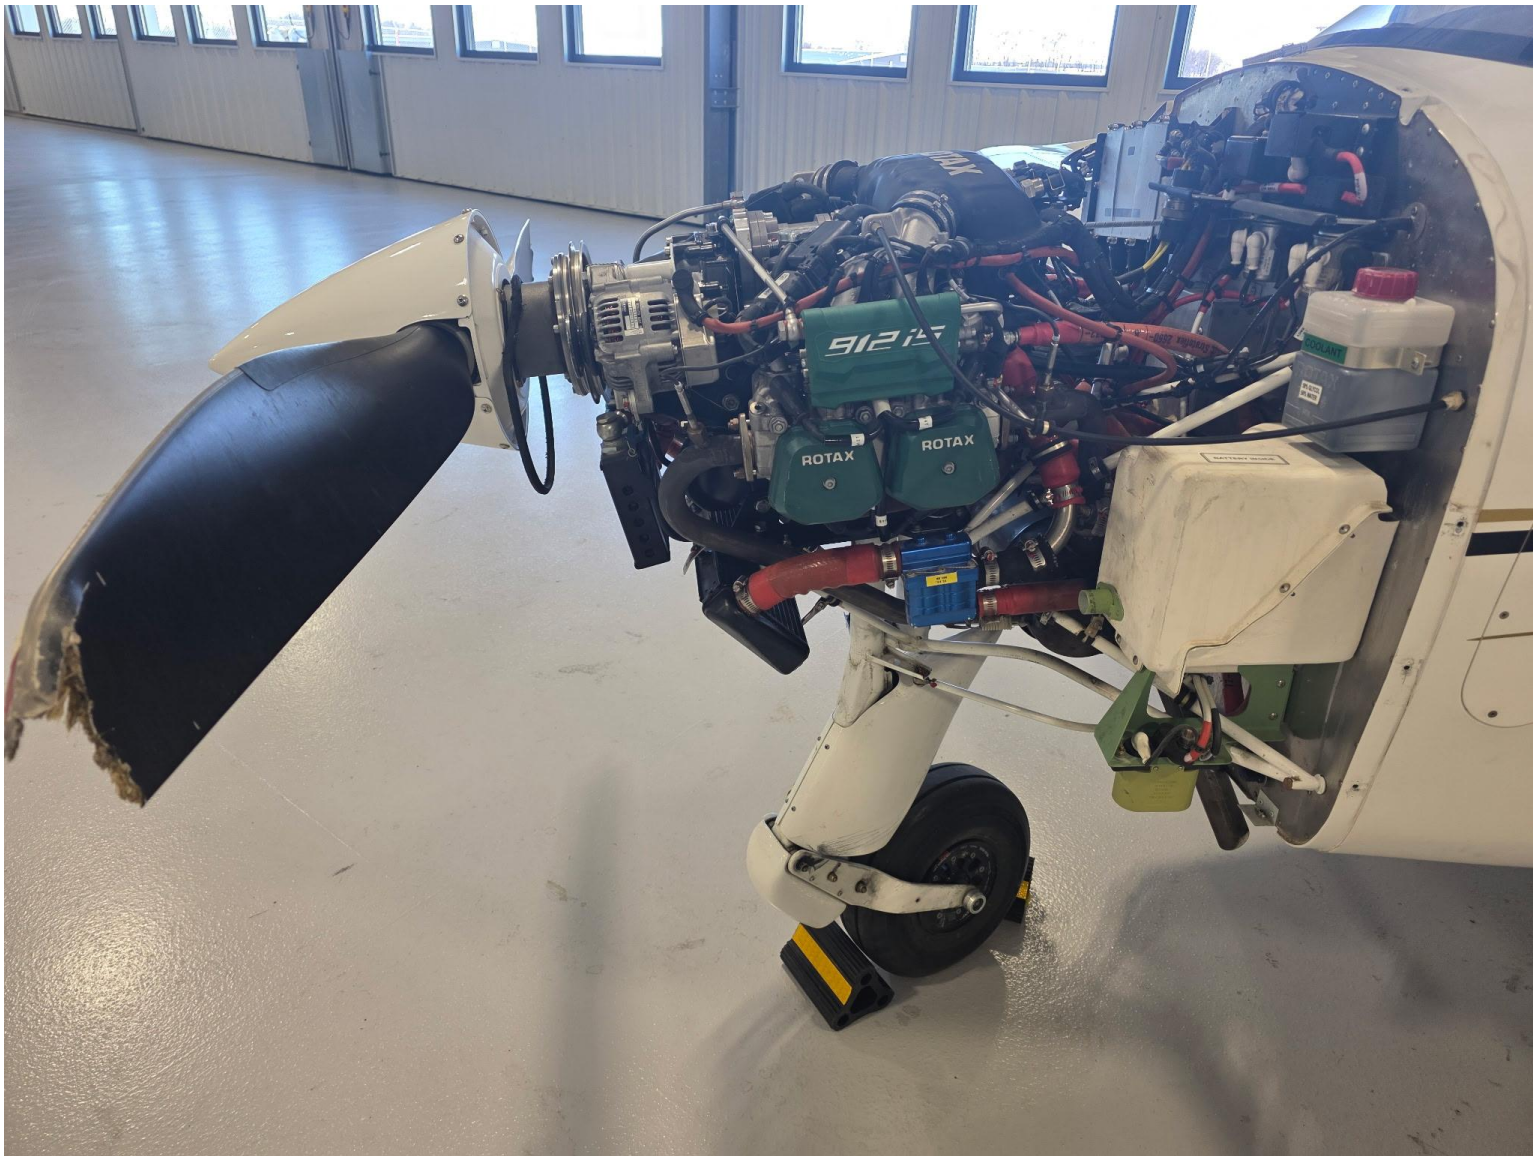
**Photograph 5 - Damage includes lower engine mount, propeller, and nose wheel steering rods  
(Courtesy of director of maintenance)**
