CEN26LA117

## INVESTIGATION PHOTOGRAPHS

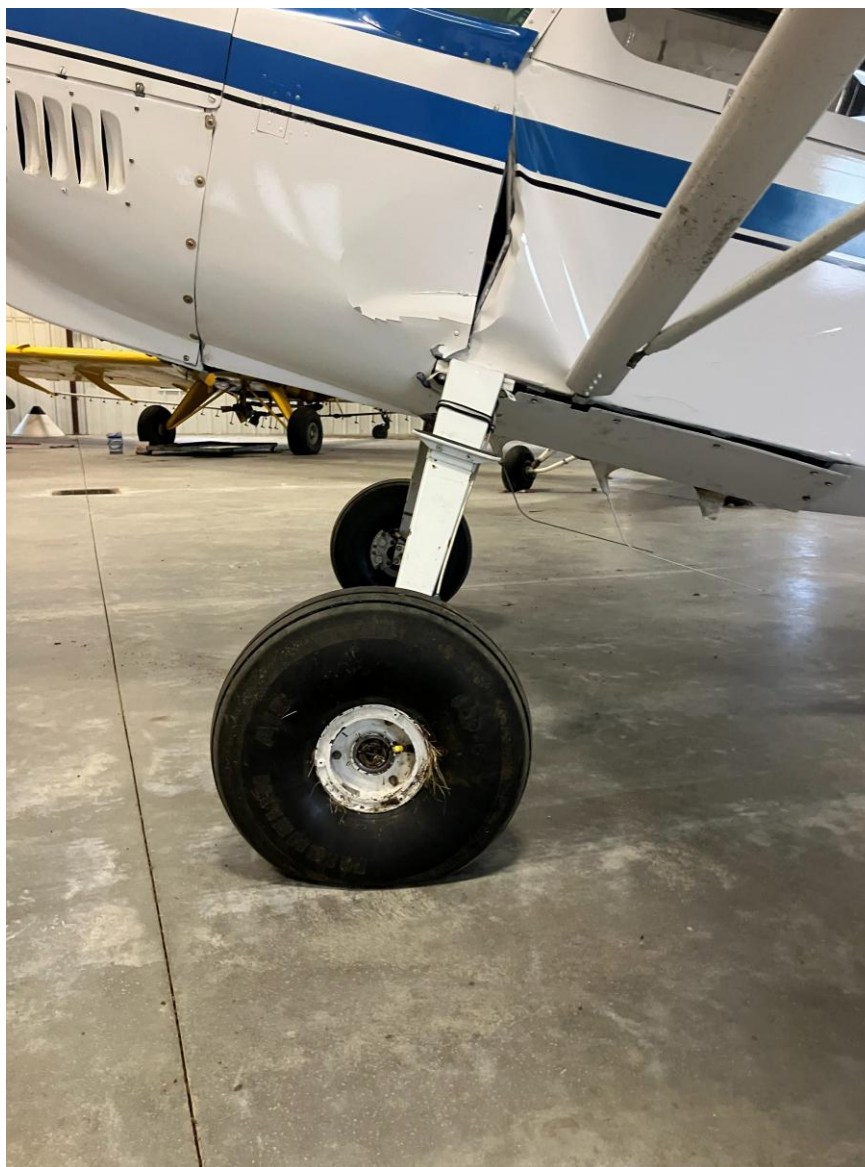
**Photograph 2 - Left profile of damages to airplane (Courtesy of owner)**

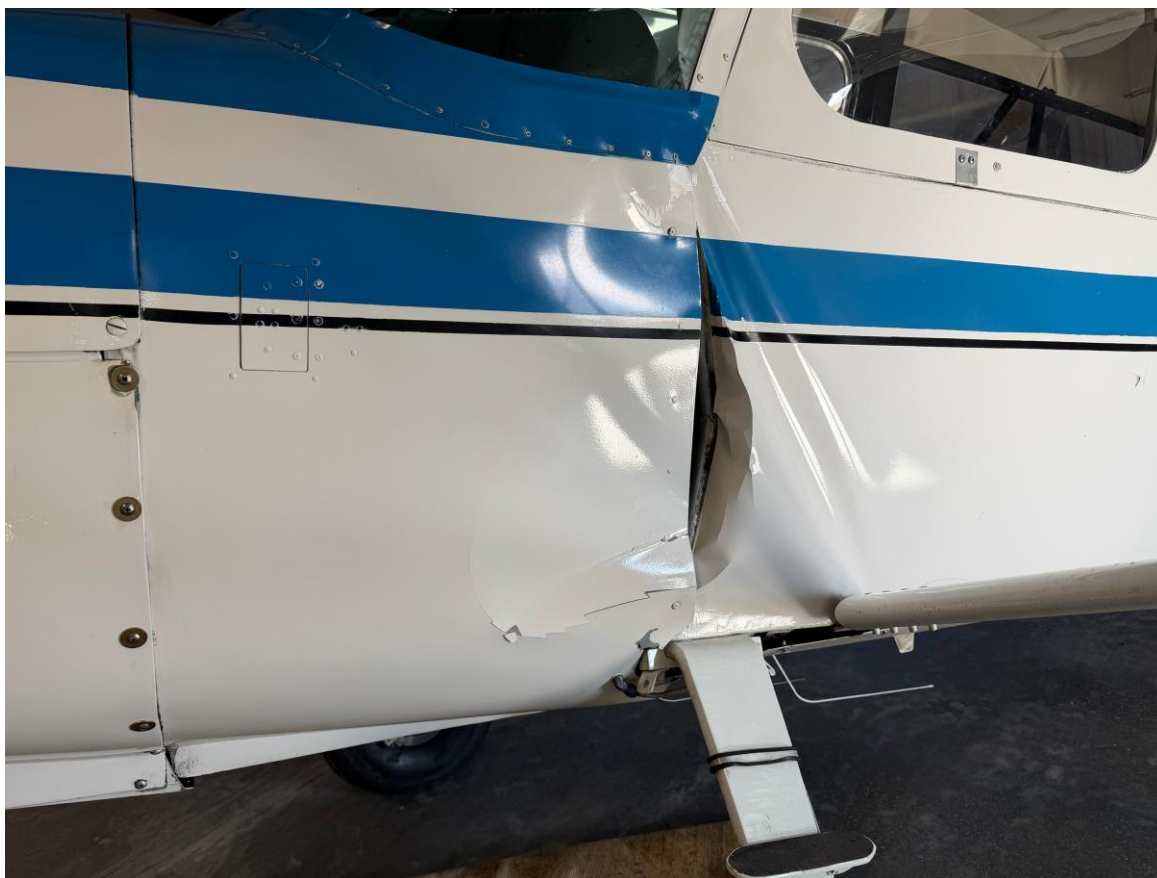
**Photograph 3 - Left side fuselage damages (Courtesy of owner)**

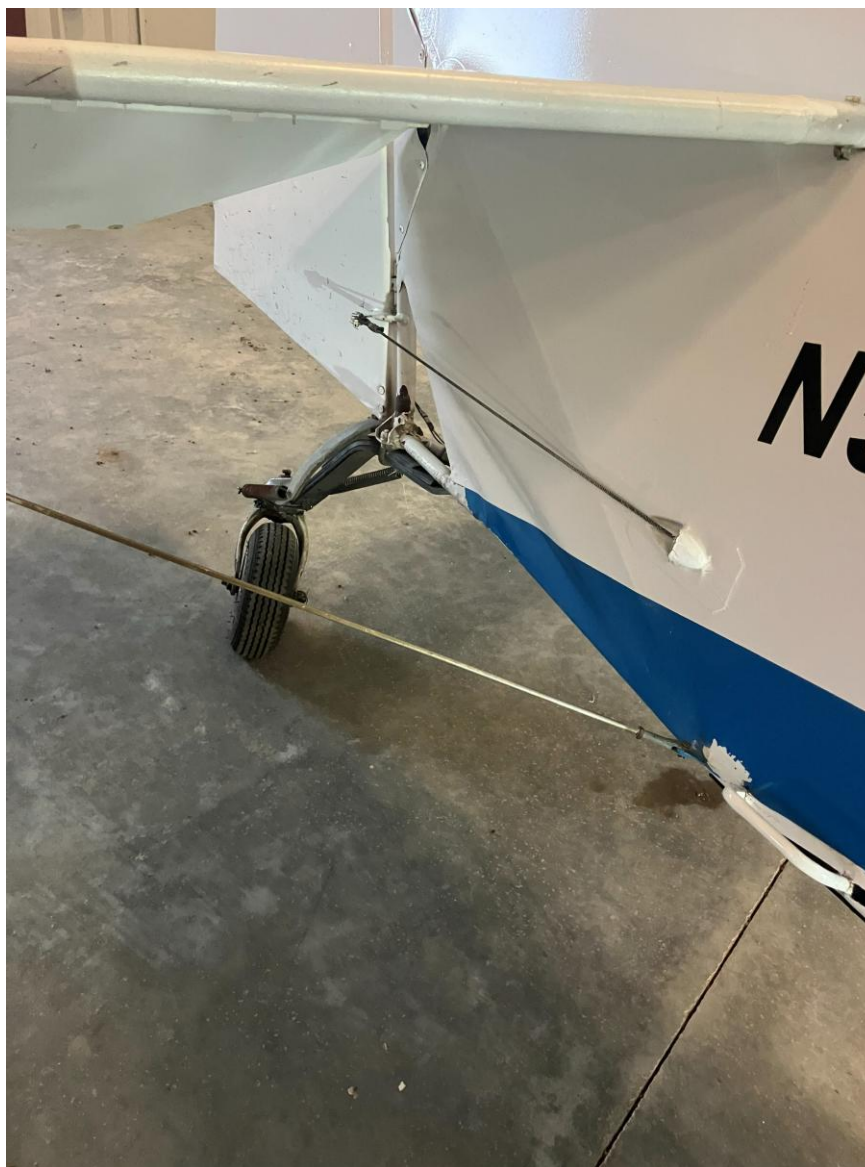
**Photograph 4 - Showing bent aft fuselage structure (Courtesy of owner)**

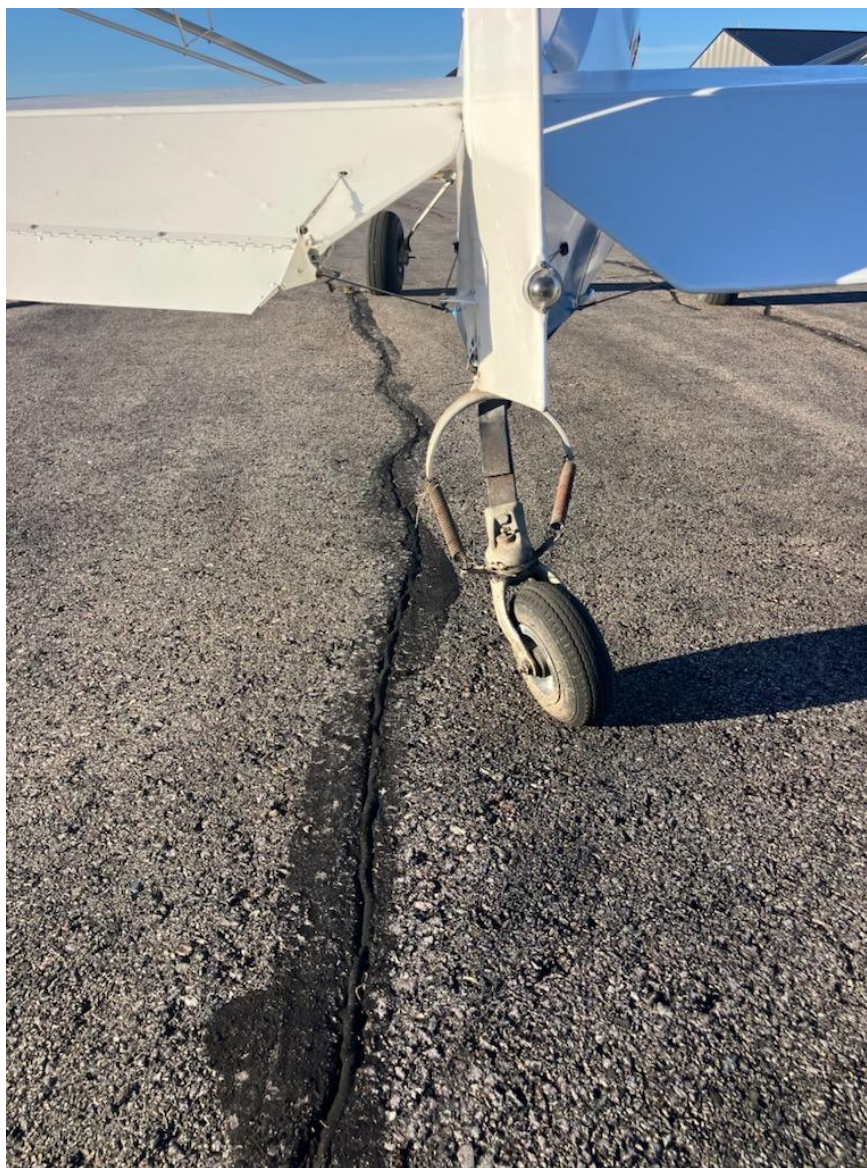
**Photograph 5 - Tailwheel bent off center (Courtesy of FAA)**
