CEN26LA122

## INVESTIGATION PHOTOGRAPHS

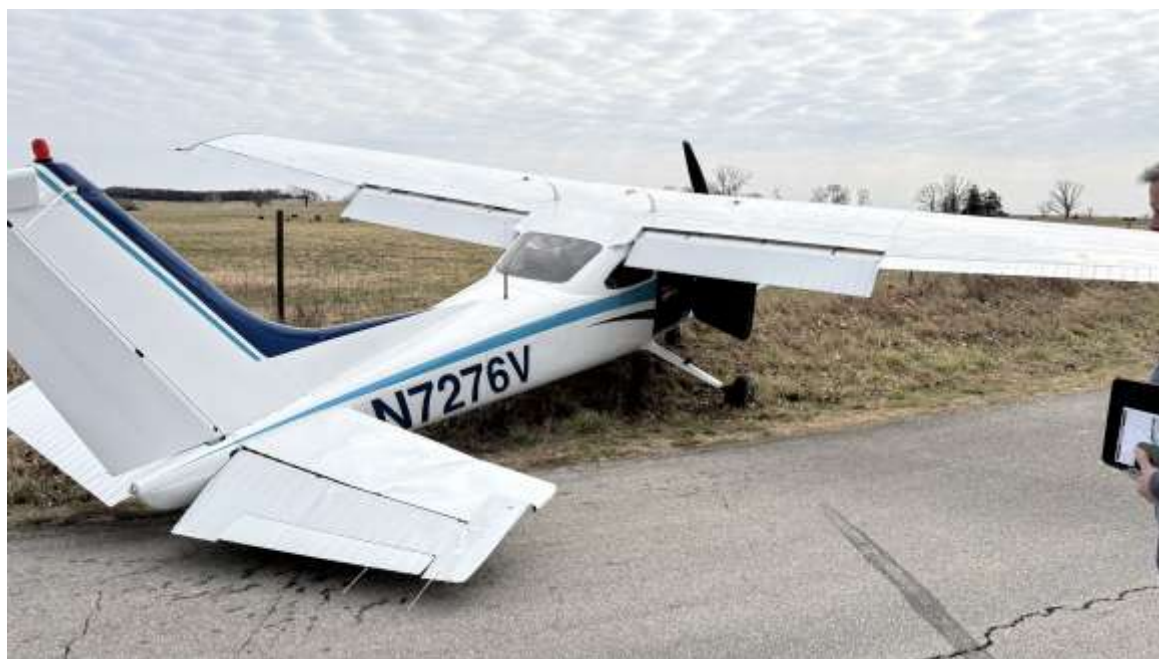
**Photograph 1 - Accident site (courtesy of operator).**

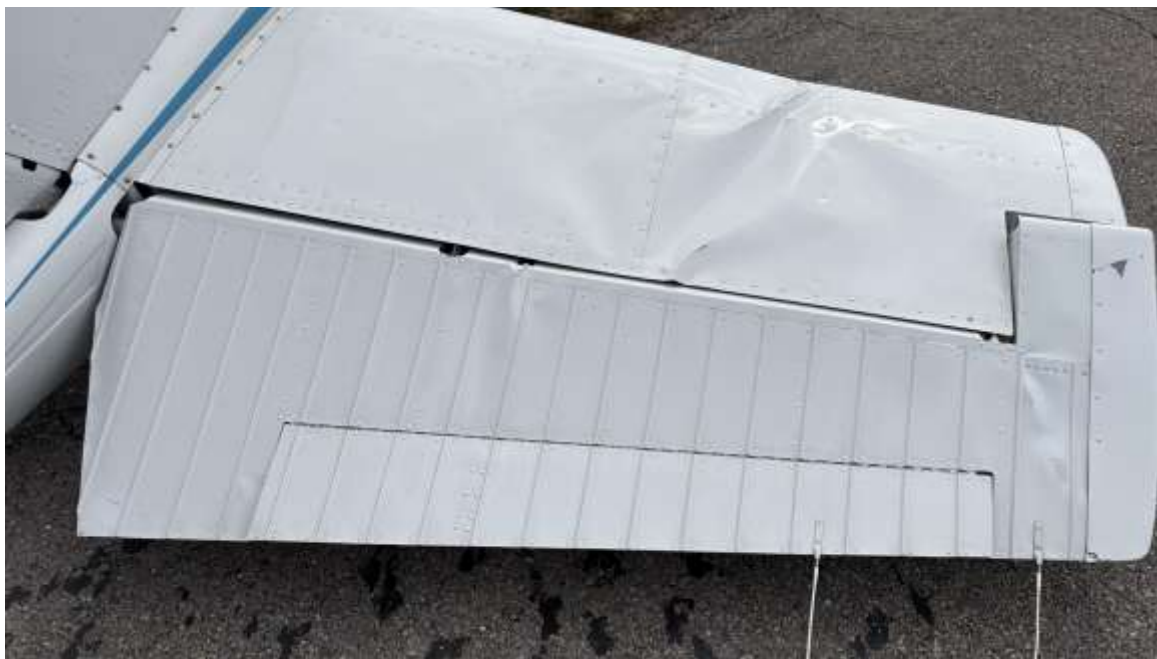
**Photograph 2 - Damage to right horizontal stabilizer and elevator (courtesy of operator).**
