Michael J. Hodges  
Investigator-In-Charge, Senior Aviation Accident Investigator  
Office of Aviation Safety, Central Regional Office

**Date:** March 11, 2026

**Subject:** CEN26LA128 - Airplane Fuel System Information  
N5063N (Air Tractor AT-502B Airplane)

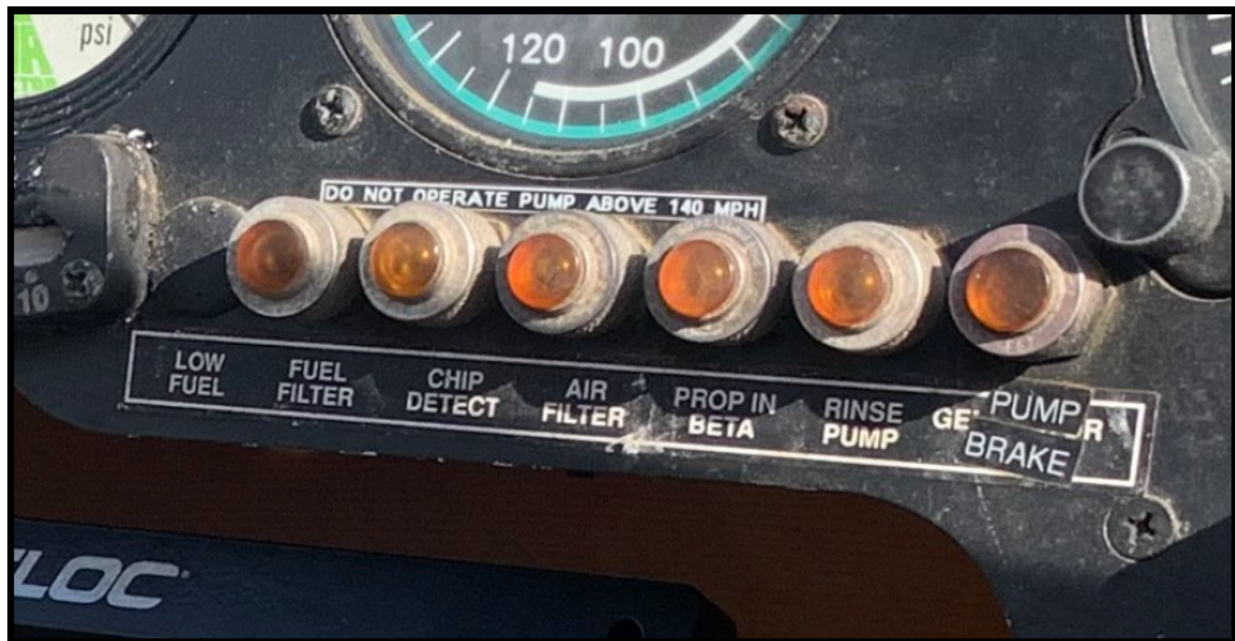
Located in the center of the cockpit, there is a row of warning lights (red colored) and caution lights (amber colored).

On the left side of the row of the lights is a space for a low fuel warning light, however the space is empty, and it is filled with a small metal cover that is painted black. Below the empty space, it states "low fuel."

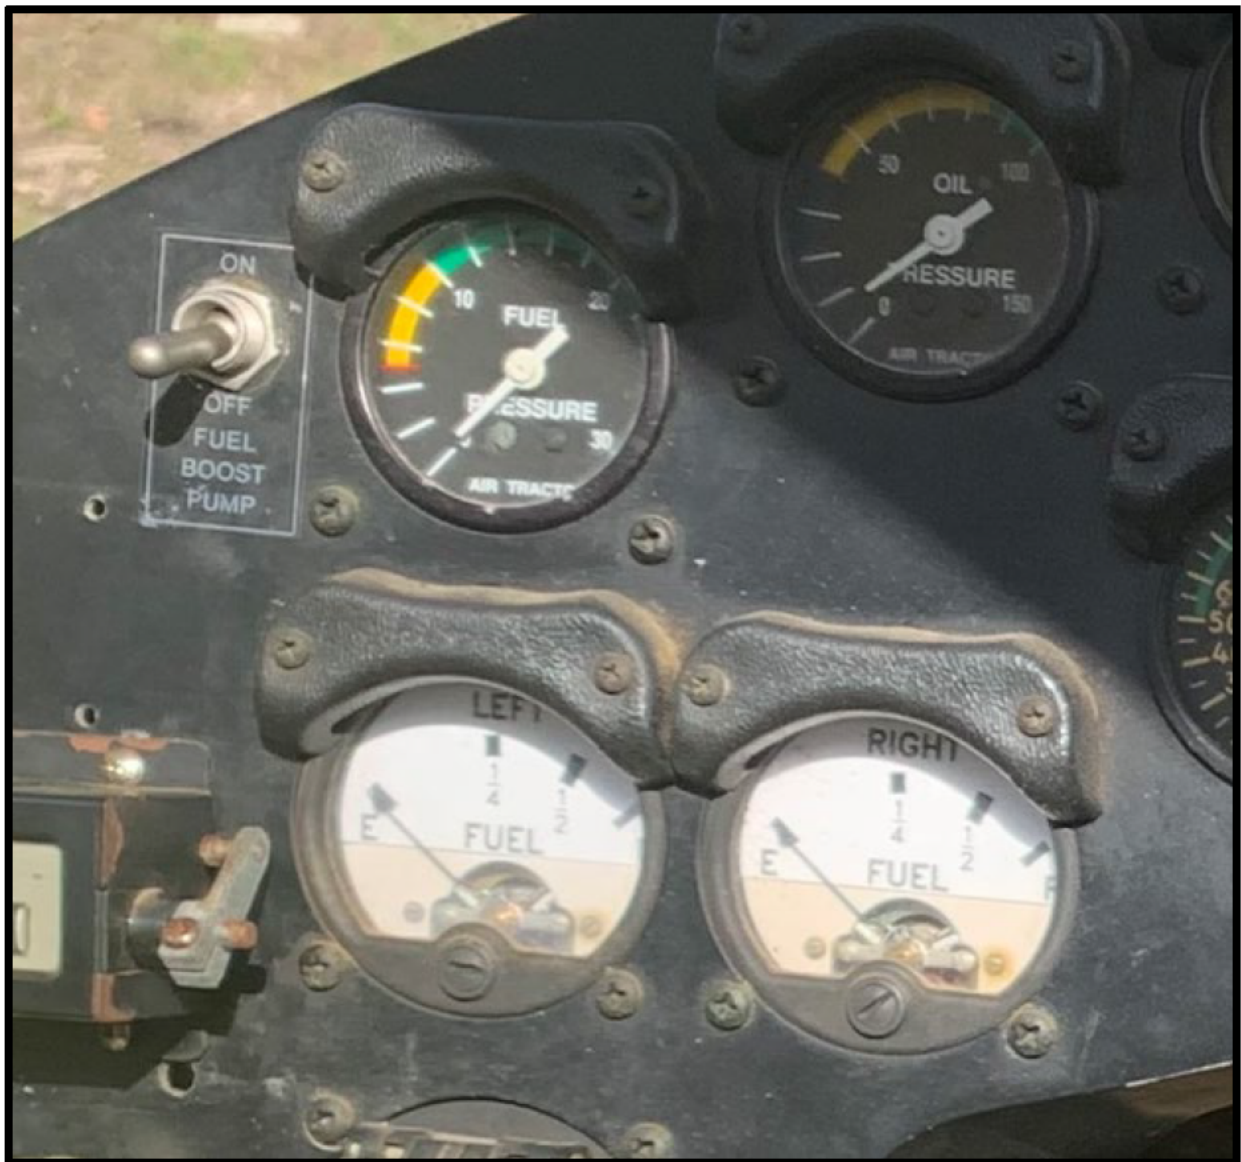
Located on the left side of the cockpit is the fuel boost pump switch, the fuel pressure gauge, the left fuel tank gauge, and the right fuel tank gauge.

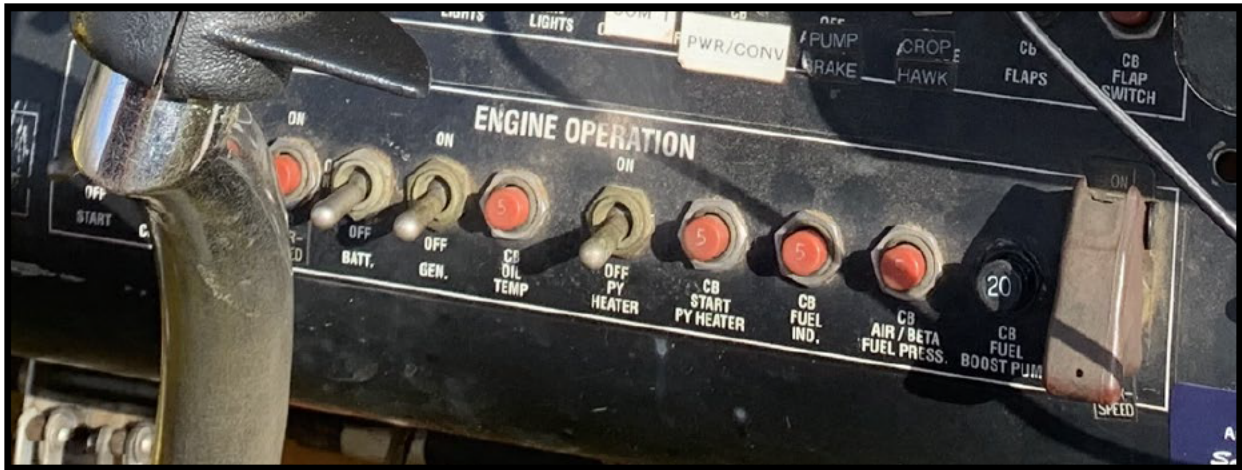
Located on the right side of the cockpit is a switch and circuit breaker panel for operation of the engine.

The circuits breakers for the fuel indicator system, the fuel pressure system, and the fuel boost pump system were all found at the non-extended positions.
