CEN26LA150

## INVESTIGATION PHOTOGRAPHS

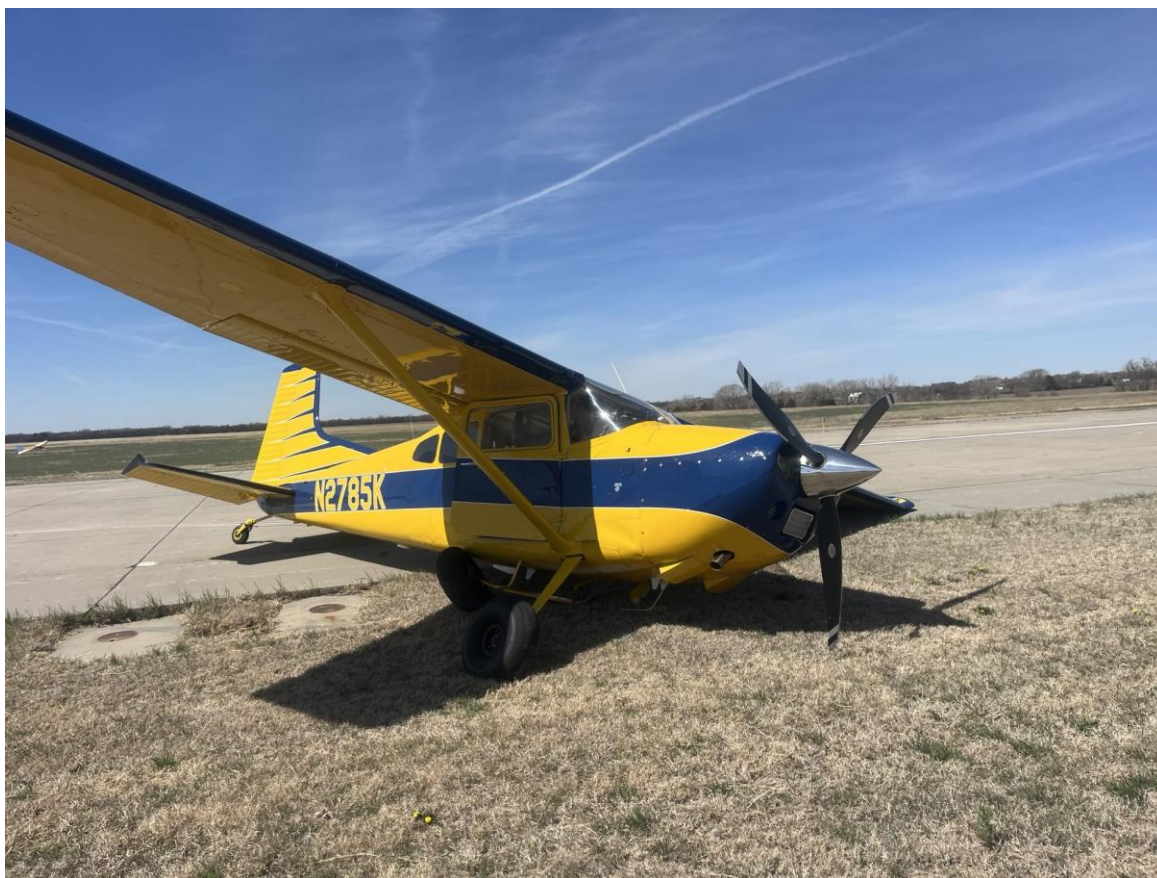
**Photograph 1 - N2785K at K61(Courtesy of owner)**

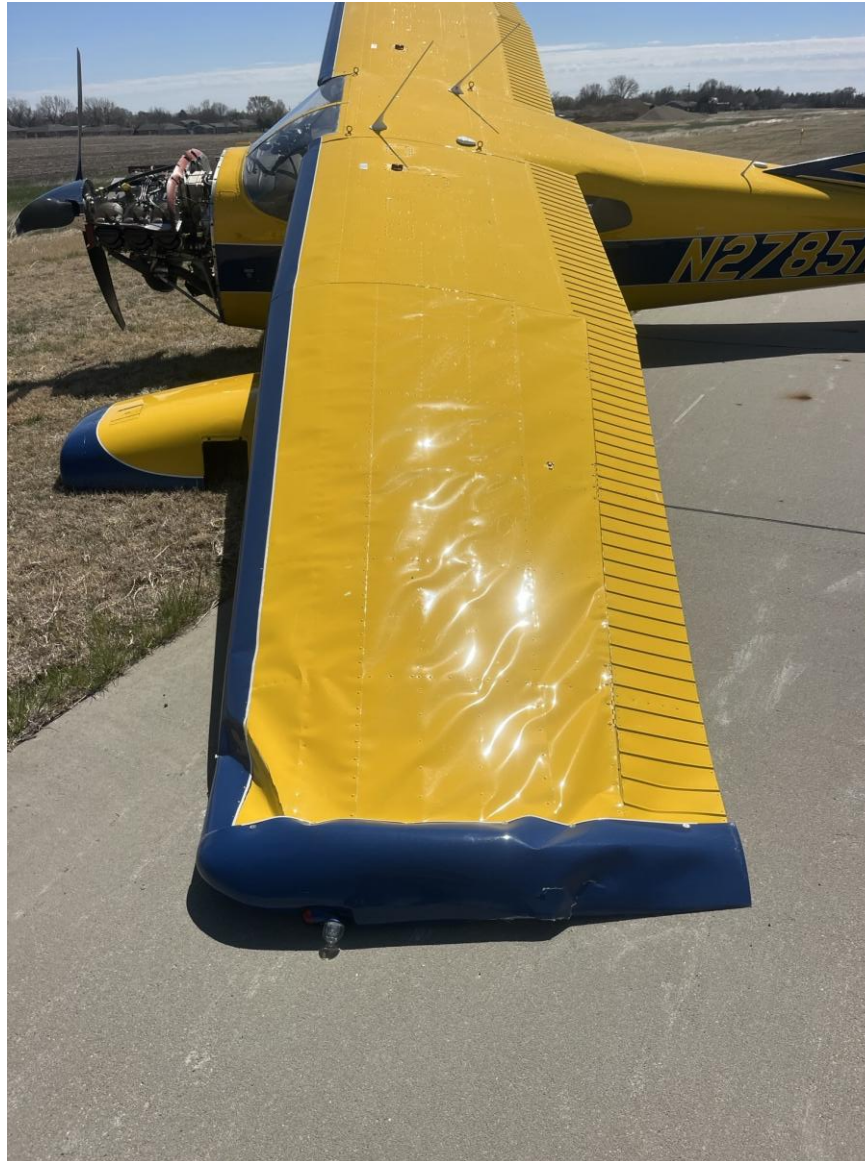
**Photograph 2 - Left wing damage (Courtesy of owner)**
