CEN26LA180

## INVESTIGATION PHOTOGRAPHS

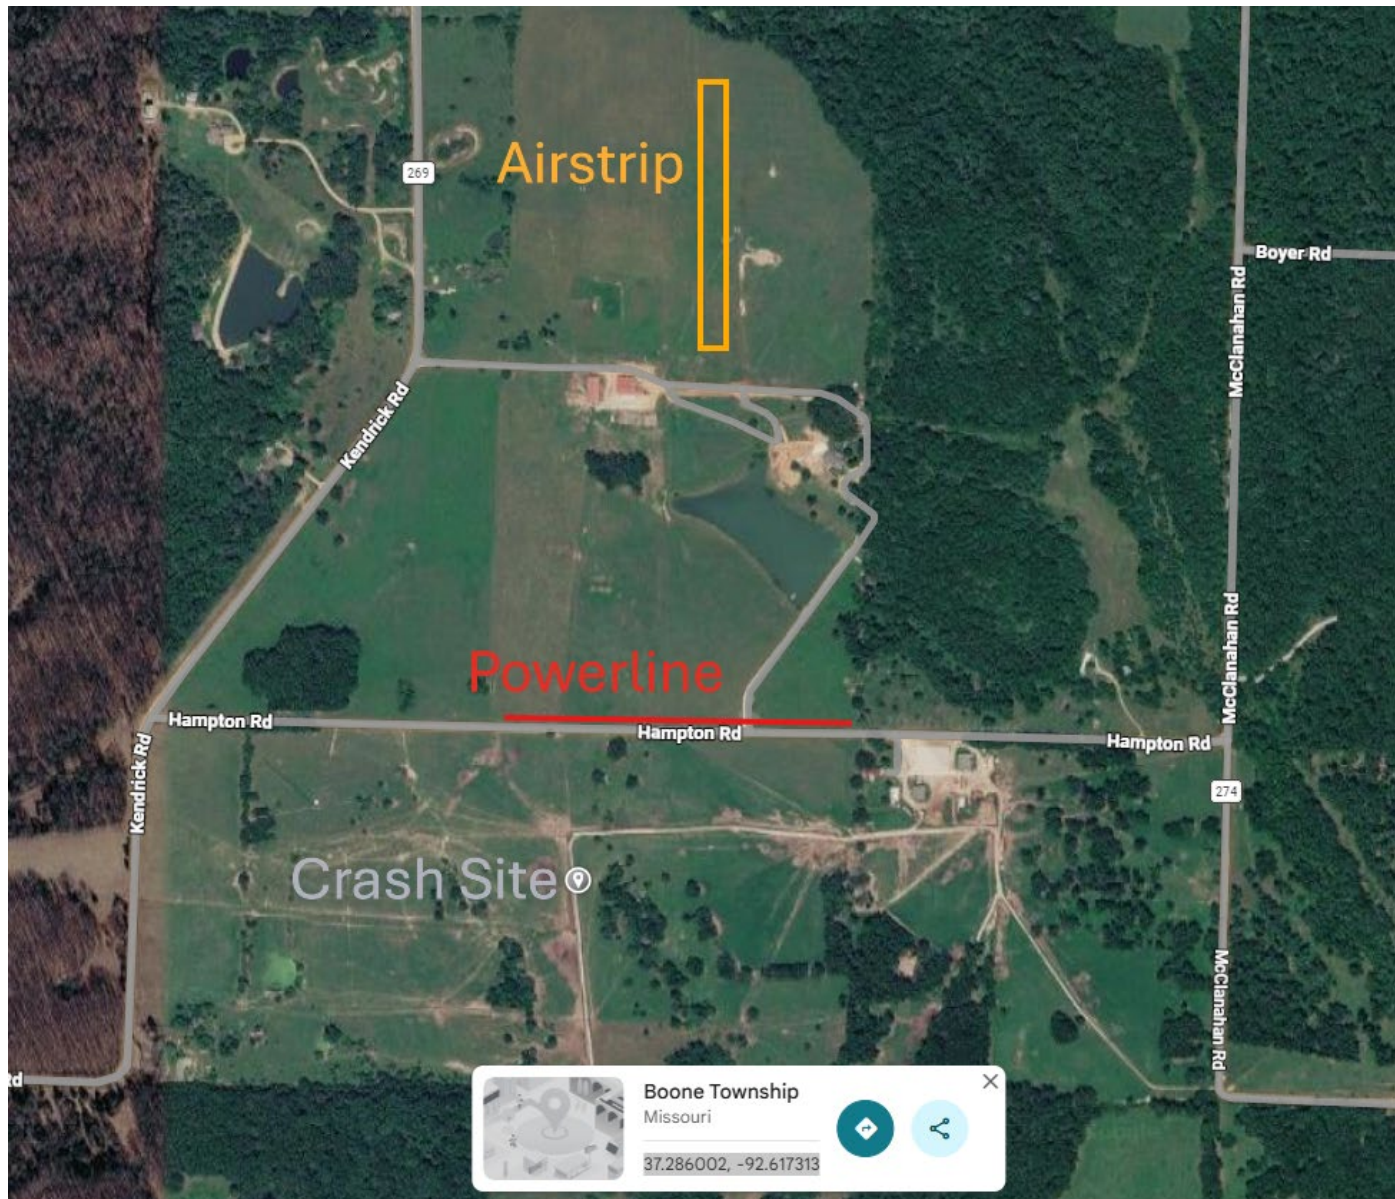
**Image 1 - Google Earth view of accident site with labels (Courtesy of FAA)**

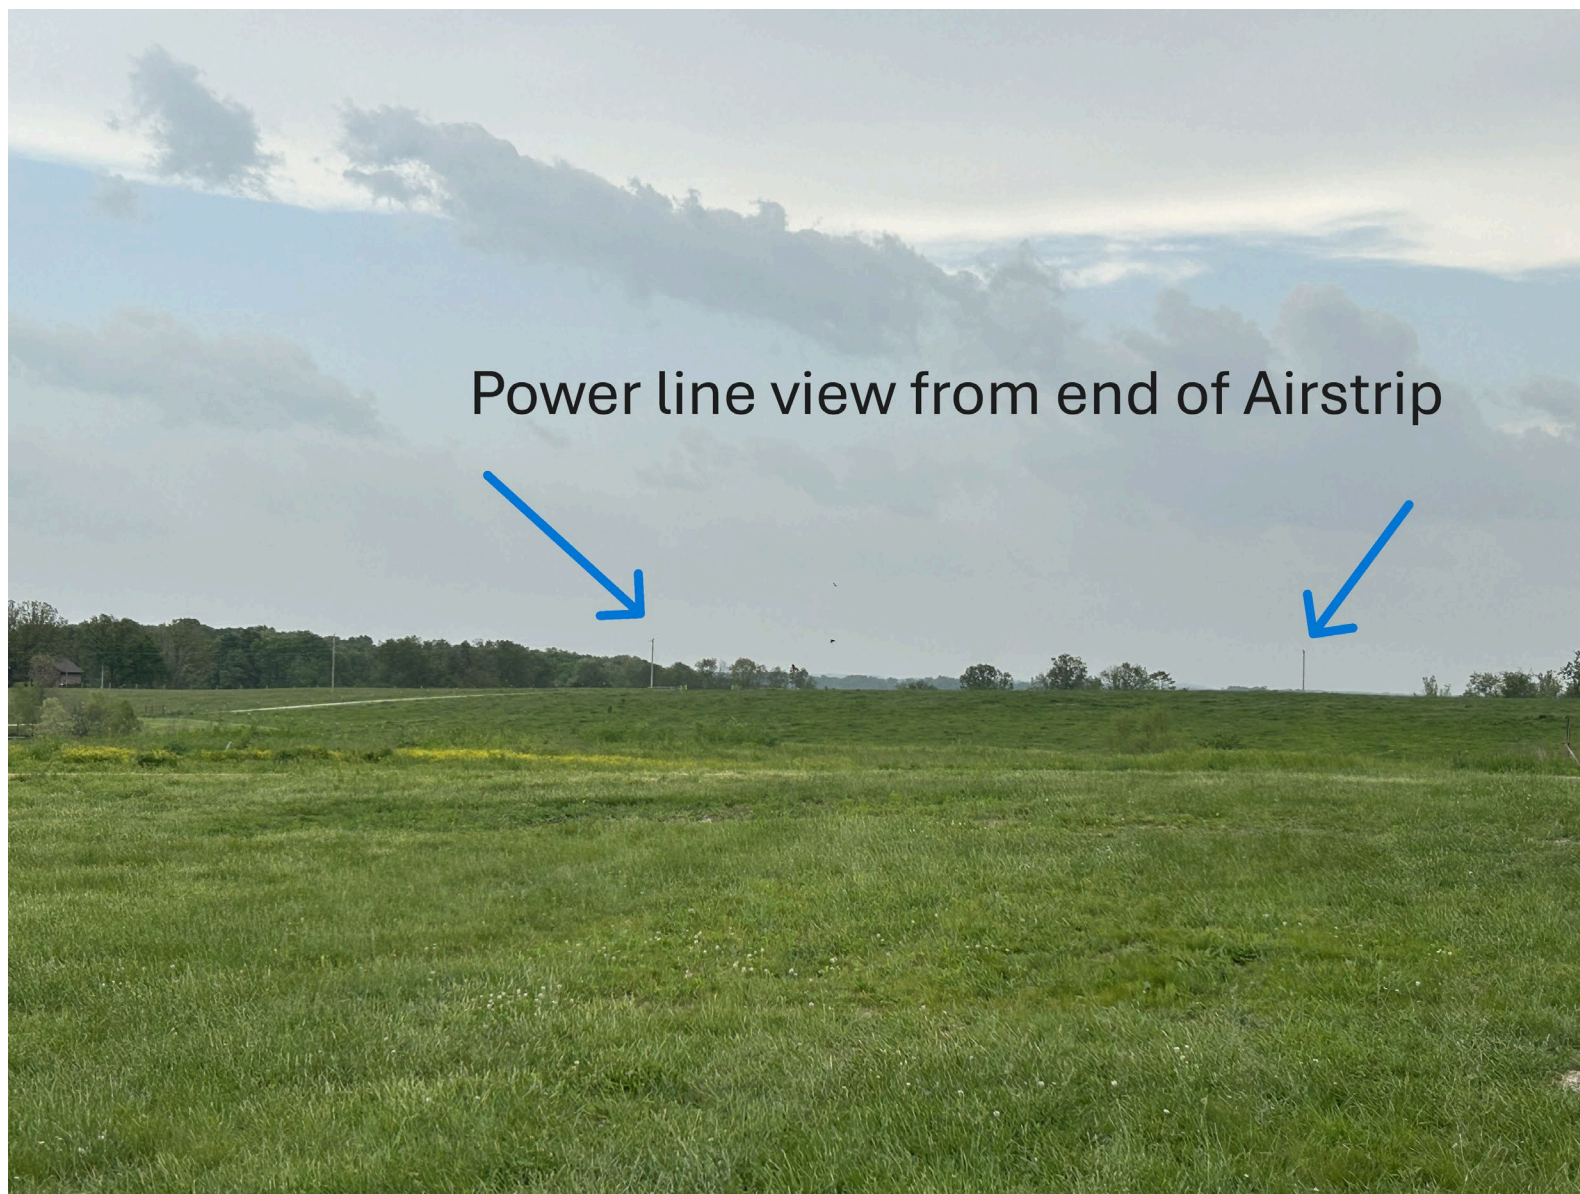
Power line view from end of Airstrip

**Photograph 1 - Powerlines viewed from the end of the airstrip (Courtesy of FAA)**

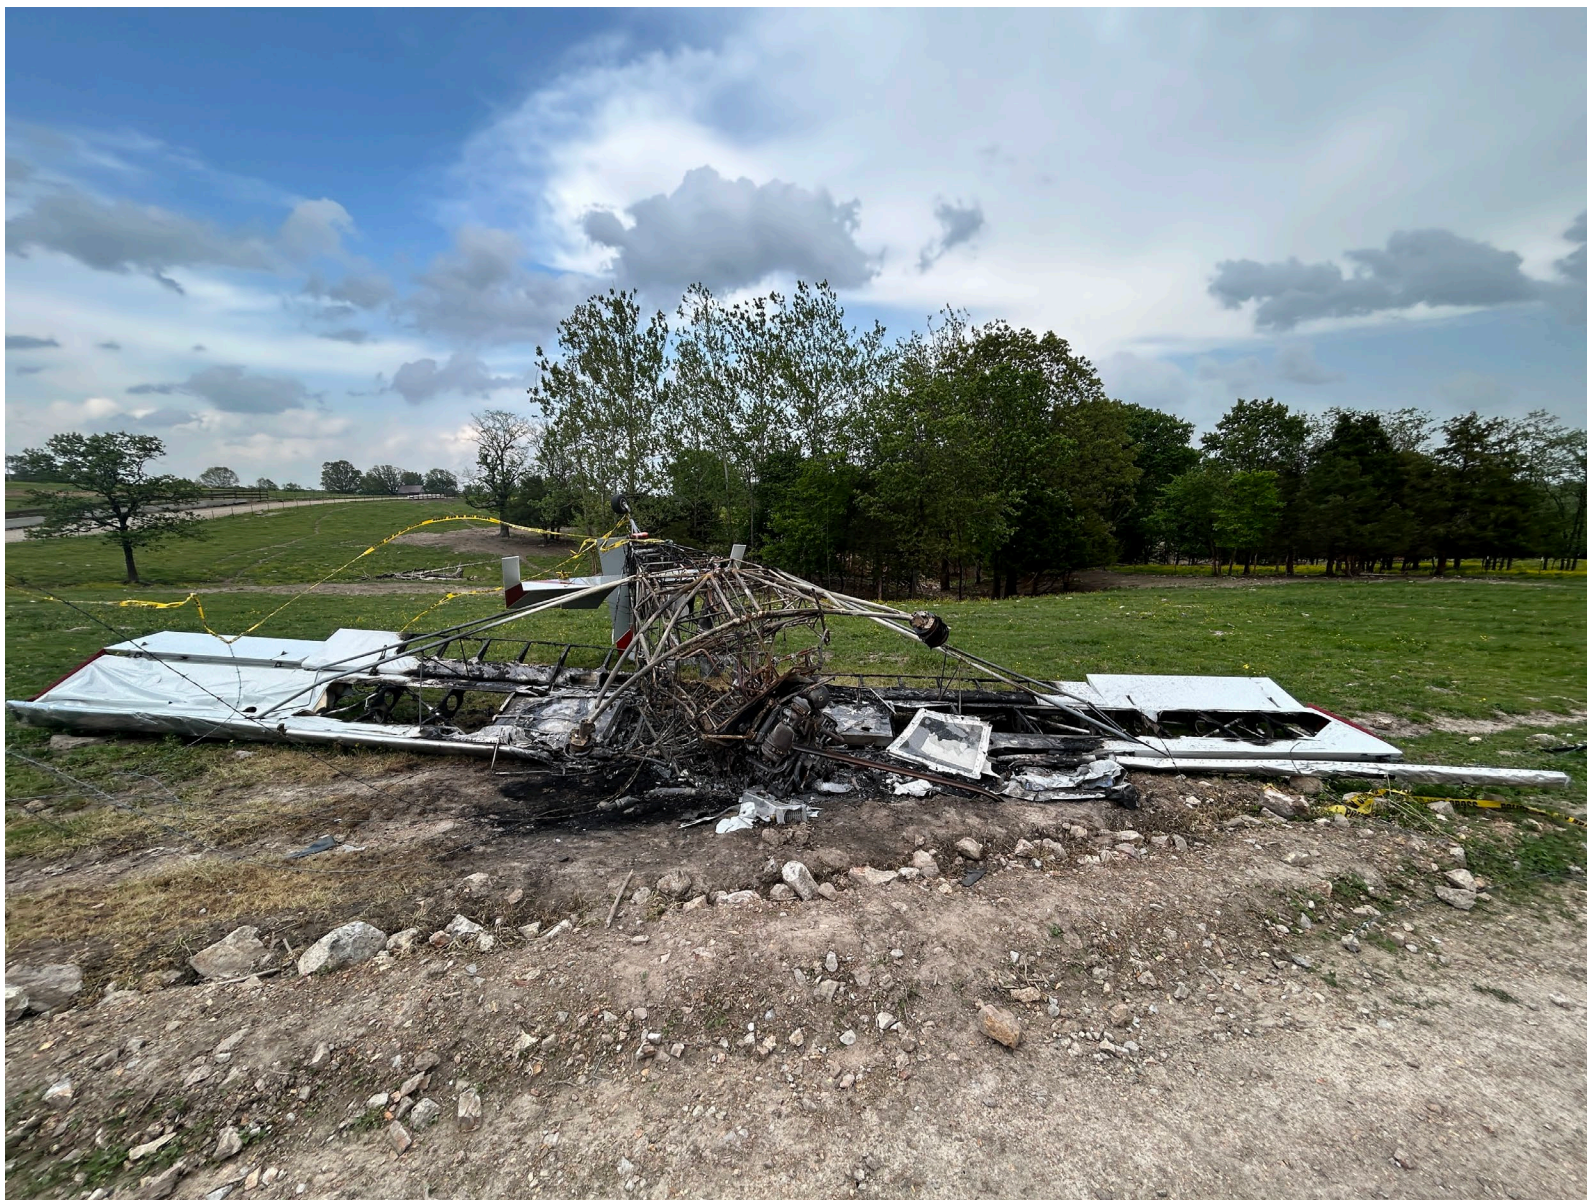
**Photograph 2 - Airplane inverted and burned (Courtesy of FAA)**
