CEN26LA198

## INVESTIGATION PHOTOGRAPHS

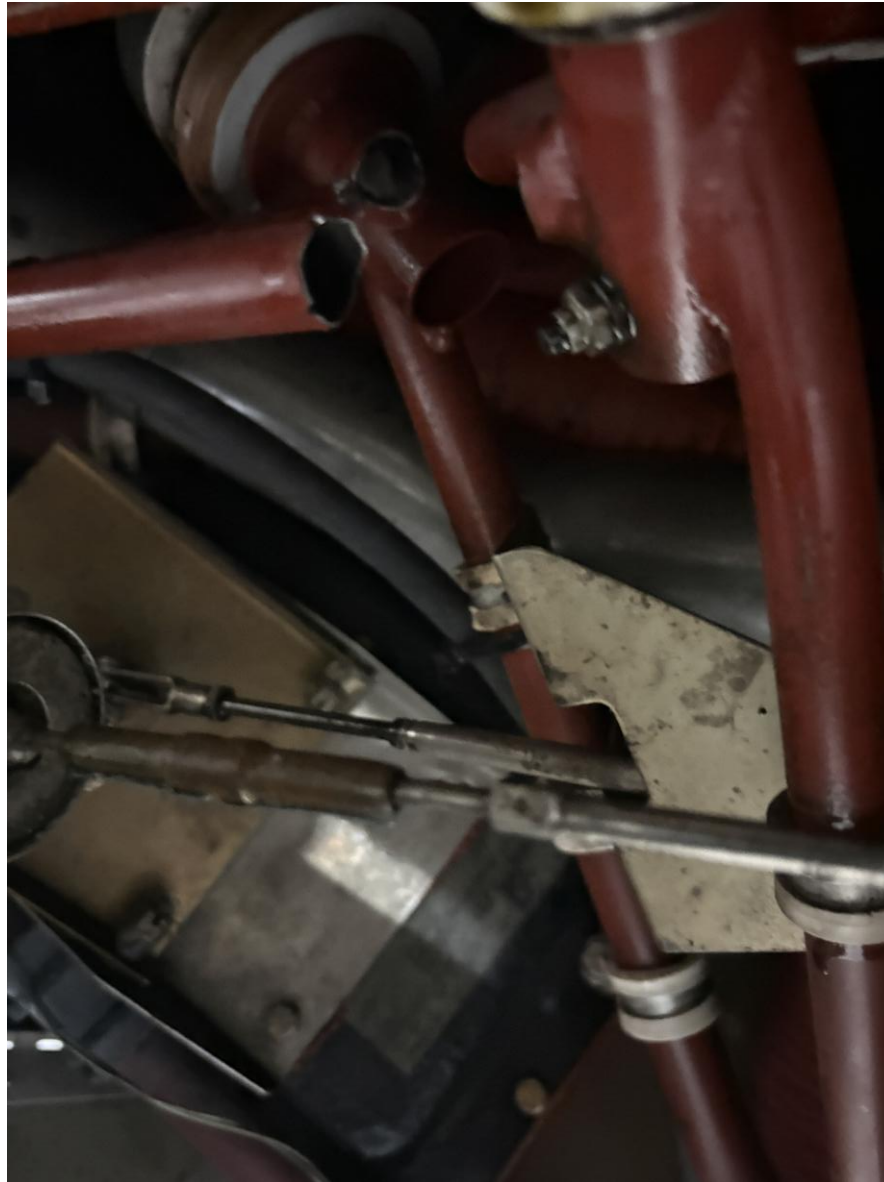
**Photograph 1 - Fractured Engine Mount (Courtesy of FAA)**
