CEN26LA233

## INVESTIGATION PHOTOGRAPHS

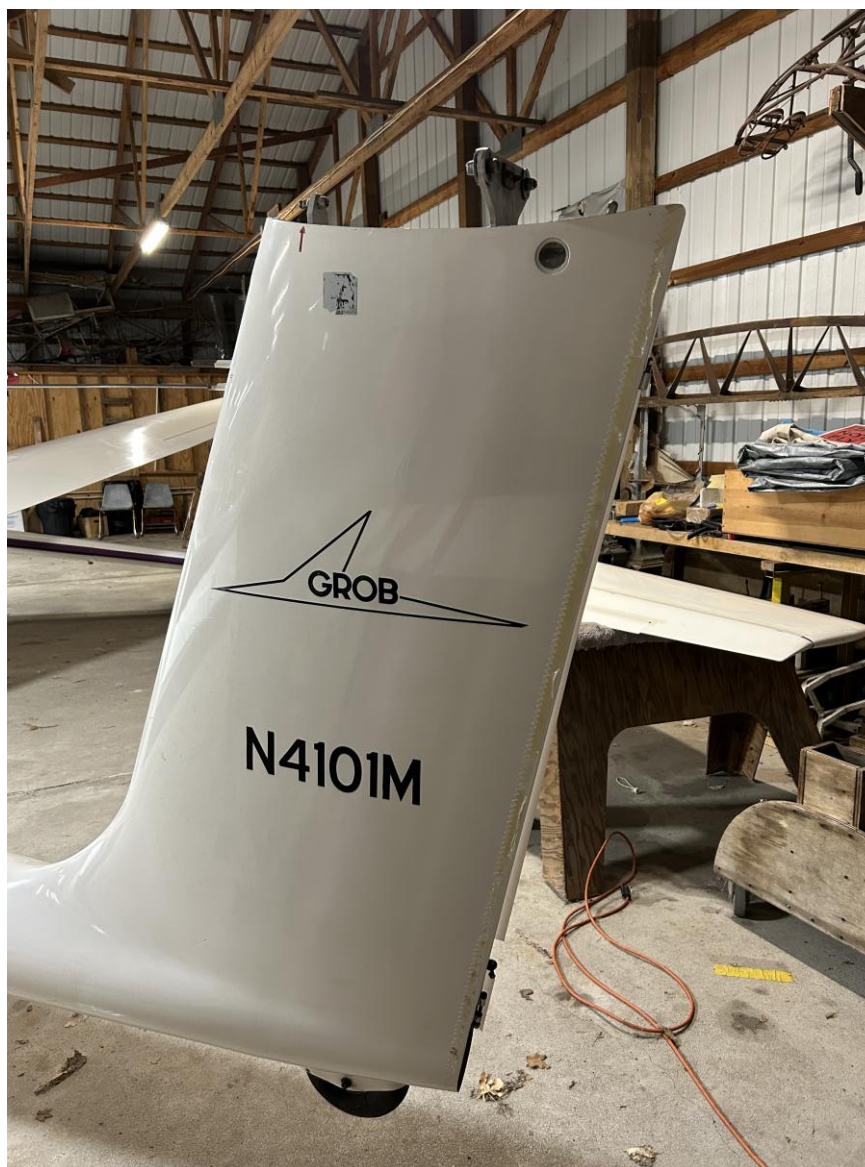
**Photograph 1 - Accident glider vertical stabilizer (Courtesy of operator)**

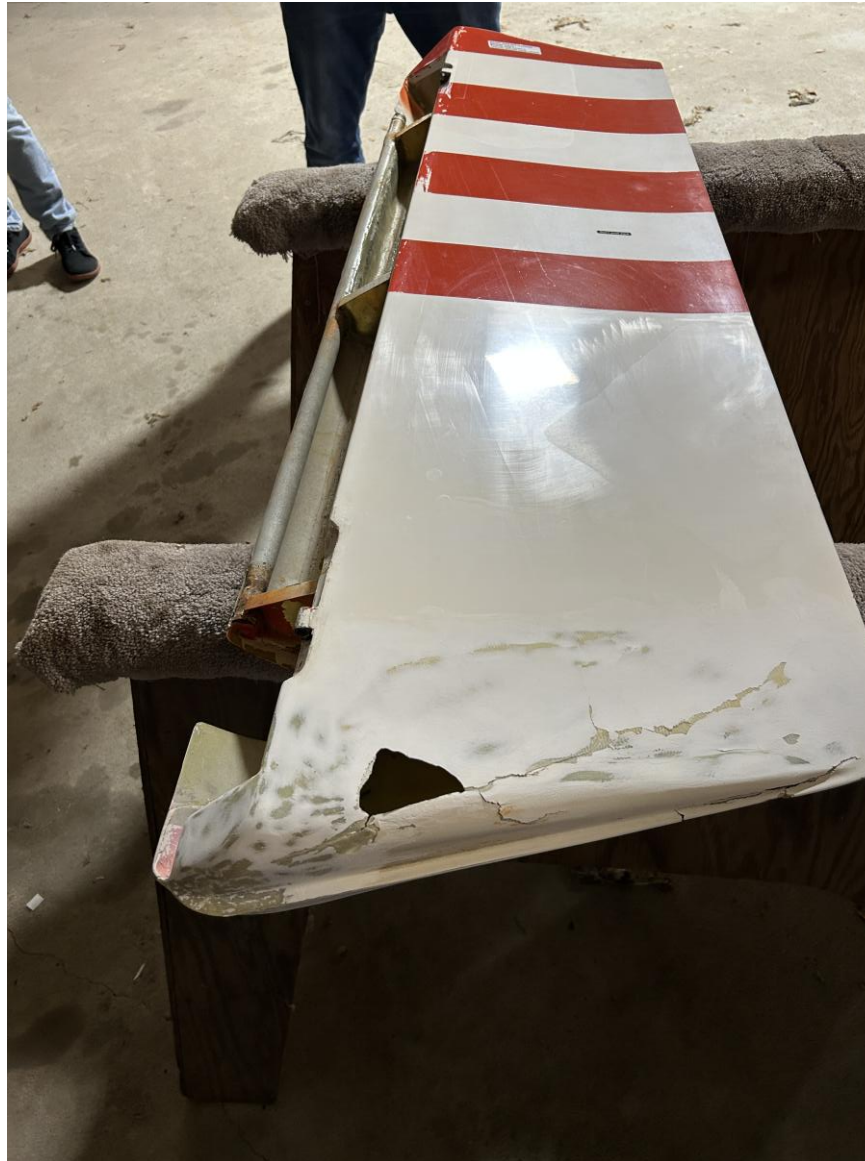
**Photograph 2 - Accident glider rudder damage (Courtesy of operator)**

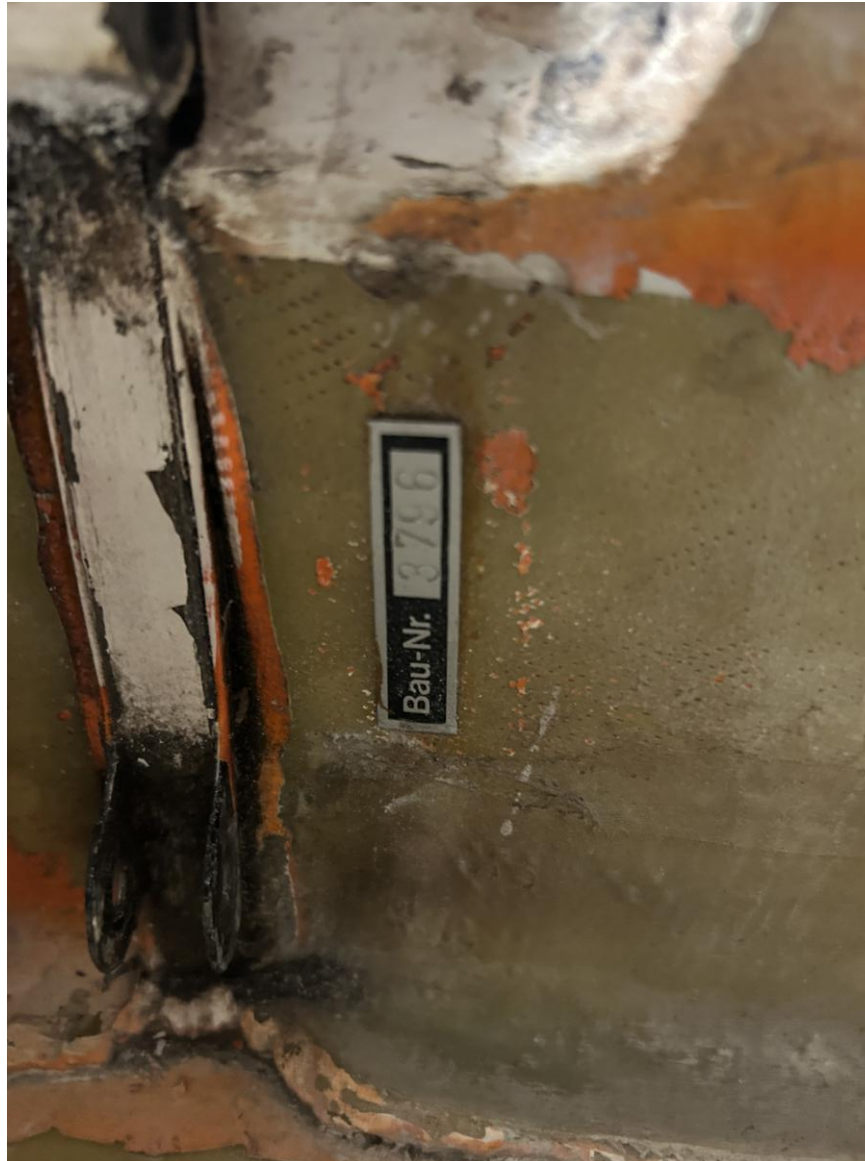
**Photograph 3 - Accident glider composite damage (Courtesy of operator)**
