CEN26LA244

## INVESTIGATION PHOTOGRAPHS

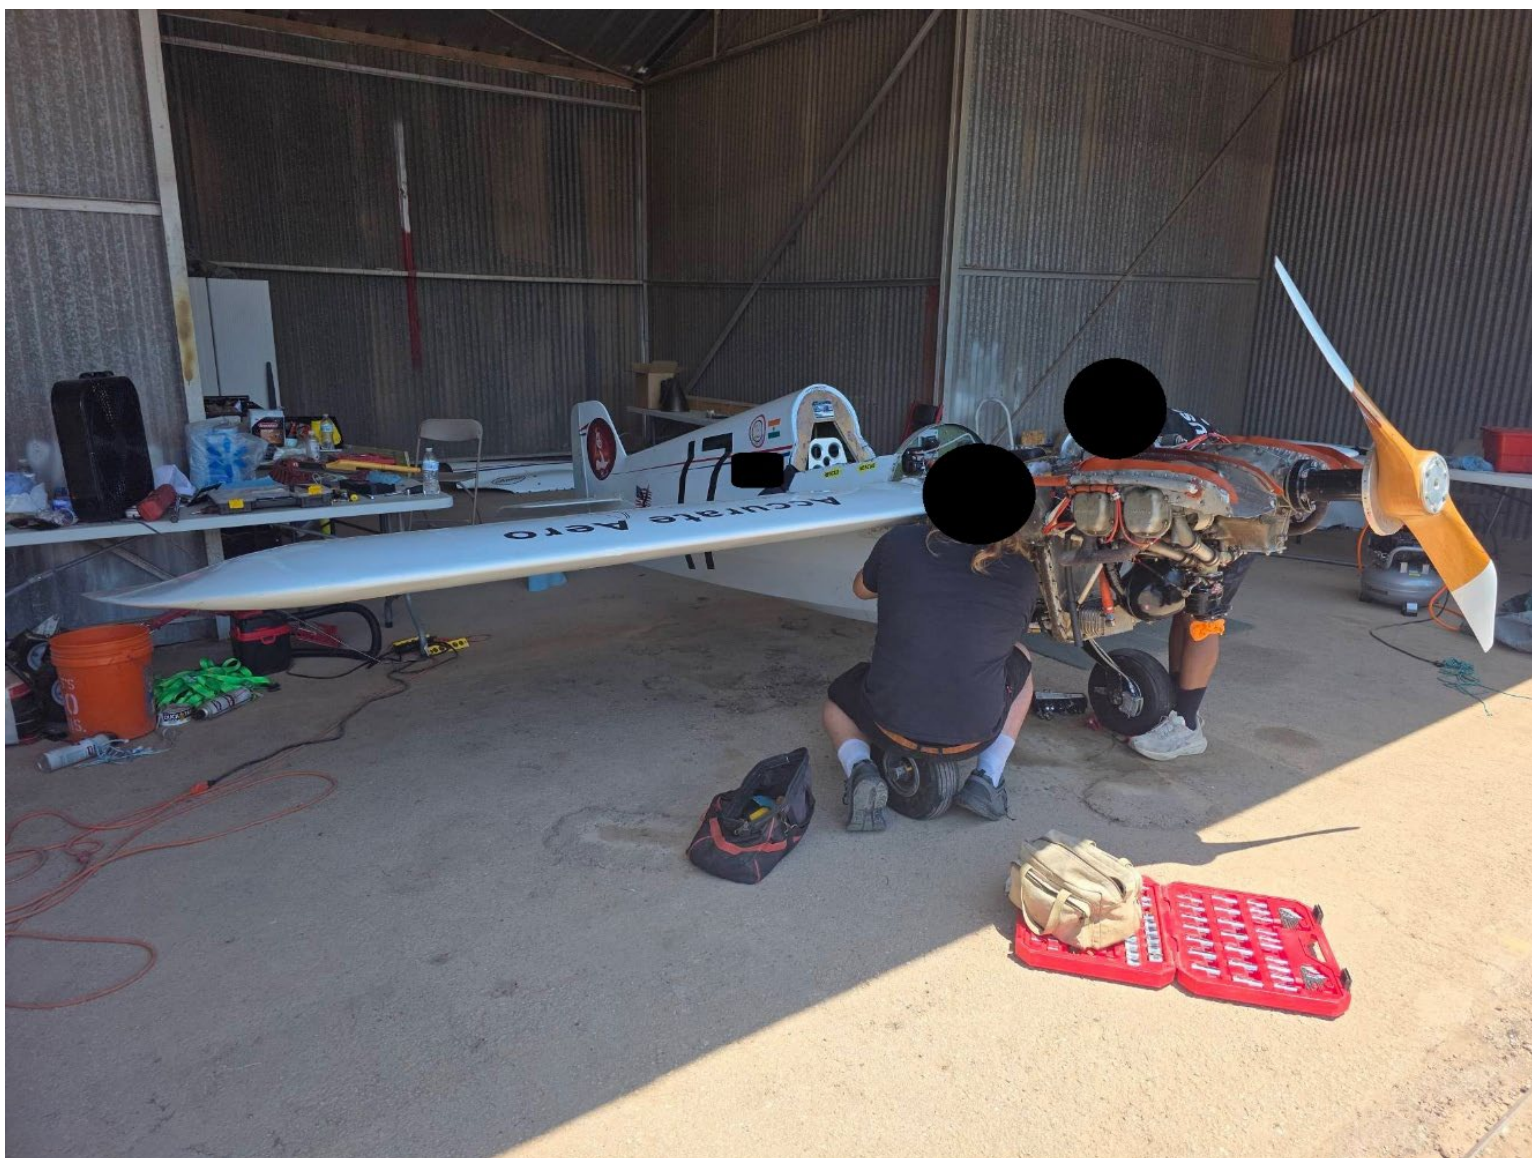
**Photograph 1 - View of the airplane during the assembly work inside of the hangar (courtesy of the air racing team mechanic)**

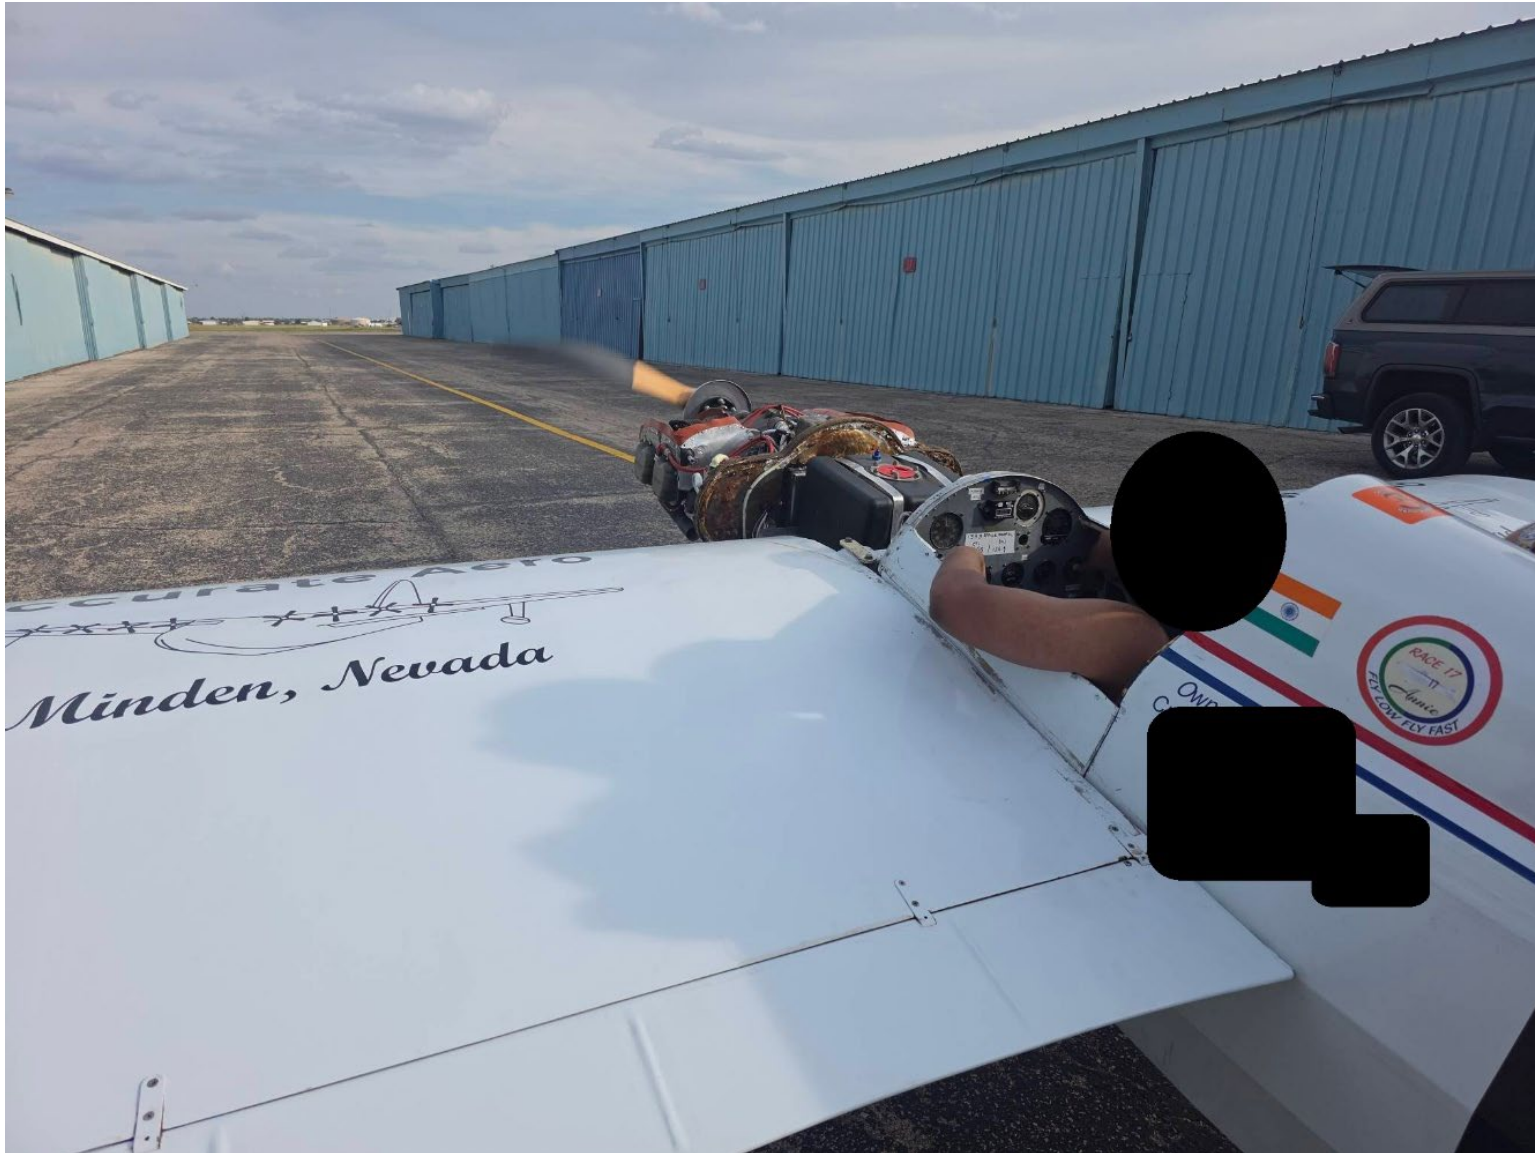
**Photograph 2 - View of the airplane during the engine run up in front of the hangar (courtesy of the air racing team mechanic)**

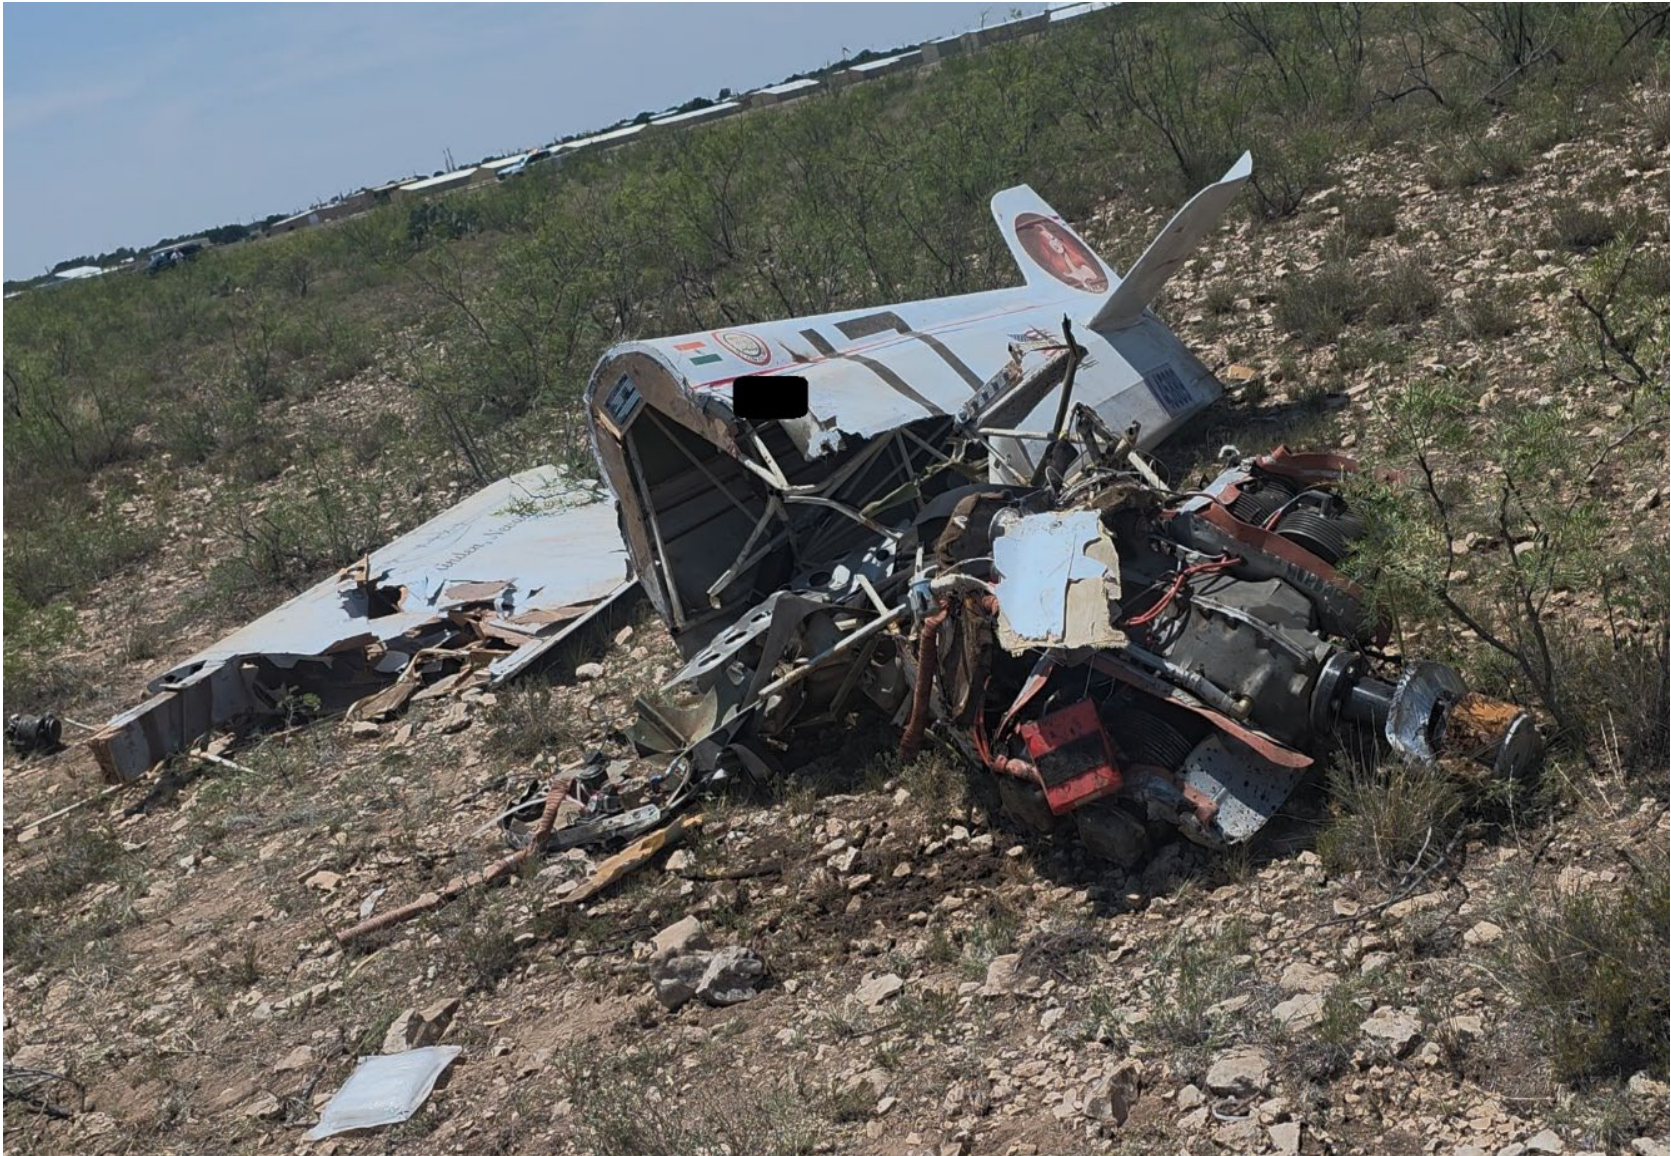
**Photograph 3 - View of the fuselage and the engine at the accident site (courtesy of the air racing team mechanic)**

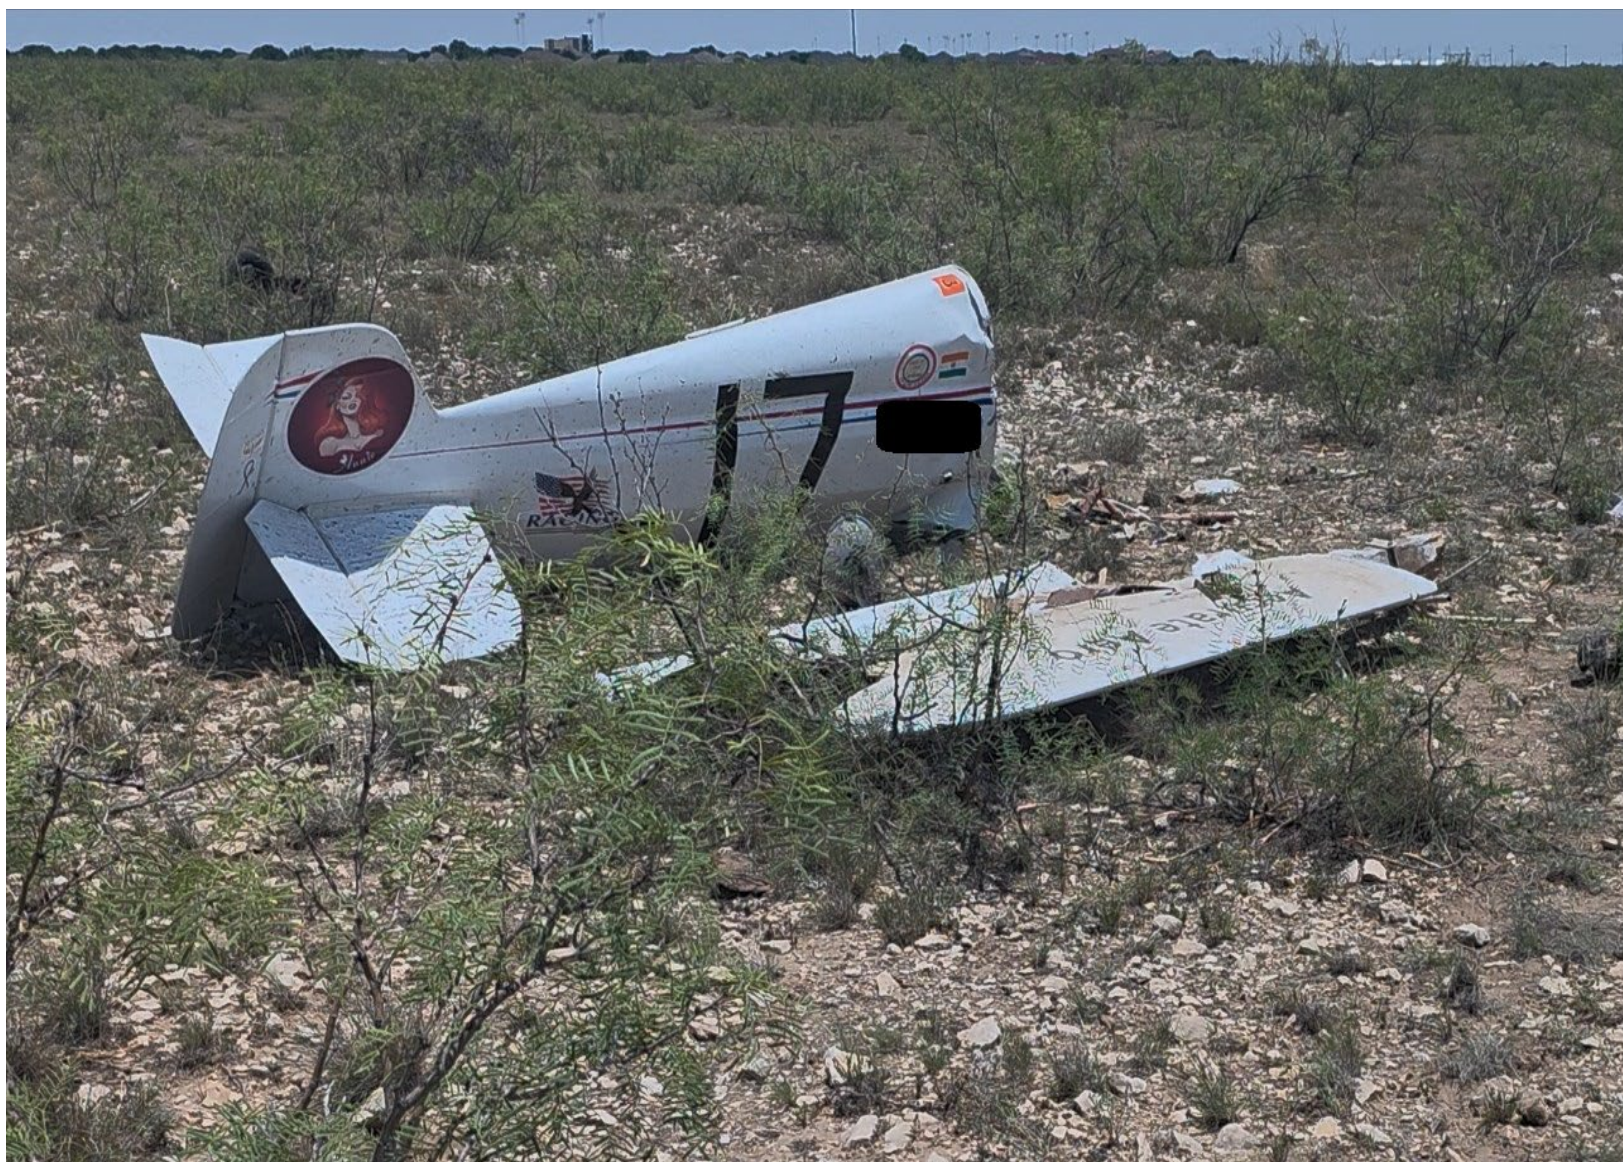
**Photograph 4 - View of the empennage at the accident site (courtesy of the air racing team mechanic)**

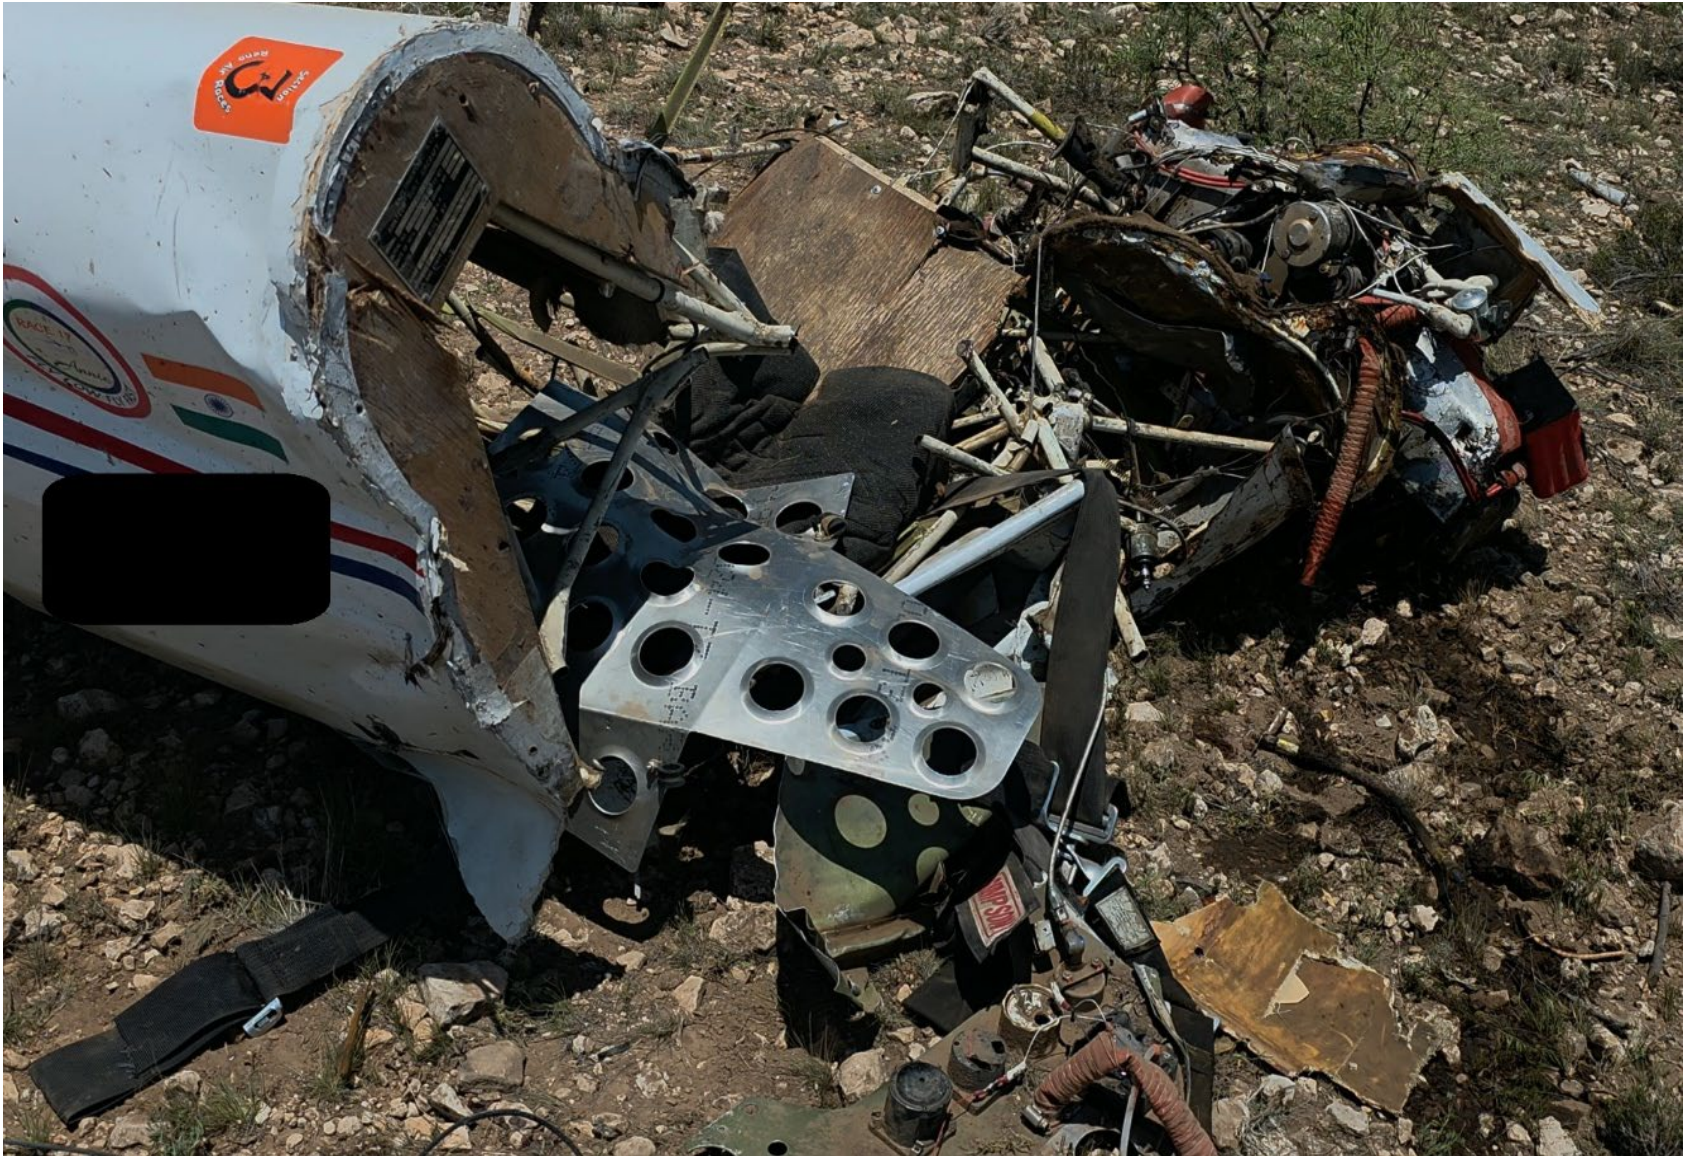
**Photograph 5 - View of the cockpit at the accident site (courtesy of the air racing team mechanic)**

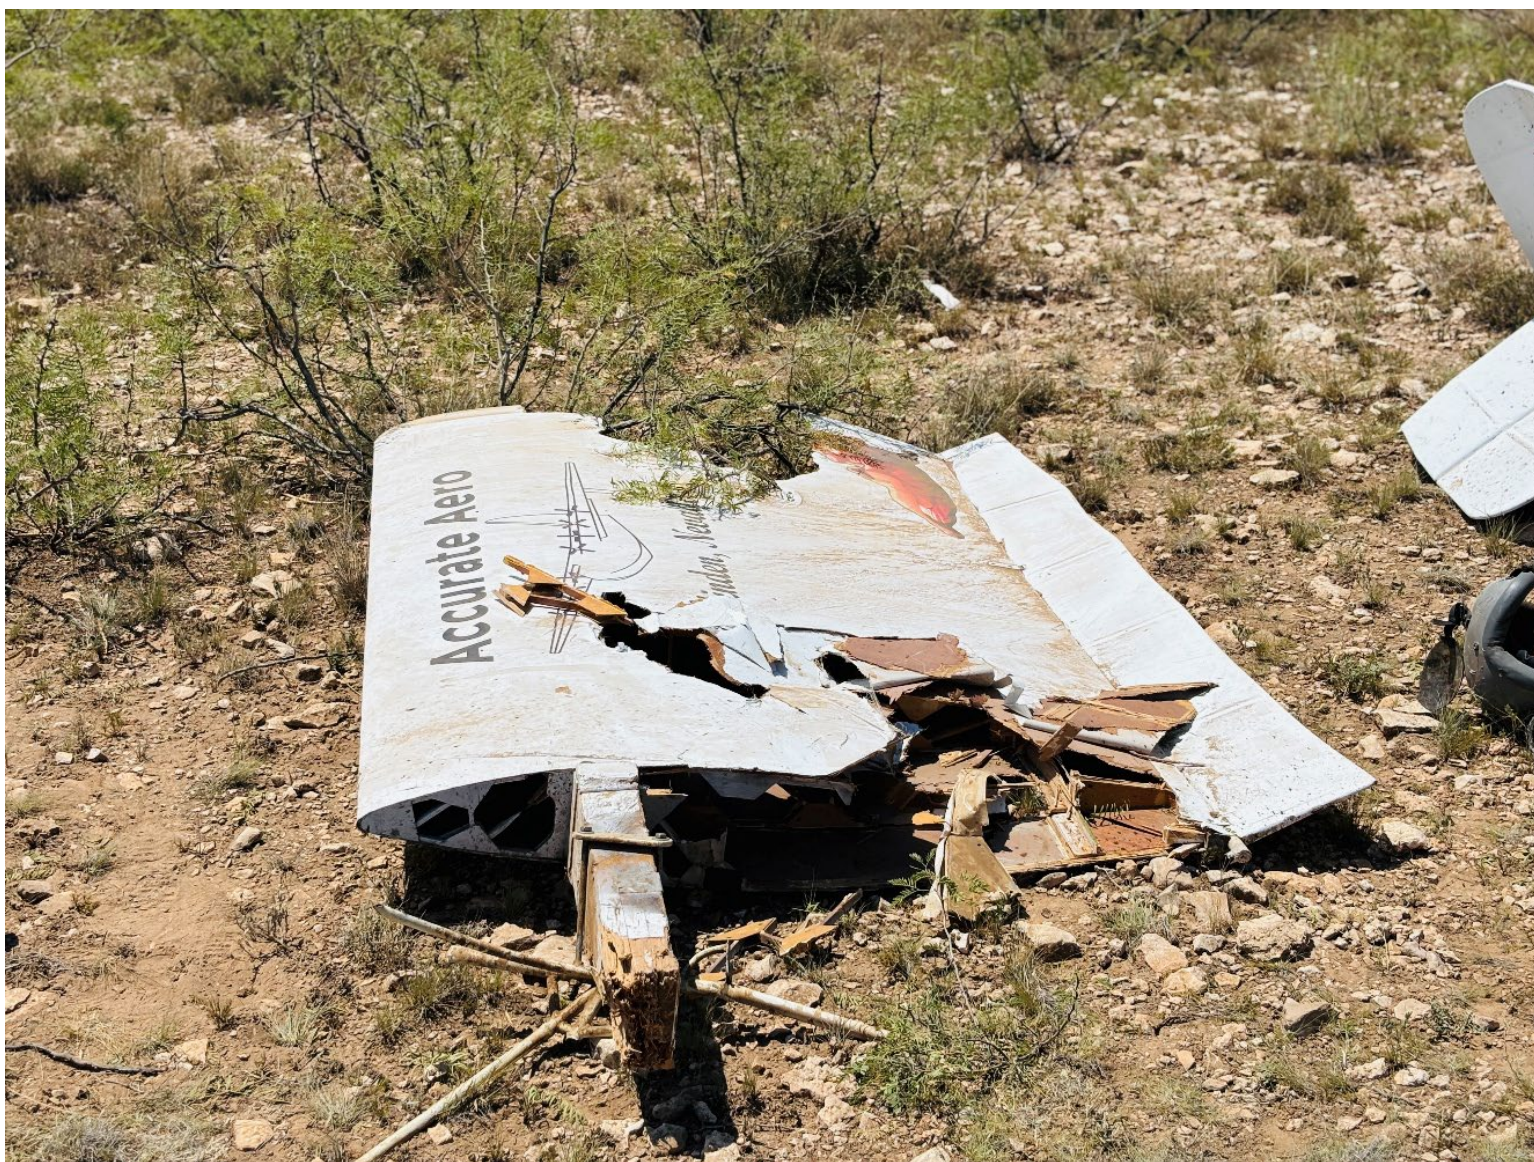
**Photograph 6 - View of the right wing at the accident site (courtesy of the Federal Aviation Administration)**

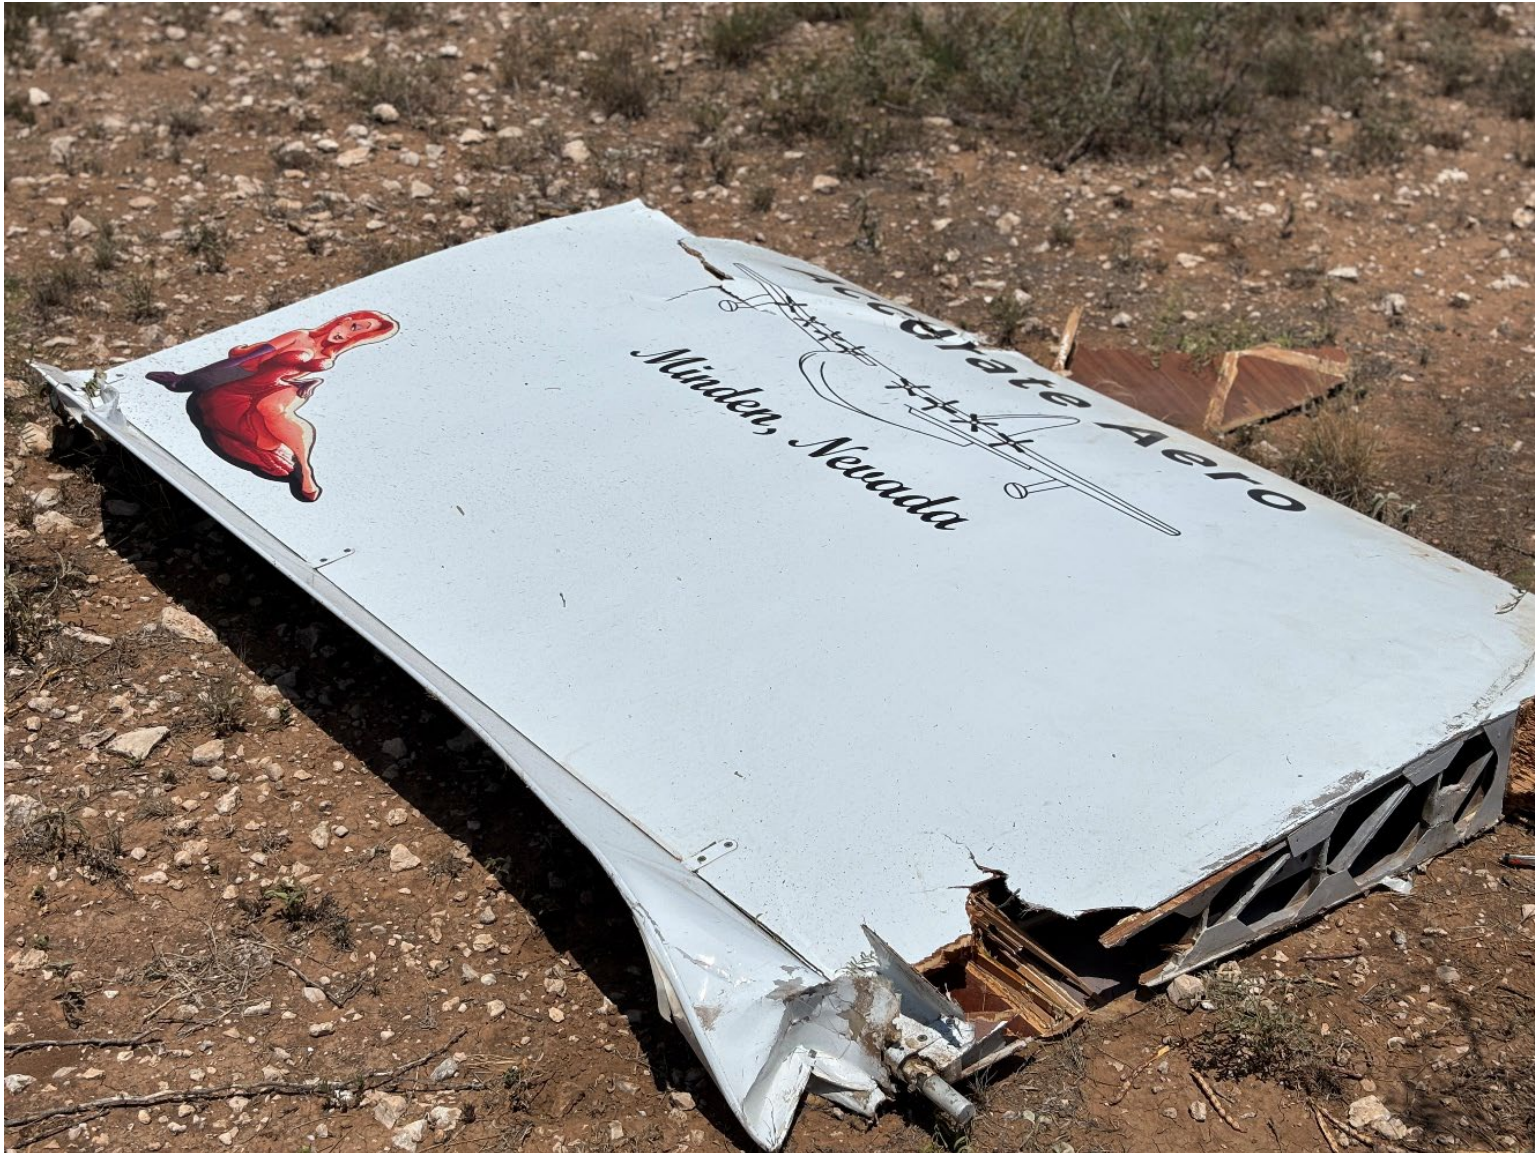
**Photograph 7 - View of the left wing at the accident site (courtesy of the Federal Aviation Administration)**

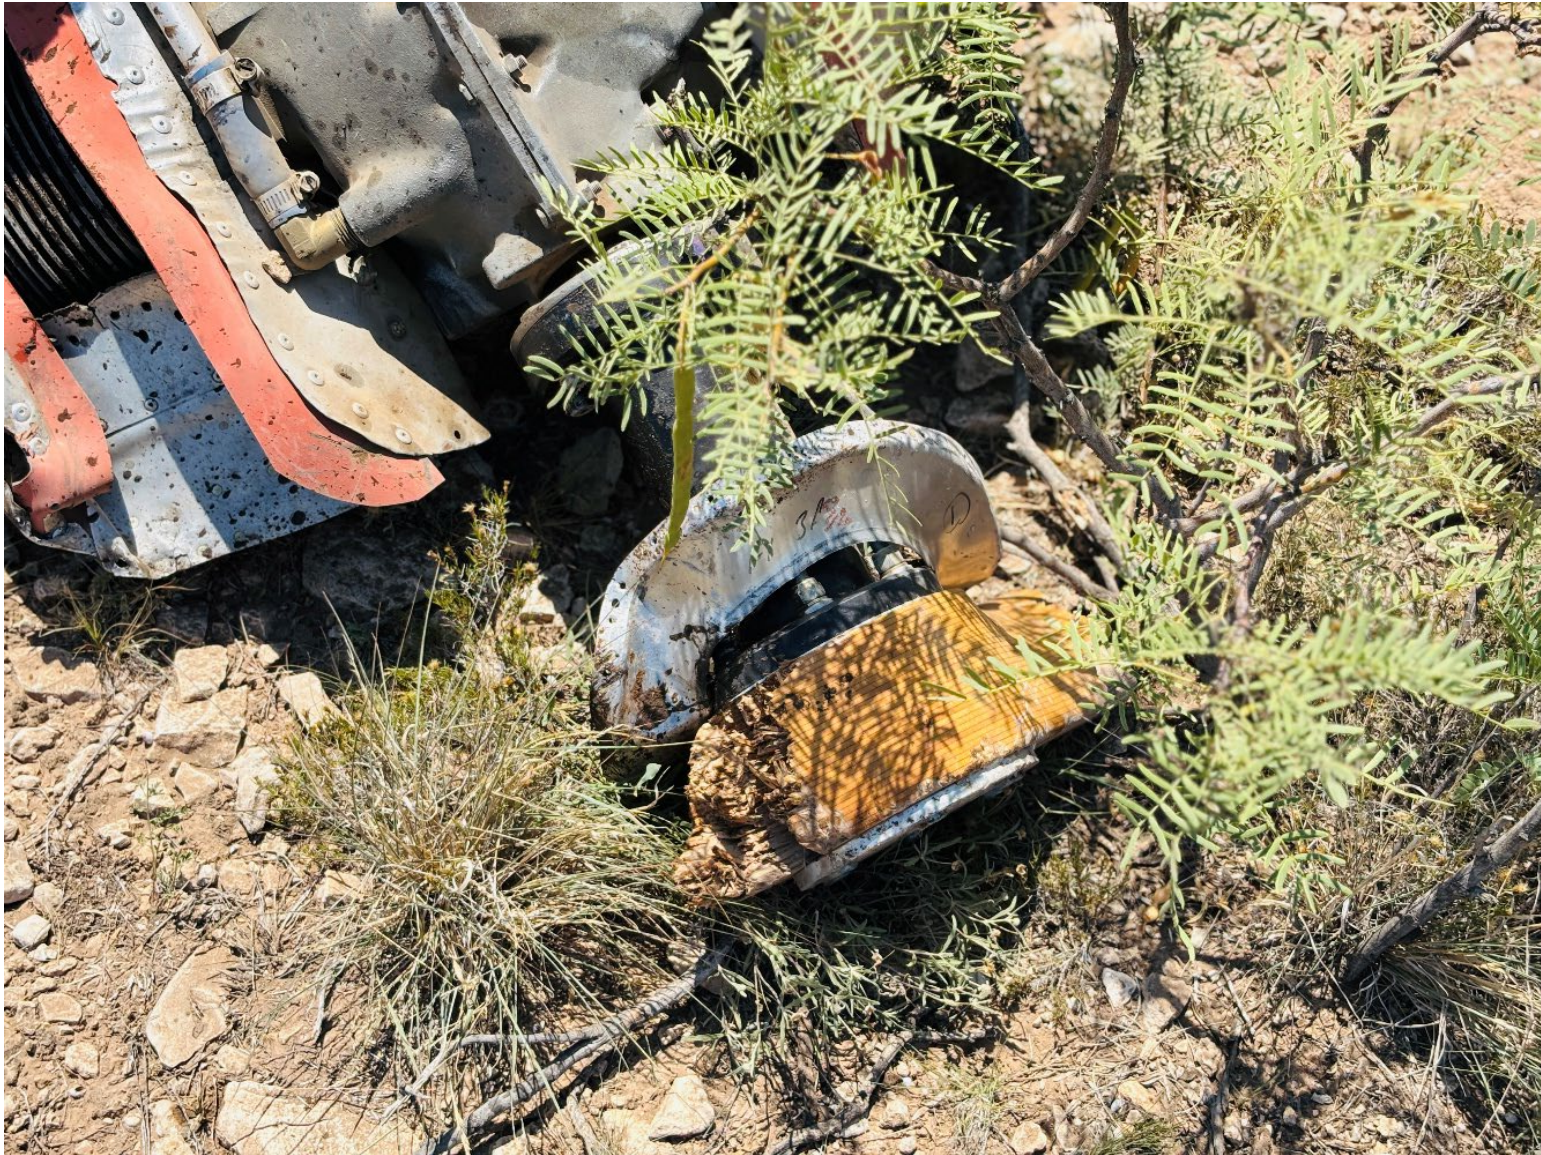
**Photograph 8 - View of the propeller at the accident site (courtesy of the Federal Aviation Administration)**

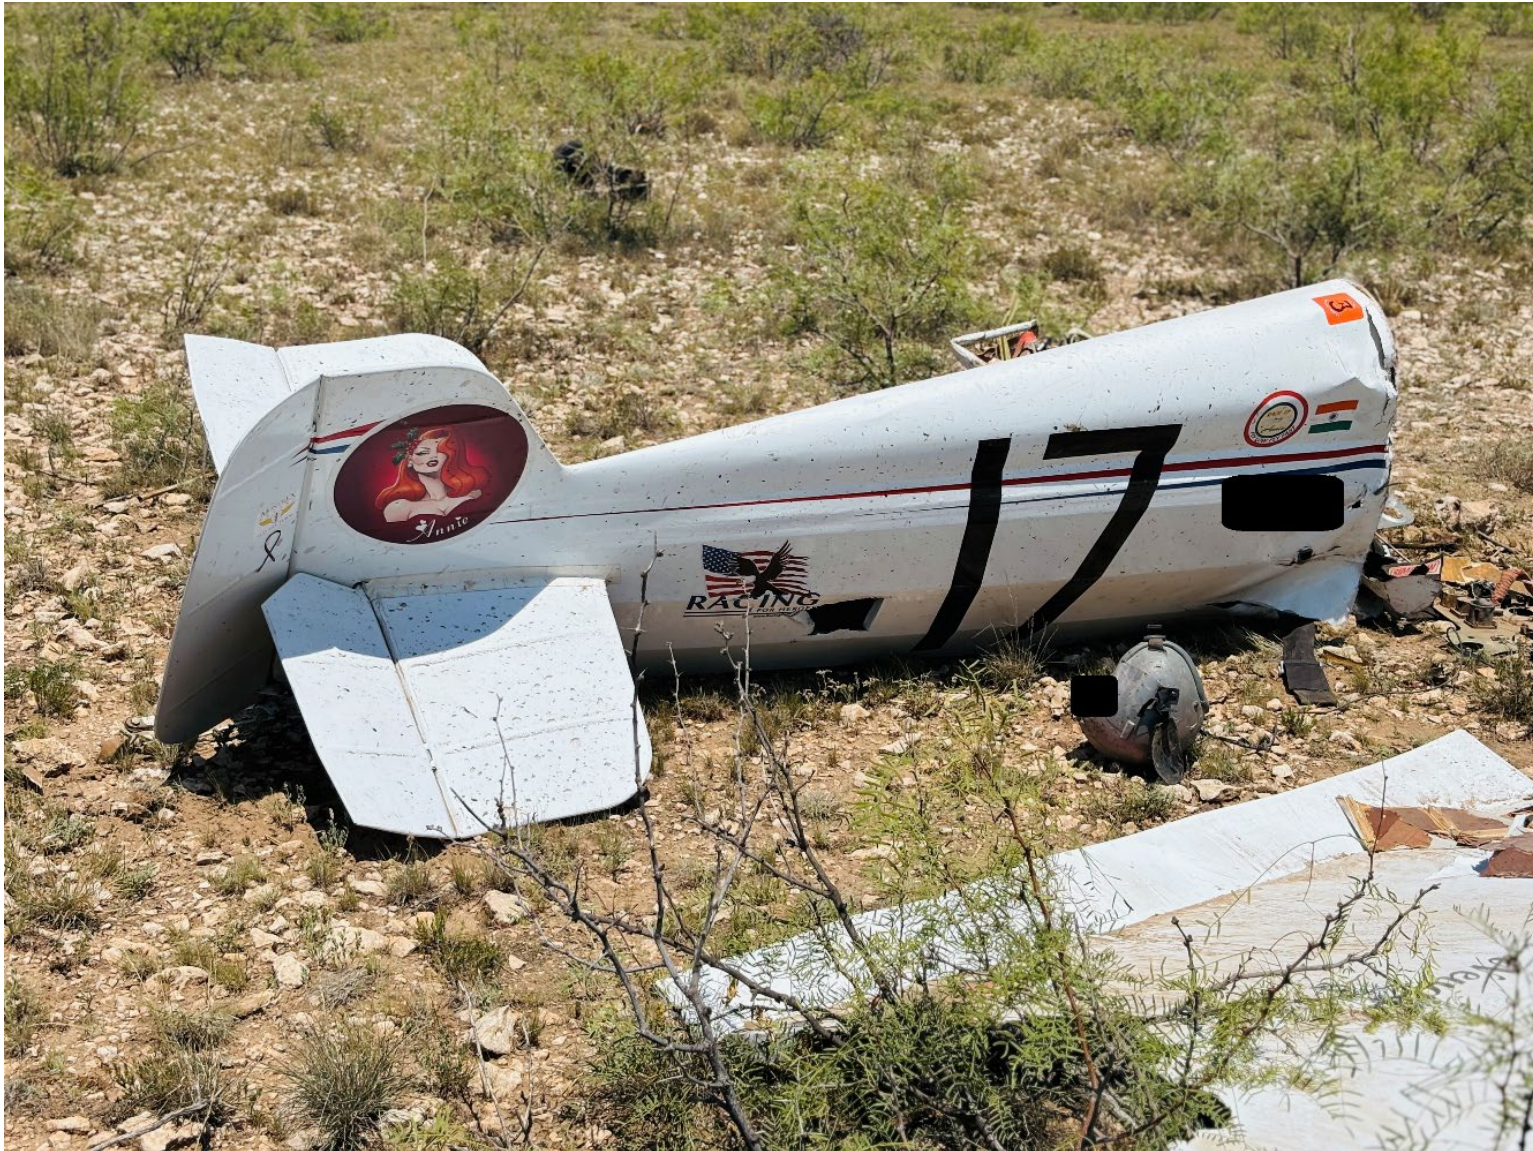
**Photograph 9 - View of the pilot's airplane flight helmet at the accident site (courtesy of the Federal Aviation Administration)**
