## Inspectors Statement Accident N45889 5 July 2026

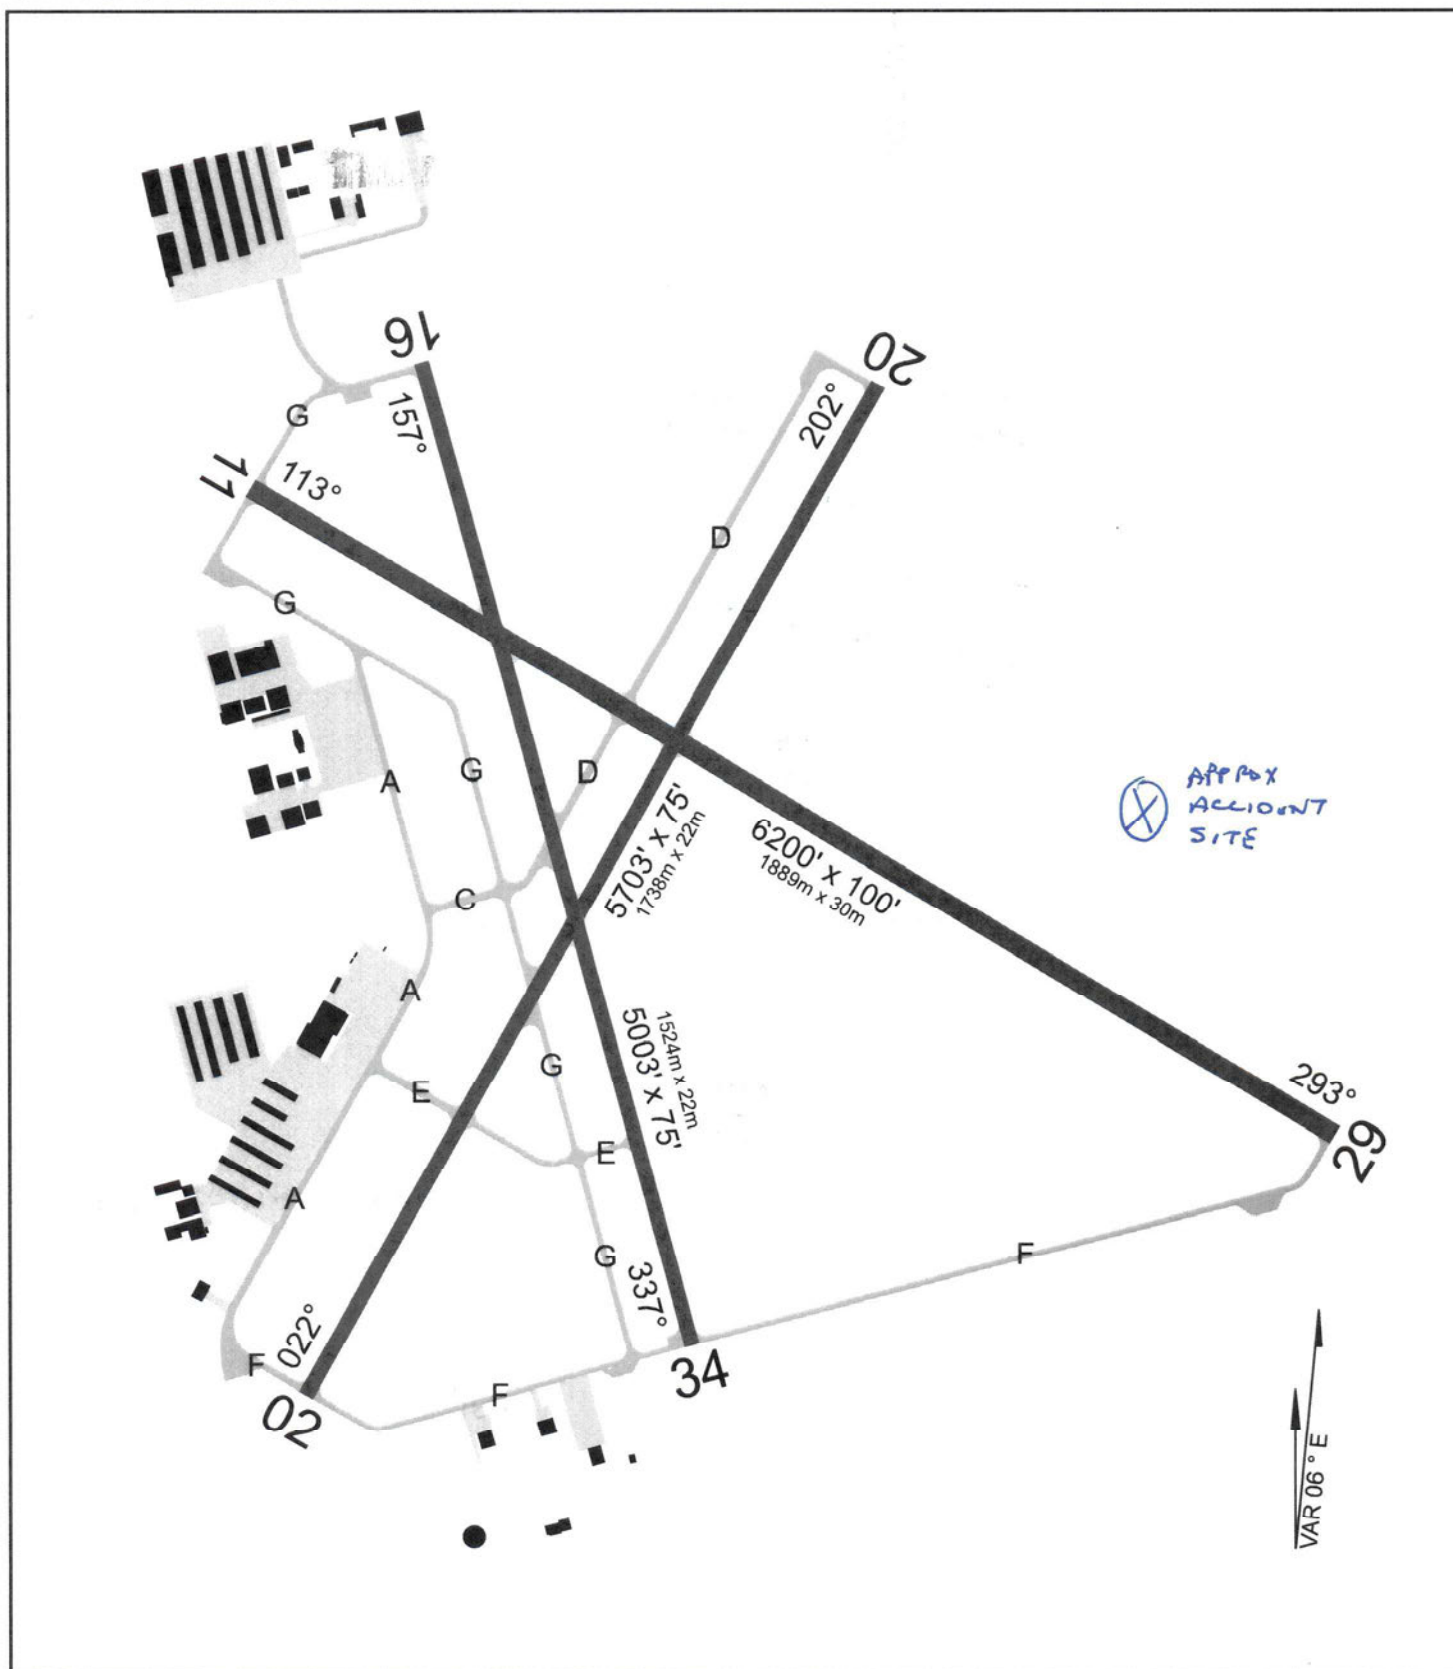
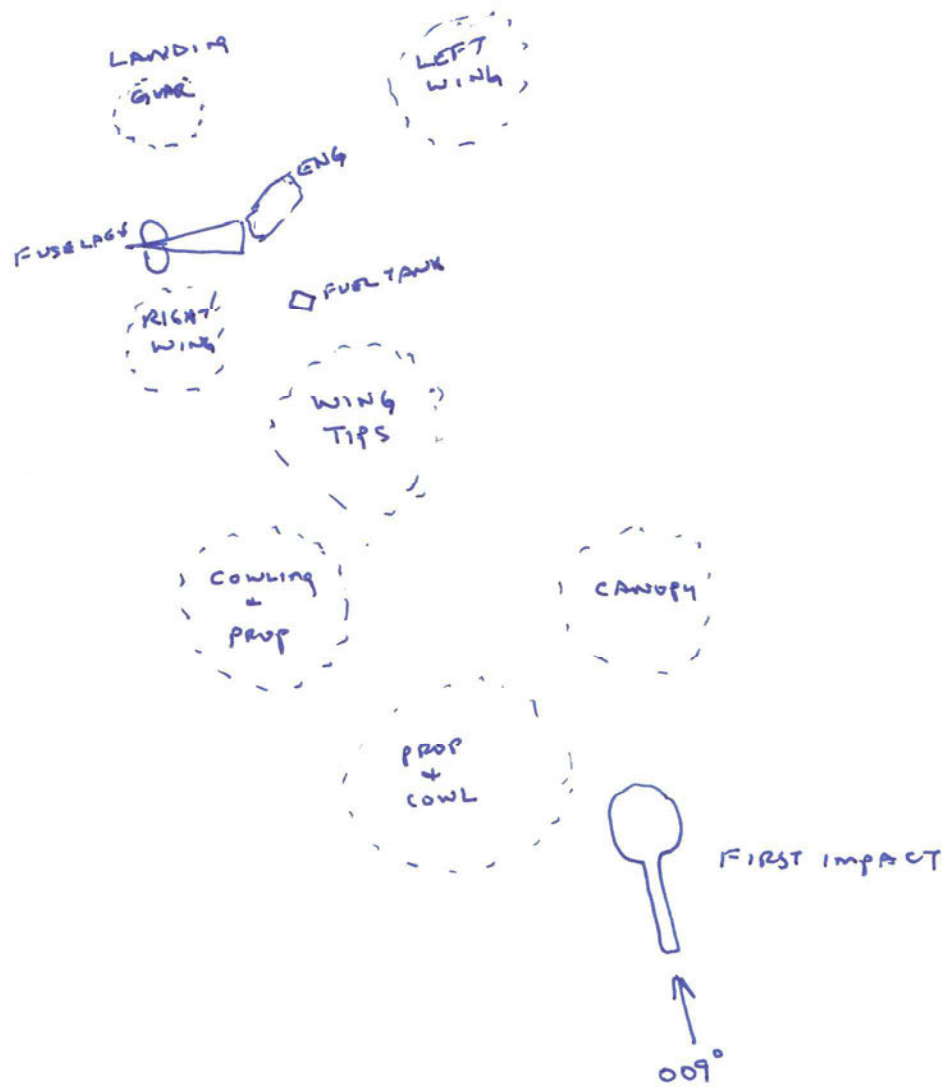
I inspected the impact and debris field. See attached diagrams.

There was a single impact scar, with a narrow gouge leading to it. Both wing tips were found, with no crushing damage on either one. Both wings were separated from the aircraft. The steel tube fuselage rear behind the pilots seat was intact with all tail surfaces attached. The pilots seat area and engine were still attached to the fuselage, and bent to the left approximately 20-30 degrees. The 5 gallon fuel tank was detached and found about 15 feet in front of remaining fuselage. It was empty when examined. Control continuity was established. The elevator pushrod was attached on both ends, but was bent at the cockpit area jamming the elevators. The rudder control cables were attached at both ends, but the distortion at the cockpit area stretched one cable tight and the rudder was also jammed. The aileron attach points on both wings were sheared off symmetrically, and parts of control linkage were found, with functioning clevis joints. The landing gear assembly was

found just beyond the fuselage with one wheel missing and bent/sheared attach bolts. The wings were mostly intact, and the main spar was broken. No wooden spar parts were found on left wing, and a stub of wooden spar was still on right wing.
