CEN26LA304

## INVESTIGATION PHOTOGRAPHS

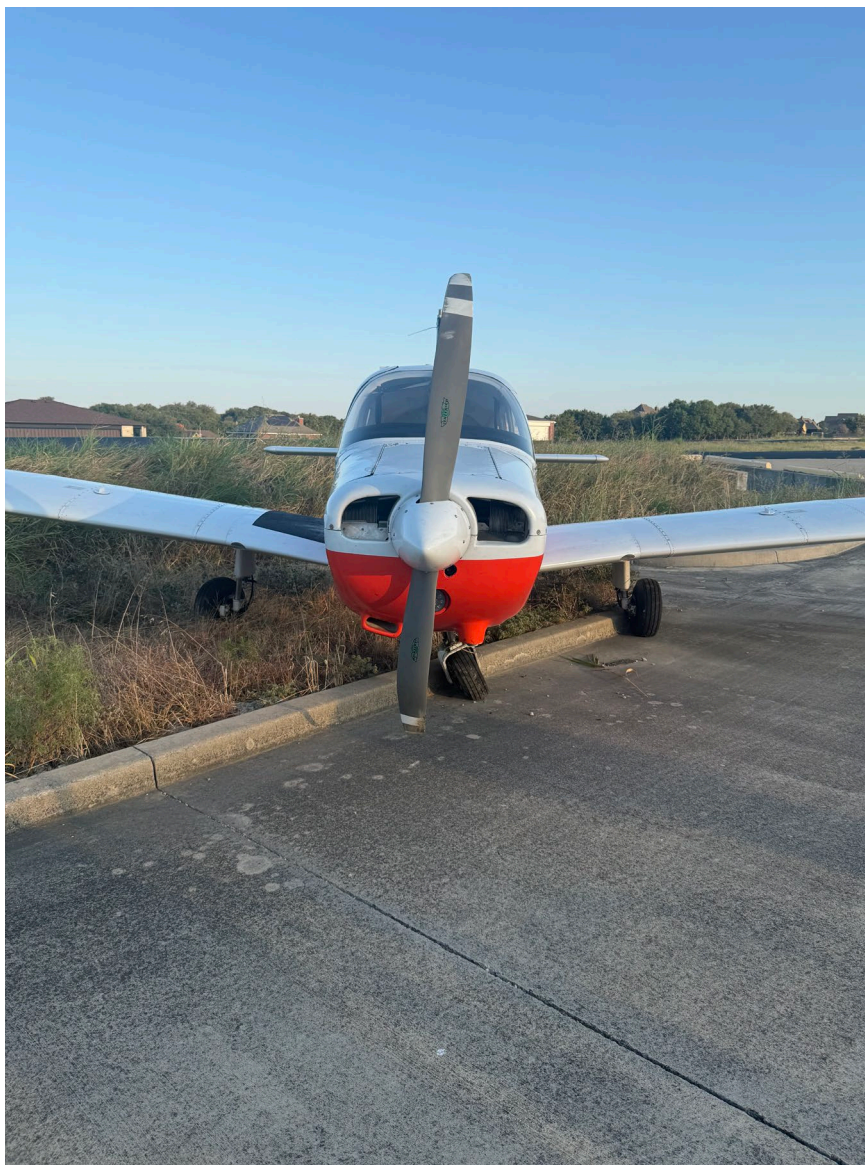
**Photograph 1 - Accident Scene (Courtesy of the FAA)**

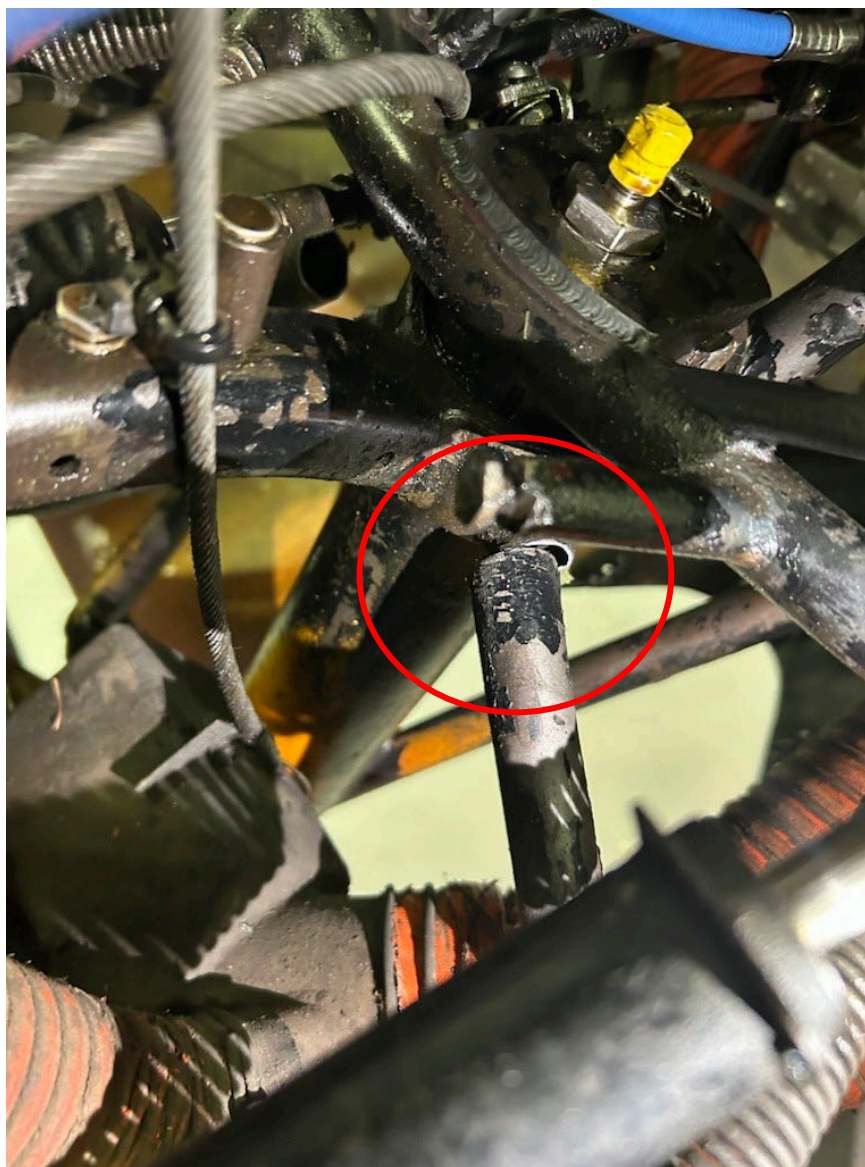
**Photograph 2 - Engine mount damage (Courtesy of the FAA)**
