NATIONAL TRANSPORTATION SAFETY BOARD  
OFFICE OF AVIATION SAFETY  
WASHINGTON, D.C. 20594

**POWERPLANTS GROUP CHAIRMAN'S FACTUAL REPORT**

NTSB ID No.: DCA12IA114

Location: Charleston International Airport, Charleston, South Carolina  
Date: July 28, 2012  
Time: About 1600 eastern daylight time  
Aircraft: Boeing 787-8, radio call sign Boeing 238

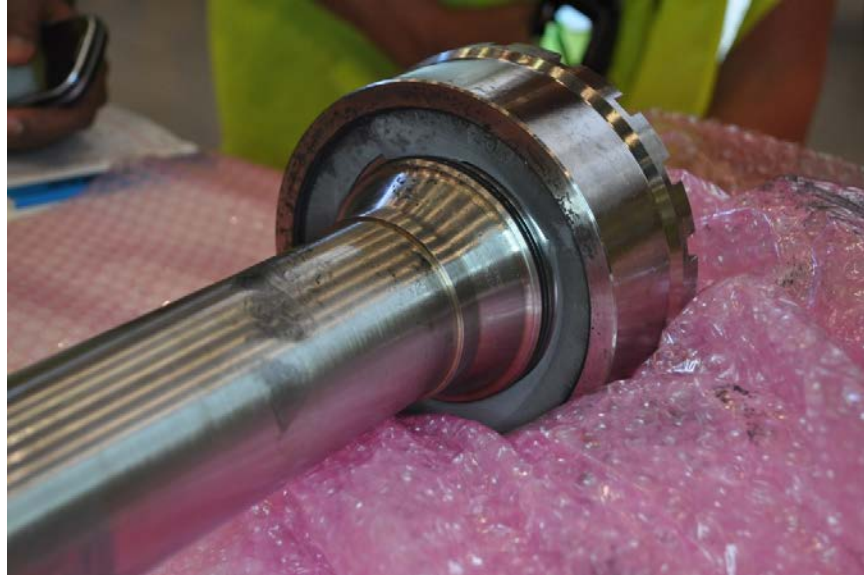
When the A-sump<sup>5</sup> bulkhead was removed from the front of the sump, it exposed the front of the FMS and the FMS retaining nut. It was noted that the FMS retaining nut was in place on the threads of the FMS. It was also noted that the front of the FMS was separated from the rest of the FMS at the rear of the threads. The front of the FMS and the FMS retaining nut along with the center vent tube (CVT) were removed through the A-sump. (Photo No. 2)

Photo No. 2: View of fractured forward end of fan mid shaft in retaining nut with center vent tube after removal from engine. (GE)

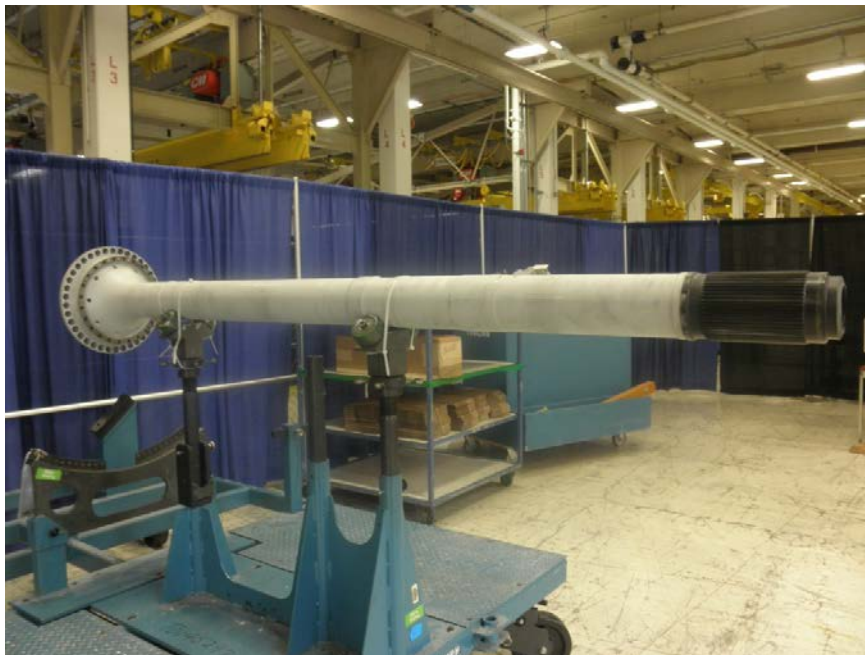
In comparison to an exemplar FMS, the incident FMS was fractured circumferentially about 5-inches aft of the forward face of the wrenching lugs. The remainder of the FMS did not have any rub marks or discolorations. (Photos Nos. 3 and 4) The fracture face at the forward end of the FMS was smooth and flat with a ratchet mark.<sup>7</sup> The fracture surface had two distinct colorations; a light, gray-colored area that appeared to radiate radially outward from the bore and a darker, gray-colored area that appeared to radiate inward from the outer diameter (OD). (Photo No. 5)

Photo No. 4: Fractured fan mid shaft.

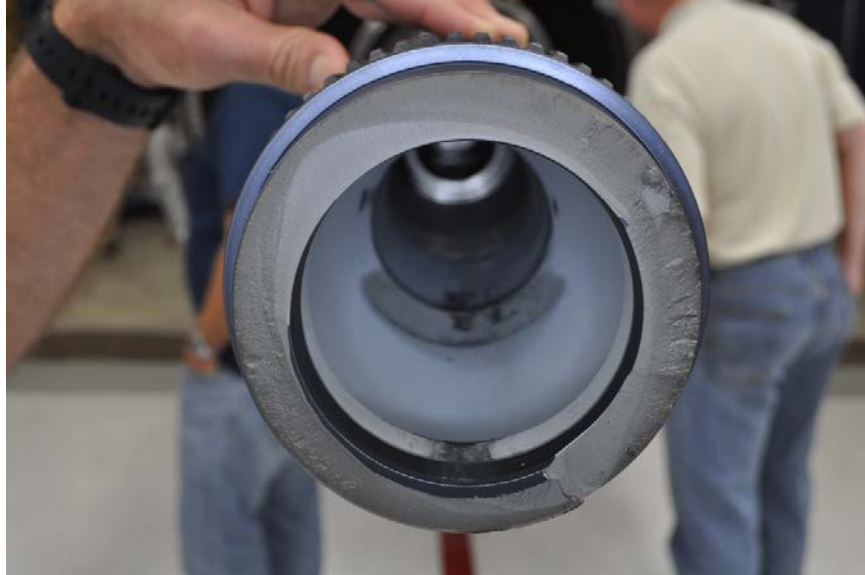
Photo No. 5: Close up of fractured forward end of fan mid shaft showing two areas with different gray colorations. (GE)

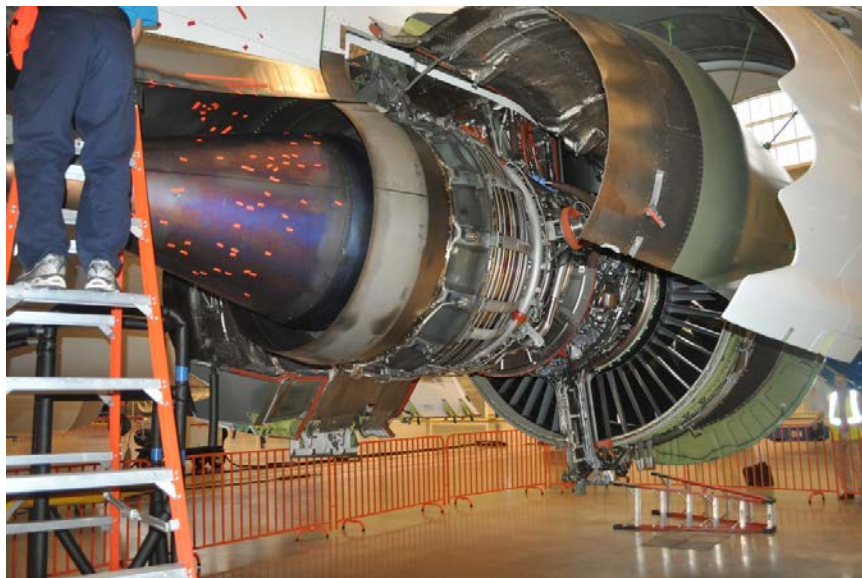
Photo No. 10: Right side of engine with cowls open showing no damage to the inner surfaces of the cowls and no soot or fire damage to the engine. The red pieces of tape mark the impact marks on the tailcone. (GE)

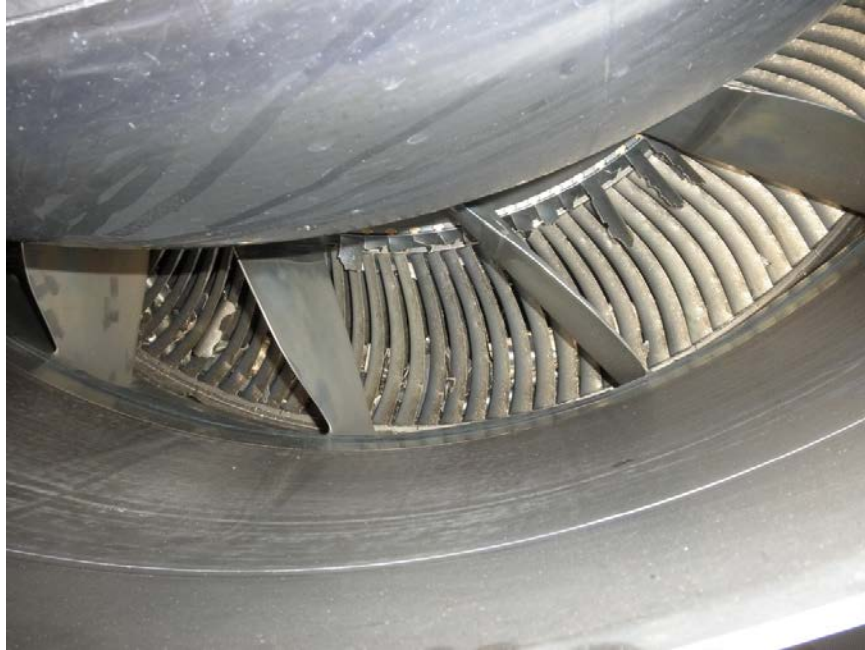
The LPT was inspected with a borescope through ports p, q, and r.<sup>18</sup> Because the LPT rotor could not be rotated, only a small portion of the rotor could be observed through each port. The LPT stage 1 blades that were visible did not have any apparent damage. The LPT stage 2 blades that were visible had portions of the trailing edge tip shroud corner and the outer span of the airfoil trailing edge missing and impact damage to the leading edges. The LPT stage 3, 4, 5, 6, and 7 blades that were visible were broken at various lengths above the blade root platform. The LPT stage 2 nozzles that were visible were intact. The LPT stage 3 nozzles that were visible were had nicks and dents on the airfoil surfaces. Where the LPT stage 4 and 5 nozzles should have been visible, the nozzles were missing. The LPT stage 6 and 7 nozzles that were visible were in place, but the airfoils were heavily battered. On each LPT stage inspected, there was a large gap between the rear of the nozzle platform and the angel wing on the front of the blade. There was no gap between the blades' trailing edges and the front of the next nozzle segment and the edges between the two were heat discolored. There were broken airfoil and shroud segments laying in the bottom of the LPT case directly in front of the LPT stage 7 nozzles. (Photo No. 11)

Photo No. 11: View of LPT stage 7 nozzles showing broken airfoil pieces in front of the nozzle airfoils and broken LPT stage 7 blades.

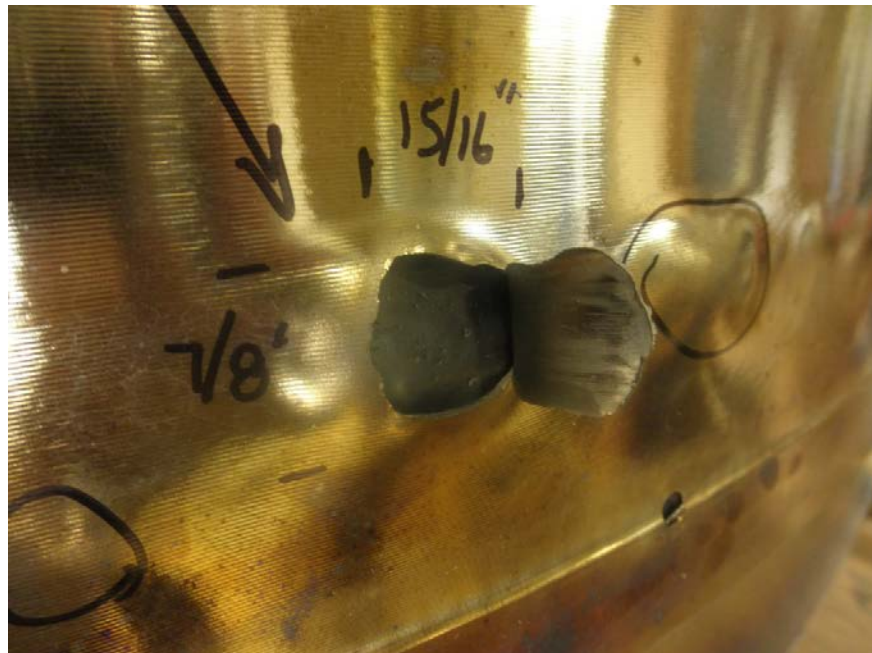
The LPT case was intact. (Photo No. 15) The exterior of the LPT case had numerous outward dents around its circumference in the plane of the LPT stage 6 rotor between about 4.5- and 6-inches forward of the rear flange. The LPT case had an approximately 0.94-inch wide circumferential by an approximately 0.88-inch long axial hole with a tab of metal bent up on the counterclockwise side of the hole at about 12 o'clock, 5-inches forward of the rear flange. (Photo No. 16) The OD of an LPT stage 6 shroud was visible through the hole. There was an approximately 0.25-inch long split at about 2 o'clock, about 4.63-inches forward of the rear flange and an approximately 0.5-inch split at about 6 o'clock, about 5.63-inches forward of the rear flange. (Photos Nos. 17 and 18, respectively)

Photo No. 16: Close up of hole in LPT case.

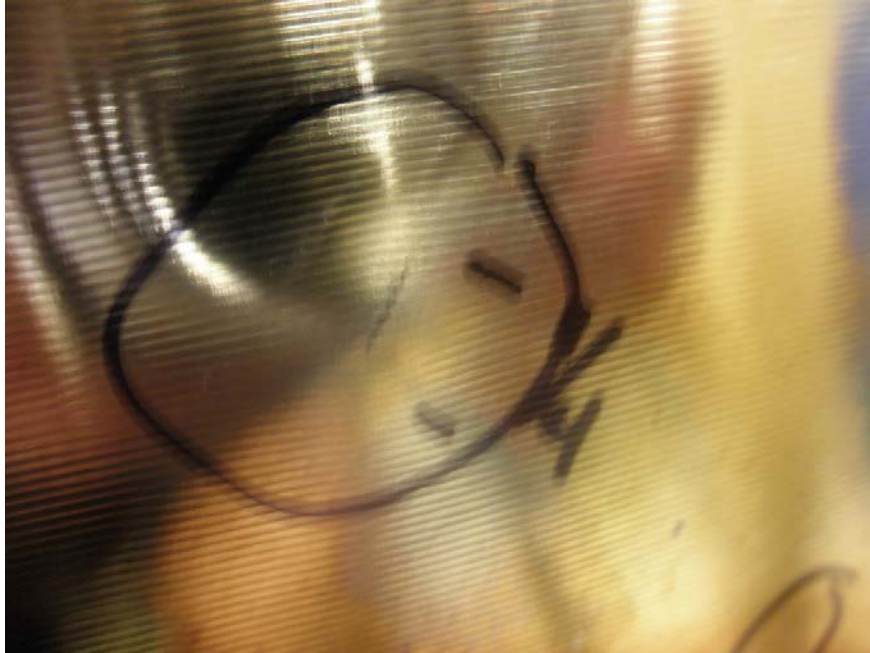
Photo No. 17: Close up of approximately 0.25-inch long split in LPT case at about 2 o'clock.

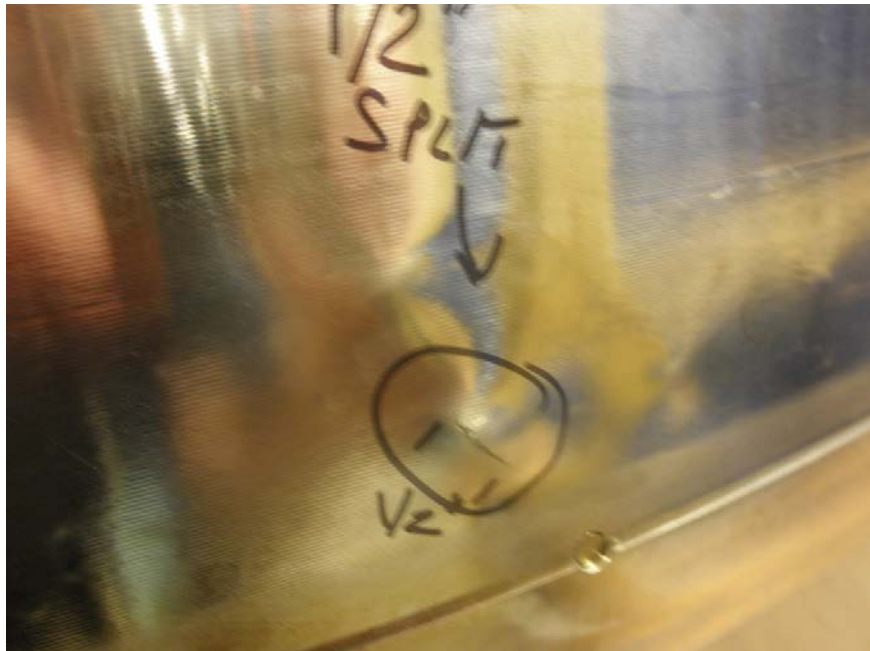
Photo No. 18: Close up of approximately 0.5-inch long split in LPT case at about 6 o'clock.

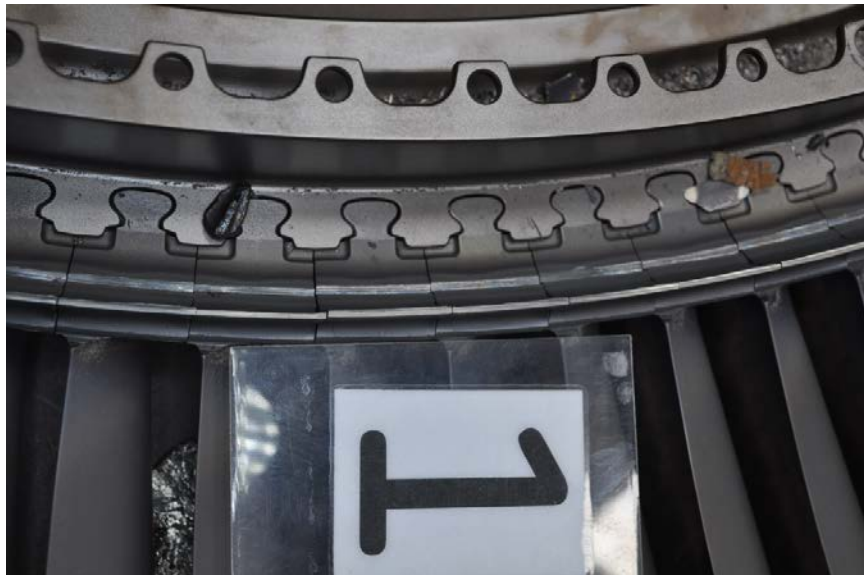
The LPT stage 1 disk was intact. The LPT stage 1 blades were all in place and there was no apparent damage to the airfoils. (Photo No. 19) The aft edge of the LPT stage 1 blades' angel wings were against the front of the LPT stage 2 nozzle support front face. The LPT stage 1 blades' angel wings had heat discoloration along the aft edge that corresponded to the circumferential rub mark on the front face of the LPT stage 2 nozzle support. The rear face on all of the LPT stage 1 blades had a circumferential rub mark with heat discoloration that corresponded to the circumferential rub marks on the forward flow guide on the LPT stage 2 nozzles. (Photo No. 20)

Photo No. 20: Close up view of rear of LPT stage 1 blade roots showing circumferential rub marks on rear face of blade root and on edge of rear angel wing. (GE)

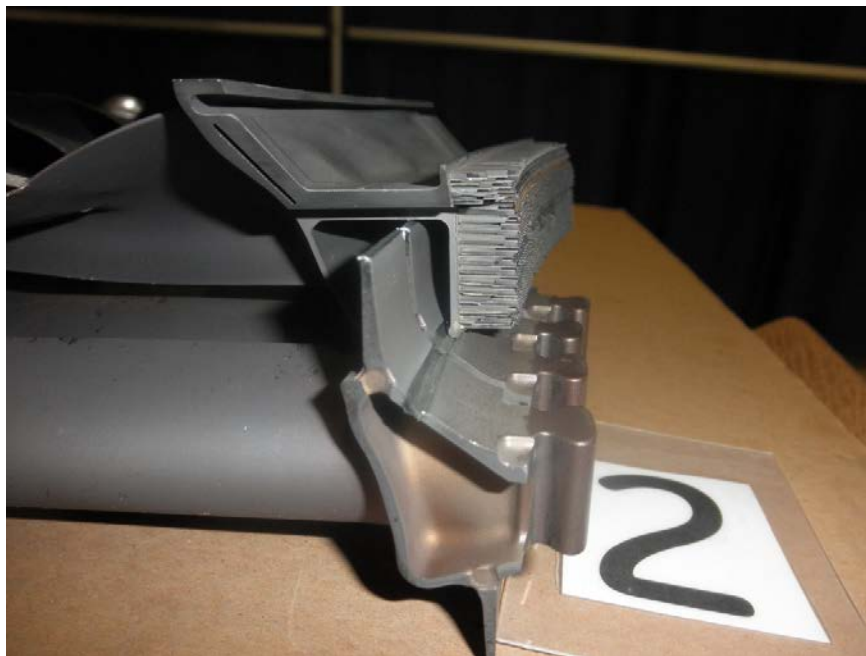
The LPT stage 2 disk was intact. The LPT stage 2 blades were all in place. (Photo No. 22) There were two LPT stage 2 blades that were fractured across the airfoil about 5 inches above the blade root platform and were missing the tip shroud. All of the LPT stage 2 blades had the blade tip trailing edge corners missing. All of the LPT stage 2 blades had minor nicks and dents on the suction side<sup>21</sup> of the blade. All of the LPT stage 2 blades had a circumferential groove in the rear face of the blade root and in the airfoil at the trailing edge fillet radius that corresponded to the circumferential rub marks on the front face of the LPT stage 3 nozzle honeycomb support and the front face of the nozzle inner platform, respectively. All of the LPT stage 2 blades aft angel wings had circumferential rub marks that corresponded to the circumferential rub marks on the front face of the LPT stage 3 nozzle honeycomb support. (Photo No. 23)

Photo No. 23: Close up view of LPT stage 2 blades and stage 3 nozzles showing contact points that corresponded with circumferential rub marks on each piece.

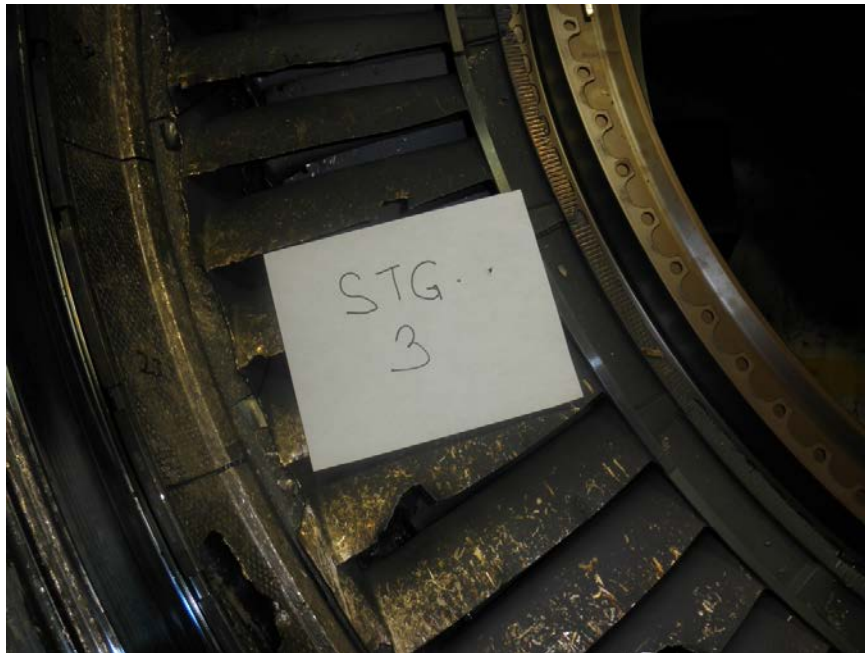
All of the LPT stage 3 nozzles were in place in the LPT case. (Refer to Photo No. 25)  
All of the LPT stage 3 nozzle airfoils had nicks and dents on the convex side. (Photo No. 24)  
There were several randomly located LPT stage 3 nozzles that had sections up to about 2.25-inches long radial by about 1.25-inches wide axial missing from the trailing edge.

Photo No. 24: Close up view of LPT stage 3 nozzles showing impact on suction side of airfoils.

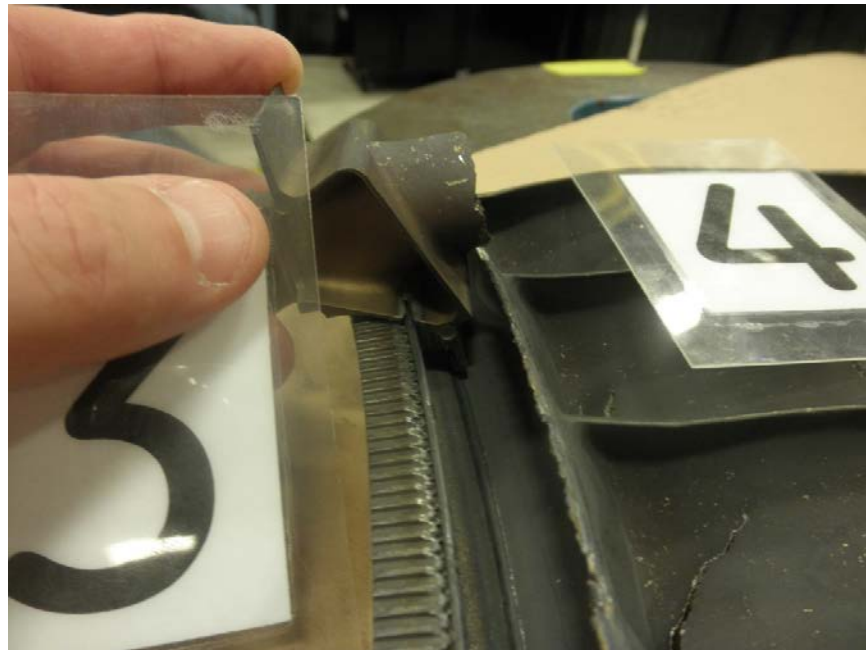
The LPT stage 3 disk was intact and did not have any apparent damage. All of the LPT stage 3 blade roots were in place in the disk. All of the LPT stage 3 blades except one were fractured transversely across the airfoil adjacent to the blade root platform. (Photo No. 25) There was one LPT stage 3 blade that was fractured across the airfoil about 1.5-inches above the blade root platform. The suction side of that airfoil had nicks and dents. The rear face of all of the LPT stage 3 turbine blade roots had an approximately 0.13-inch wide circumferential groove on the rear face that cut through the skirt. There was also a groove on the trailing edge that corresponded to the circumferential rubmarks on the LPT stage 4 nozzle honeycomb support. (Photo No. 26)

Photo No. 26: Close up view of LPT stage 3 blade and stage 4 nozzle showing contact points that corresponded to rub marks on each component.

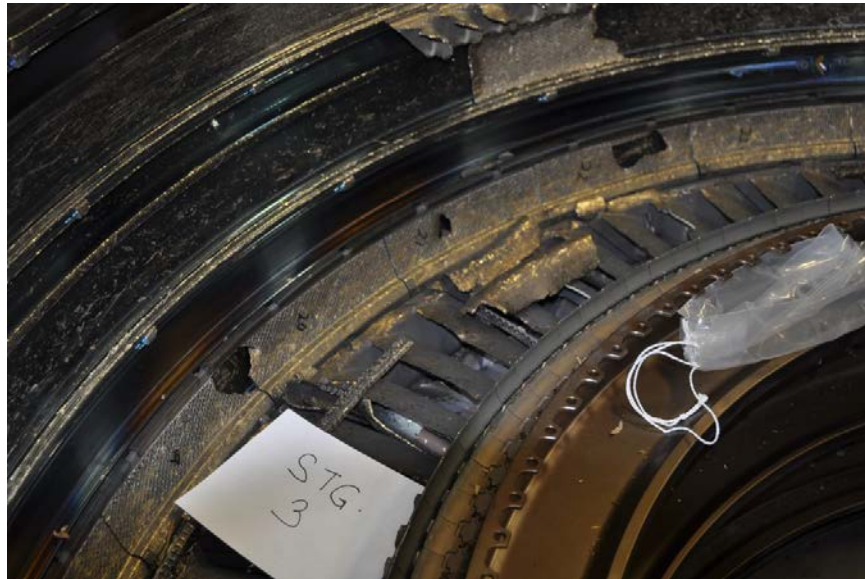
All of the LPT stage 3 shroud segments were in place. The honeycomb on the LPT stage 3 shroud segments was rubbed down to the base metal. There were four holes in the LPT stage 3 shroud segment backplates: an approximately 2.75-inch by 1.25-inch hole at about 2 o'clock, an approximately 1.75-inch by 1.25-inch hole at about 8:30 o'clock, an approximately 1-inch by 1-inch hole at about 9 o'clock, and an approximately 2.75-inch by 1.25-inch hole at about 10 o'clock. (Photo No. 27)

Photo No. 27: Close up view of LPT stage 3 shroud segments showing holes through several segments.

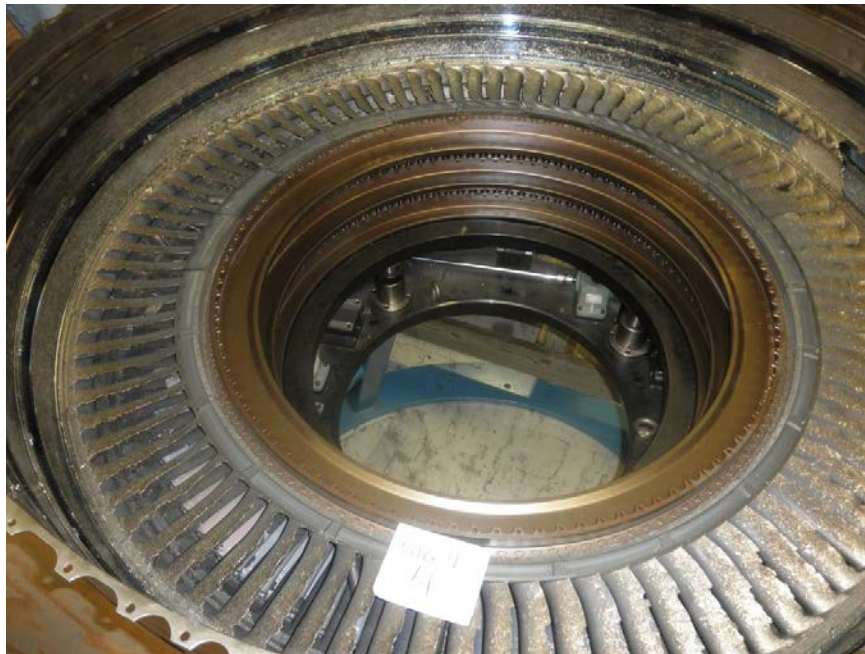
Photo No. 28: View of LPT stage 4 nozzles showing all are in place. Also shown are the LPT stage 4 shroud segments showing all are missing except one and the LPT stage 5 nozzles showing that all are missing except one platform hook.

All of the LPT stage 4 shroud segments except one at about 9 o'clock were missing. The shroud segment that remained had the honeycomb material rubbed down to the backplate. (Refer to Photos Nos. 28 and 29)

All of the LPT stage 5 nozzles except one were missing from the LPT case. There was one platform hook of an LPT stage 5 nozzle segment with the airfoils fractured at the fillet radius at about 10 o'clock. (Refer to Photos Nos. 28 and 29)

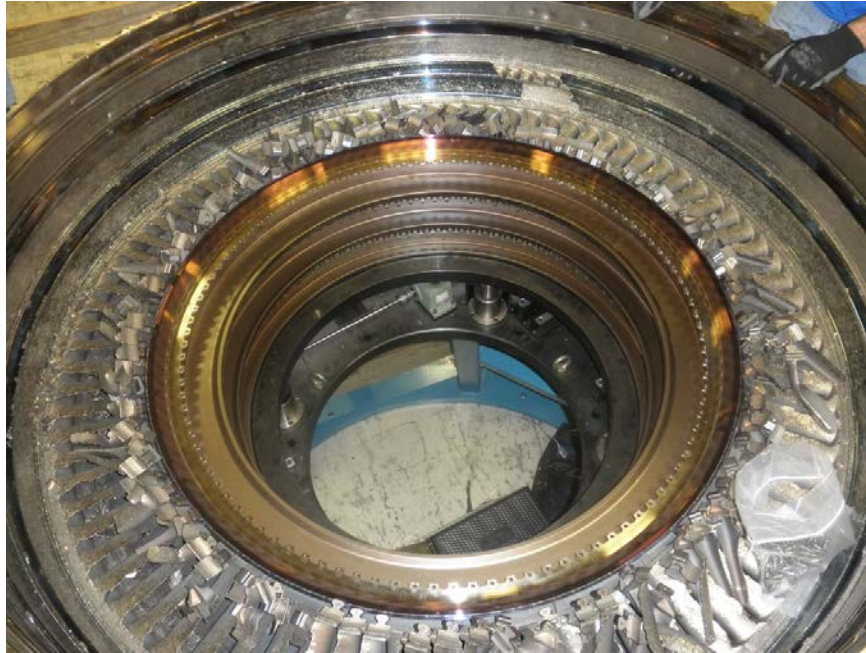
The LPT stage 4 disk was intact and did not have any apparent damage. All of the LPT stage 4 blade roots were in place in the disk. All of the LPT stage 4 blades were fractured across the airfoil between approximately 0.25- and 6.25-inches above the blade root platform. (Photo

No. 29) All of the longer blades had nicks and dents on the convex airfoil surface. Many of the longer blades were bent opposite the direction of rotation. The aft angel wings on all of the LPT stage 4 blades had circumferential rub marks, heat discoloration, and material displacement.

Photo No. 29: View of LPT stage 4 disk showing it is intact. (All of the LPT stage 4 blades had fallen out of the disk while the rotor was being disassembled.) Also shown is all of the LPT stage 4 LPT shroud segments missing except one and all of the LPT stage 5 nozzles missing except one. Also shown is all of the LPT stage 5 shroud segments missing.

All of the LPT stage 5 shroud segments were missing and there were impact and scuff marks 360° around the inside of the LPT case where the stage 5 shroud segments would have been. (Refer to Photo No. 29)

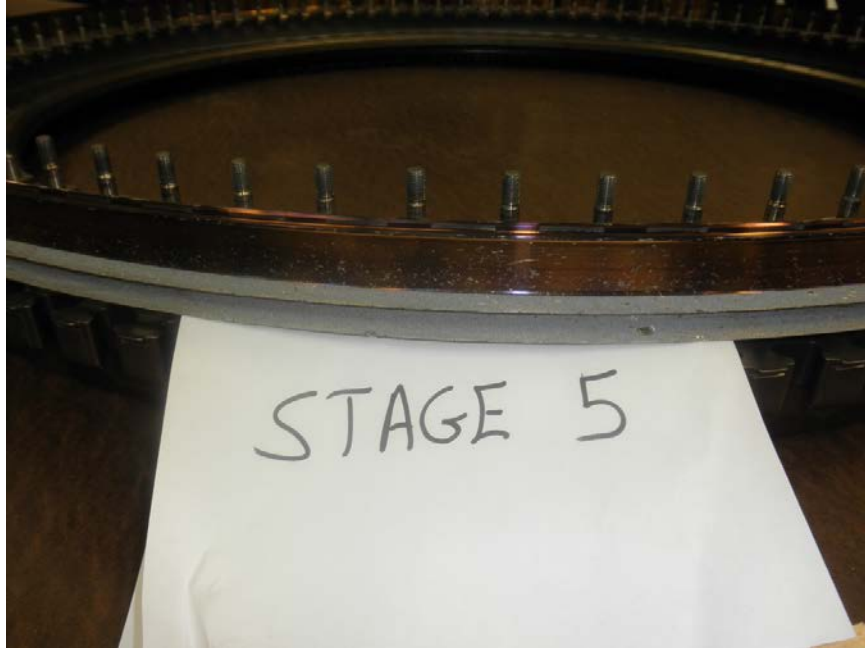
The LPT stage 5 disk was intact. The OD surface of LPT stage 5 disk had numerous nicks. The knife edge seals were still in place, but there were chips in the coating. (Photo No. 30) All of the LPT stage 5 blade roots were in place in the disk. All of the LPT stage 5 blades were fractured across the airfoil at varying heights from just above the blade root platform to about 2.5-inches above the blade root platform. The LPT stage 5 turbine blade airfoils that remained had numerous nicks and dents primarily on the convex side of the airfoil.

Photo No. 30: Close up of LPT stage 5 disk showing impact marks on outer diameter and chips on coating on knife edge seals.

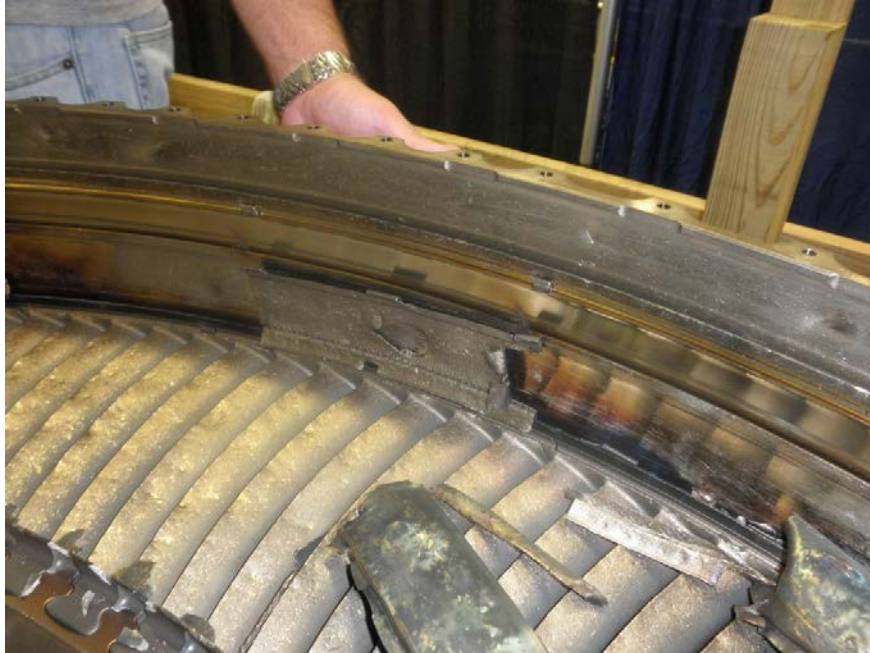
Photo No. 31: View of LPT stage 6 LPT nozzles showing battered airfoils.

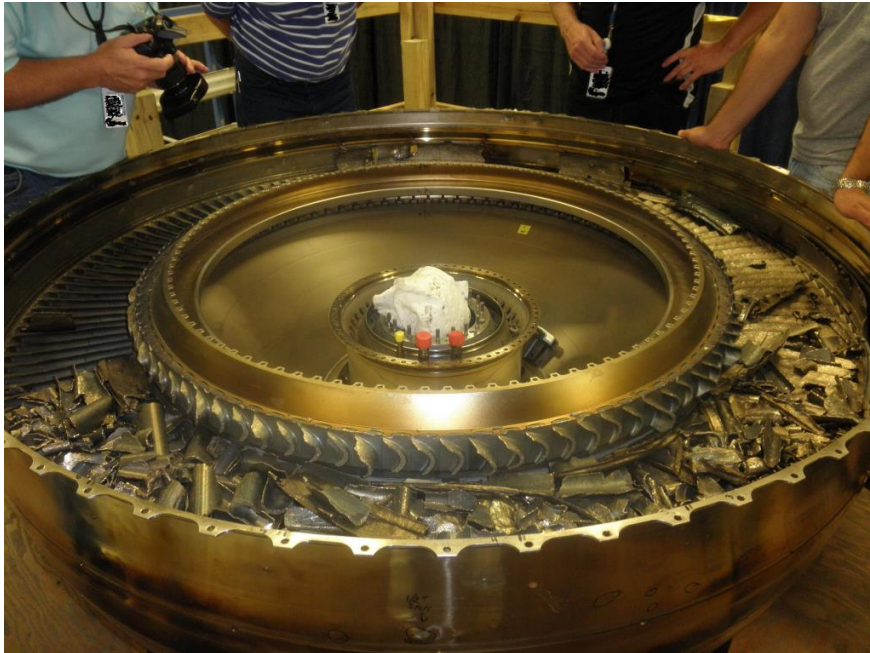
The LPT stage 6 disk was intact. The front face and arm and the rear face of the LPT stage 6 disk did not have any impact marks, but the OD of the aft conical arm had several randomly located impact marks. All of the LPT stage 6 blade roots remained in the LPT stage 6 disk. All of the LPT stage 6 turbine blades were fractured across the airfoil at varying heights from just above the blade root platform to about 1.25-inches above the blade root platform. (Photo No. 32)

There were three LPT stage 6 shroud segments in the LPT case at about 12, 5 and 7 o'clock. (Refer to Photo No. 32) The shroud segment at about 12 o'clock was over the hole in the LPT case, but the counterclockwise side of the shroud segment had a section missing that matched the shape of the hole in the case. (Refer to Photo No. 16) The honeycomb material was rubbed down to the backing plates.

Photo No. 32: View of LPT stage 6 showing the disk is intact and all of the blade roots are in place in the disk and the blades fractured at various lengths above the blade root platform. Also shown are some of the LPT stage 6 shrouds that remained in the LPT case.

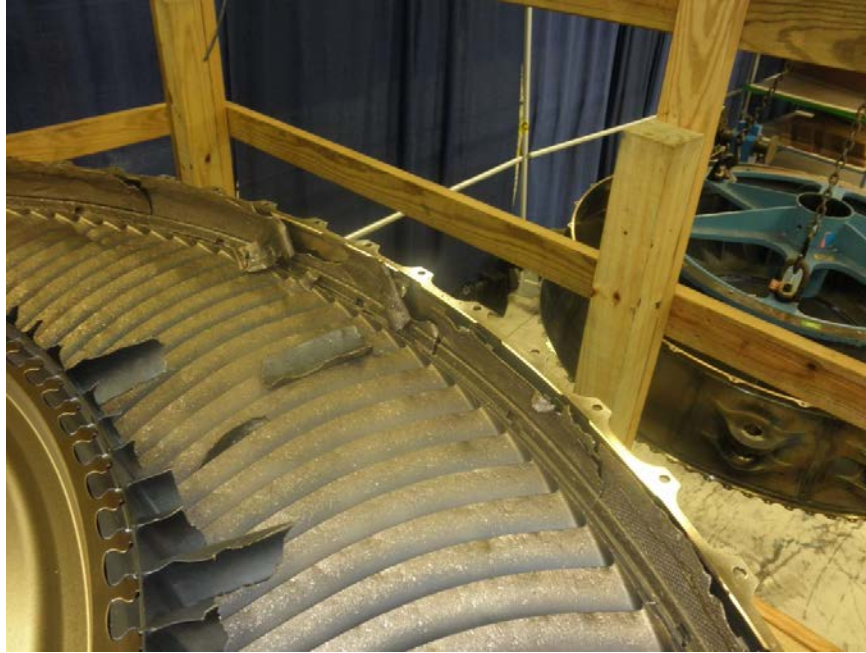
All of the LPT stage 7 nozzles were in place. All of the LPT stage 7 nozzles were battered with nicks and dents on the leading and trailing edges and on both sides of the airfoils. (Photo No. 33)

Photo No. 33: View of LPT stage 7 nozzles showing battered airfoils. Also shown are the LPT stage 7 shrouds in place in the case with the honeycomb rubbed down to the backing plate.

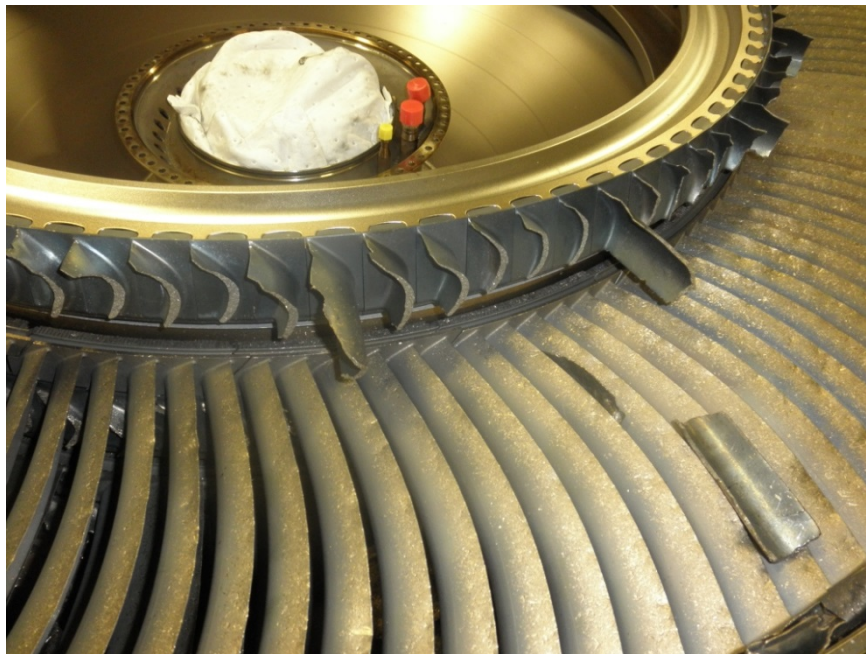
The LPT stage 7 disk was intact. The rear face of the LPT stage 7 disk did not have any rub marks or impact marks. All of the LPT stage 7 blades were in place, but all of the LPT stage 7 blades were fractured across the airfoils at varying heights from adjacent to the blade root platform to up to about 4 inches above the blade root platform. (Photo No. 34)

Photo No. 34: View of LPT stage 7 disk showing it is intact and that all of the blades are in place, but fractured at various lengths above the blade root platform.

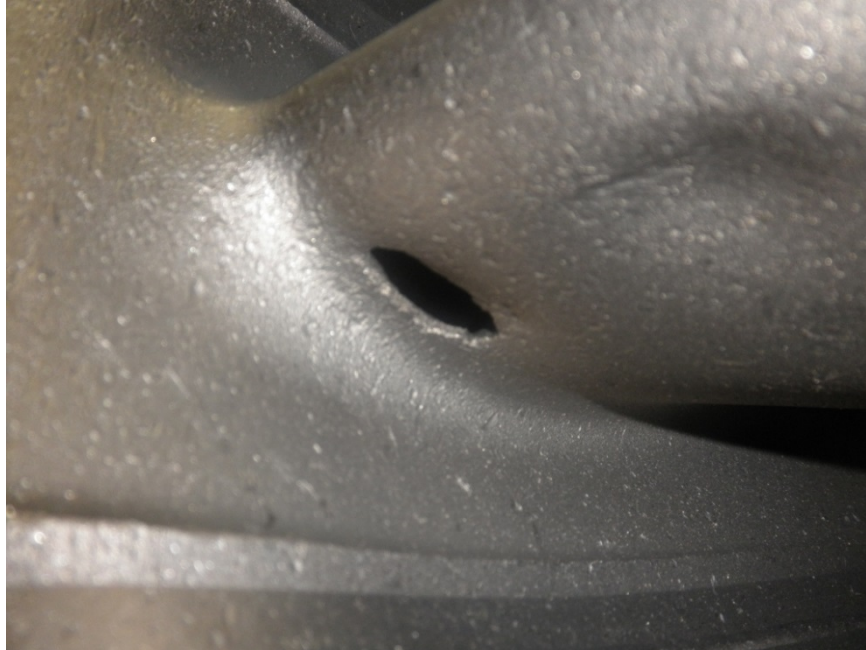
The TRF was intact. (Photo No. 35) The inner diameter of the outer case had numerous nicks and dents. All of TRF struts were in place and there were no visible cracks on the inner or outer ends of the struts where they join with the inner duct or outer case, respectively. All of the struts had numerous nicks and dents, primarily on the convex side. There was one strut, strut No. 5<sup>22</sup> at about 3:30 o'clock, that had an approximately 0.25-inch wide radial by 0.88-inch long axial hole about 0.63-inches aft of the leading edge adjacent to the outboard fillet radius. (Photo No. 36)

Photo No. 36: Close up view of hole in turbine rear frame strut.

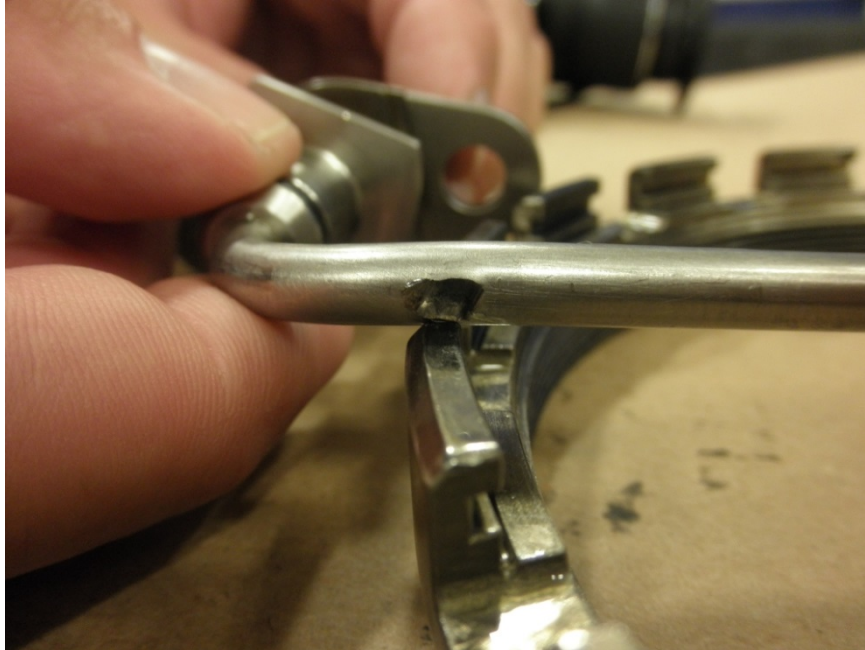
The No. 5 bearing oil jet tube had a 0.13-inch wide groove on the forward side that corresponded to the impact marks on the corner of the No. 5 bearing retaining nut wrenching lugs. (Photos Nos. 37 and 38, respectively) The No. 5 bearing oil jet tube was bent rearward. The No. 5 bearing oil jet tube was cracked at the base.

Photo No. 37: Close up of groove in side of No. 5 bearing oil jet that corresponded to the No. 5 bearing retaining nut wrenching lugs.

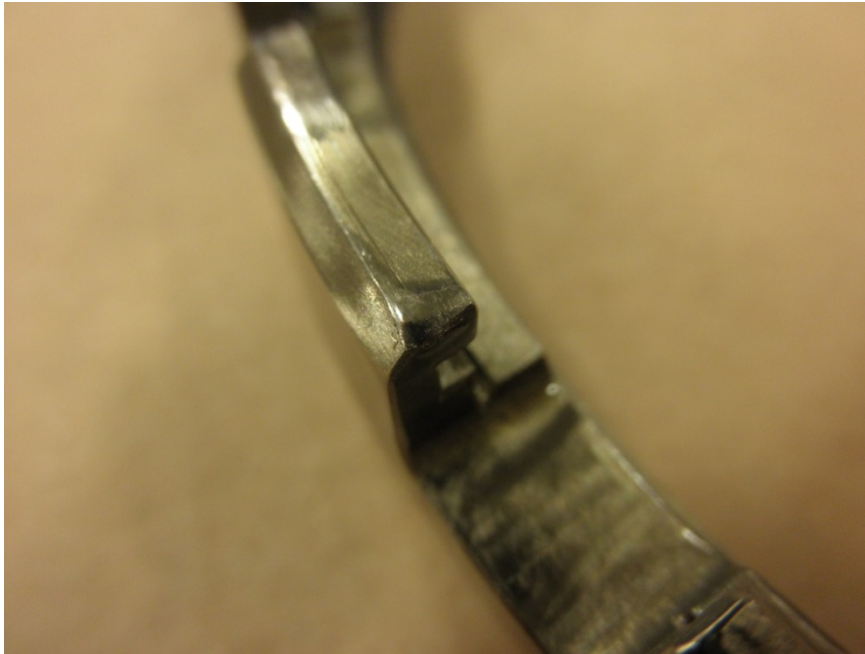
Photo No. 38: Close up of impact mark on No. 5 bearing retaining nut wrenching lug.

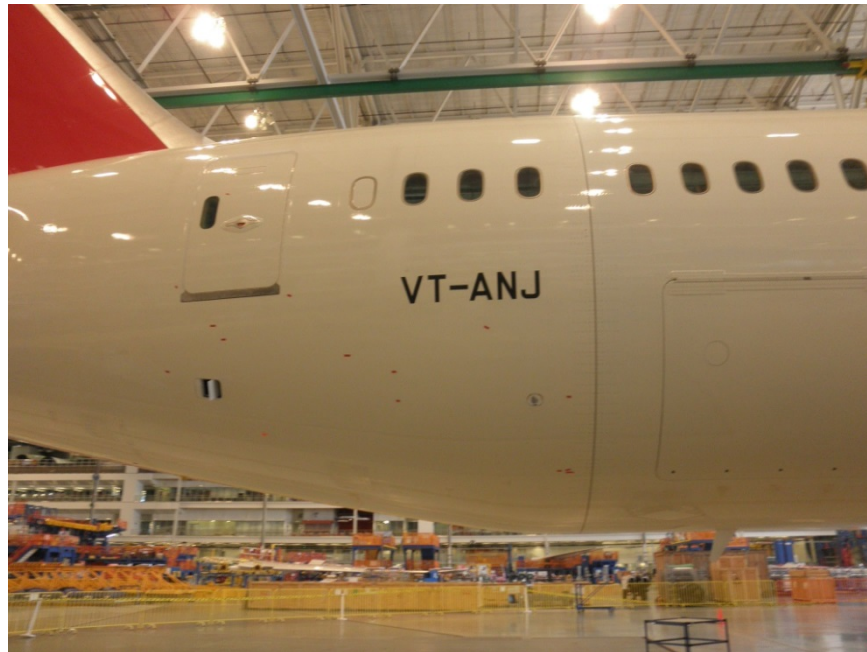
The right side of the fuselage from just aft of the aft cargo door to just aft of the aft cabin door below the cabin floor level had numerous impact marks. There was one impact mark on the aft cabin door slightly above and in front of the window. (Photo No. 39)

Photo No. 39: View of right side of aft fuselage with red tape showing impact marks.

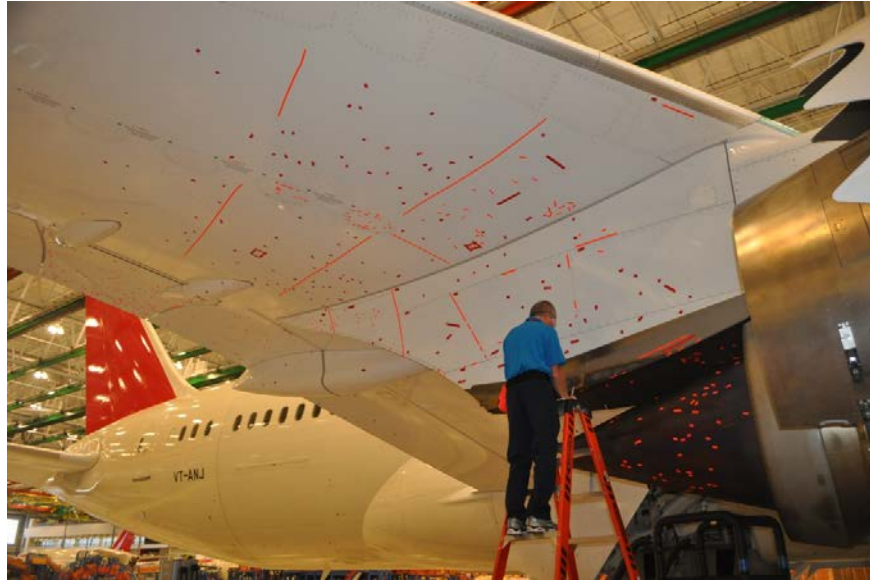
longitudinal; towards that aft end. The inboard aileron and outboard flap had several impact marks. (Photo No. 40)

Photo No. 40: View of underside of right wing aft of engine showing impact marks marked with red tape. Also shown is outboard side of right engine's pylon showing impact marks marked with red tape. (GE)
