# NATIONAL TRANSPORTATION SAFETY BOARD

## MATERIALS LABORATORY FACTUAL REPORT

Report No. 13-086

Place : Charleston, South Carolina  
Date : July 28, 2012  
Vehicle : Boeing 787-8, ZA238  
NTSB No. : DCA12IA114  
Investigator : Dave Helson, AS-10

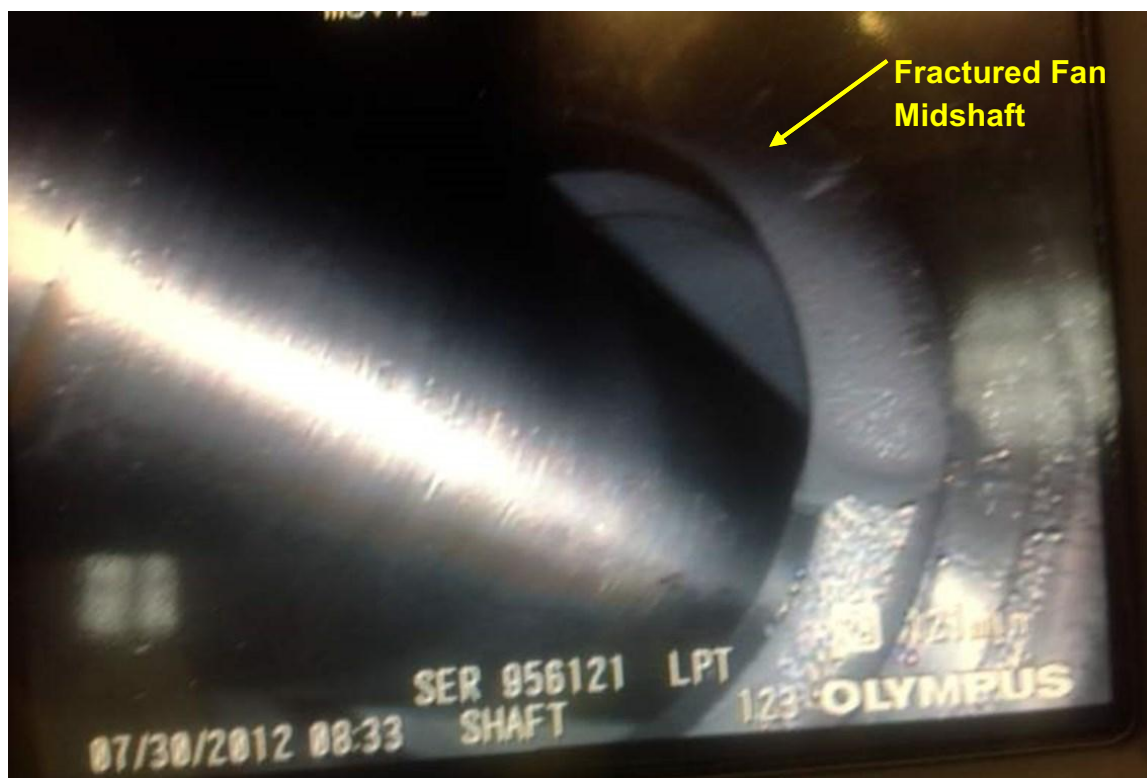
Borescope inspection of ESN 956-121 revealed a separation in the fan midshaft adjacent to the lock nut face as shown in Figure 2. Figure 3 shows the forward FMS fracture half with lock nut and center vent tube (CVT) assembly upon arrival at GE-Aviation. The FMS fracture and inside region of the FMS were still covered in engine oil. Examination of the FMS fracture revealed distinct color differences, consistent with multiple failure modes: one progressive and one instantaneous. The progressive

Figure 2 - Initial borescope image of fractured fan midshaft while inside the GENx engine (ESN 956-121), aft looking forward.

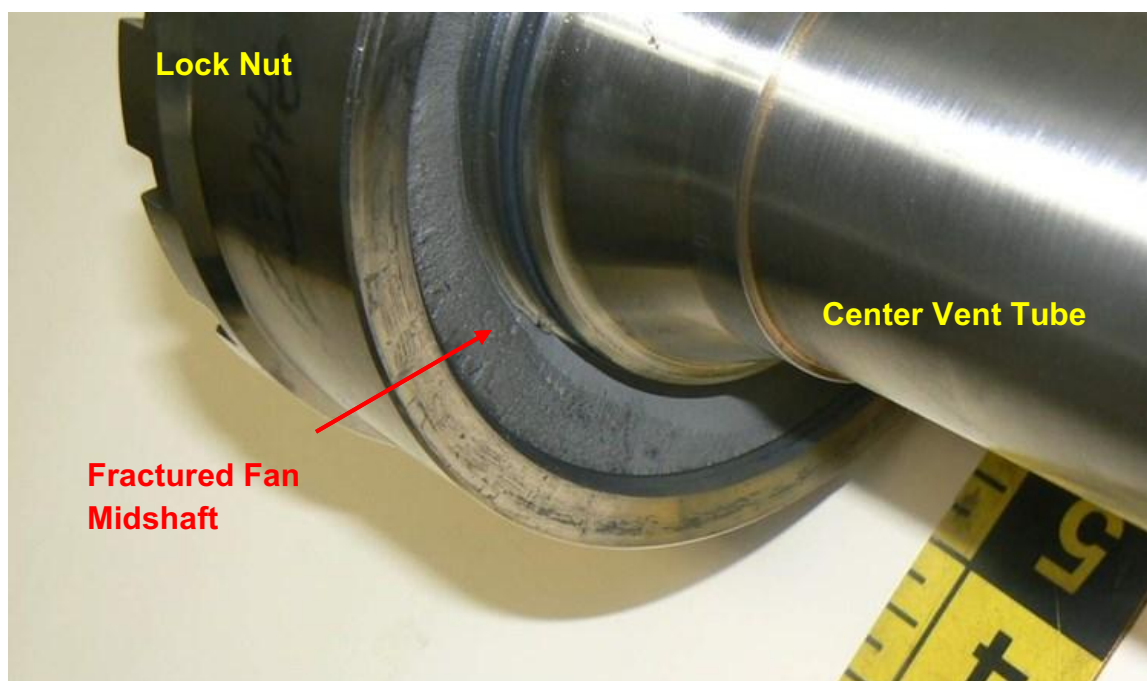
Figure 3 – Fracture surface of the forward segment of the fan midshaft, still held in the coupling nut.

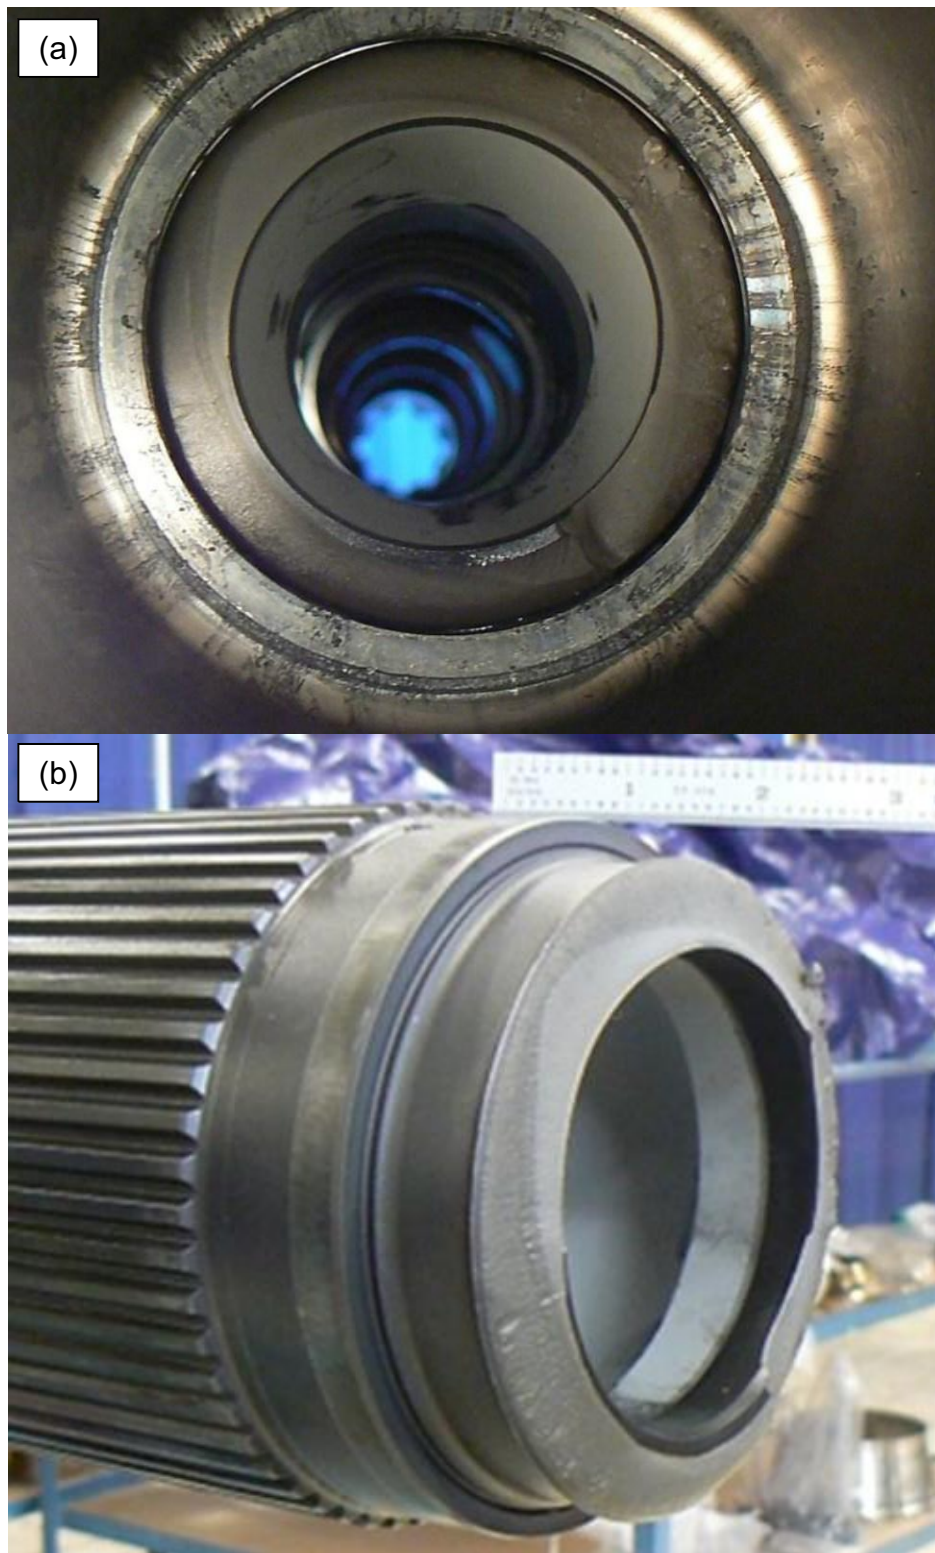
regions generally showed two separate origin regions, located approximately 180° apart.<sup>5</sup> The mating aft FMS fracture surface mirrored the pattern of the forward side (see Figure 4). The oil-covered aft fracture surface was rinsed with acetone, and the liquid was captured for further examination (see *Report 13-087*).

Figure 4 – The aft section of the fan midshaft, still inside the engine center after removal of the forward fan midshaft section and center vent tube (a) inside the engine and (b) after removal.

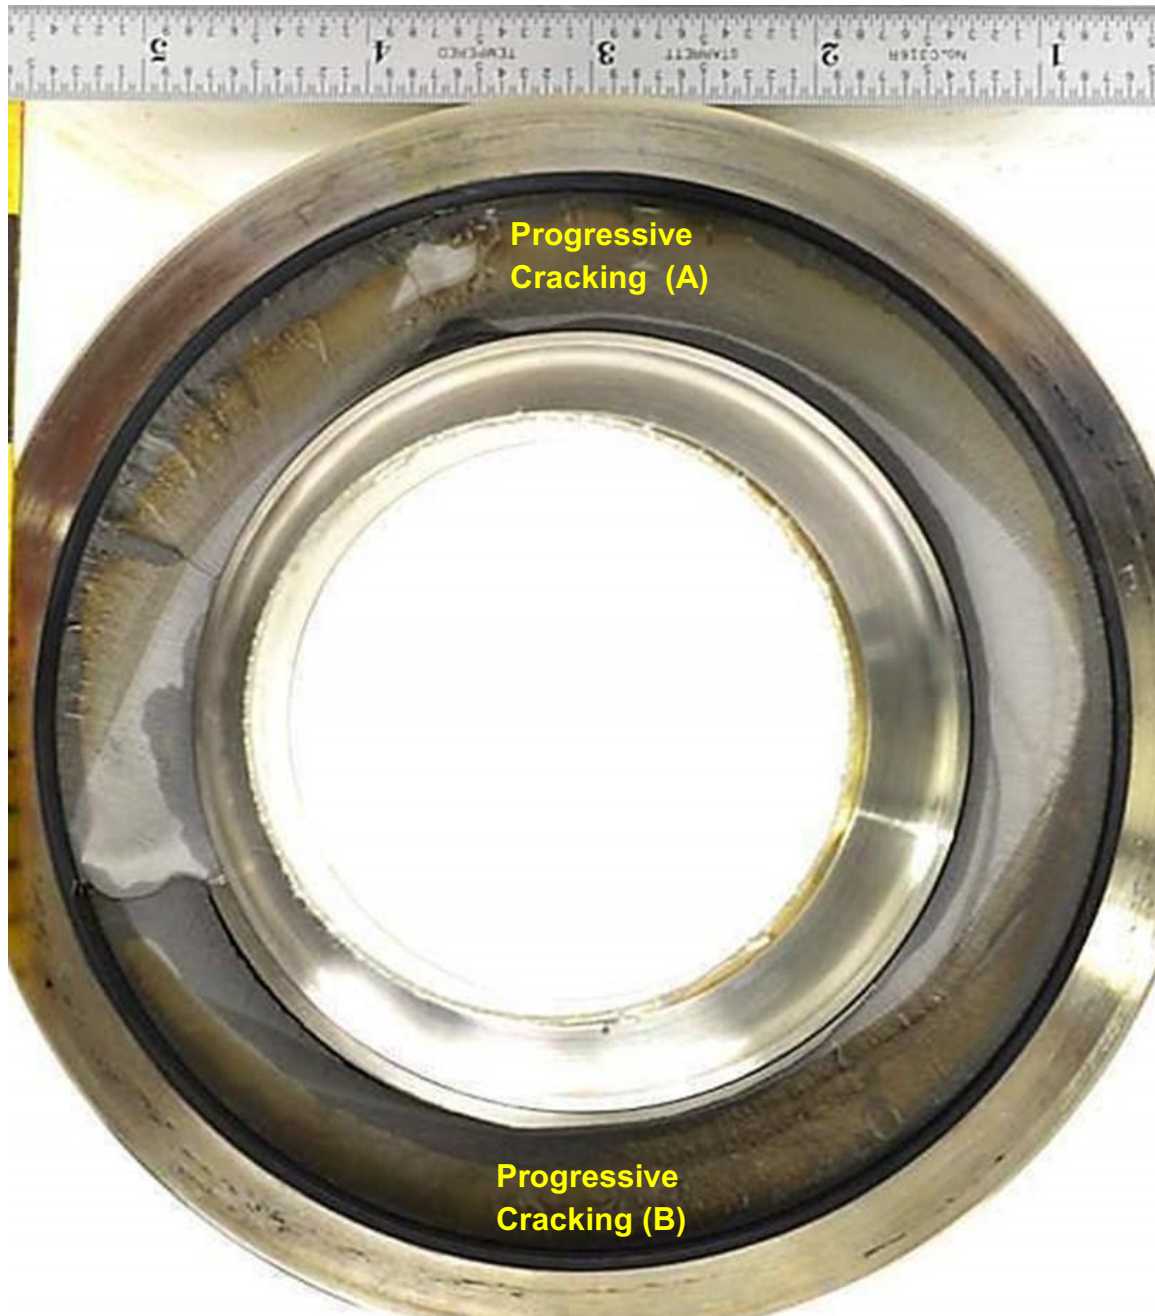
As shown in Figure 6, two fracture origins were identified on the FMS fracture surface—these origin regions were labeled A and B for the purpose of this investigation. This view shows the progressive fracture regions, which contained visible crack arrest and ratchet marks. Figure 7 and Figure 8 show the forward FMS fracture segment after removal of the lock nut. The fracture emanated from the aft most thread root progressing primarily through the thicker (~0.6 inch) cross-section portion. After more extensive cleaning, the forward FMS fracture face showed a discolored region encompassing ~85% of the FMS cross-section (see Figure 9). Comparable fracture features were noted on the aft FMS fracture surface (see Figure 4).

Figure 6 – The fracture surface of the fan midshaft forward section, aft looking forward. The fracture surface shows features consistent of two modes of failure: one progressive and one overstress.

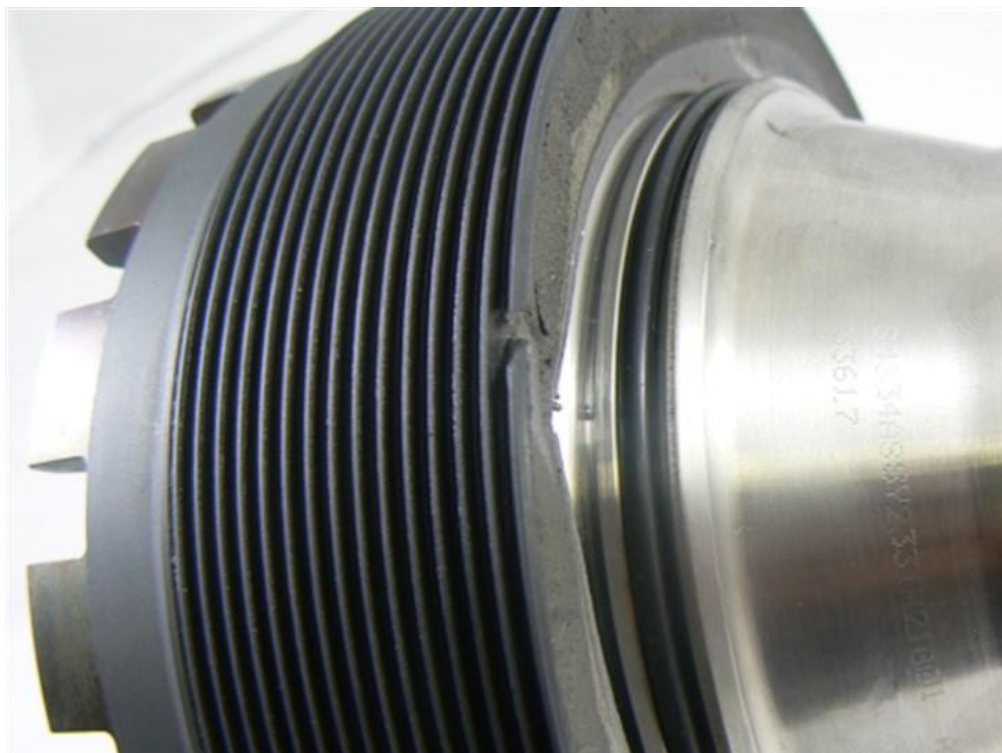
Figure 8 – The forward fan midshaft segment, showing a break in the aft most outer thread at the location of the fracture.

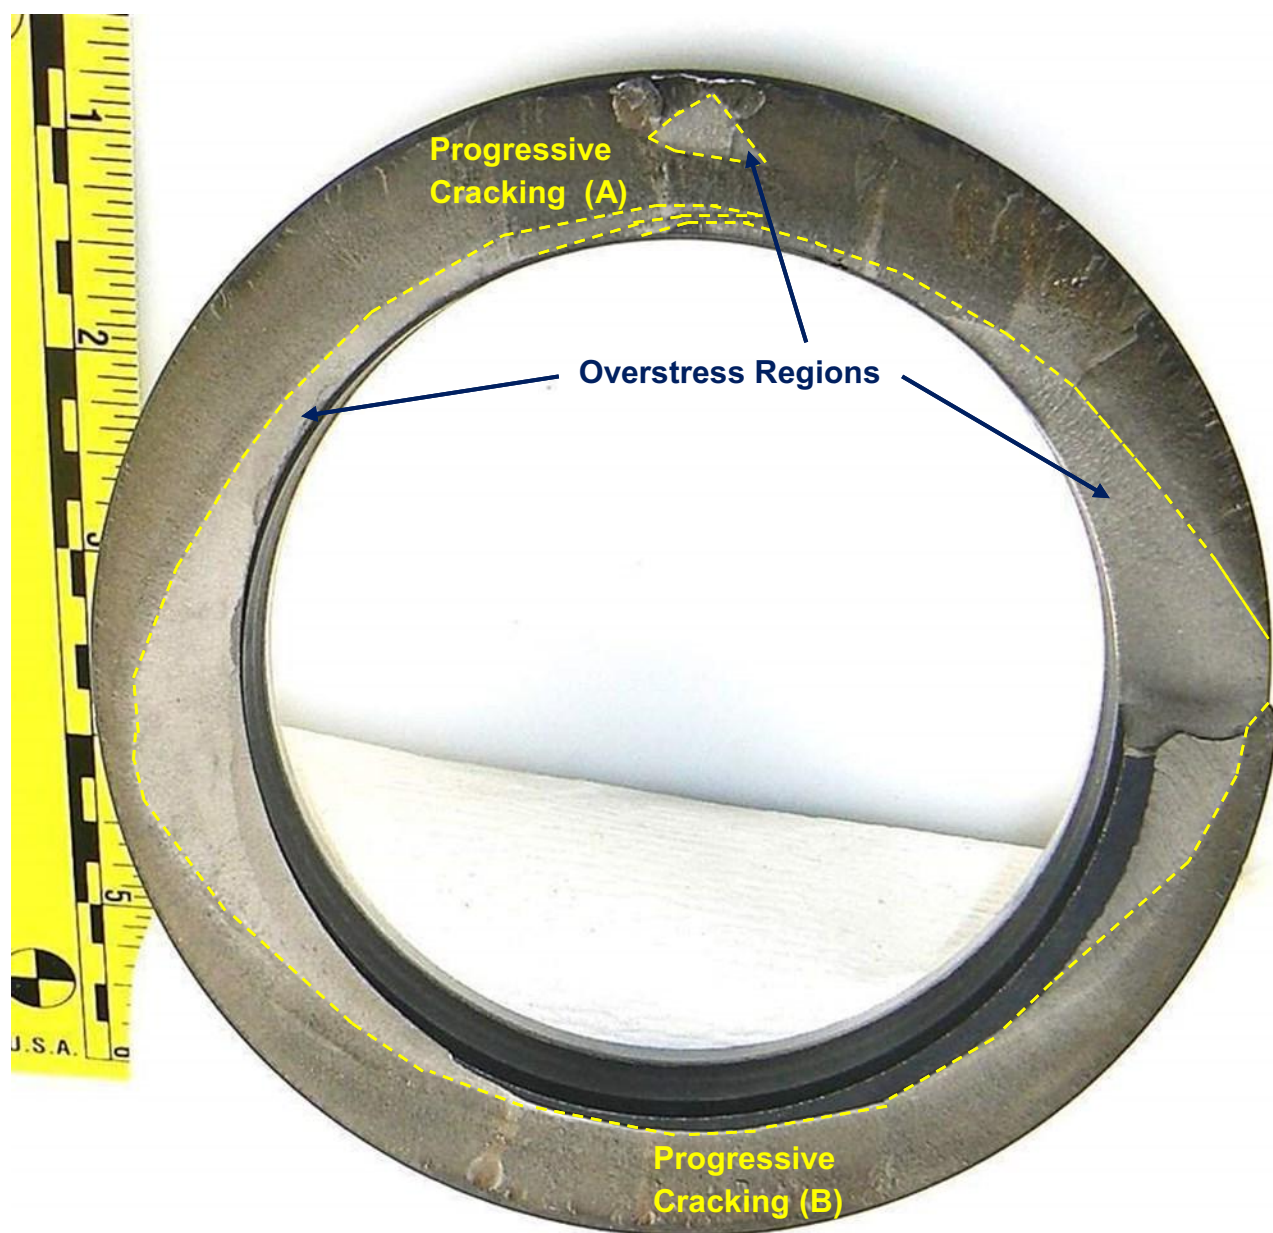
Figure 9 – The forward fan midshaft fracture surface, after removal of the lock nut and center vent tube. The different failure mode regions are identified, with the progressive regions labeled A and B.

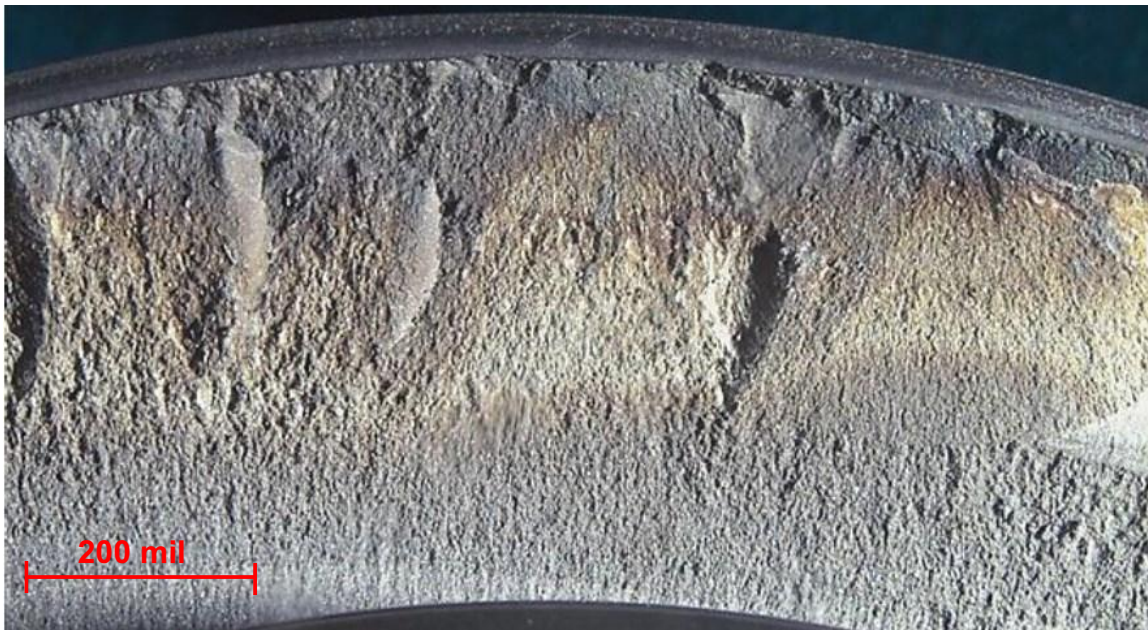
Closer views of the fracture highlighting numerous discolored, thumbnail-shaped sites at origin regions A and B are shown in Figure 10, Figure 11, and Figure 12. The average thumbnail region depth measured 0.062 inch in origin region A and 0.059 inch in origin region B. Greater discoloration present on progressive regions near the fracture origin regions was consistent with longer exposure times to the local environment in the thread root region. The thumbnail-shaped origin regions exhibited multiple crack arrest, or beach mark, features consistent with progressive crack growth. Crack arrest marks outside of the thumbnail appeared more widely spaced, consistent with a change in the crack growth rate.

Figure 10 – Thumbnail features on the fracture surface (after cleaning).

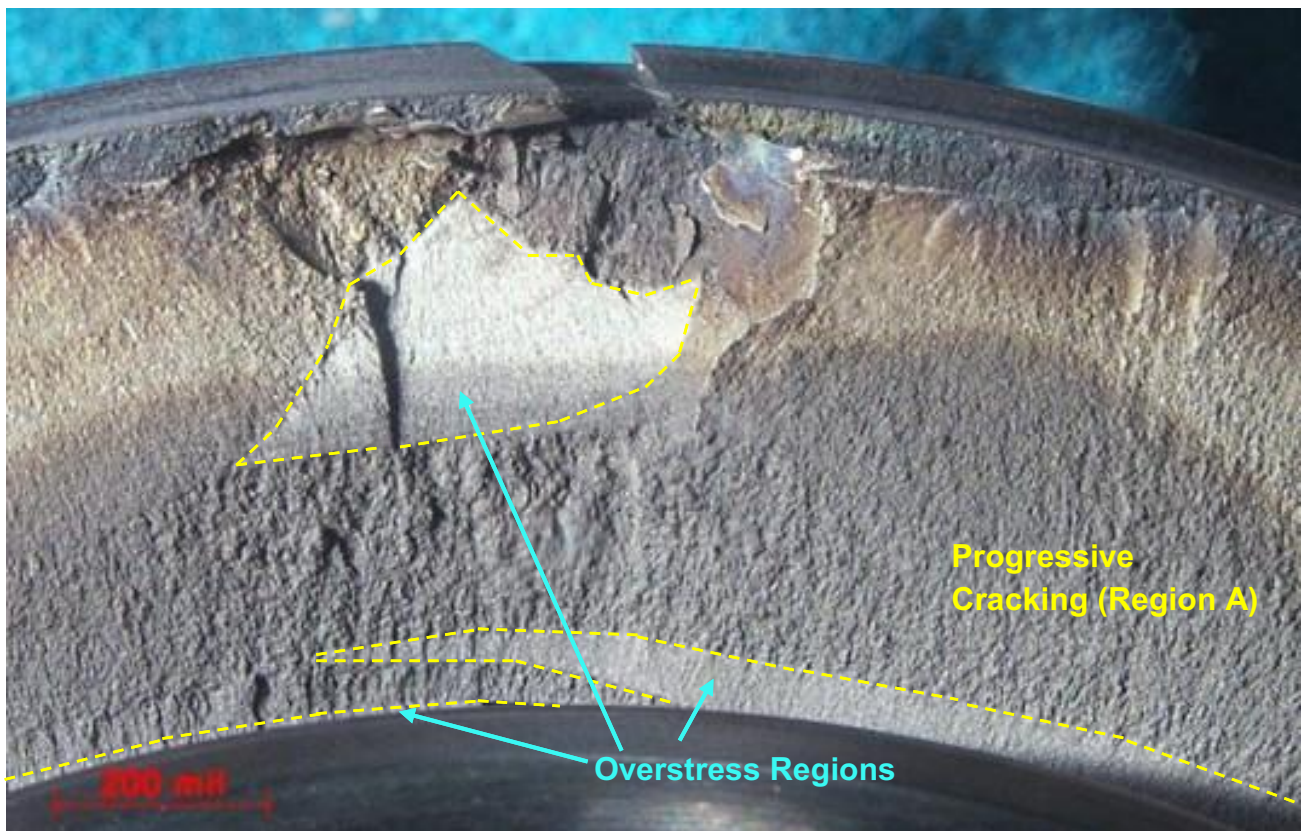
A distinct boundary was observed between the progressive EAC cracking and the triangular-shaped area shown in Figure 11 and Figure 12. Dimple rupture, consistent with failure by overstress, was seen within the triangular patch as shown in Figure 20. A continuation of the predominantly transgranular EAC fracture morphology, with an occasional smooth intergranular facet, was observed at areas inward of the triangular patch, as shown in Figure 21 and Figure 22. Distinct crack initiation sites were observed adjacent to the aftmost thread (see Figure 23 and Figure 24). The innermost regions displayed dimple rupture, consistent with instantaneous ductile overstress (Figure 25).

Figure 11 – Forward fan midshaft fracture surface near the aft broken thread, showing thumbnail, discoloring, and crack arrest features. These surrounded an area of rough, cleaner looking region inside of the fractured thread (before cleaning). The dashed lines represent the boundaries of the progressive cracking regions from the overstress regions.

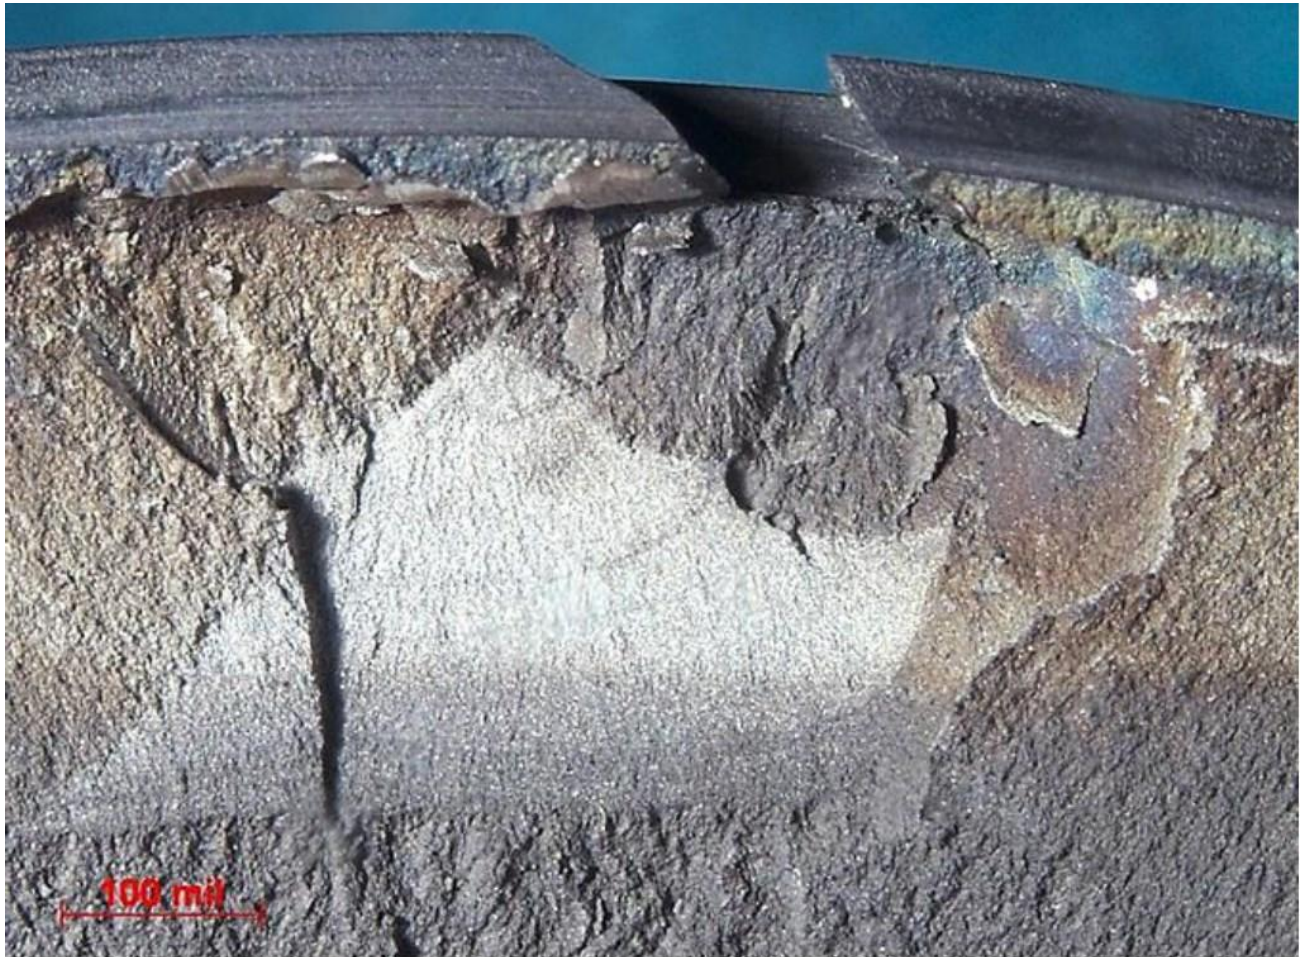
Additional views of origin region A are shown in Figure 12 and Figure 13. Cracking was also noted in the adjacent thread root along the circumferential direction of the root. As seen in Figure 13, this cracking resulted in liberation of a small thread fragment. Near this origin area for cracking region A, a triangular-shaped “island” was present bearing features consistent with the inner instantaneous fracture regions. As detailed in Section 3.3.2, this region was consistent with monotonically-increasing load to failure (overstress), as opposed to the surrounding progressive features.

Figure 12 – Closer look at the fracture surface from Figure 11.

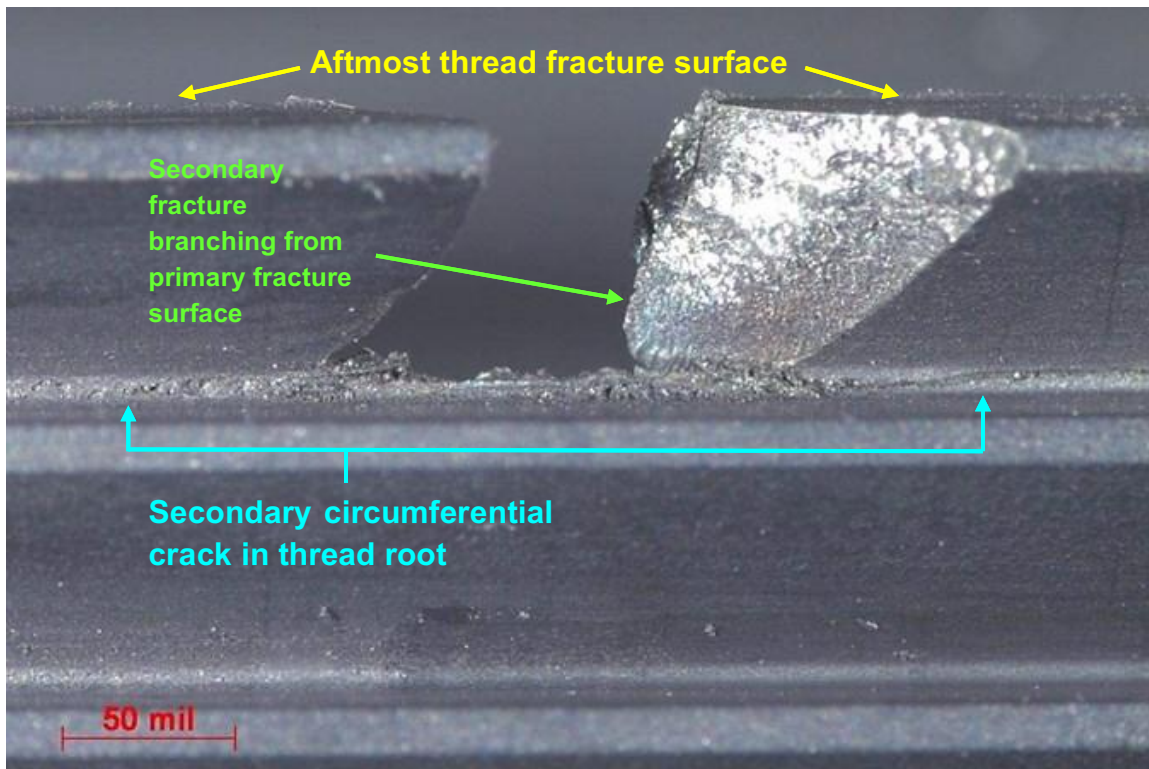
Figure 13 – View of the aft most fractured thread root, from above.

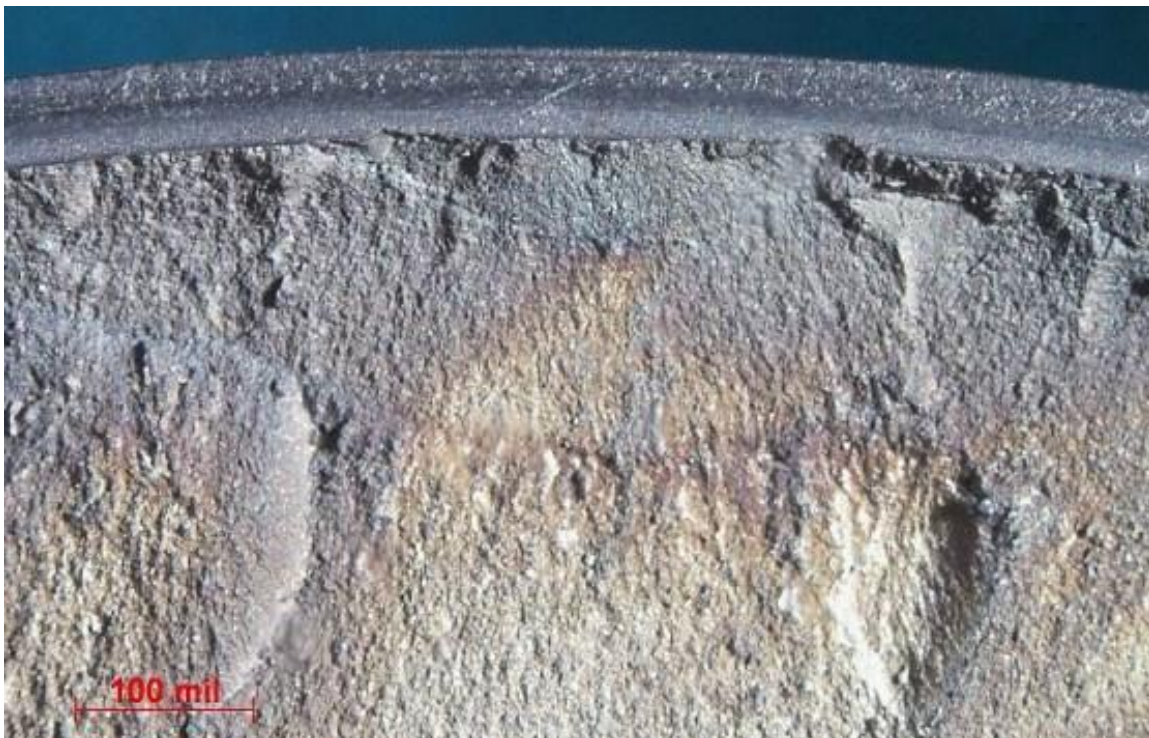
On the opposite side of the fracture (region B) away from the origin area of region A, other smaller thumbnail features emanating from the aft thread root were observed (see Figure 14 through Figure 16). Beach marks were more evident within the progressive region contrasted with the fracture outside of the thumbnail region. The presence of multiple ratchet marks around the periphery of the thumbnail region was consistent with later crack propagation from the thumbnail boundary.

Figure 14 – Closer view of the thumbnail feature near the thread root depicted in Figure 10a.

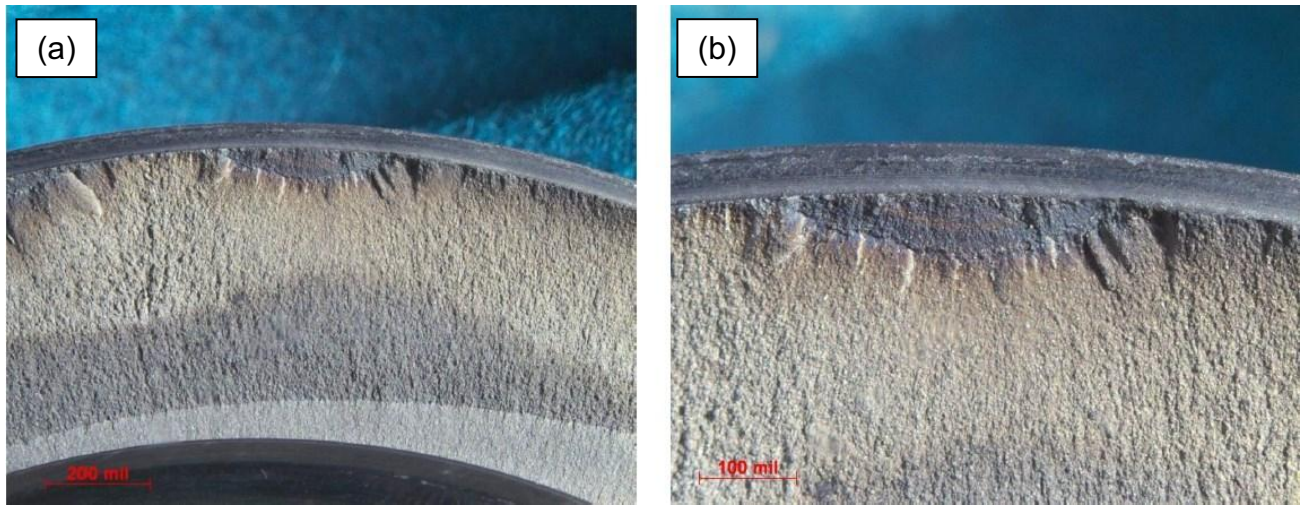
Figure 15 – Two other thumbnail features and discoloration approximately 180° away from the larger crack front on the forward fan midshaft fracture surface.

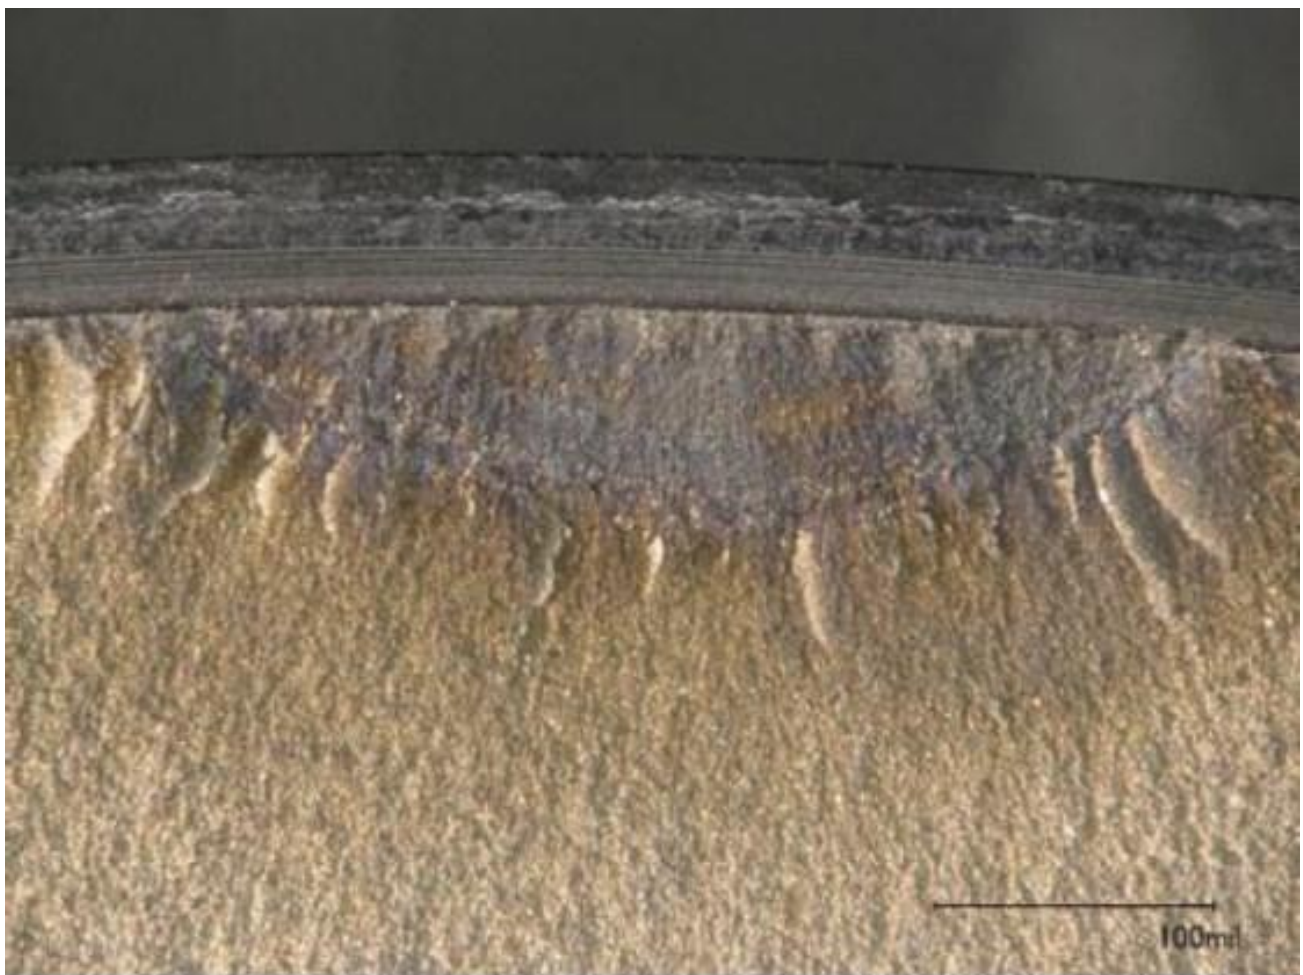
Figure 16 – Closer view of the thumbnail feature and discoloration in Figure 15b.

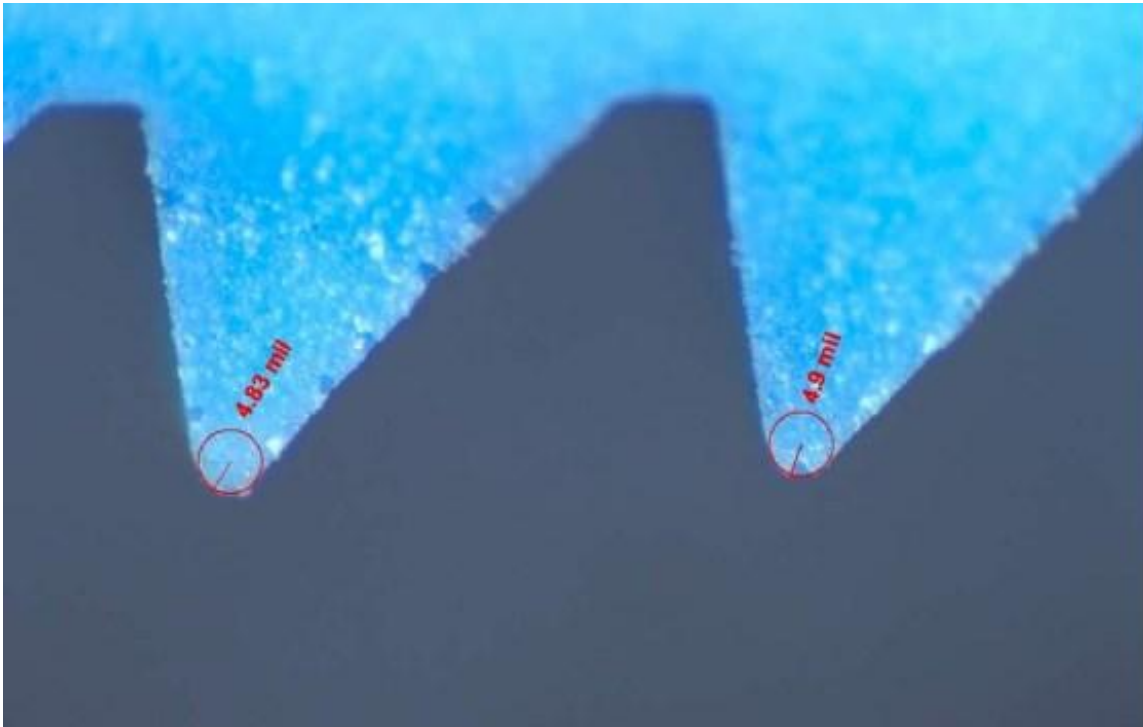
Replicating silicon rubber was used to evaluate the profile of the thread roots before destructive inspection. A cross-section of one area is shown in Figure 17. Initial thumbnail regions were angled at  $\sim 50\text{--}55^\circ$  with respect to the  $7^\circ$  thread flank angle. The deepest thumbnail shaped region associated with origin region A measured 0.075 inch. The radius of curvature of the thread roots was consistent with specification requirements.

Figure 17 – Cross-section a replica of the thread roots adjacent to the aft most thread (right), created to determine the minimum radius of the roots.

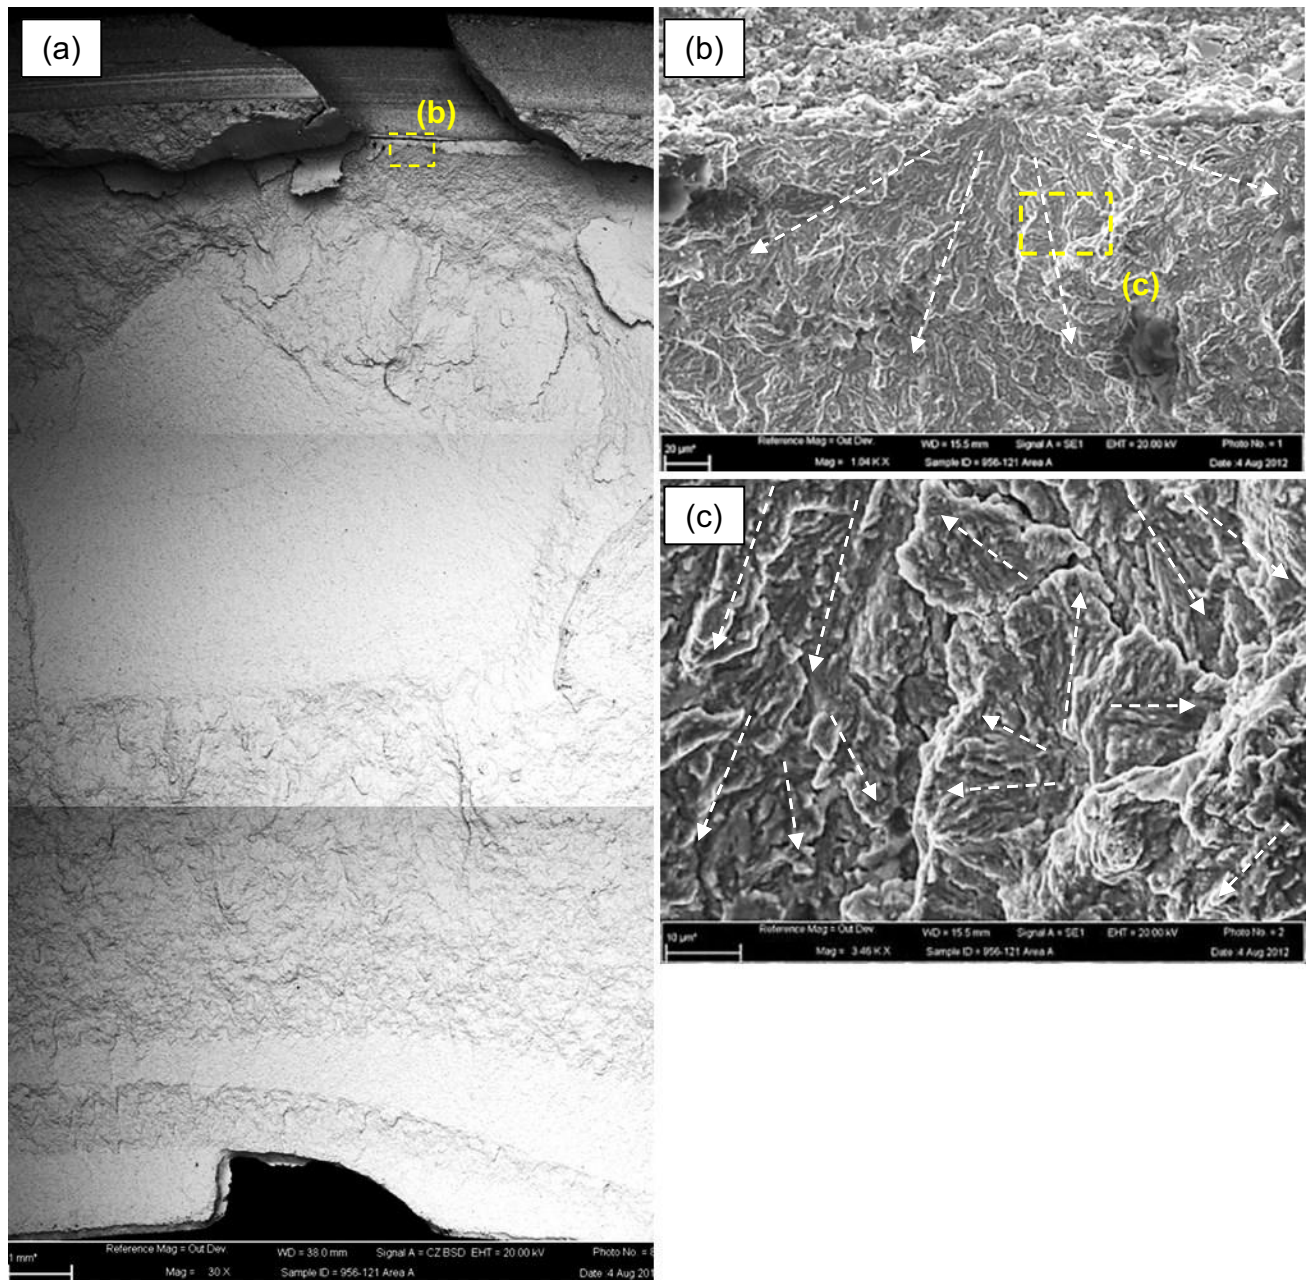
The forward FMS was sectioned in order to examine the fracture surface using scanning electron microscopes (SEM), as shown in Figure 18. Evidence of faceted, quasicleavage fracture was observed emanating from the aft most thread root region as shown in Figure 19. These facets showed small cleavage “tongues” which generally faced inward, but in some locations were oriented in sporadic directions. Similar fracture morphology along with prevalent secondary surface cracking was observed just inboard of the thread root region. This fracture morphology was consistent with environmentally assisted cracking (EAC) in certain ultrahigh strength steels, such as the fan midshaft material, GE1014.<sup>6</sup> No evidence of fatigue striations was found.<sup>7</sup> Inspection using energy dispersive X-ray spectroscopy (EDS) found the FMS material to be consistent with GE1014.<sup>8</sup> No evidence of any corroding elements, namely chlorine and other halogens, was detected on the fracture surface. Major levels of carbon and oxygen were commonly detected on the discolored fracture surface.

Figure 19 – The forward fan midshaft fracture (a) showing a backscattered electron (BE) micrograph montage of the area depicted in Figure 11, (b) showing a secondary electron (SE) micrograph of the fracture near the initiation site, and (c) showing a closer view of (b). The fracture surface shows a faceted, quasicleavage morphology (crack direction in arrows).

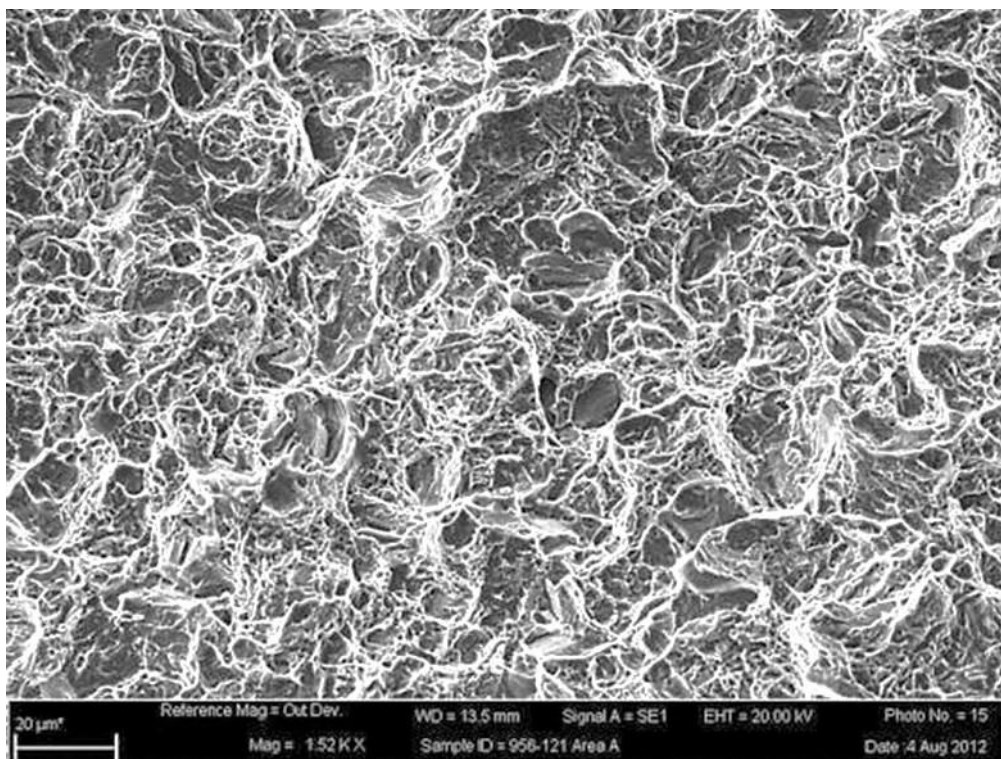
Figure 20 – SE micrograph of the triangular-shaped feature in Figure 19a, showing dimple rupture indicative of overstress.

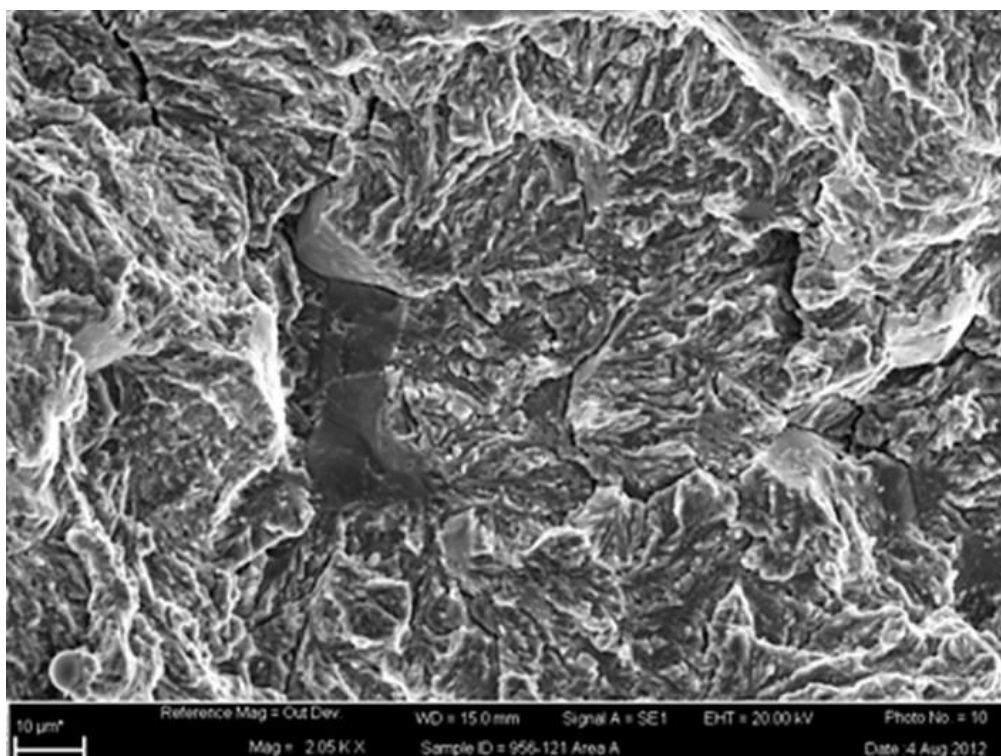
Figure 21 – SE micrograph of the fracture surface outboard of the triangular-shaped feature, showing intergranular facets in the EAC region.

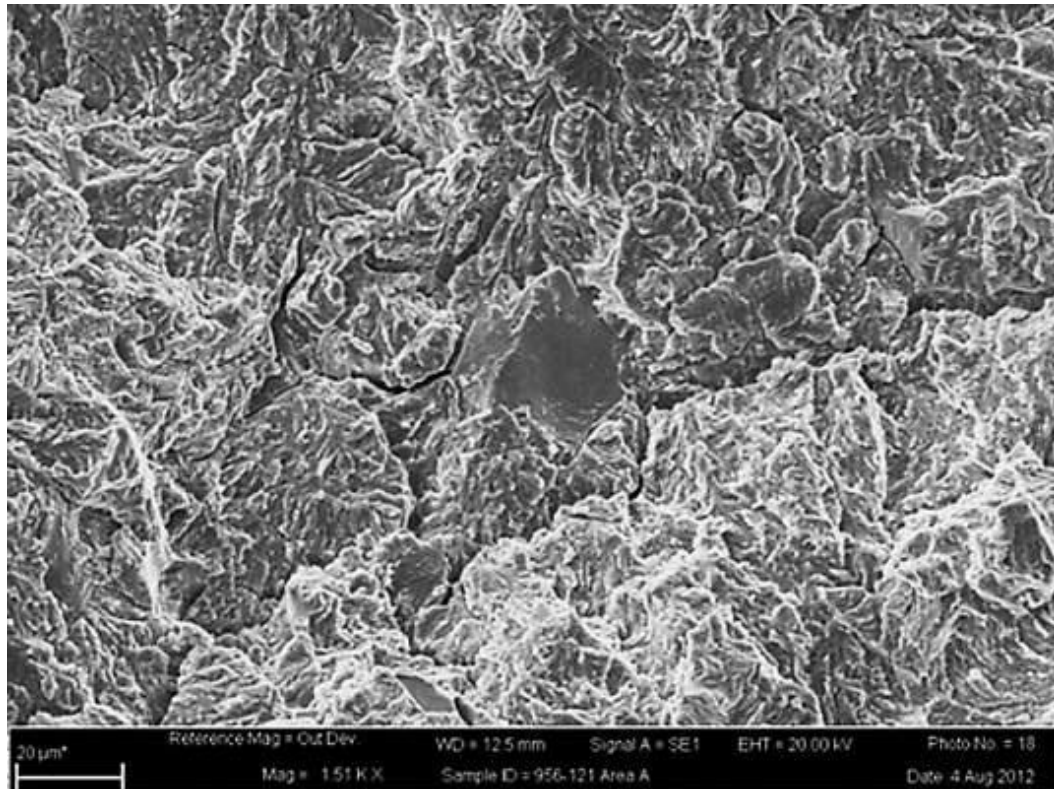
Figure 22 – SE micrograph of the fracture surface inboard of the triangular-shaped feature, showing intergranular facets and comparable features to Figure 21.

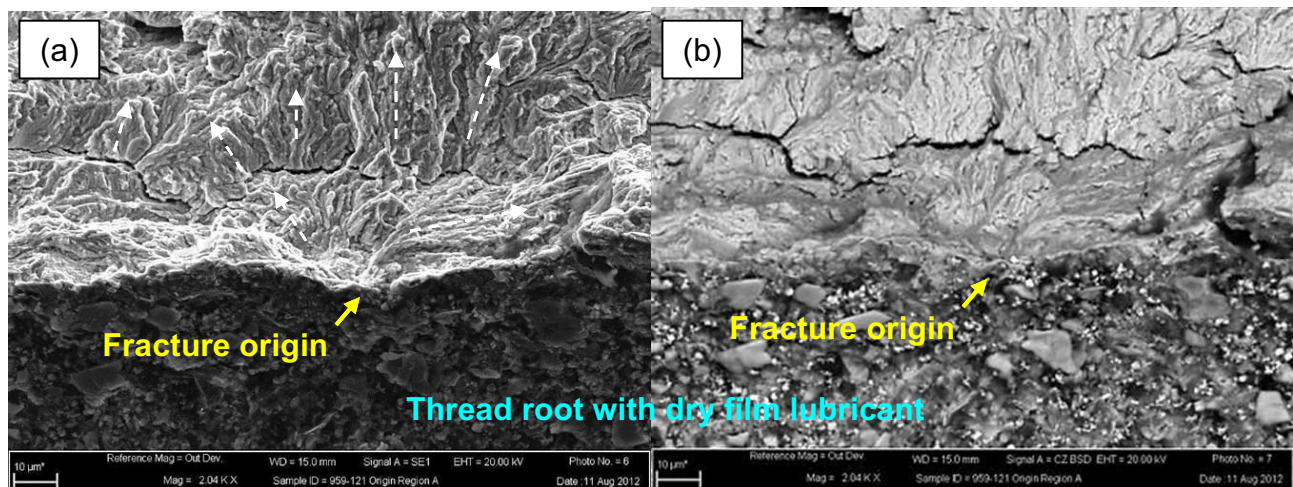
Figure 23 – Progressive crack origin at a thread root in the aft most thread using (a) secondary and (b) backscattered modes. The lower sections show the thread root with the dry film lubricant.

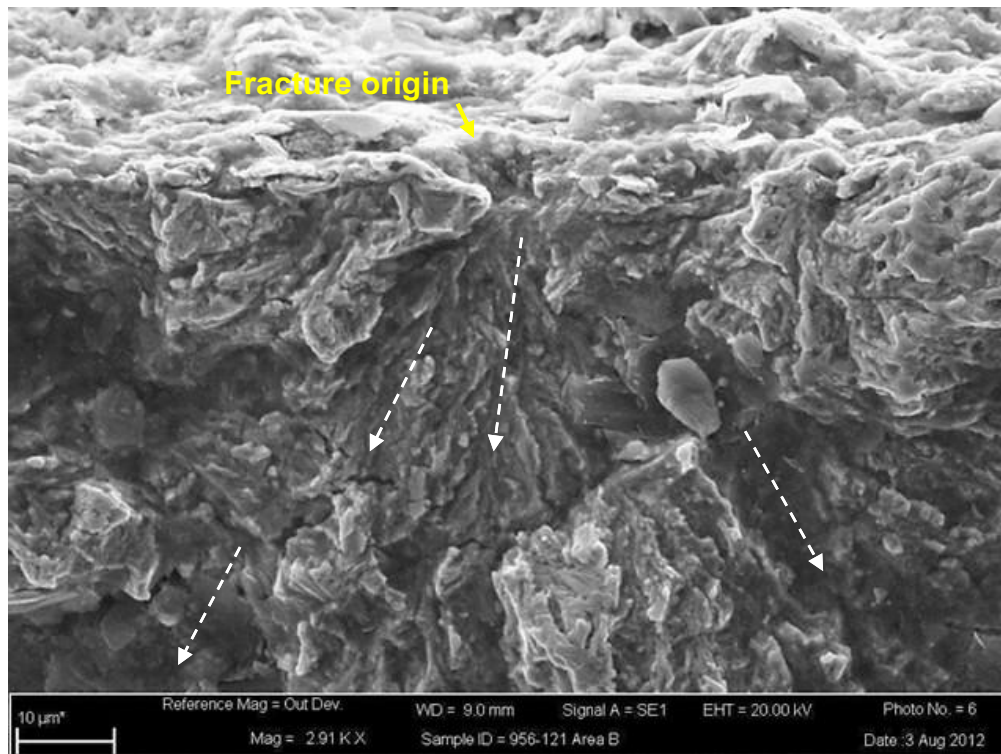
The progressive region on the opposite side of the FMS fracture surface showed fracture features consistent with EAC. Multiple-origin, quasicleavage cracking was again observed emanating from the thread root region (see Figure 24). Fracture outside of the initial thumbnail region, consistent with progressive EAC, continued inward abruptly transitioning to an overstress region. In addition, a thin band with fracture morphology consistent with EAC was observed progressing in an inward direction parallel to the inner diameter surface, just prior to the final overstress fracture at the edge (Figure 25).

Figure 24 – SE micrograph of a crack initiation site on the region B thumbnail shown in Figure 16, with arrows showing crack growth directions.
