# NATIONAL TRANSPORTATION SAFETY BOARD

## MATERIALS LABORATORY FACTUAL REPORT

Report No. 13-086

Place : Charleston, South Carolina  
Date : July 28, 2012  
Vehicle : Boeing 787-8, ZA238  
NTSB No. : DCA12IA114  
Investigator : Dave Helson, AS-10

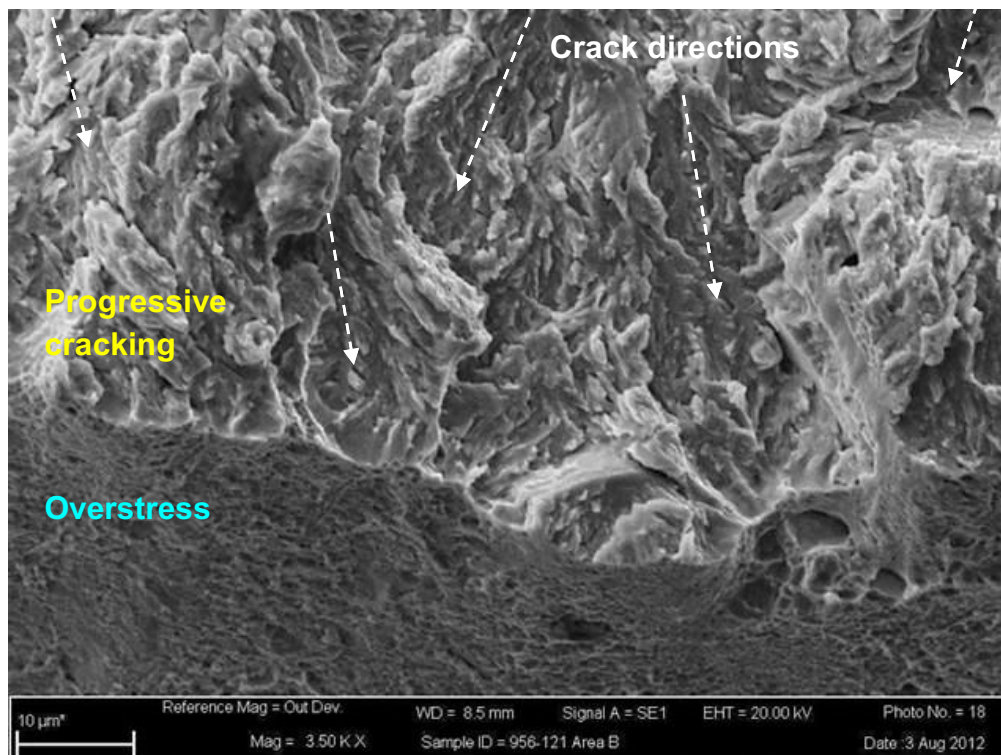
Figure 25 – SE micrograph of the innermost portion of EAC cracking on Region B before overstress.

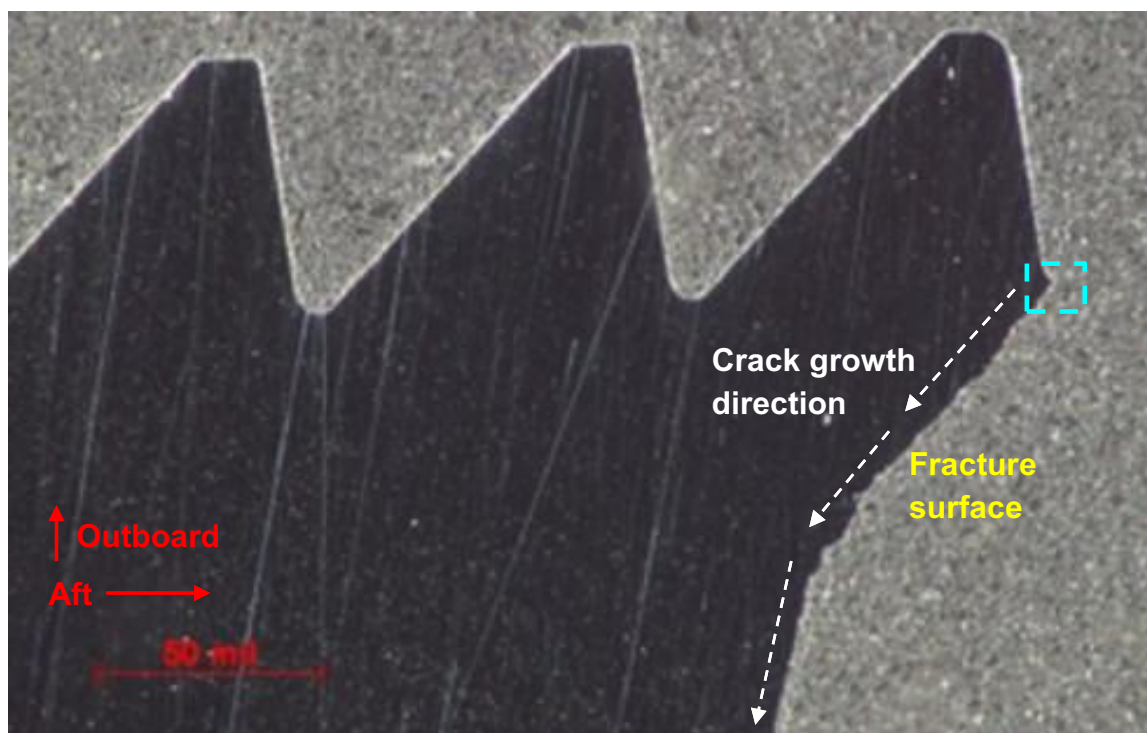
Additional SEM examination was performed to characterize the thread root at the origin region as shown in Figure 26. This cross-section revealed the initial thumbnail fracture regions angled between  $\sim 49^\circ$  and  $\sim 59^\circ$  with respect to longitudinal axis of the FMS. The fracture angle transitioned to approximately  $90^\circ$  further inward of the FMS cross-section. Secondary cracking was observed adjacent to the thread root region, with additional secondary cracking found emanating from the thumbnail fracture that had progressed back towards the adjacent thread root, as shown in Figure 27. The end of the secondary crack exhibited a branched appearance consistent with EAC. A closer view of transgranular, secondary cracking below the primary fracture surface in the center region of the fracture is shown in Figure 28. The appearance of cracking observed during metallographic examination was consistent with EAC cracking mechanisms in high strength steels.

Figure 26 – Optical metallograph of a cross-section of forward end of the fan midshaft, showing the crack orientation. The boxed area is shown in Figure 29.

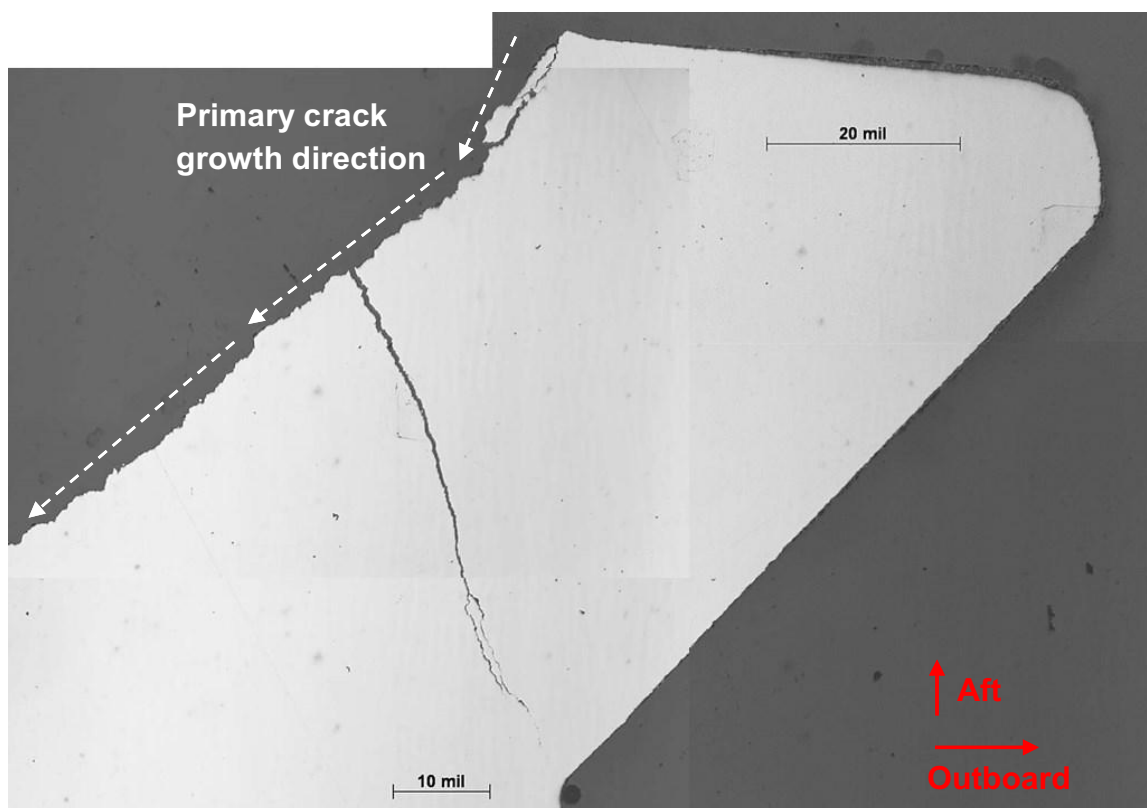
Figure 27 – Optical metallograph of the thread adjacent to the forward FMS fracture, showing a secondary crack growing under the thread.

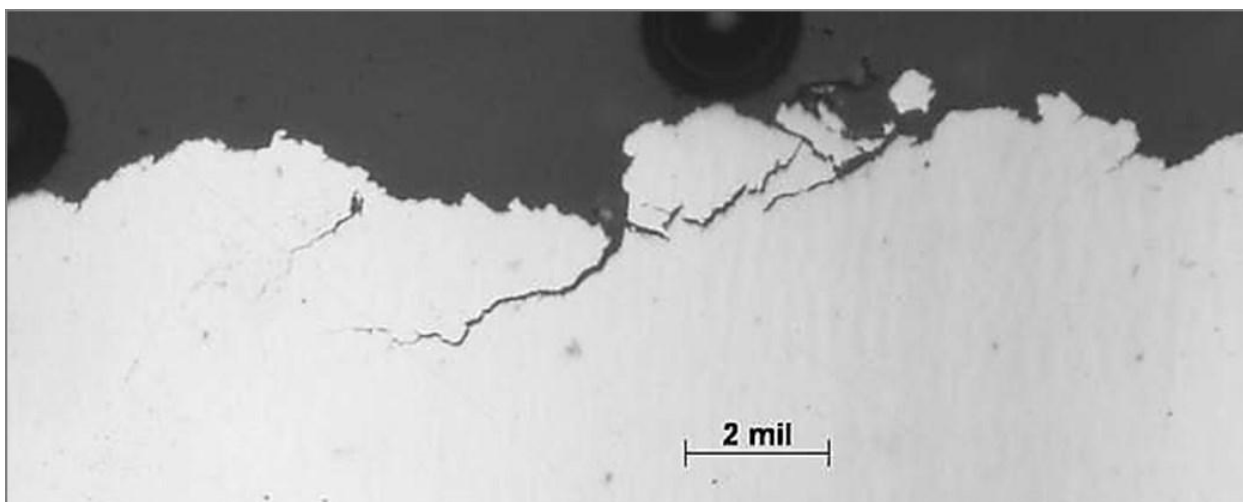
Figure 28 – Optical metallograph of a close-up of the forward FMS fracture surface, showing sub-surface cracking.

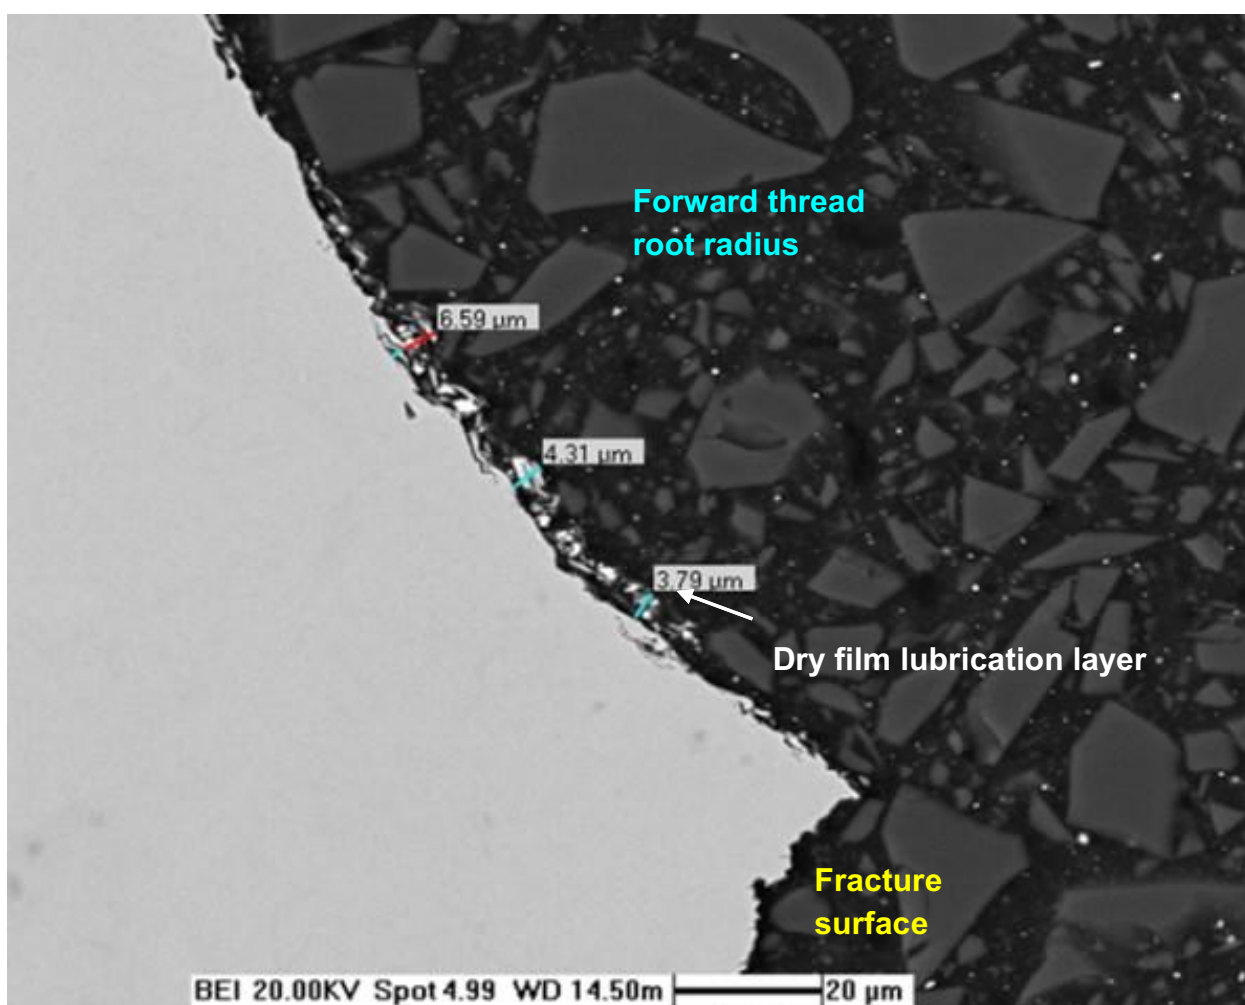
The thread root region adjacent to the cracking showed thin dry film lubrication thicknesses measuring less than the prescribed minimum, particularly certain regions on the  $45^\circ$  flanks (Figure 29). Some regions within the thread root appeared bare, consistent with previous observations. These thread roots also exhibited areas with shallow semi-circular features resembling pits. However, features were filled with mounting material rather than foreign debris or corrosion products, as shown in Figure

Figure 29 – BE micrograph of the thread root near the fracture, showing lack of complete dry film lubricant coverage.

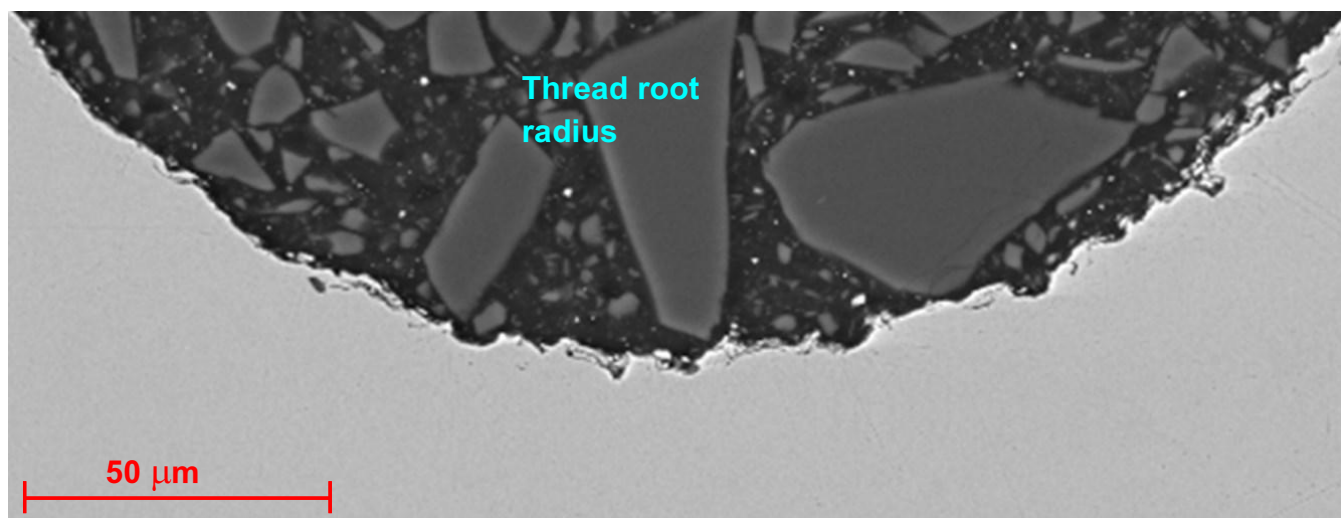
Figure 30 – BE micrograph of a close-up of a FMS thread root, showing pit-like divots at the surface.

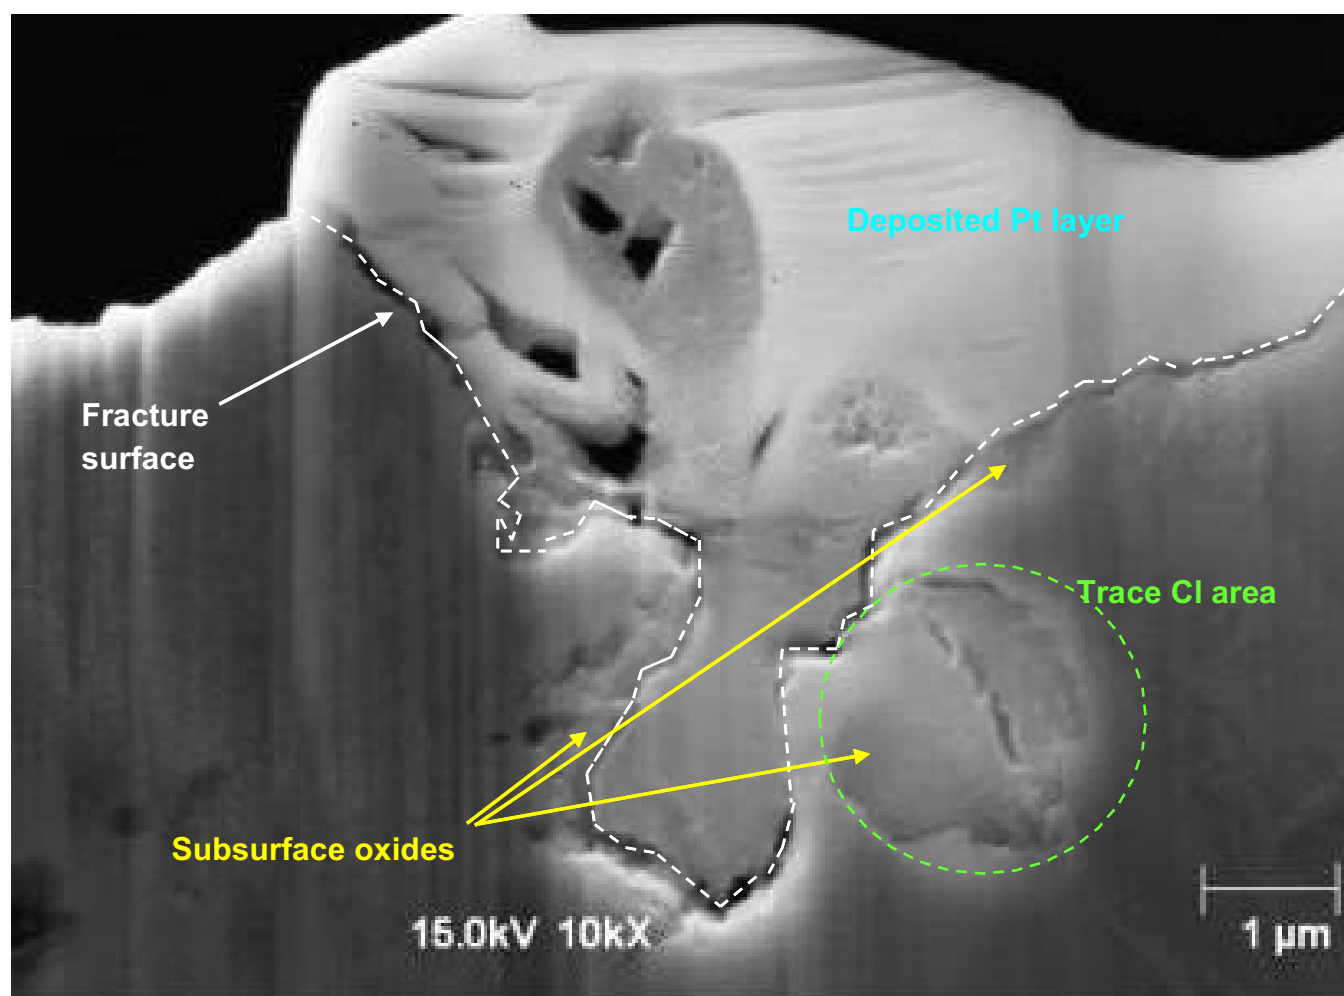
A portion of the fracture surface from origin region A was sent to GE Global Research Center (GRC) in Niskayuna, NY for focused ion beam (FIB)<sup>9</sup> and Auger electron scanning<sup>10</sup> surface analysis to characterize the discolored surface debris layer. The outermost layer of the fracture surface specimen (under the protective platinum layer) consistently exhibited elevated carbon and oxygen peaks, with no evidence of chlorides or other similar species, consistent with previous EDS results obtained from the fracture surface. However, trace amounts of chlorine were detected under the outermost layer after sputtering (see Figure 31).

Figure 31 – SE micrograph of a focused ion beam (FIB) cross-section of the surface of progressive fracture region A.

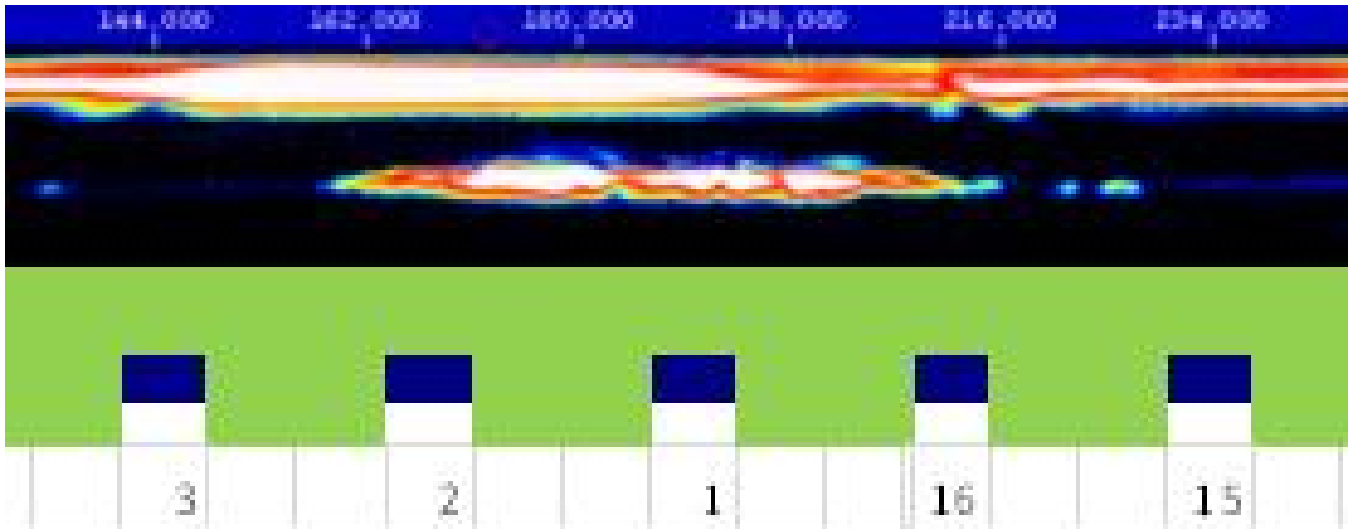
Figure 33 – Close-up of the UT scan showing the largest crack indication in the 956-175 fan midshaft between castellations #2 and #16.

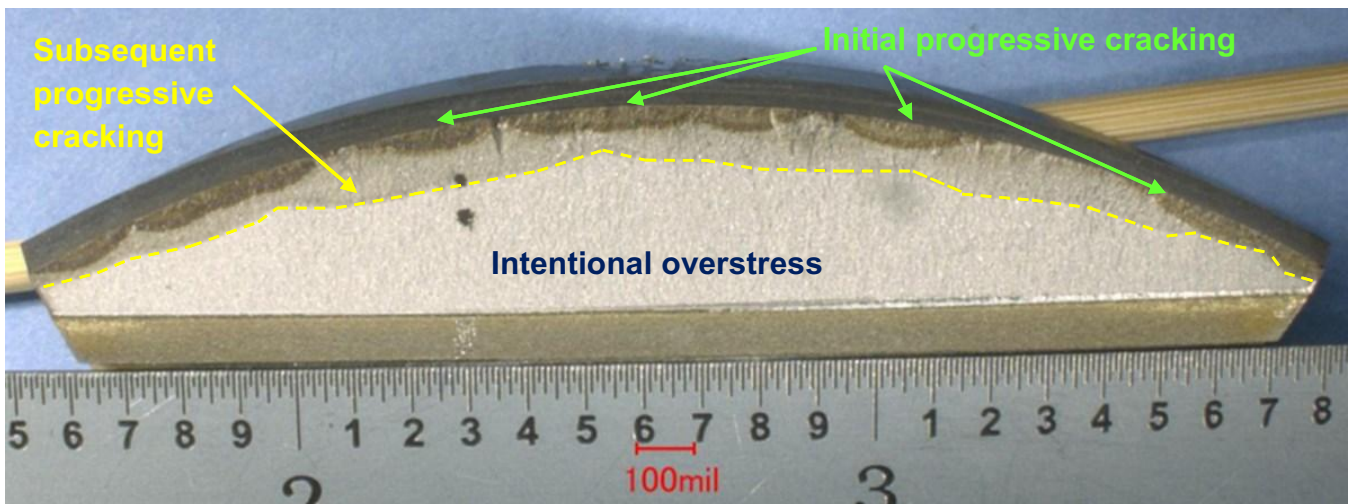
Figure 34 – The largest progressive crack in the 956-175 fan midshaft, after backcutting intentional overstressing. The dark areas are the pre-existing crack.

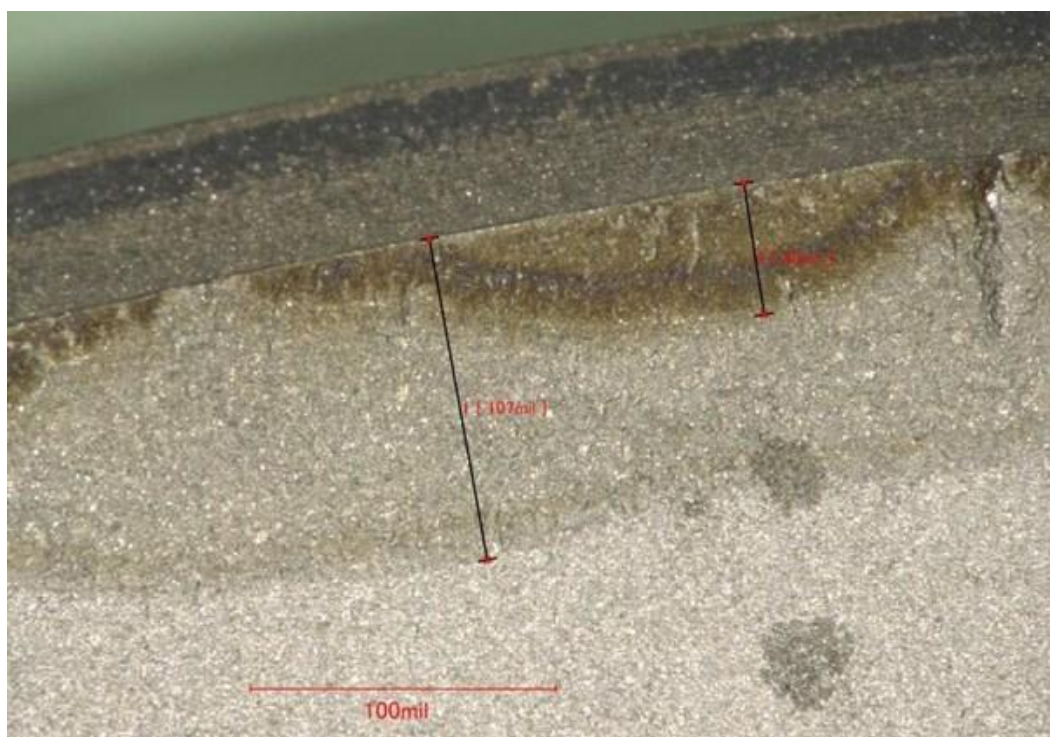
EDS analysis was performed on the discolored fracture surface in Figure 35. As with the 956-121 FMS, elevated levels of carbon and oxygen on the progressive crack face were observed. No evidence of typical corroding elements, namely chlorine, was observed on the fracture surface in the uncleansed condition. Incomplete dry film lube coating was noted in the thread root region with local bare regions of GE1014 commonly observed.

Figure 35 – Closer view of Figure 34, showing the depth of penetration of the progressive environmentally assisted crack.

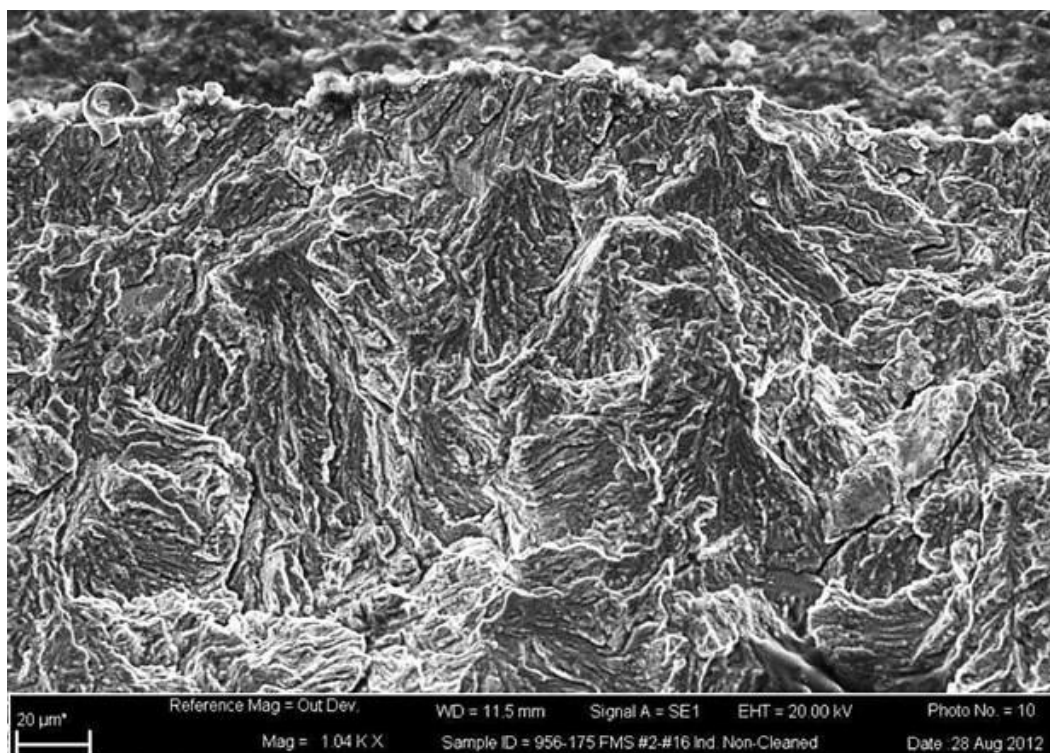
Figure 36 – SE micrograph of one of the initiation sites of the 956-175 progressive crack, comparable to the 956-121 fan midshaft fracture.

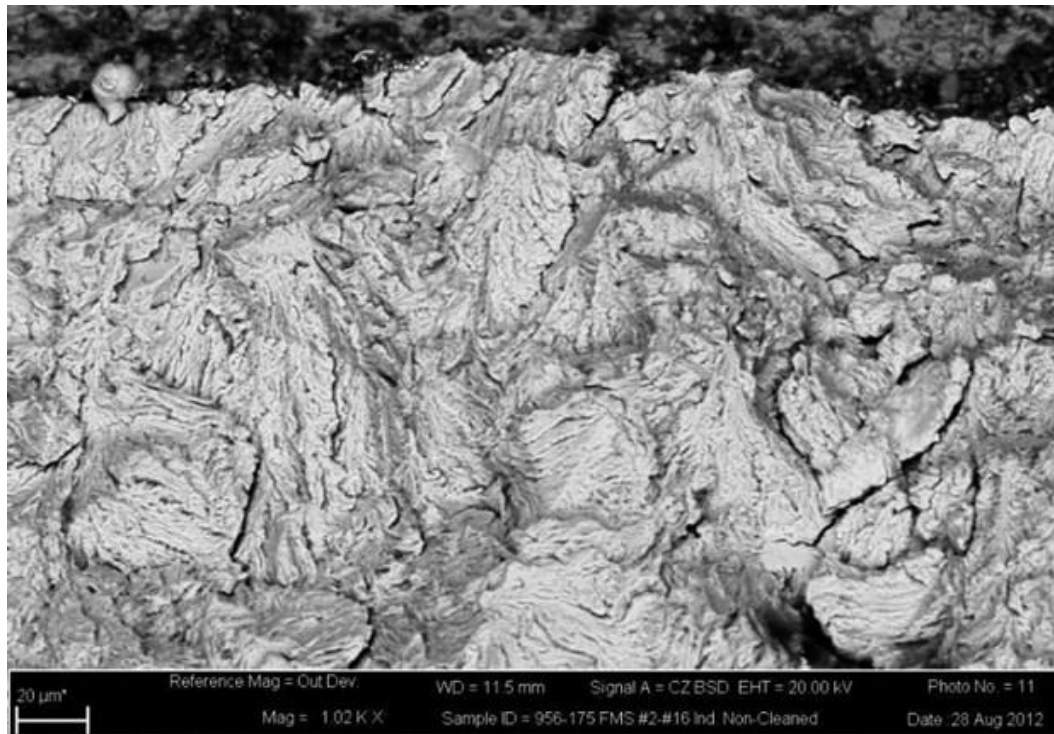
Figure 37 – BE micrograph of Figure 36, revealing the faceted morphology of the progressive crack surface.

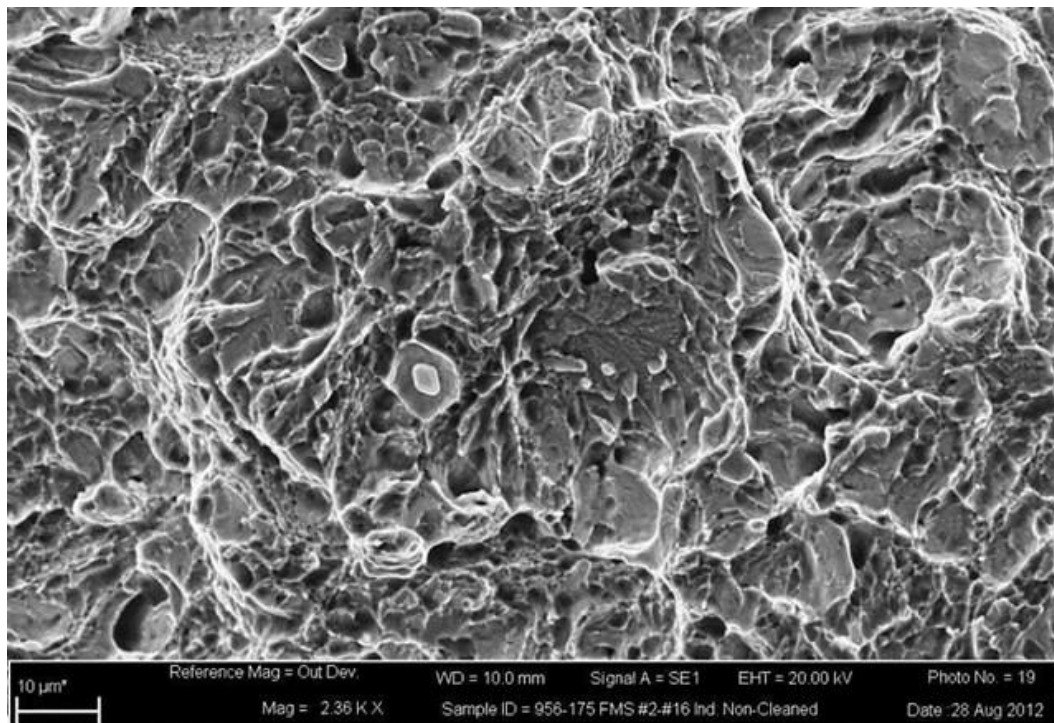
Figure 38 – SE micrograph of the 956-175 fracture surface inboard of the progressive area that was backcut, showing dimple rupture.

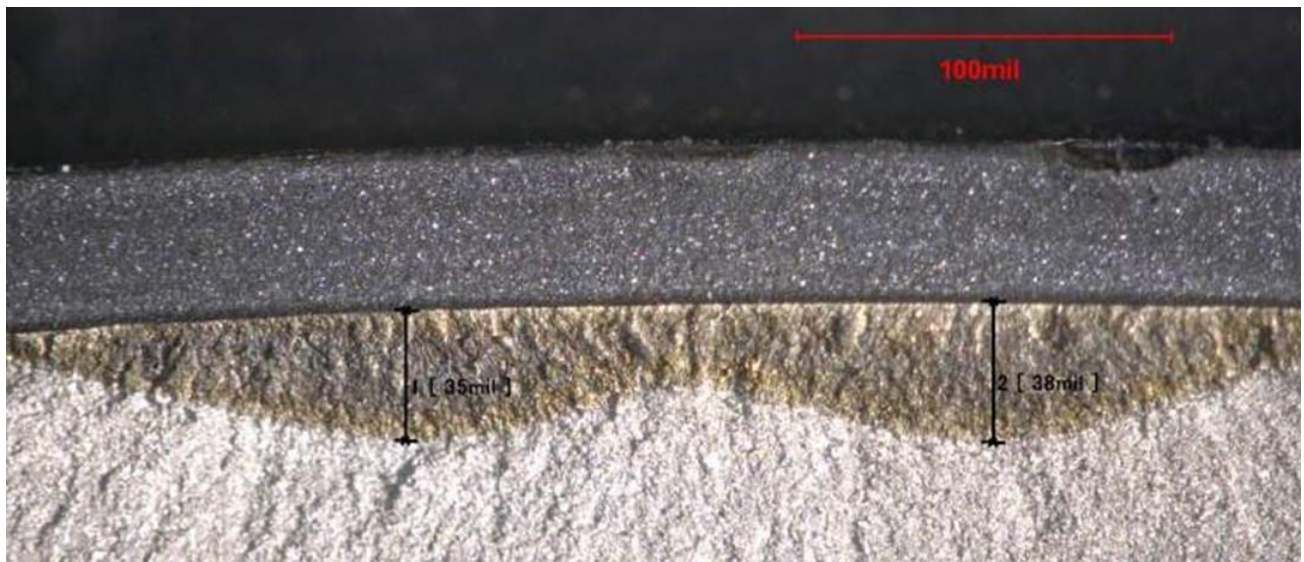
The smaller double indication, detected via MPI and immersion ultrasound inspection at the castellation #11 location (right side of Figure 31), was sectioned, backcut, and intentionally overstressed. Separate, discolored thumbnail regions were observed measuring 0.035 and 0.038 inch deep, as shown in Figure 39.

Figure 39 – The smaller crack located at castellation #11. The dark areas are the pre-existing crack.

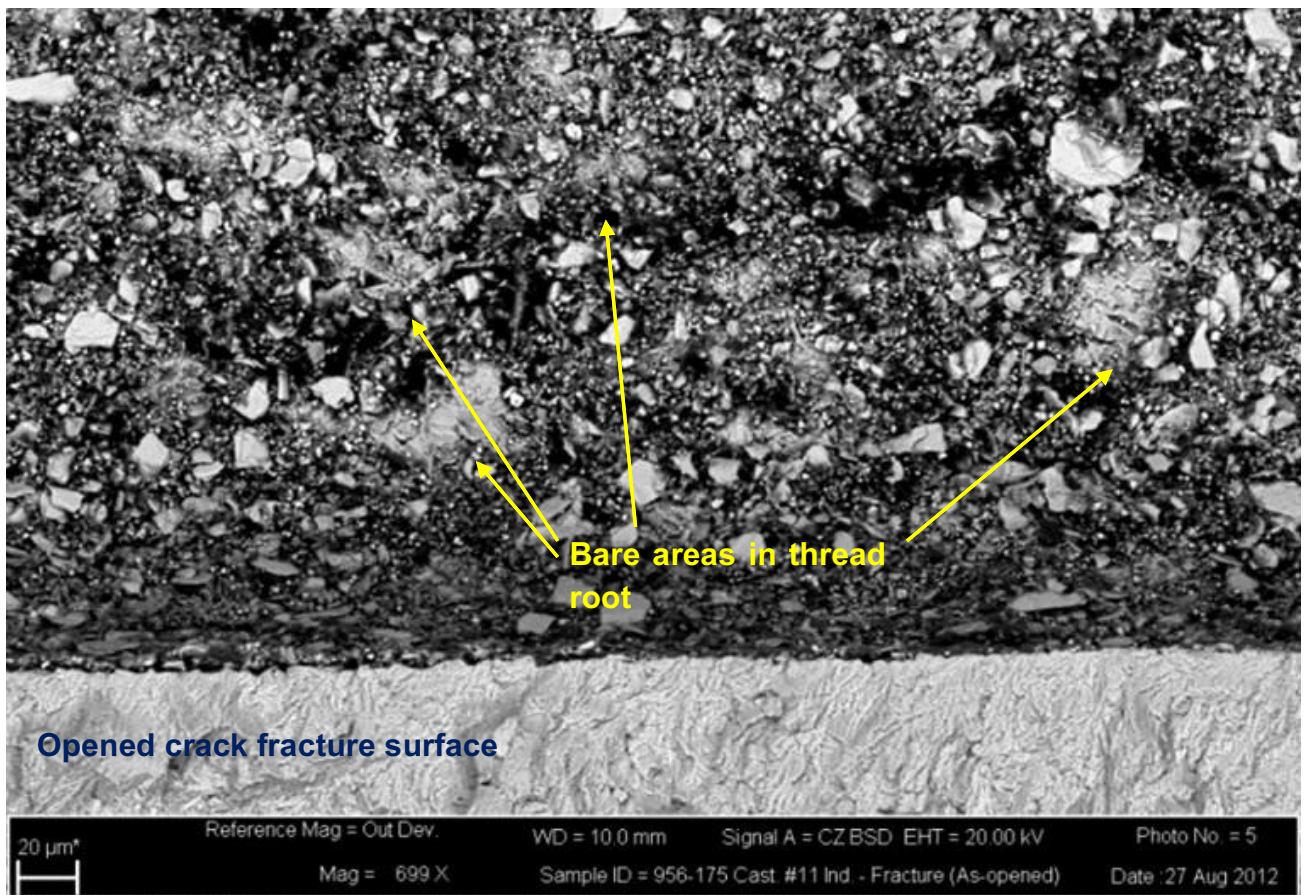
Figure 40 – BE micrograph of the thread root adjacent to the pre-existing crack. The circled areas show bare regions of the part surface.

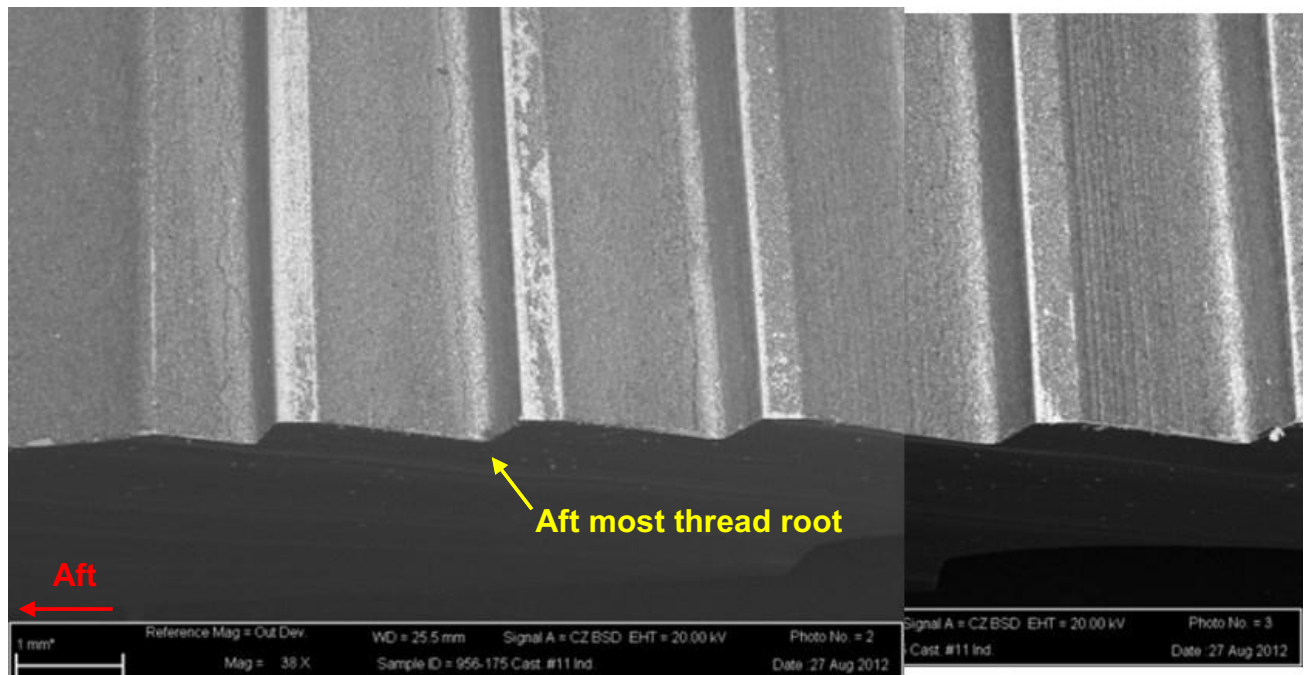
Figure 41 – BE micrograph showing bare areas (lighter shade) of the fan midshaft threads.

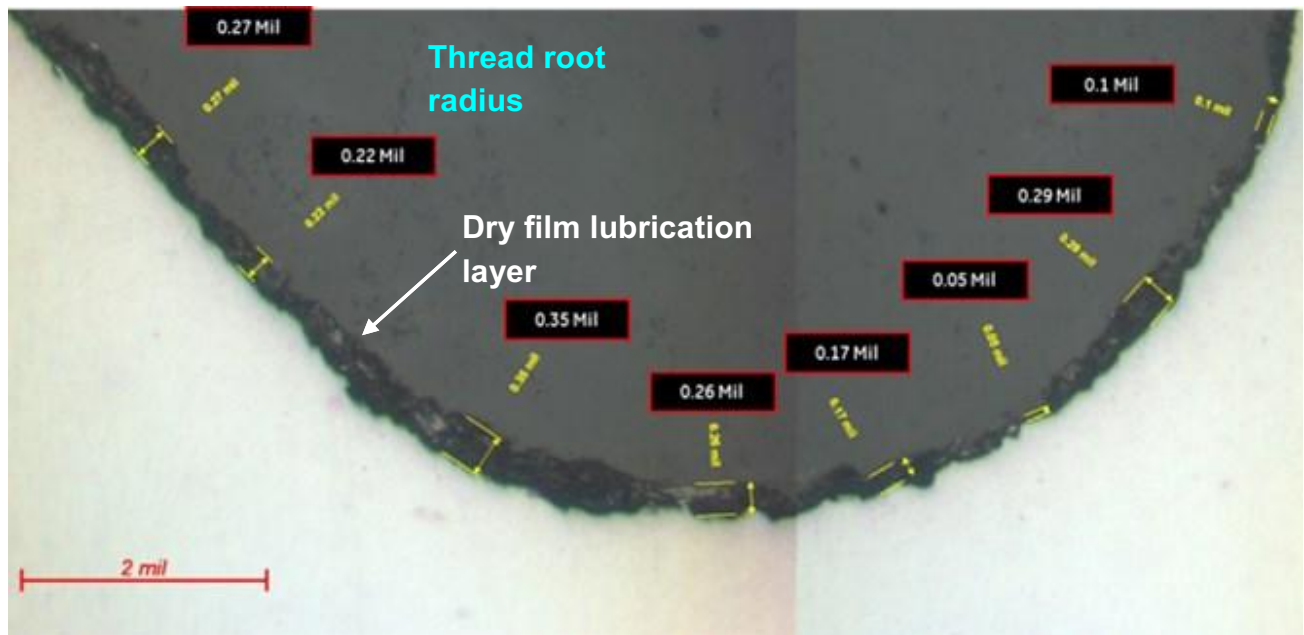
Figure 42 – Optical metallograph of a cross-section of the last thread root from 956-175 fan midshaft, showing the thickness of the dry-film lubrication layer.

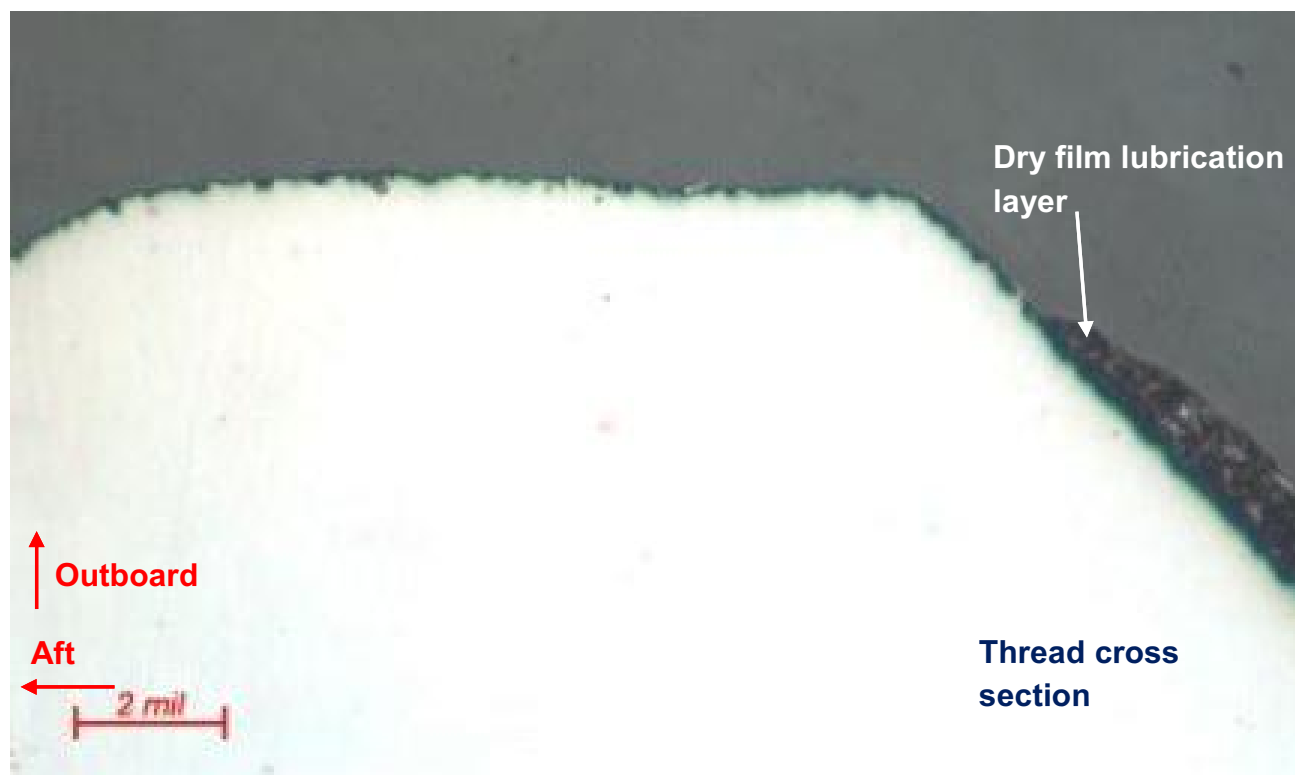
Figure 43 – Optical metallograph of a cross-section of the last thread of 956-175 FMS, showing a lack of dry film lubrication on the top of the thread crest.

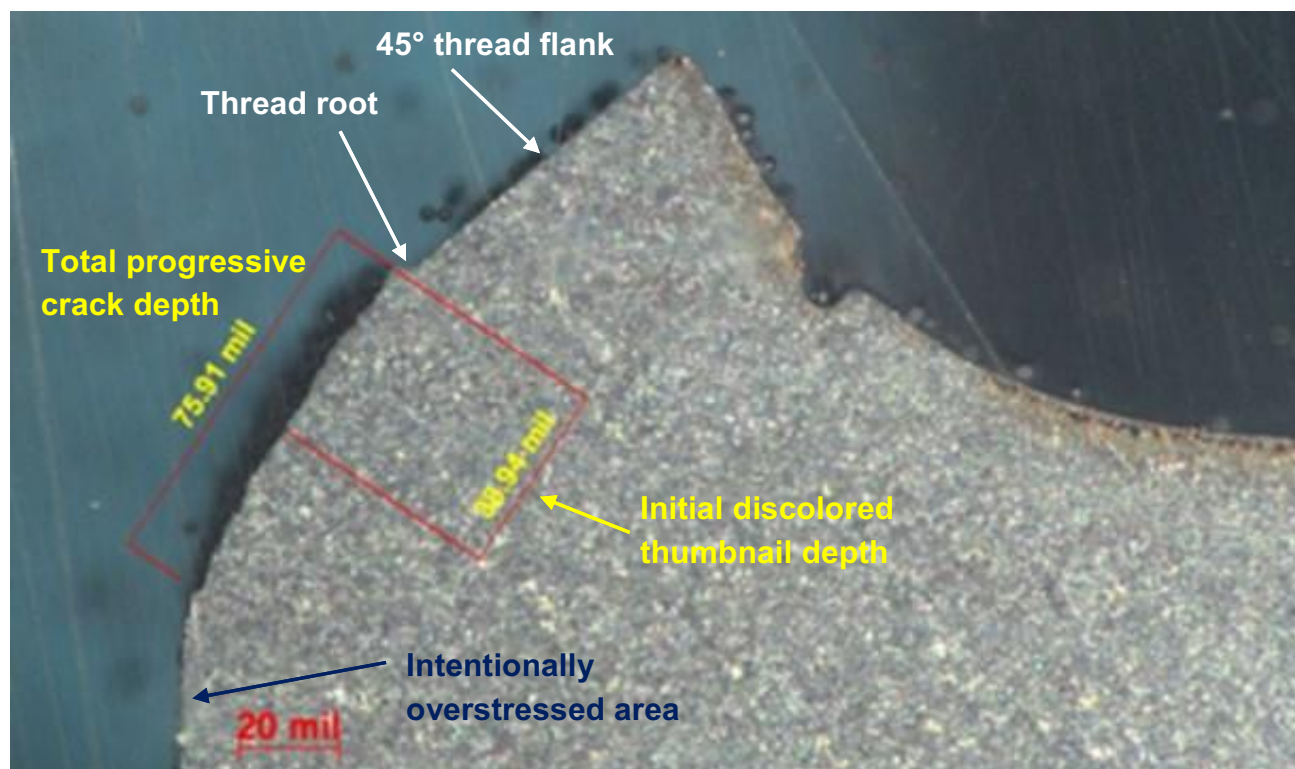
Metallographic cross-sections through one of the discolored, thumbnail origin sites, from cracking between castellations #2 through #16, are shown in Figure 44. The initial thumbnail crack was angled at ~60° with respect to the longitudinal direction, similar to that observed with fractured FMS in ESN 956-121. No evidence of abusive machining or other material anomalies were noted at the origin region.

Figure 44 – Optical metallograph of a cross-section of the largest fracture surface at the aft most thread root.

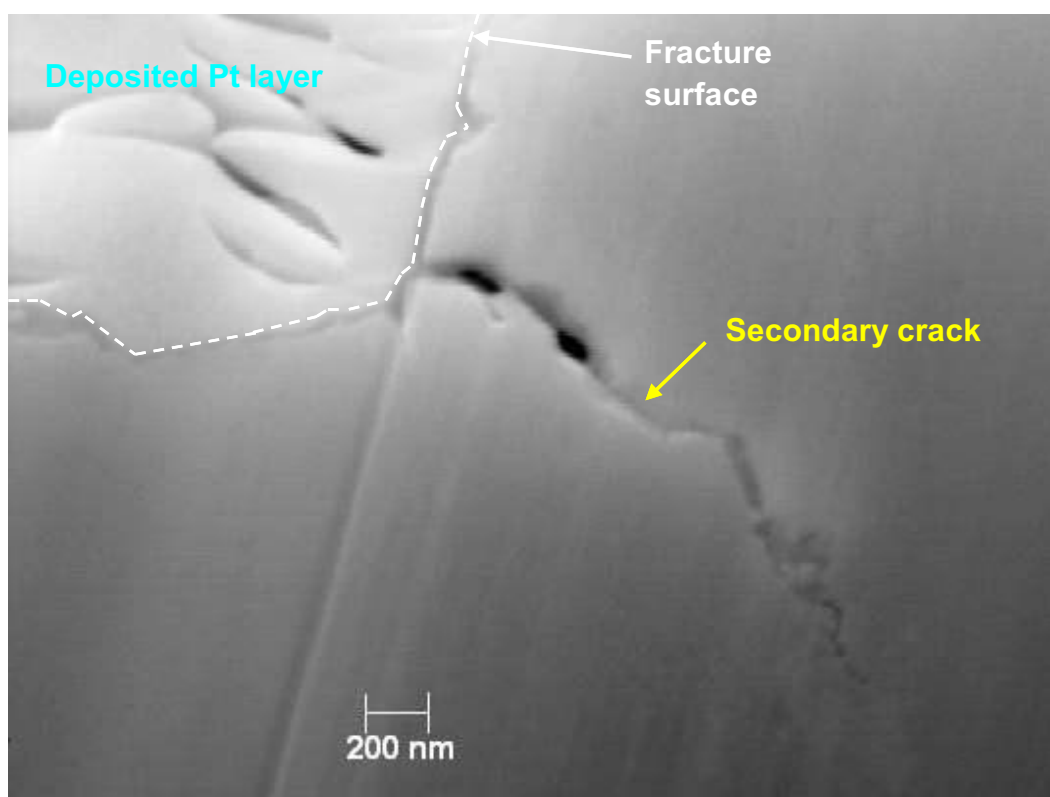
Figure 45 – SE micrograph of a FIB cross-section of the #11 castellation crack from ESN 956-175.
