# NATIONAL TRANSPORTATION SAFETY BOARD

## MATERIALS LABORATORY TESTING REPORT

Report No. 13-087

Place : Charleston, South Carolina  
Date : July 28, 2012  
Vehicle : Boeing 787-8, ZA238  
NTSB No. : DCA12IA114  
Investigator : Dave Helson, AS-10

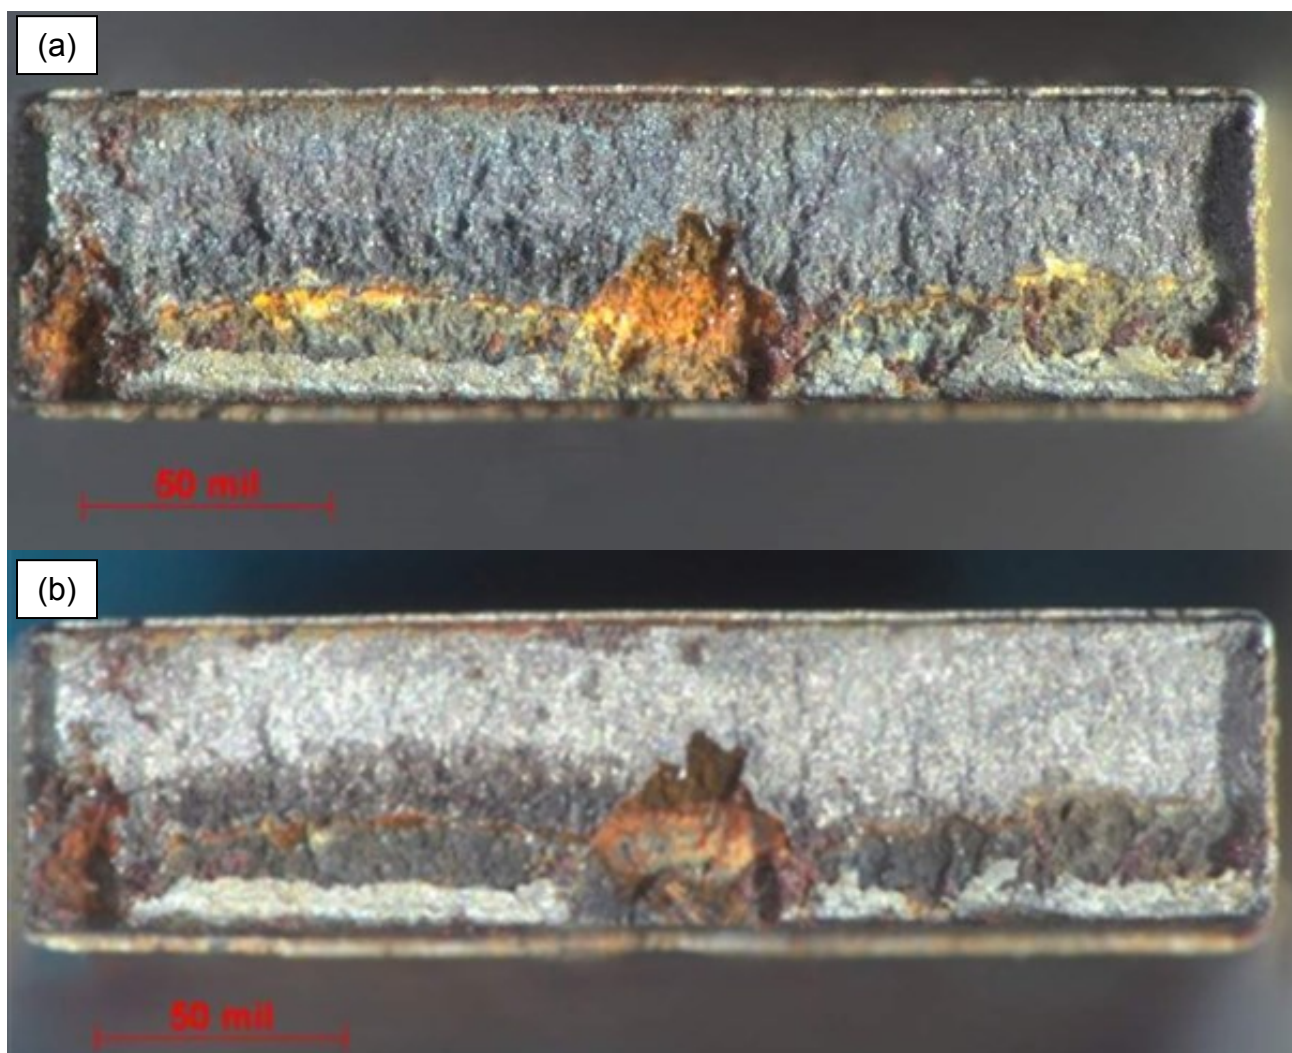
One GE1014 stress corrosion cracking (SCC) bend specimen tested during prior alloy developmental studies (per ASTM G39) in salt water (NaCl) was made available for fractographic examination to compare with the incident FMS fracture surfaces, documented in *NTSB Materials Lab Report 13-086*.<sup>9</sup> The SCC bend specimen fractured after 91.7 days of testing. The fracture surfaces of the SCC test specimen in both the uncleansed and cleaned conditions are shown in Figure 1. Both mating halves of the fracture surface remained discolored after cleaning. SEM examination of the test specimen revealed fewer corrosion products on the fracture surface, as illustrated in Figure 2. Figure 3 shows a transgranular fracture morphology with secondary surface cracking observed near the end of the SCC specimen crack consistent with fracture features observed on the fractured fan midshaft from ESN 956-121 (see *NTSB Materials Lab Report 13-086*). The innermost areas of the fracture without discoloration exhibited dimple rupture, indicative of overstress in the last cross-section of the specimen to fail (Figure 4). Cross-sections of the test specimen were produced, showing branched cracking consistent with stress corrosion cracks in high strength steels (see Figure 5). No evidence of chlorine was detected by EDS at the end of the progressive crack on the SCC test specimen fracture surface. Chlorine was found on the surface of the SCC specimen exposed directly to the NaCl environment.

Figure 1 – Fracture surface of the developmental SCC sample (a) before and (b) after cleaning.

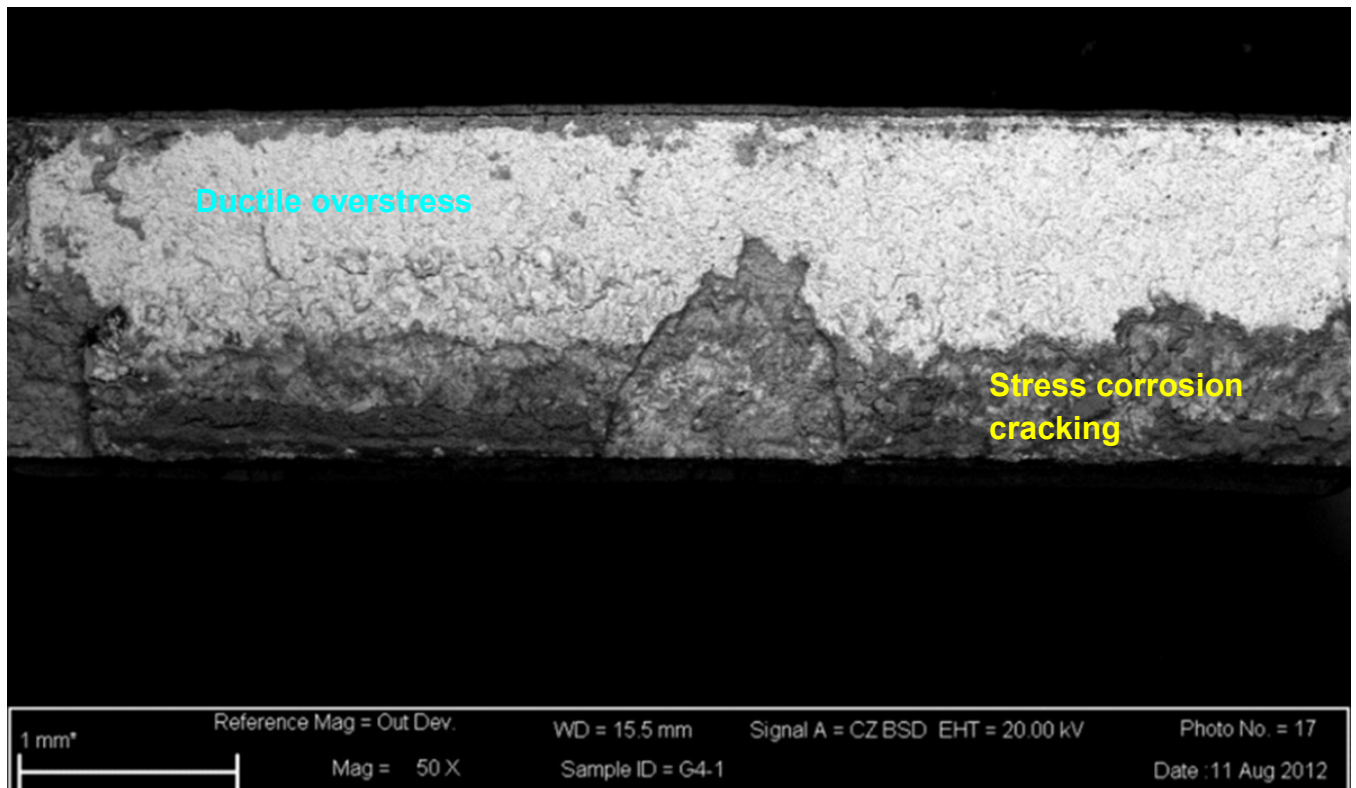
Figure 2 – Backscattered electron (BE) micrograph of the fracture surface in Figure 1. The darker areas are corroded and are indicative of stress corrosion cracking. The lighter areas, which are not corroded, indicate ductile overstress.

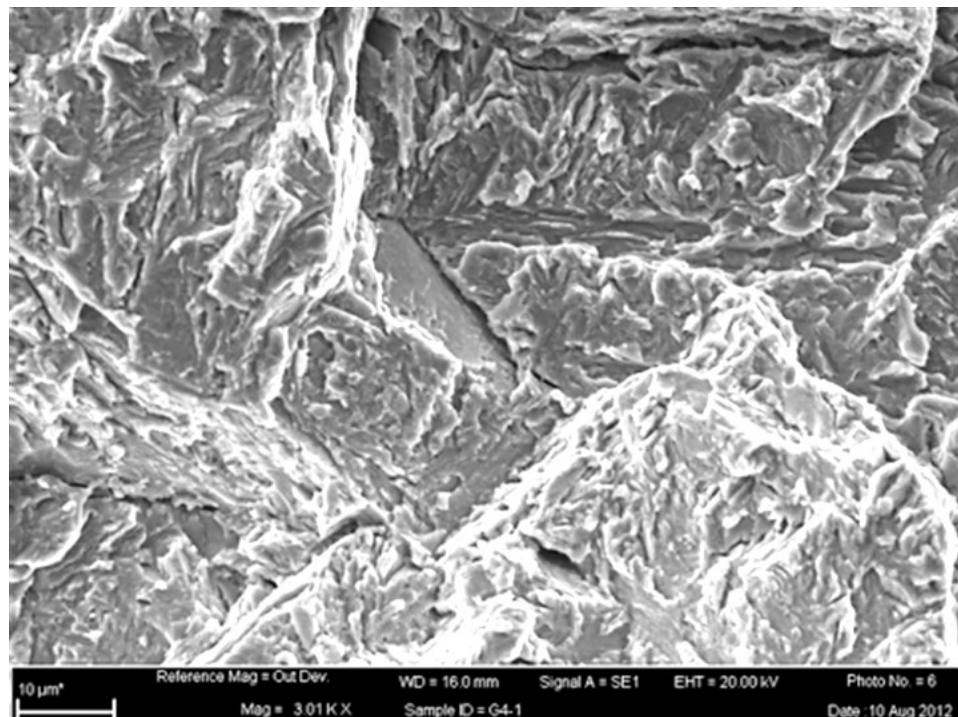
Figure 3 – Secondary electron (SE) micrograph of the fracture surface with stress corrosion cracking.

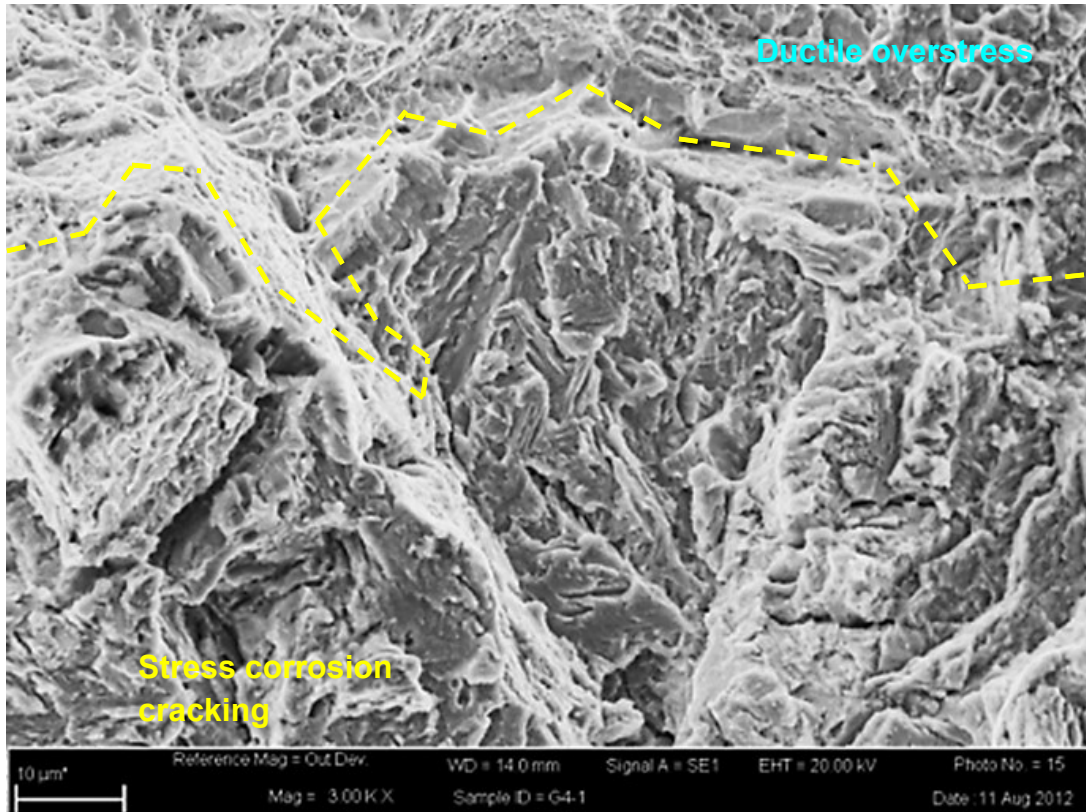
Figure 4 – SE micrograph of the transition from stress corrosion to overstress fracture.

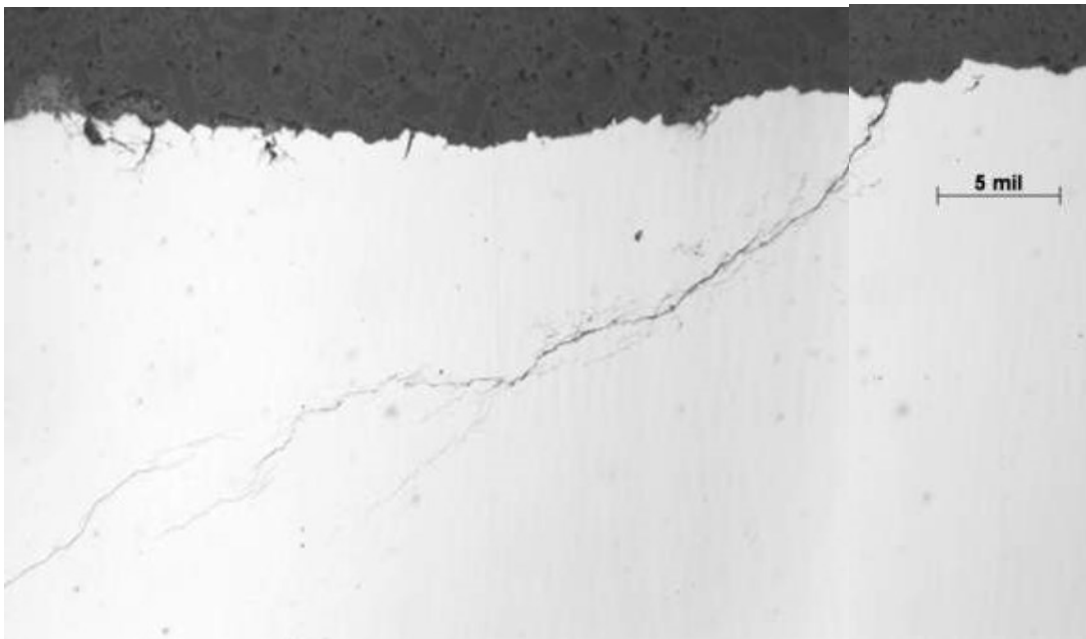
Figure 5 – Cross-section of a SCC specimen, showing branched secondary cracking indicative of SCC.

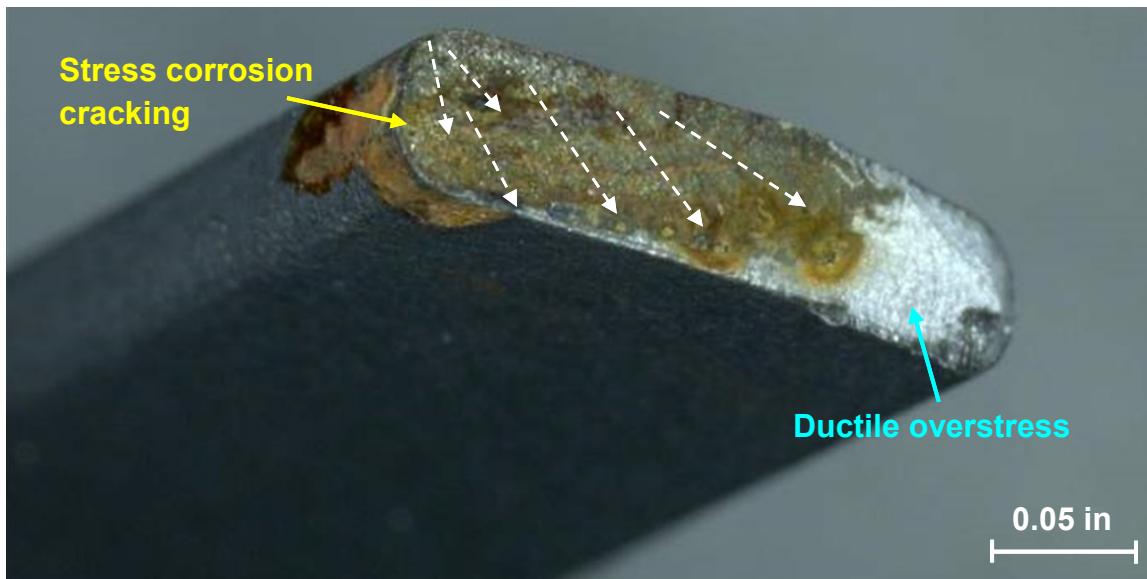
As of the time of this report, two GE1014 specimens had fractured: one at 43 days with Everlube 9002 dry film lube and graphite grease, and the second at 149 days with the Everlube 9002 dry film lube and synthetic engine oil (both failed at the lower 170 ksi stress level and higher humidity). Figure 6 shows the fracture surface of the specimen that failed after 43 days. The fracture surface shows the rust-colored area consistent with environmental cracking that initiated at a corner on the tensile loaded surface of the specimen. The crack progressed until the remaining cross section failed from overstress. The fractured specimen showed similar fracture surface features to the previous stress corrosion specimen. However, there was a discernible corrosion product layer on the compressive-loaded side of the fracture surface, as depicted in Figure 7. This corrosion product exhibited blister morphology—these features contained minor levels of chlorine, as detected using EDS.

Figure 6 – Fracture surface of the stress corrosion specimen that failed after 43 days. The specimen shows a rust-colored region where the progressive stress corrosion crack grew from the specimen corner (white arrows denote crack growth direction).

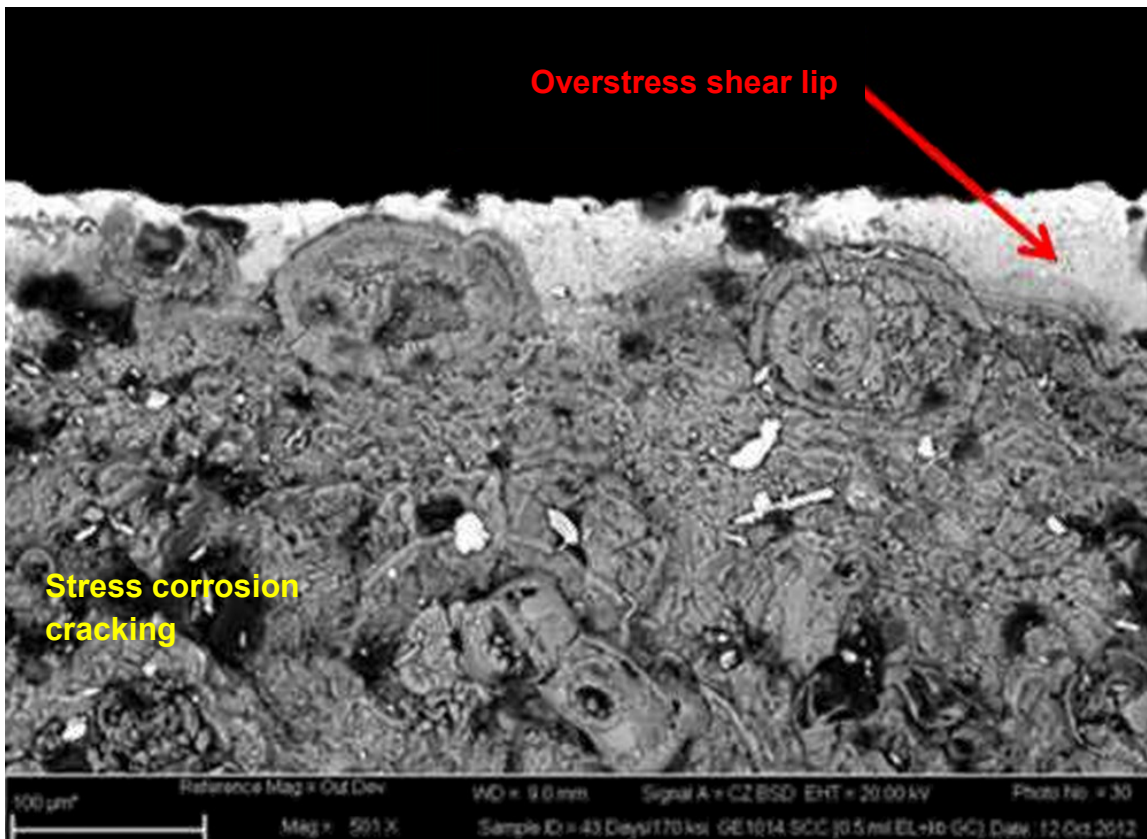
Figure 7 – BE micrograph of the stress corrosion specimen that fractured after 43 days, showing corrosion blisters near an overstress shear lip.

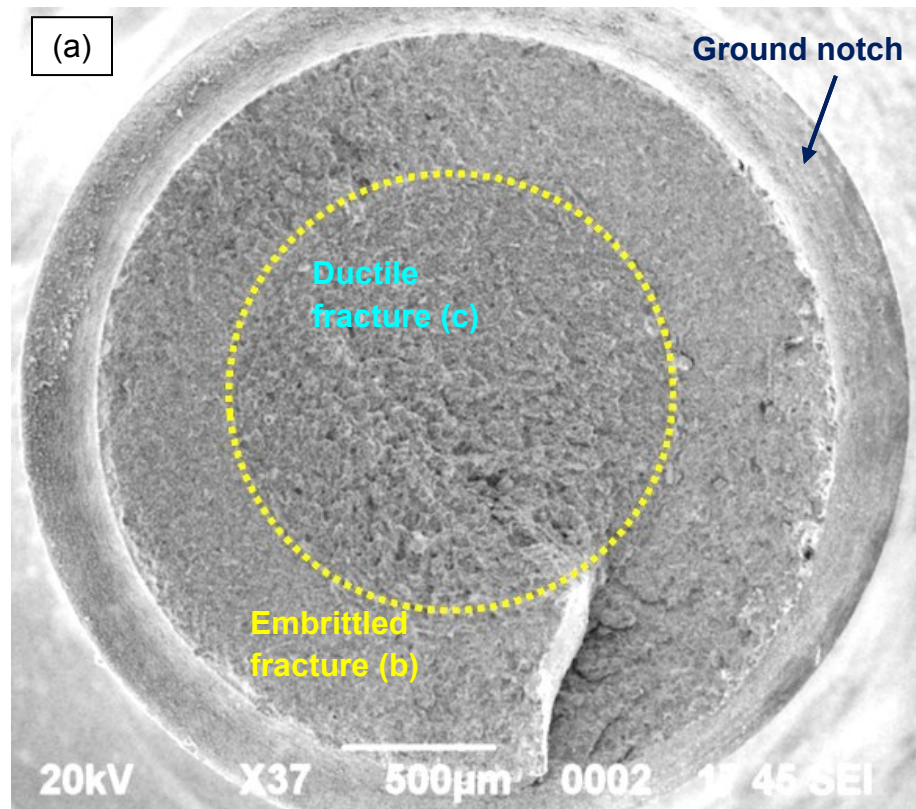
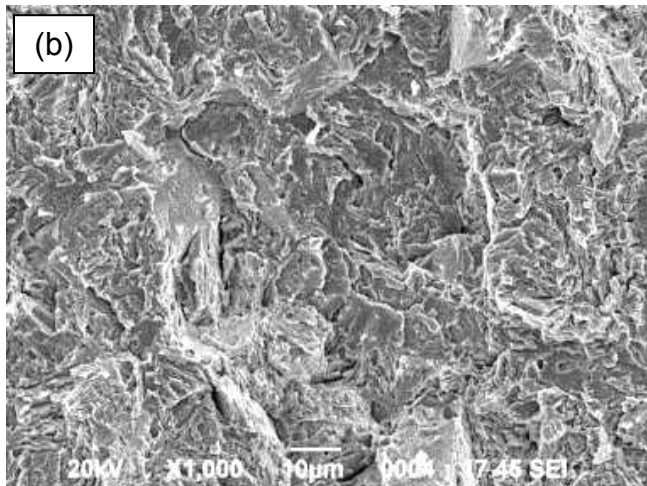
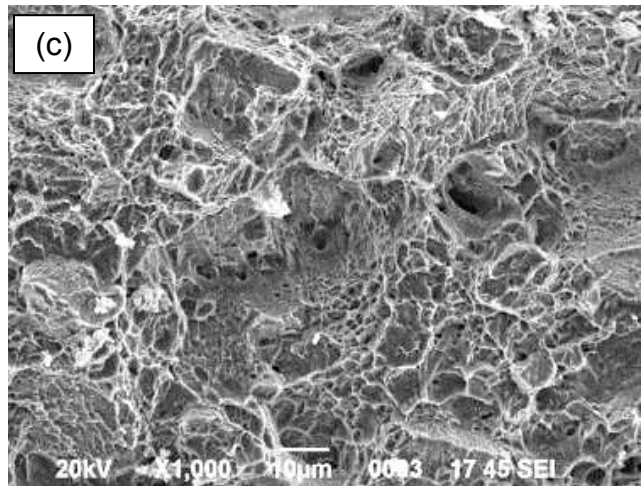
A GE1014 tensile specimen, notched 0.01 inch deep with a 0.01 inch root radius, was subjected to cathodic hydrogen charging conditions with no applied load. The experiment was performed to assess the resulting fracture morphology of a hydrogen embrittled GE1014 material. The charged specimens were subjected to charge voltages of 2.5 V versus a platinum foil counter electrode for 68 hours in 1 N sulfuric acid ( $\text{H}_2\text{SO}_4$ ) solution at ambient temperature. Subsequent tensile tests demonstrated successful hydrogen charging of test specimen, showing a reduction in ultimate tensile strength (~60%) compared to control GE1014 specimens. SEM examination revealed an annular region of less ductile, transgranular fracture morphology adjacent to the notch as shown in Figure 8. The fracture morphology closely resembled that of the EAC regions of both event FMS fracture surfaces (Figure 8b). The inner area of the test specimen showed only dimple rupture, indicative of overstress (Figure 8c).

Figure 8 – The unloaded notched test specimen charged with hydrogen using  $H_2SO_4$  showing (a) the overall specimen fracture surface with (b) an outer embrittled zone with cleavage-like transgranular fracture morphology and (c) the inner non-embrittled area showing only overstress dimple rupture.
