# NATIONAL TRANSPORTATION SAFETY BOARD

## MATERIALS LABORATORY FACTUAL REPORT

Report No. 14-018

Place : Soldotna, Alaska  
Date : July 7, 2013  
Vehicle : de Havilland DHC-3, N93PC  
NTSB No. : DCA13MA121  
Investigator : Clinton Crookshanks, AS-40

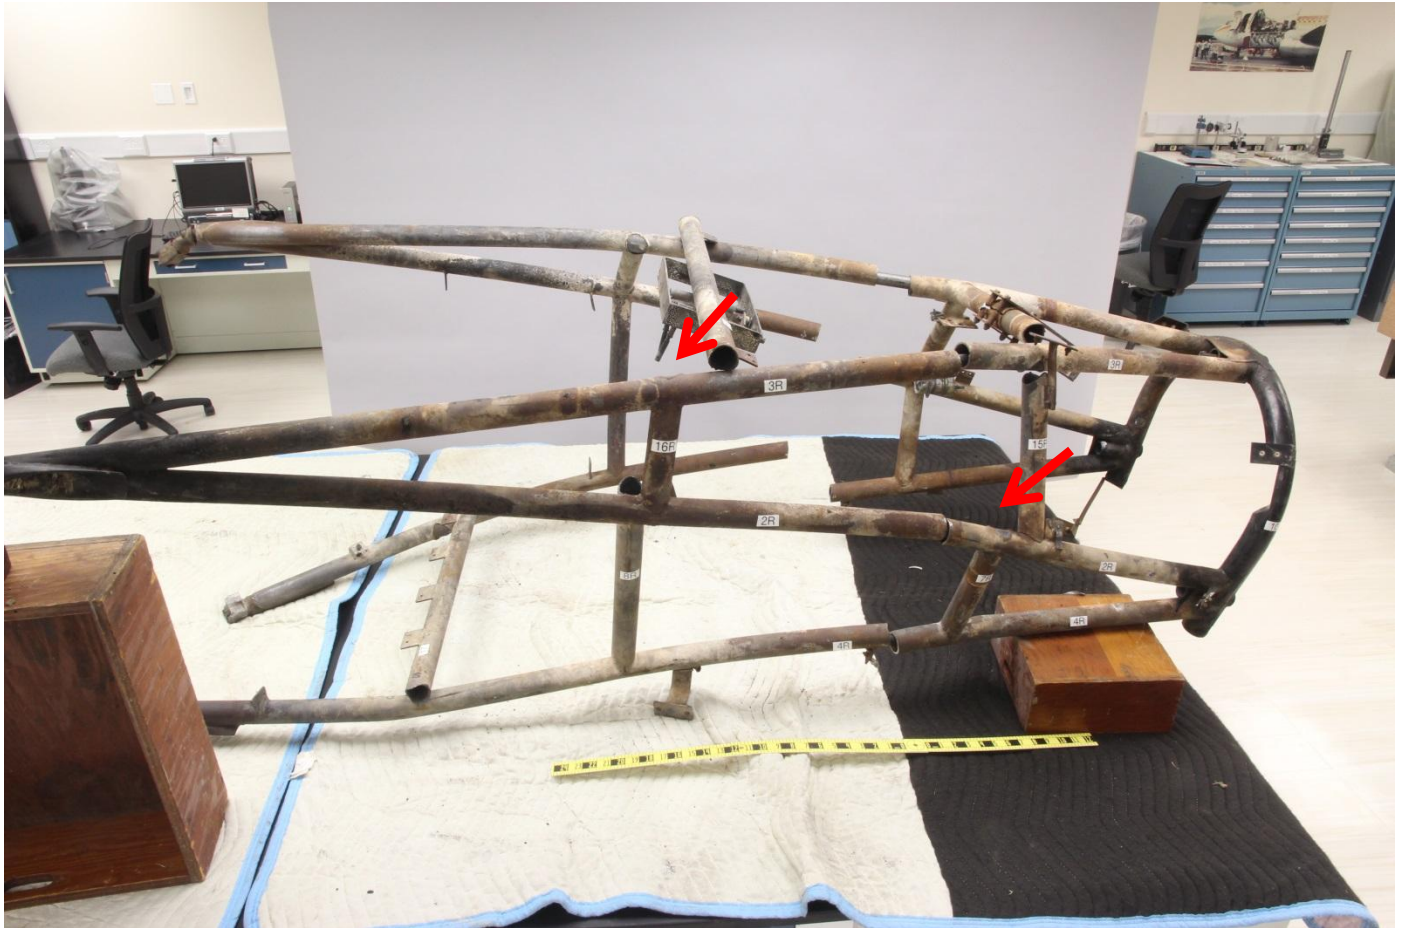
An overall right side view of the as received engine mount is displayed in figure 1. The mount contained multiple fractures and was saw cut into several pieces for shipping. Figure 2 displays left side and top view drawings of the mount. The mount was a welded tubular steel assembly that converted aircraft for use with a turbine engine instead of the original reciprocating engine.

Figure 1. A right side view of the as-received engine mount with tubes in approximate original positions. Numbers on tubes refer to individual items numbers as listed on the drawing with "R" and "L" used to indicate right and left sides. Red arrows indicate areas shown in figure 3.

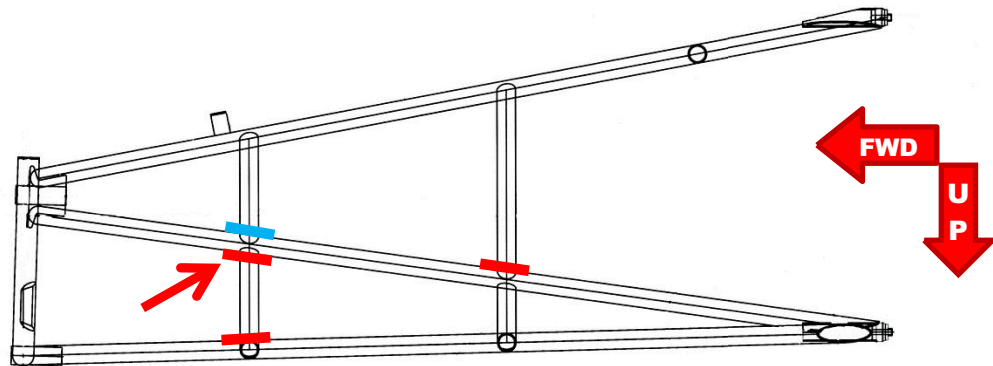
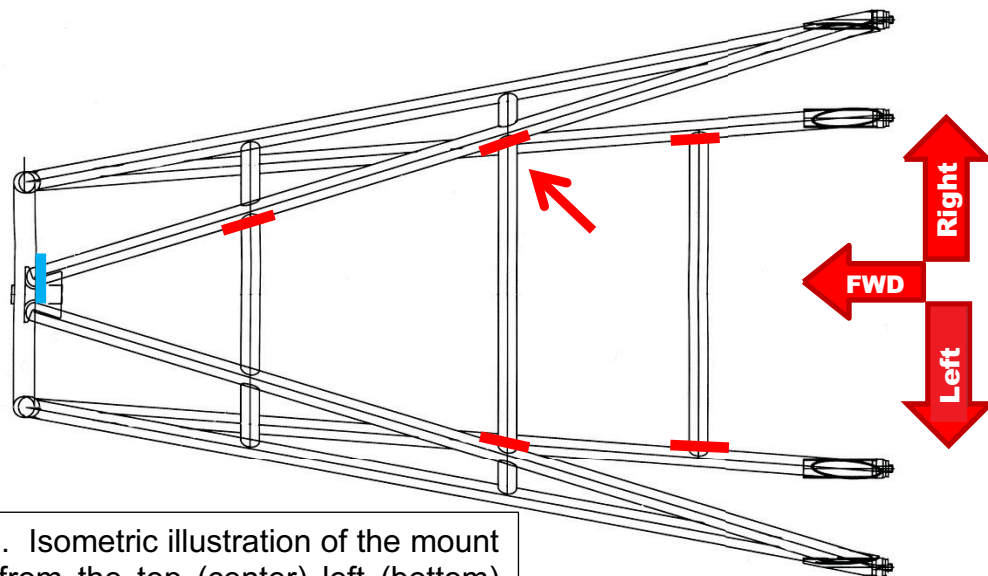
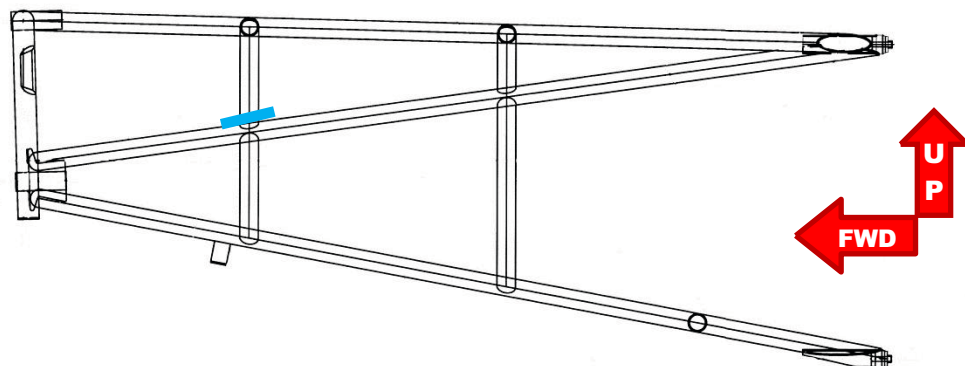
Visual examinations uncovered 8 fractures and three cracks in the assembly, all associated with assembly welds. The fracture and crack locations are indicated on the illustration of figure 2. Many areas on the mount displayed fire damage with the original paint burnt off and the tubing oxidized.

Figure 2. Isometric illustration of the mount viewed from the top (center) left (bottom) and right (top) perspectives. Red lines denote fractures, Blue lines cracks. Red arrow areas are shown in figure 3.

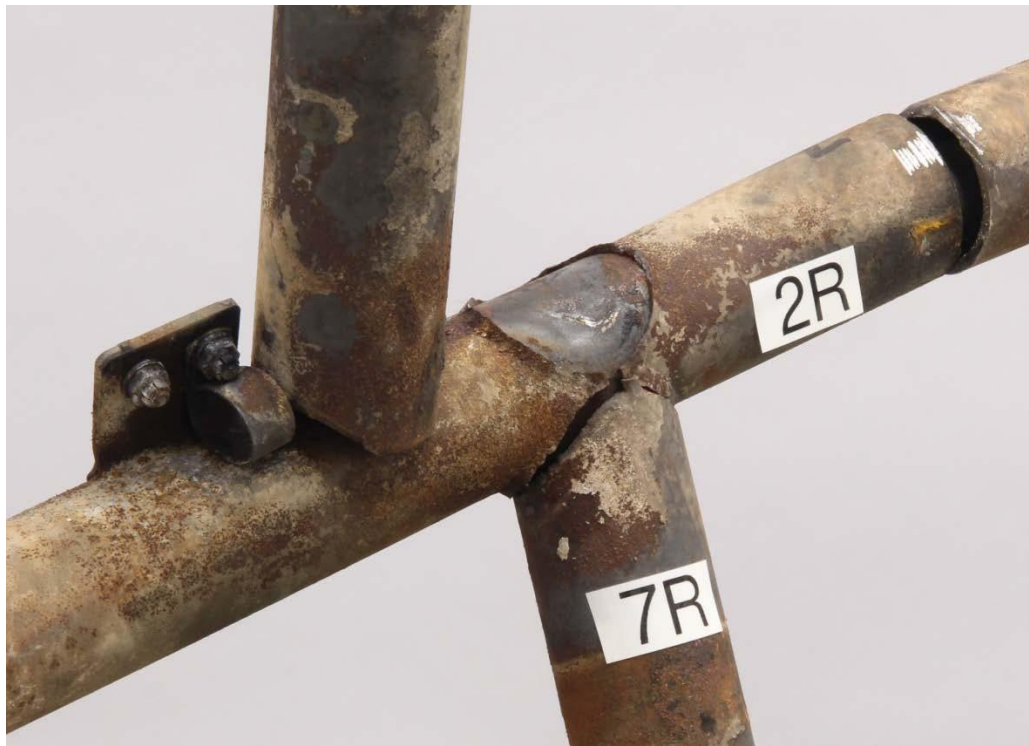
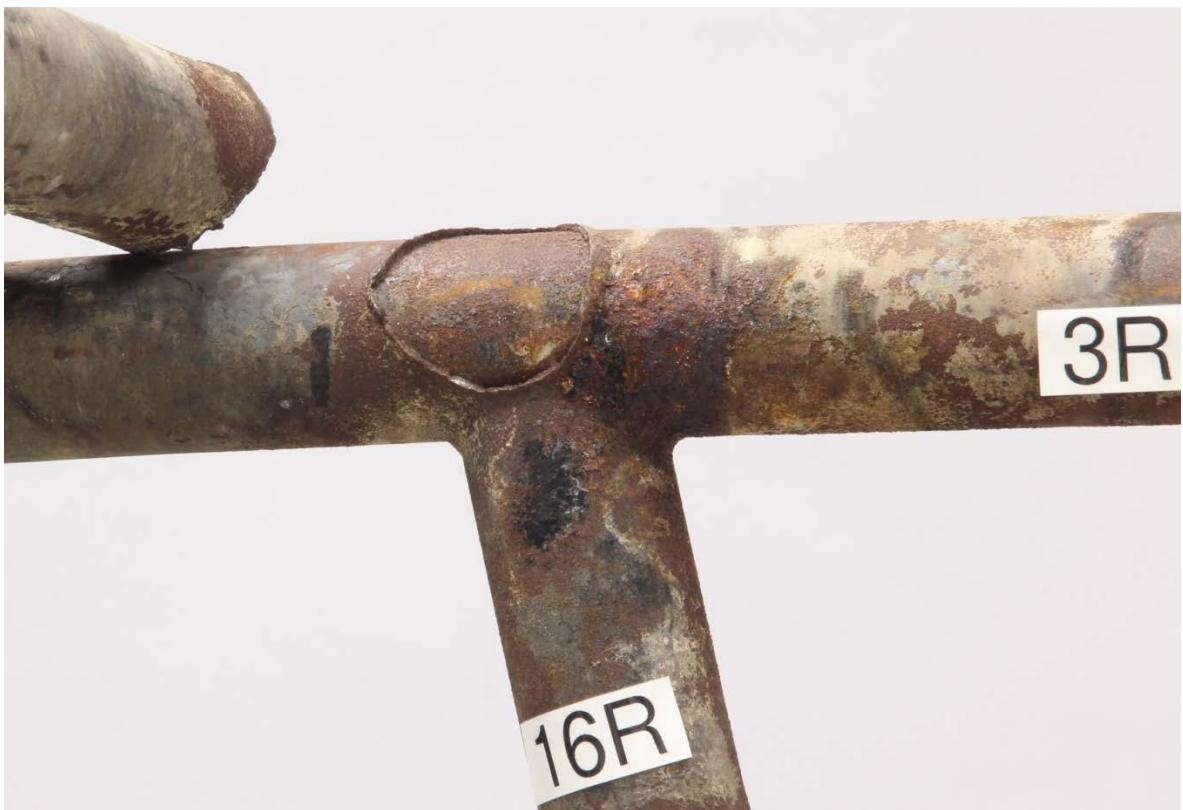
Closer examinations of the fractures and cracks revealed indications of overstress separations with no indications of progressive cracking or corrosion. The fracture paths in most cases were along the edges of the weld beads (fusion zones) with many also showing fracturing of the weld beads. Two examples of fractures are shown in figure 3.

A representative of the manufacturer indicated that all tube to tube welds were specified as fillet welds. Close examination of the fractured welds found that almost all welds showed complete penetration to the root of the weld with only one weld showing a short (<1/4 inch) length of incomplete penetration.

Figure 3. Two views of typical fractures and crack in the engine mount assembly.

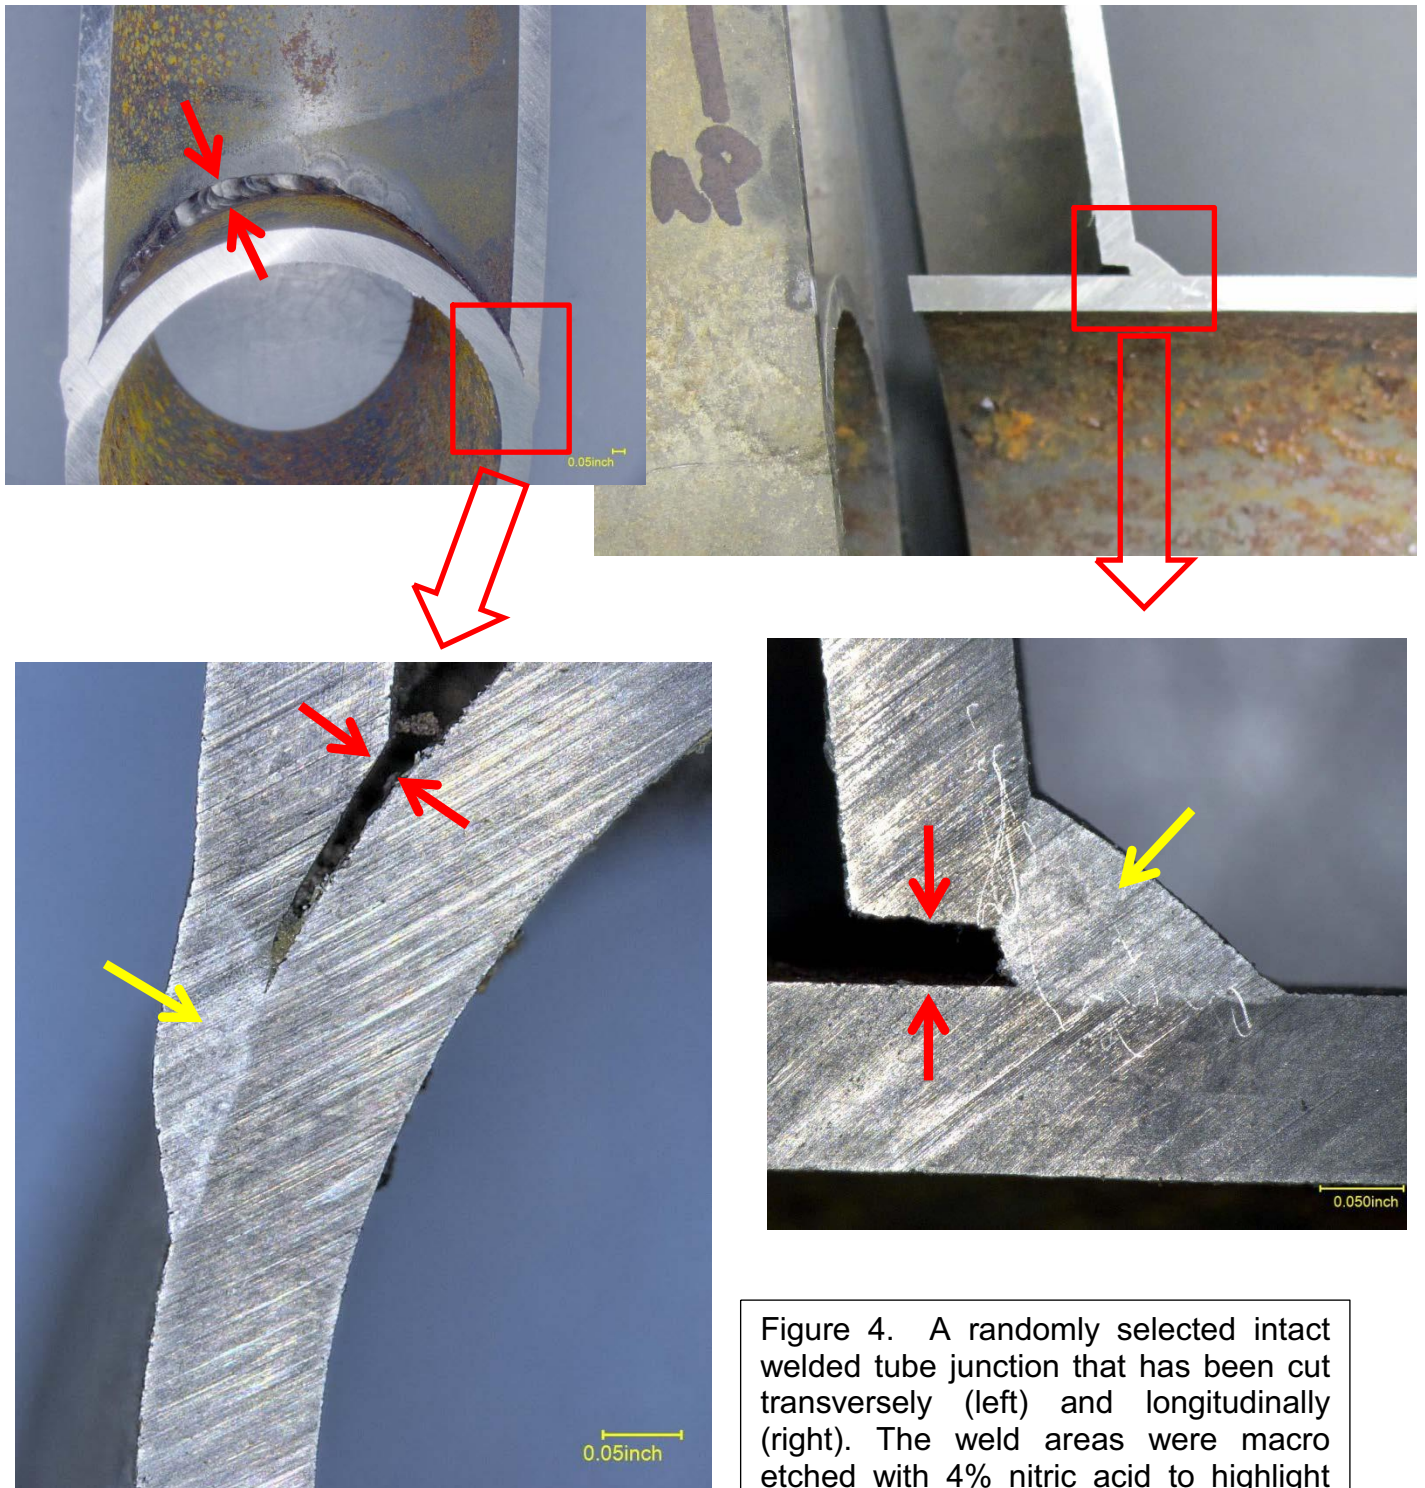
One intact weld was cross sectioned longitudinally and transversely as shown in figure 4. The fillet weld (yellow arrows) displayed complete penetration as shown, however fit-up between the tubes was not perfect and some separations between mating tubes were visible. The separations between tubes are indicated by opposed red arrows.

Figure 4. A randomly selected intact welded tube junction that has been cut transversely (left) and longitudinally (right). The weld areas were macro etched with 4% nitric acid to highlight the fusion zones (yellow arrows). Tube to tube separations are indicated by opposed red arrows.
