**NATIONAL TRANSPORTATION SAFETY BOARD**  
**Office of Aviation Safety**  
**Washington, D.C. 20594**

**POWERPLANT GROUP CHAIRMAN'S FACTUAL REPORT**

**NTSB No: DCA-13-MA-121**

Aircraft: de Havilland DHC-3 'Otter', Registration No. N93PC

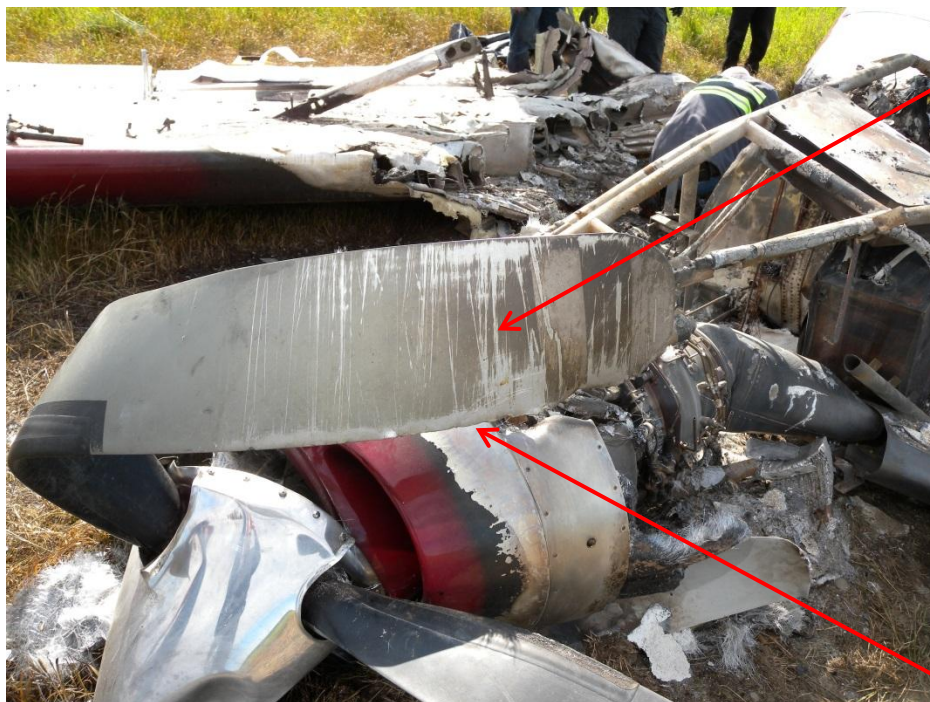
Figure 3 - Propeller blade – In-situ

On-scene, the engine was found within the main wreckage still contained within the nacelle/firewall engine mount frame and 'horse-collar' which had rolled on its right side. The engine exhibited extensive fire damage due to the post impact fire but none of its cases exhibited evidence of an un-containment or breach. All four propeller blades were present, attached to the propeller hub, and exhibited rotational scoring on the front surfaces, dents on the leading edges and torn tips.

Rotational  
Scoring  
Marks

Leading Edge  
Dents and Tears

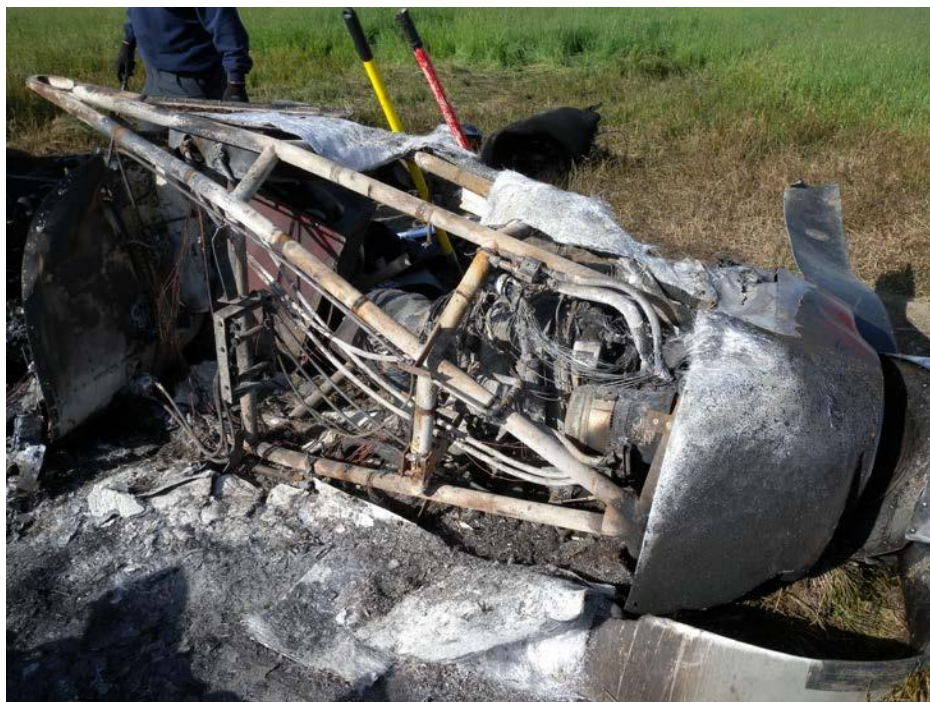
Figure 5 – Honeywell TPE331 Engine – On Scene

The engine was found still contained within the nacelle/firewall engine mount frame and 'horse-collar' and had rolled on its right hand side (Figure 5). The engine is supported in the front by three elastomeric engine mounts situated on the right, top and left side of the main gearbox. The left hand engine mount was fractured at the 'horse-collar' location of the engine mount frame and was missing. The upper engine mount was intact and attached to the engine and 'horse-collar'; however the elastomeric components were severely fire damaged. The right hand engine mount was intact, in location and undamaged. The single aft engine mount which is located on the top of the engine was connected to the engine, and the engine mount hanger was connected to the engine mount frame; however the hanger had slid along the engine mount frame support tube approximately 7 inches to the right of its normally centered location. All the metal mount tube surfaces were coated with a layer of tan-rust colored corrosion, consistent with fire damage.

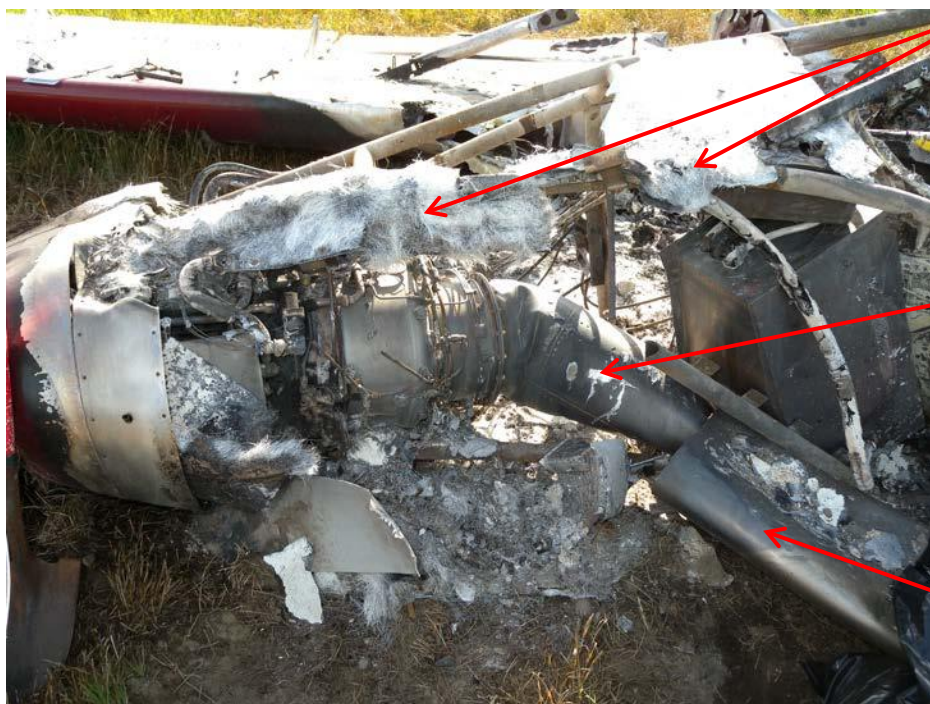
Figure 6 – Honeywell TPE331 Engine – On Scene

The majority of the nacelle skin is of a composite material, consistent with that of a fiberglass/resin construction. Almost the entire resin component of the composite material of the nacelle skin was consumed by fire, leaving only the fibrous matrix which no longer had structural integrity (Figure 6). Most of the loose fiber was separated from the nacelle frame and was on the ground around the nacelle area. The engine air inlet is aluminum crescent shaped duct which was intact but dented at the lower right hand corner with a maximum deformation of approximately 1 inch towards the left. The duct contained loose grass and dirt debris, most of which was near the front.

The primary exhaust pipe was intact; however it was bent near the engine attachment flange and dented near its aft section. The secondary exhaust tube was intact; however it was flattened along its length.

Nacelle  
Composite  
Skin Residuals

Primary  
Exhaust Pipe

Secondary  
Exhaust Pipe

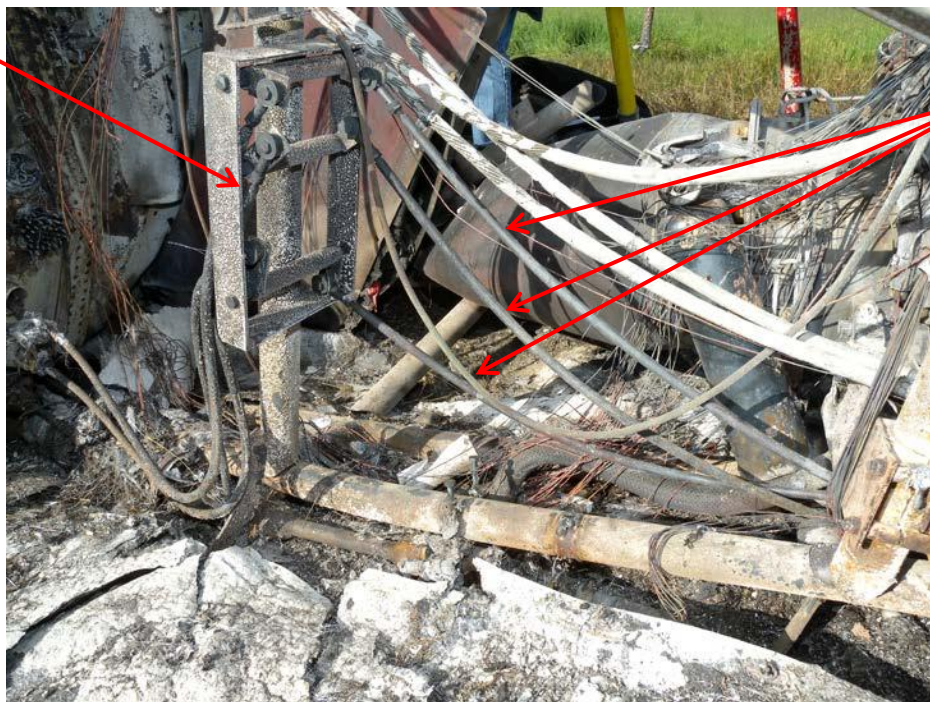
Figure 7 – Push-pull Tubes and Bell-crank Assembly

There are three engine control push-pull tubes which transmit pilot input from the (1) power lever, (2) speed lever, and (3) fuel shut-off and feather lever. From the cockpit control quadrant, the three primary push-pull tubes run through the firewall into a bell-crank assembly (Figure 7). From the bell-crank assembly, three secondary push-pull tubes run to the engine accessories they control: the (1) Fuel and pitch controller, (2) Propeller speed governor and engine speed control, and (3) Fuel shut off and feather valve. The cockpit control quadrant assembly was fractured, separated and fire damaged. Only the top portion two levers were found but they were separated from the quadrant assembly, and therefore no final lever position could be established. The primary push-pull tubes were found intact and in location but bent. The aft ends of the primary push-pull tubes were not connected to the quadrant levers, however the spherical bearings on both ends were intact, as were the connecting bolts, nuts and cotter pins. The forward ends of the primary push-pull tubes were still connected to the bell-crank assembly. The

three secondary push-pull tubes were intact but bent. The aft spherical bearing ends were connected to the bell-crank assembly and the cotter pins were in location. The forward ends of the secondary push-pull tubes were still connected to their respective engine accessory and the cotter pins were still in location.

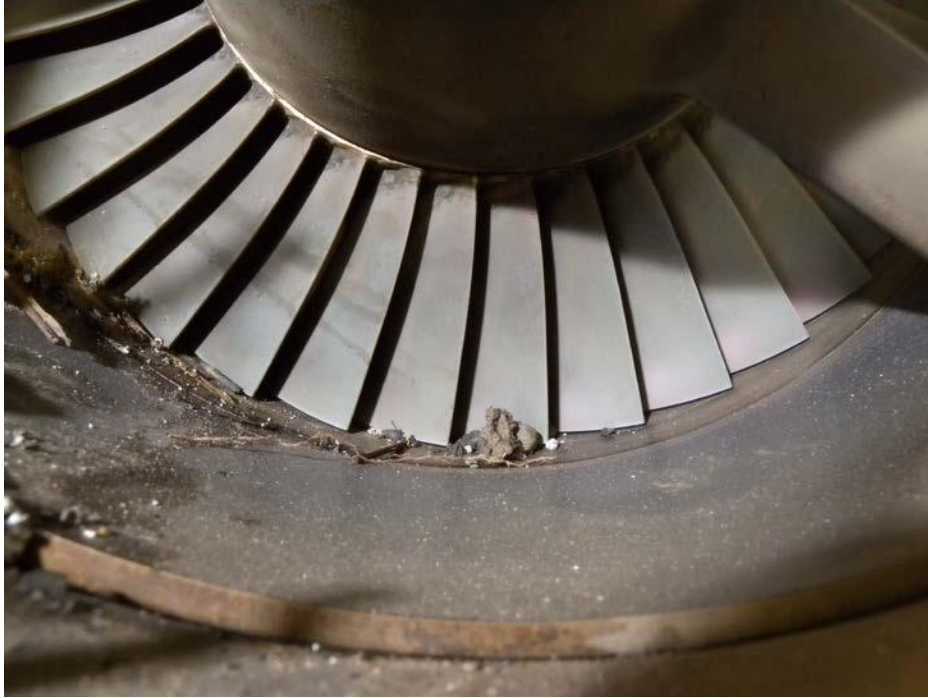
Figure 9 – 3<sup>rd</sup> Stage Turbine Wheel – Intact

The engine was generally intact with all external components and accessories fire damaged. There were no signs of uncontainment. The front of the engine was sooted while the aft was free of soot and oil, consistent with pyrolytic cleaning. The 1<sup>st</sup> stage impeller appeared to be clean and undamaged as viewed through the inlet duct (Figure 8). Once the powerplant was removed from the airplane, the propeller could be turned with some even resistance. With the 3<sup>rd</sup> stage turbine wheel physically restrained, the propeller shaft could be turned, indicating discontinuity between the power section and the gearbox, which is consistent with a sheared torsion shaft, consistent with a sudden propeller stoppage event. Removal of the primary exhaust duct permitted access to the 3<sup>rd</sup> stage turbine wheel, which was found to be intact and undamaged (Figure 9).

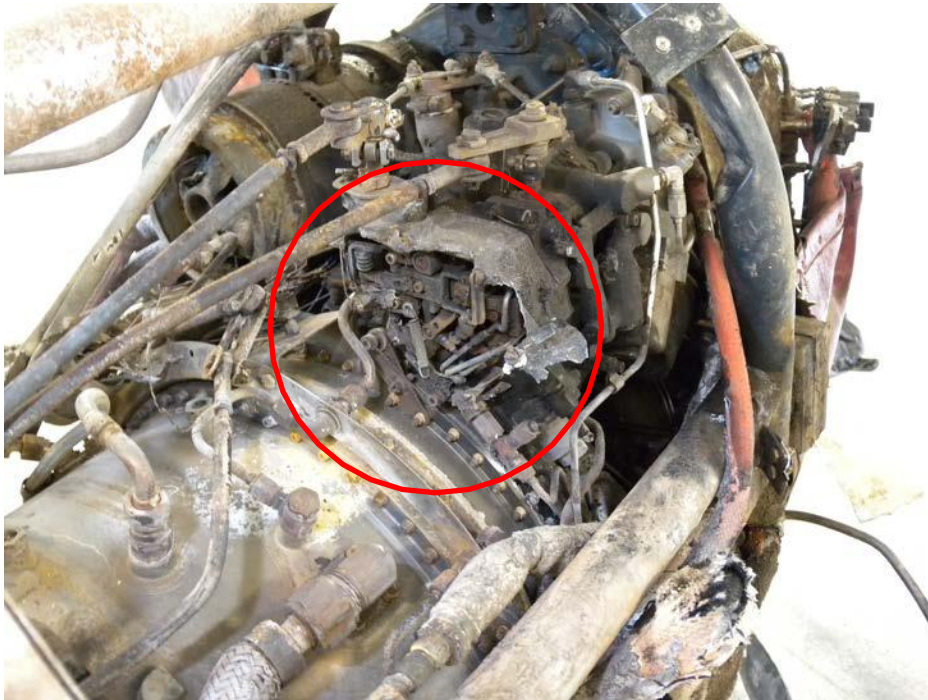
Figure 10 – Fuel Control Unit (FCU) - Breached

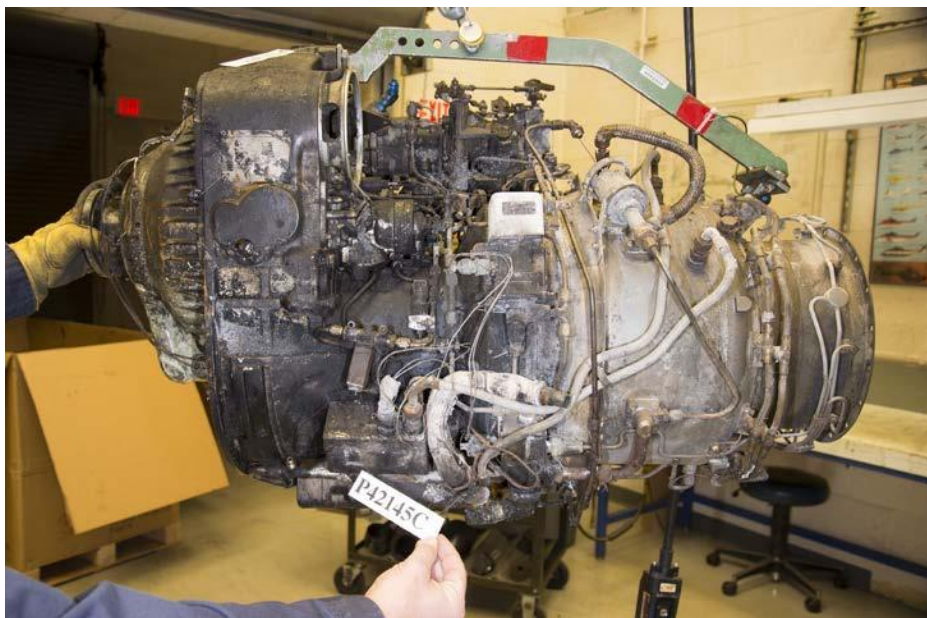
Figure 11 – Honeywell TPE331-10R-511C Engine – As Received

The engine ([Figure 11](#)) was externally generally intact; however, coated with an oily film. Additionally, the left side of the gearbox and compressor housings were coated with soot. A section of the gearbox housing 'boat-tail' flange between 1:30 and 3:00 o'clock<sup>2</sup> was melted, exposing the inner 1<sup>st</sup> stage compressor housing ([Figure 12](#)). The engine showed damage generally consistent with impact and fire damage.

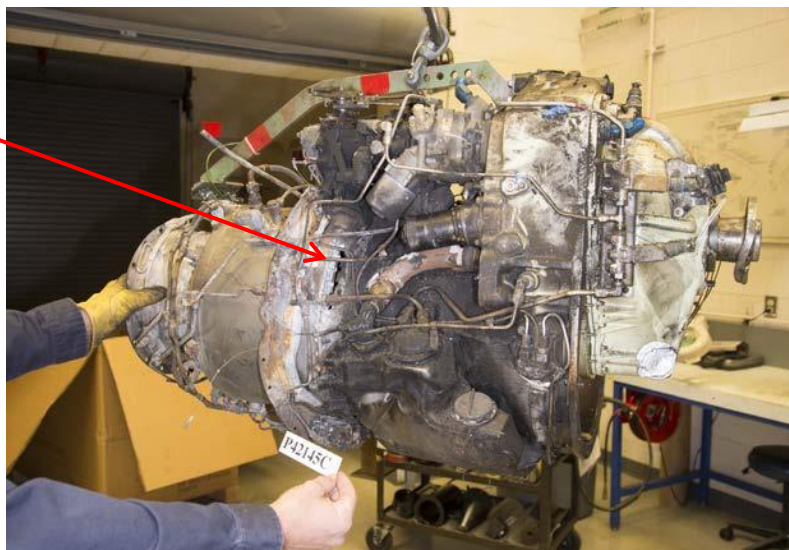
Figure 12 – Honeywell TPE331-10R-511C Engine – As Received

Gearbox  
Housing  
'Boat-Tail'  
Flange Melted

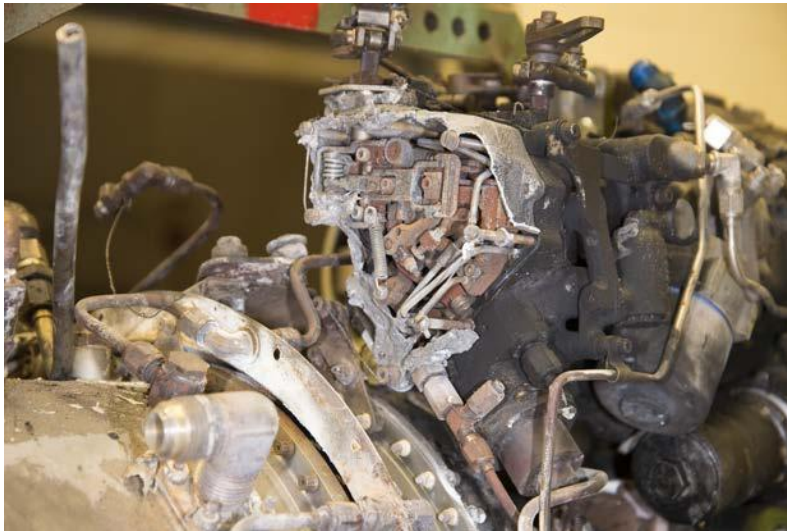
The fuel pump was intact but was not removed from the engine. The aft cover of the fuel control was melted, exposing the internal mechanical controlling components. The internal components were also fire damaged and corroded, making testing of the fuel control impossible (Figure 13).

Figure 13 – Fuel Control Unit – Melted Aft Cover

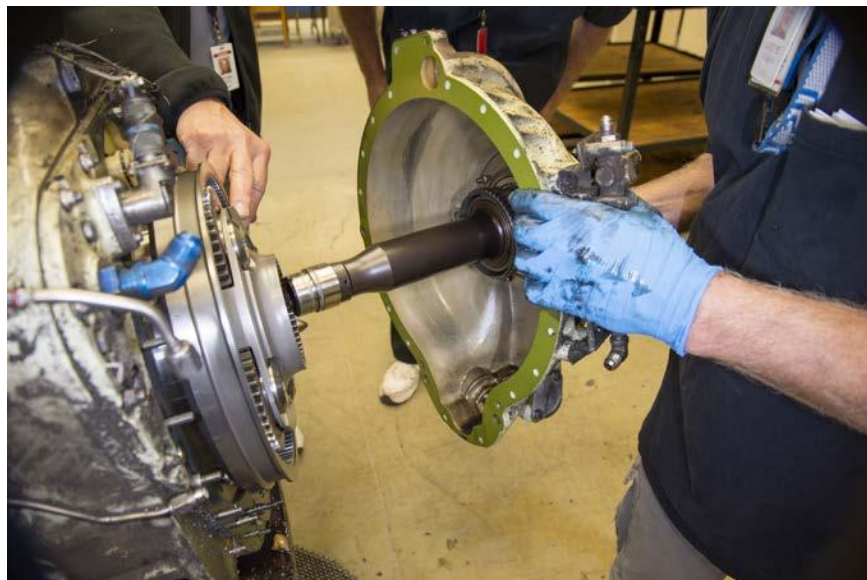
Figure 14 – Nose Cone & Propeller Shaft Being Removed

The nose cone was intact and undamaged, and oil was seen leaking from the mating flange when removed from the gearbox housing (Figure 14). The two propeller shaft flange dowel pins were missing. The propeller shaft flange was bent along a line of three consecutive bolts. The propeller shaft had several rotational score marks along its length, consistent with contact against the inner bore of the sun gear while rotating (Figure 15 & Figure 16). The forward propeller shaft bearing was clean, oil wetted, and rotated freely. The threads of four of the 7 propeller shaft bearing support bolts in the lower right quadrant were sheared, but the nuts were still in location.

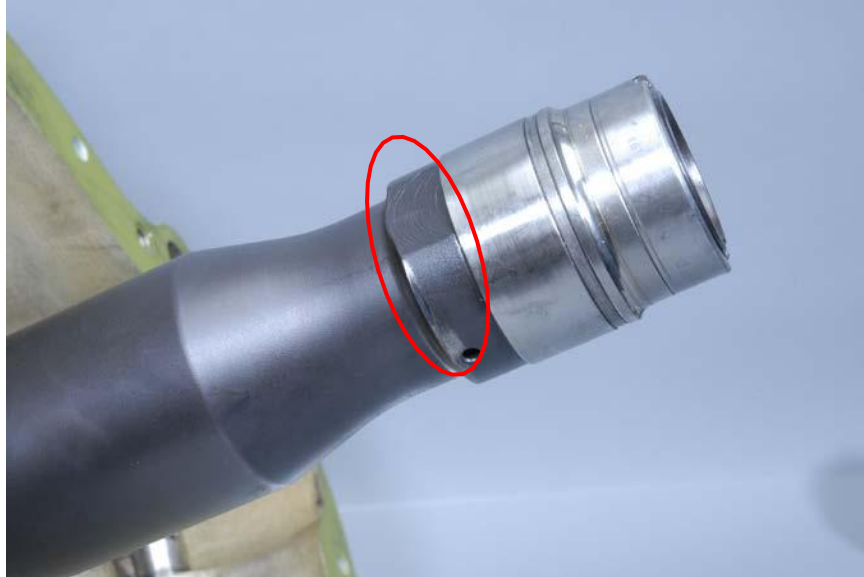
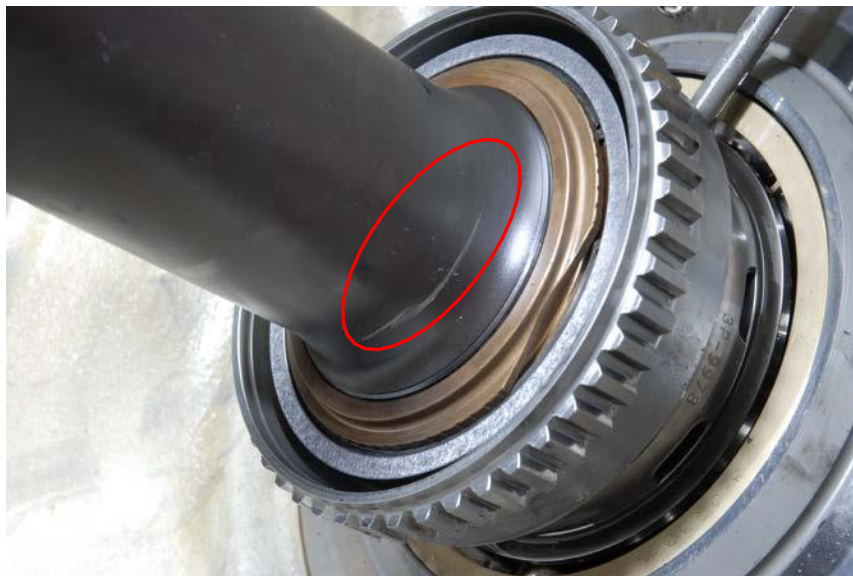
Figure 15 – Propeller Shaft – Rotational Scoring

Figure 16 – Propeller Shaft – Rotational Scoring

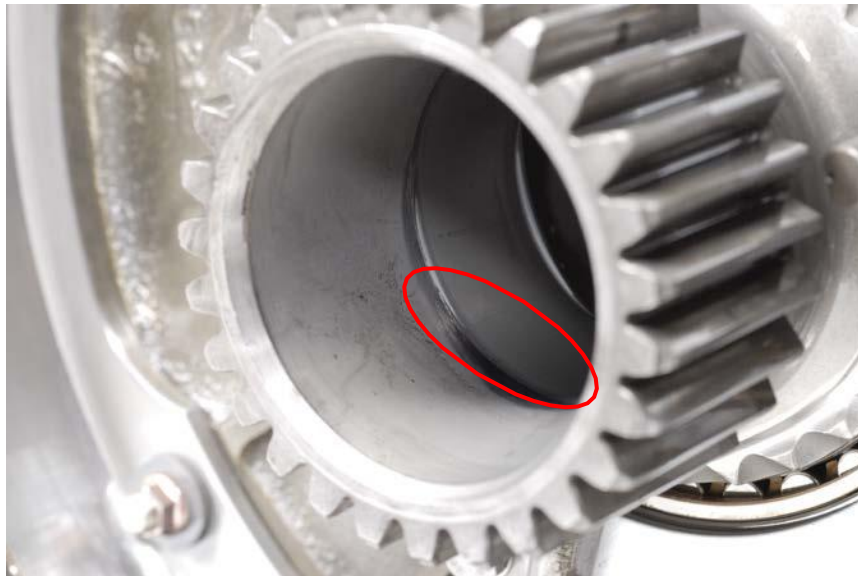
The ring gear and its three retaining brackets were intact & undamaged. The forward gear teeth of the sun gear exhibited coarse witness marks on the contact surfaces, however it was intact and otherwise undamaged. The internal bore of the sun gear was rotationally scored in the locations where bore diameters changed, consistent with the matching score locations of the outer diameter of the propeller shaft (Figure 18). The oil nozzles, which direct oil into the sun gear mesh, were intact and undamaged.

Figure 18 – Rotational Scoring On Inner Bore Of Sun Gear

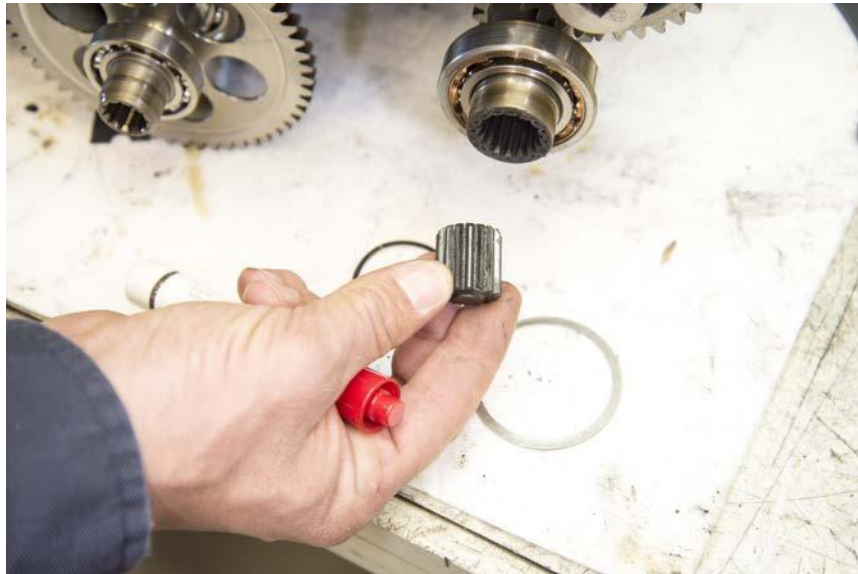
A sheared section of the airframe starter/generator (S/G) output shaft was found in the S/G input spline of the gearbox (Figure 19), consistent with a sudden stoppage of the engine. The diaphragm was removed from the gearbox and the internal components were all oil wetted. All of the hydraulic drive, propeller governor drive, S/G drive gears and

Figure 19 – Sheared Starter Generator spline

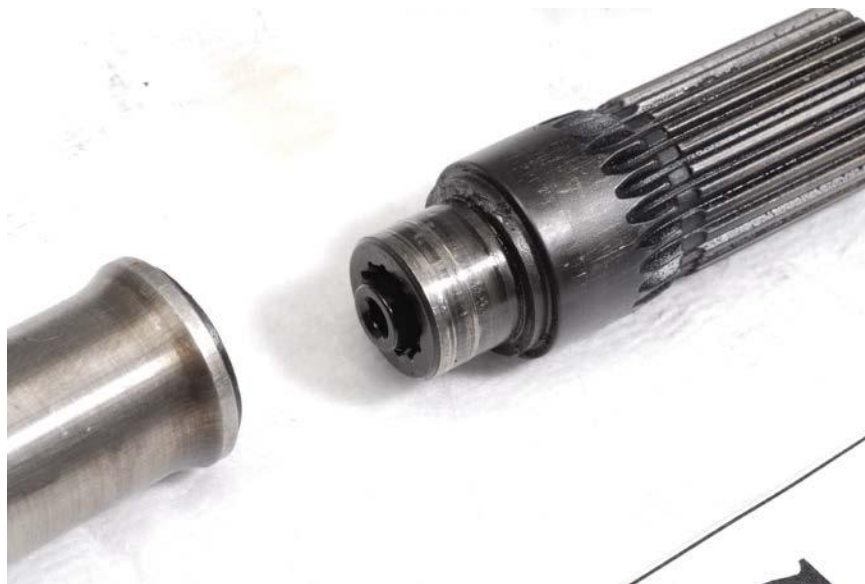
The rear turbine bearing housing was undamaged and the rear bearing was oil wetted and darkened, consistent with normal operation (Figure 23). The rear oil scavenge pump was removed from the rear bearing turbine housing and was undamaged. The front internal and aft external splines of the torsion shaft were undamaged; however, the torsion shaft itself was sheared just forward of the aft external spline, consistent with a rotating engine sustaining a sudden propeller stoppage (Figure 24).

Figure 24 – Sheared Torsion Shaft

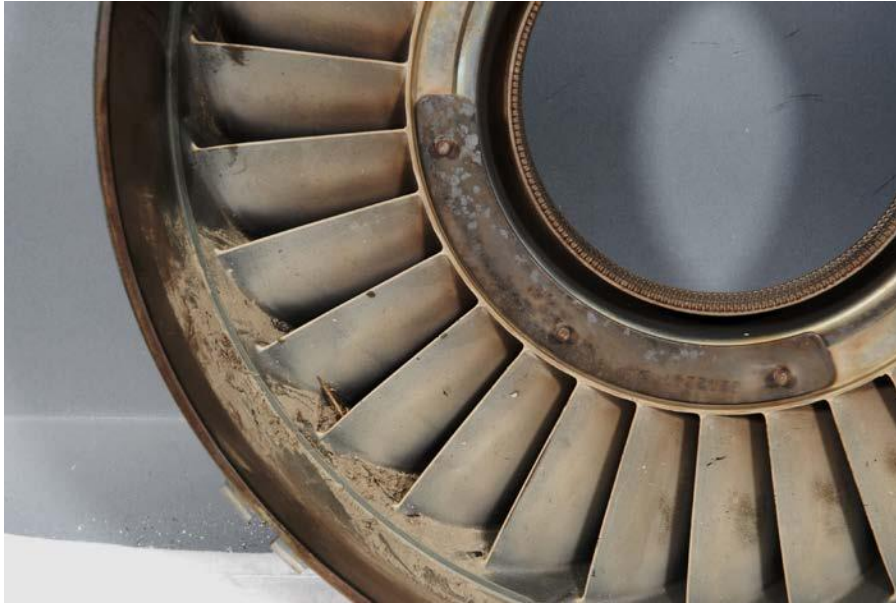
The 3<sup>rd</sup> stage turbine nozzle was undamaged. There was metal spray on the convex side of the several vanes near the trailing edge (Figure 25). The honeycomb labyrinth seal was moderately grooved.

Figure 25 – 3<sup>rd</sup> Stage Turbine Nozzle – Metal Spray (White Speckles)

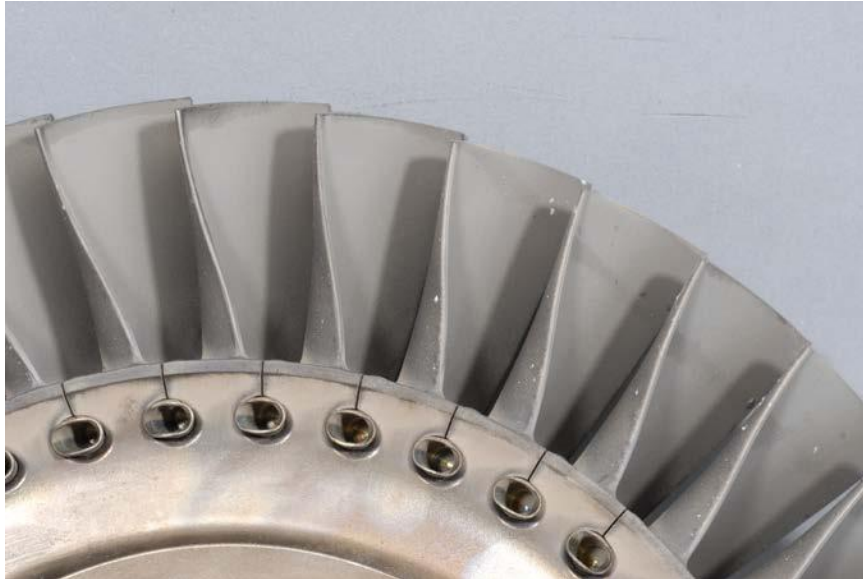
The 2<sup>nd</sup> stage turbine blisk hub, blades and curvic coupling were undamaged. The knife edge seals were intact. There was metal spray on the convex side of several blades near the leading edges (Figure 26).

Figure 26 – 2<sup>nd</sup> Stage Turbine Blisk – Metal Spray (Silver Speckles)

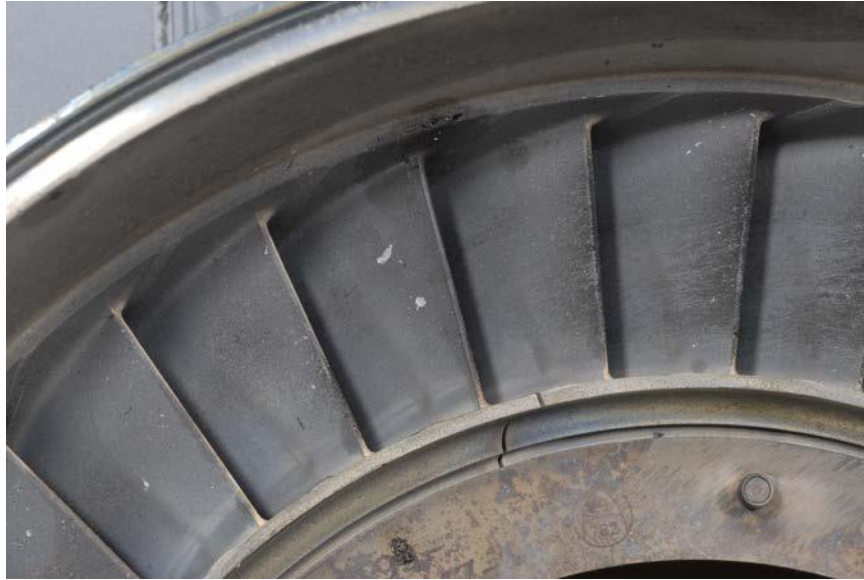
The 2<sup>nd</sup> stage turbine nozzle was undamaged. There was metal spray on the convex side of the several vanes near the trailing edge (Figure 27).

**Figure 27** – 2nd Stage Turbine Nozzle – Metal Spray (Silver Speckles)

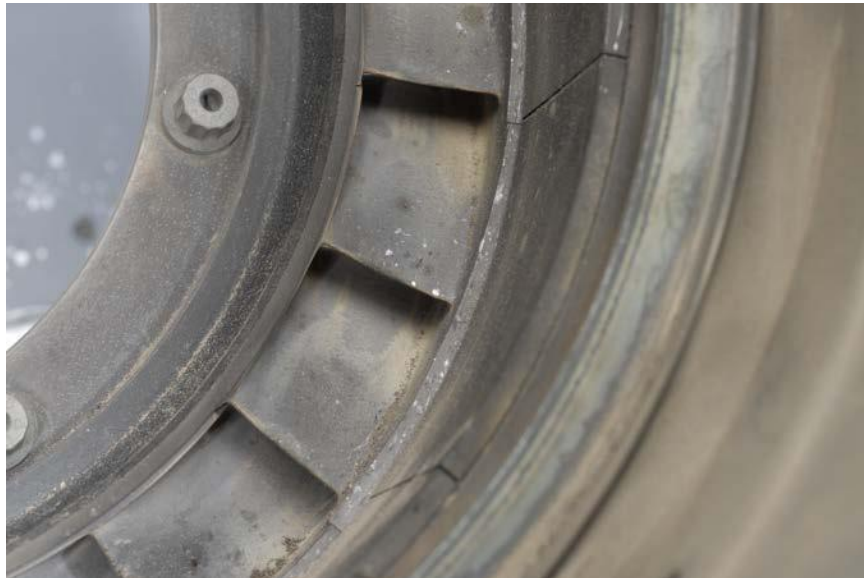
The 1<sup>st</sup> stage turbine nozzle was undamaged. There was metal spray on the convex side of the several vanes near the trailing edge (Figure 28).

**Figure 28** – 1<sup>st</sup> Stage Turbine Nozzle – Metal Spray (White Speckles)

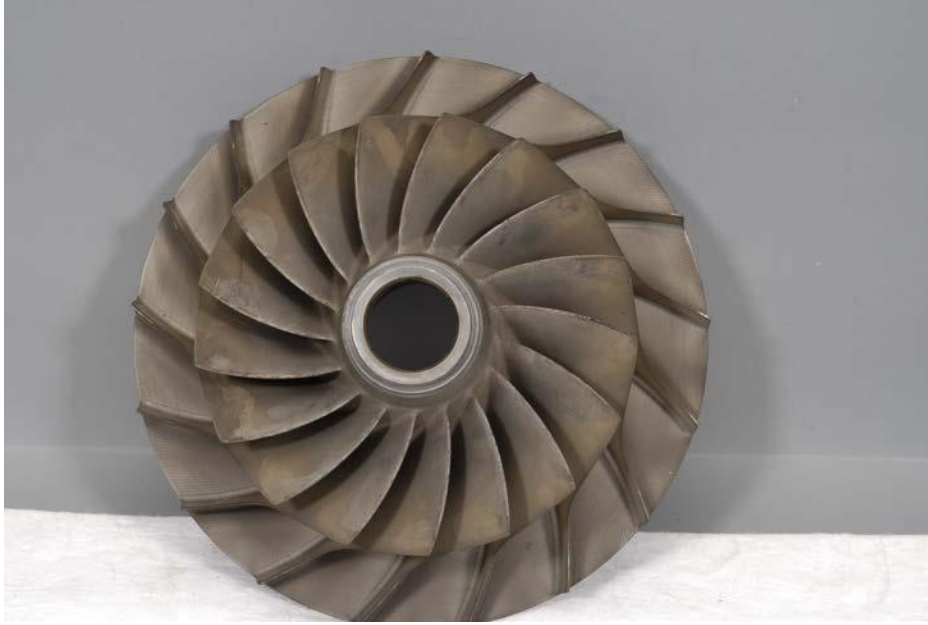
Figure 29 – 1<sup>st</sup> Stage Impeller Wheel – Intact

The 1<sup>st</sup> stage impeller was intact; however, the leading edges of all vanes had numerous very small dents (Figure 29). The aft curvic coupling was undamaged. The 1<sup>st</sup> stage impeller shroud showed heavy rotational scoring in the lower right hand quadrant near the inducer side, where all the abradable material was missing, exposing the parent structural metal below. This is consistent with an impact from the right side.

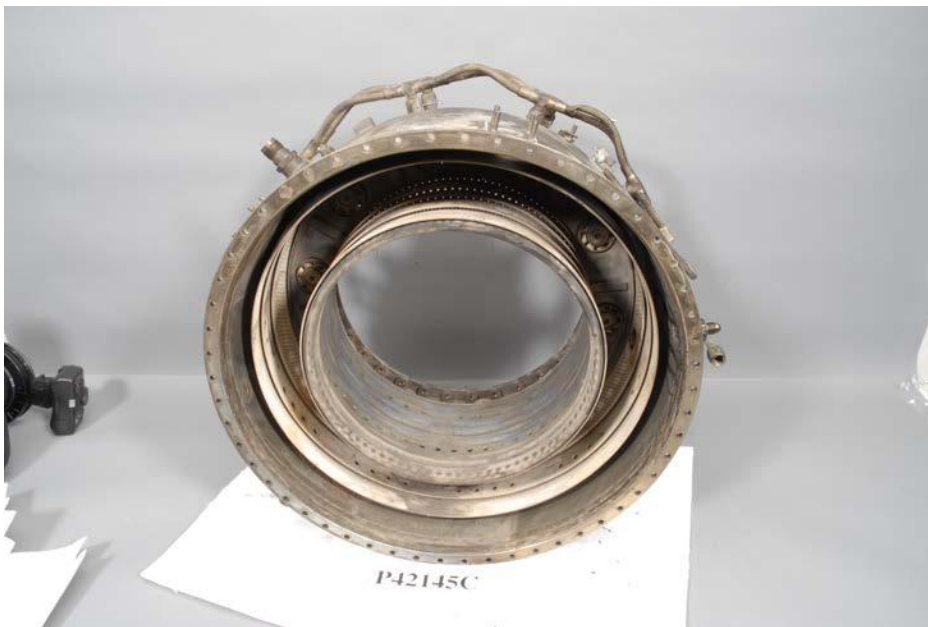
Figure 30 – Combustor Housing and Liner

The combustor and combustor housing were coated with a light-gray powdery material but were otherwise intact and undamaged (Figure 30). The fuel nozzles were intact and undamaged (Figure 31). The combustor was not further disassembled.

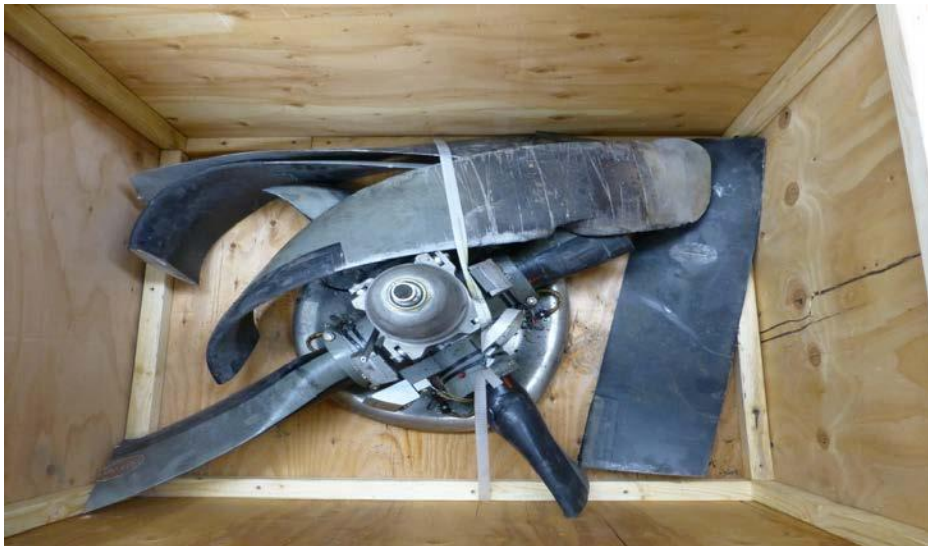
Figure 32 – Propeller – As Received

All four blades had been cut near the hub on-scene for shipping (Figure 32). The spinner was not returned. The blades were numbered 1 to 4 in a clockwise pattern as viewed from the rear of the propeller. Blade No. 1 was chosen randomly. The hub serial number was between the No. 3 and No. 4 blades. Blade No. 1 was in the feather position,

blade No. 2 was in the low blade angle setting, blade No. 3 was in the reverse setting and blade No. 4 was in extreme reverse when received. The spinner bulkhead was intact, however it was slightly bent along the edges. All eight engine/prop mounting bolts were stripped out of the mounting flange threads. It was not possible to functionally test the propeller because of the severe damage.

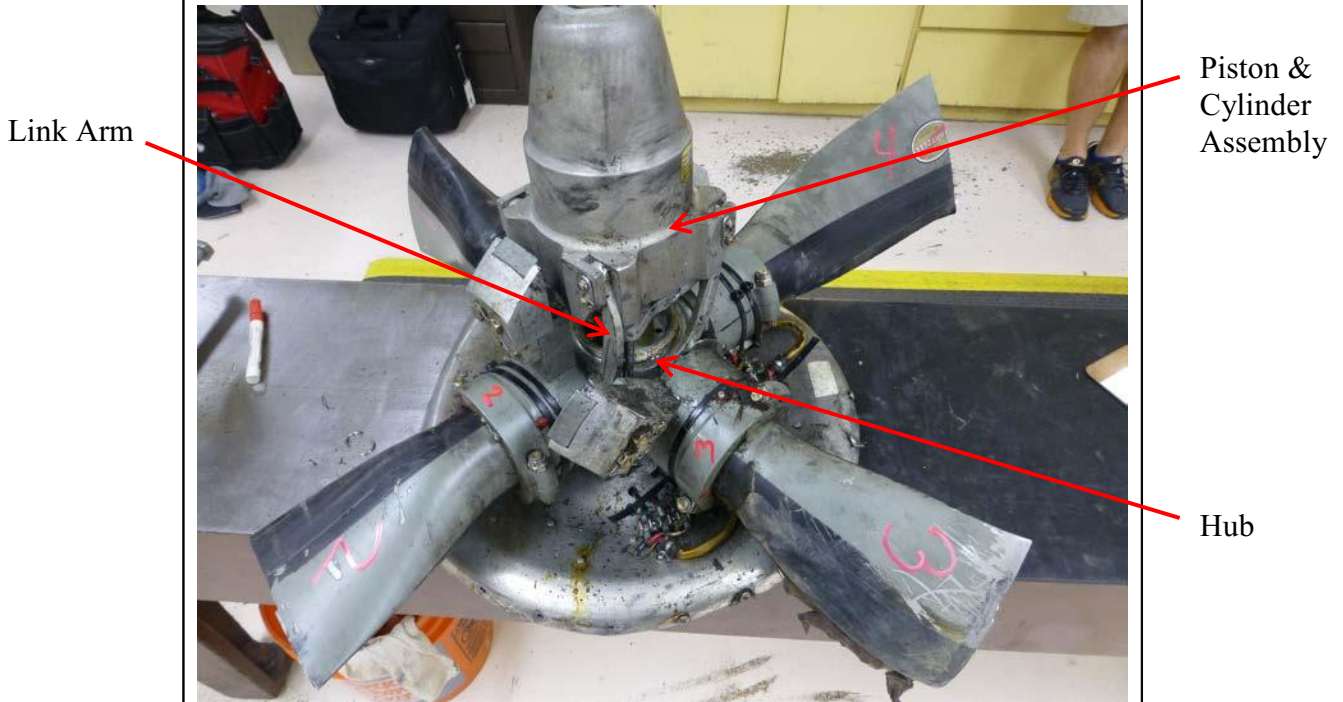
The piston and cylinder assembly was stripped from the hub thread (Figure 33) and was held in place only by the link arms. Additionally, the cylinder base was fractured near one of the guide rod sleeve holes (Figure 34). The guide rods were intact, however they were bent. The pitch change rod was bent and could not be removed from the piston. The link arms were intact. The feathering spring and guides were intact (Figure 35).

Figure 33 – Piston and Cylinder Assembly Stripped From Hub

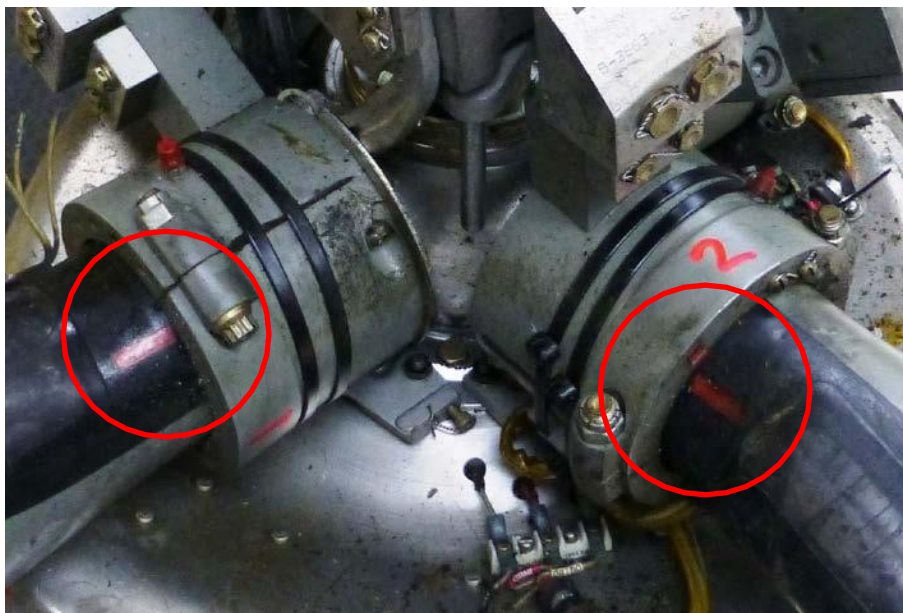
The red paint blade and clamp alignment indicators of all four blades were not coincident, indicating that they had rotated within their respective clamps (Figure 36), consistent with a severe prop strike.

Figure 36 - Blade Alignment Indicators - Misaligned
