## **NATIONAL TRANSPORTATION SAFETY BOARD**

# **AIRWORTHINESS**

## **Group Chairman's Factual Report**

**DCA13MA121**

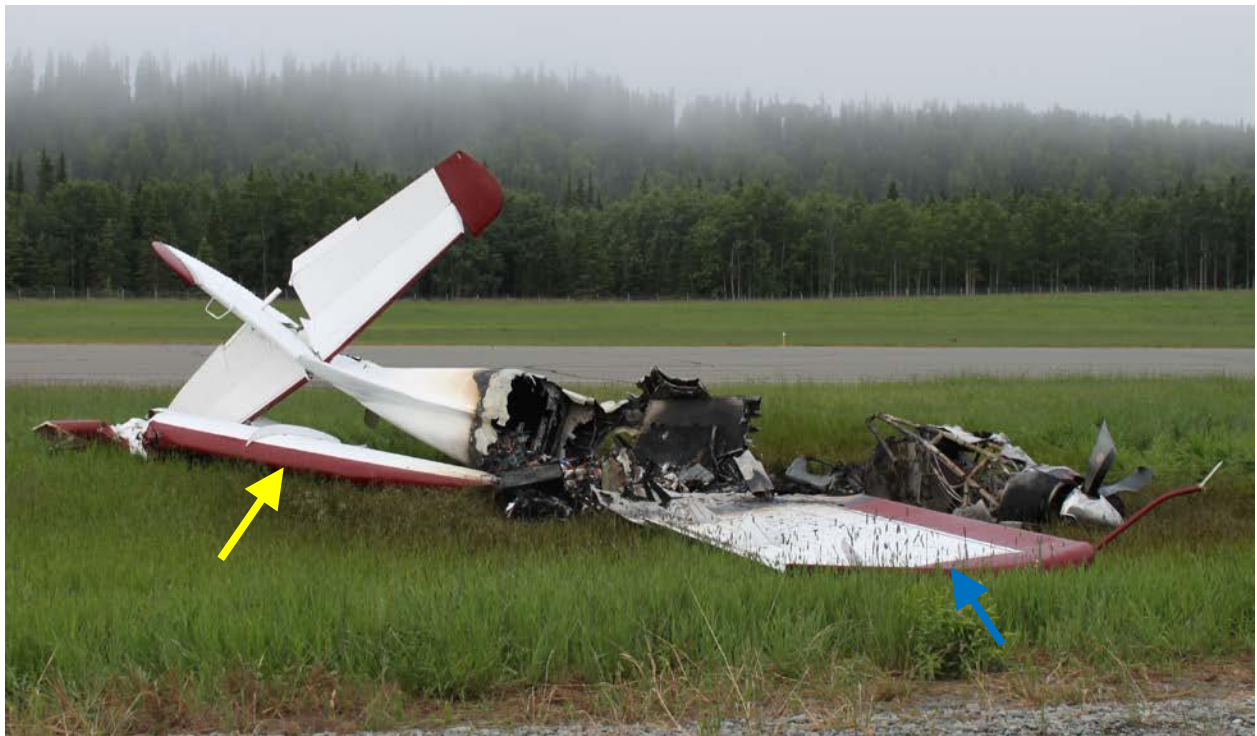
**Figure 2 – N93PC airplane wreckage**

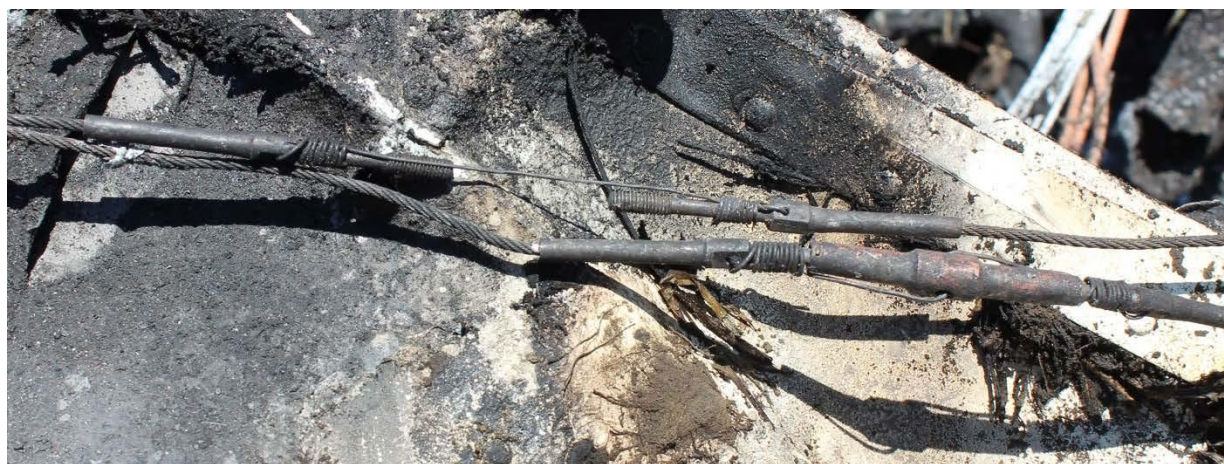
Figure 4 – Pitch trim cable turnbuckles

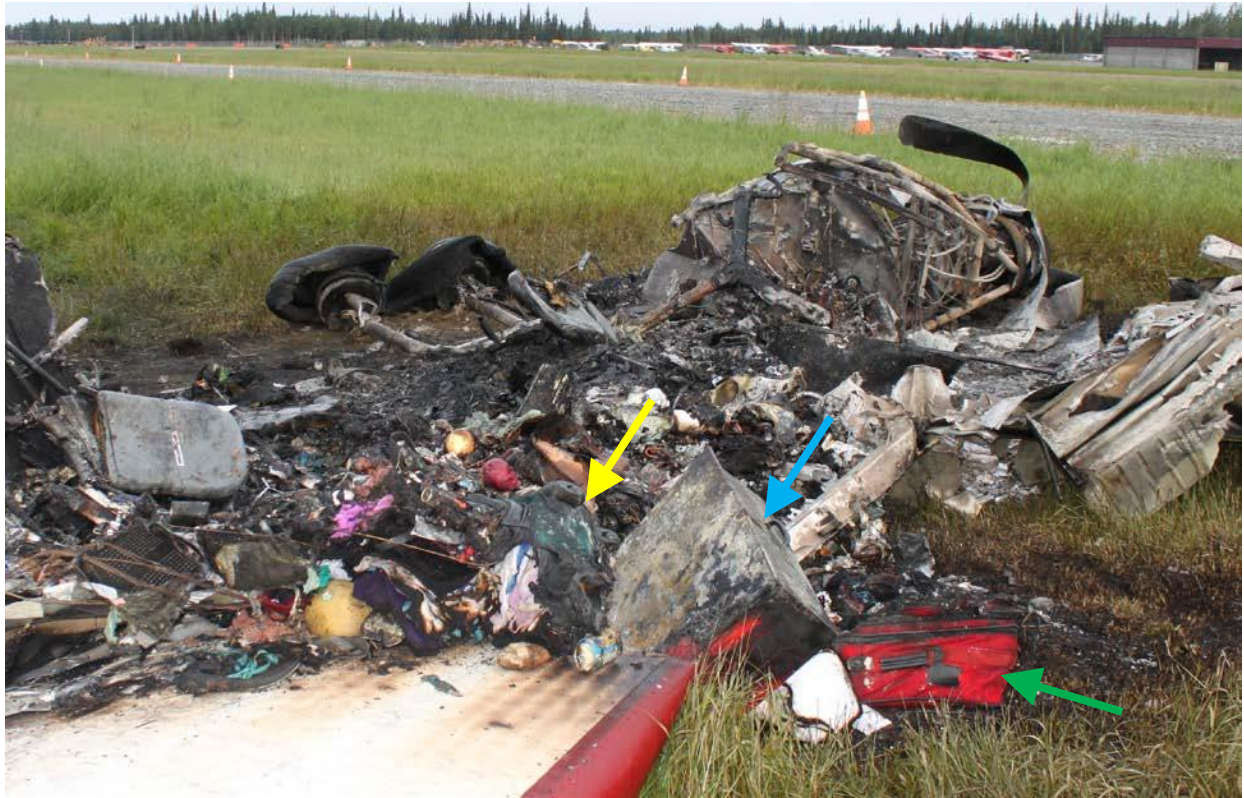
**Figure 7 – Baggage and cargo in airplane wreckage**

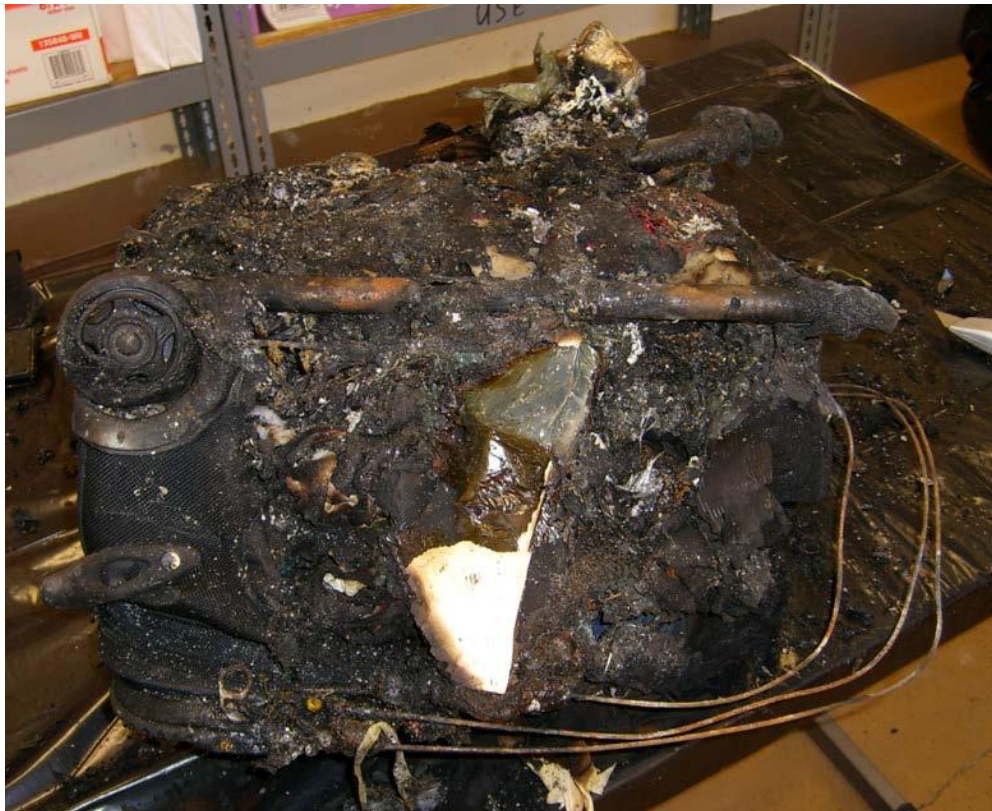
**Figure 8 – Small black roller bag recovered in wreckage**

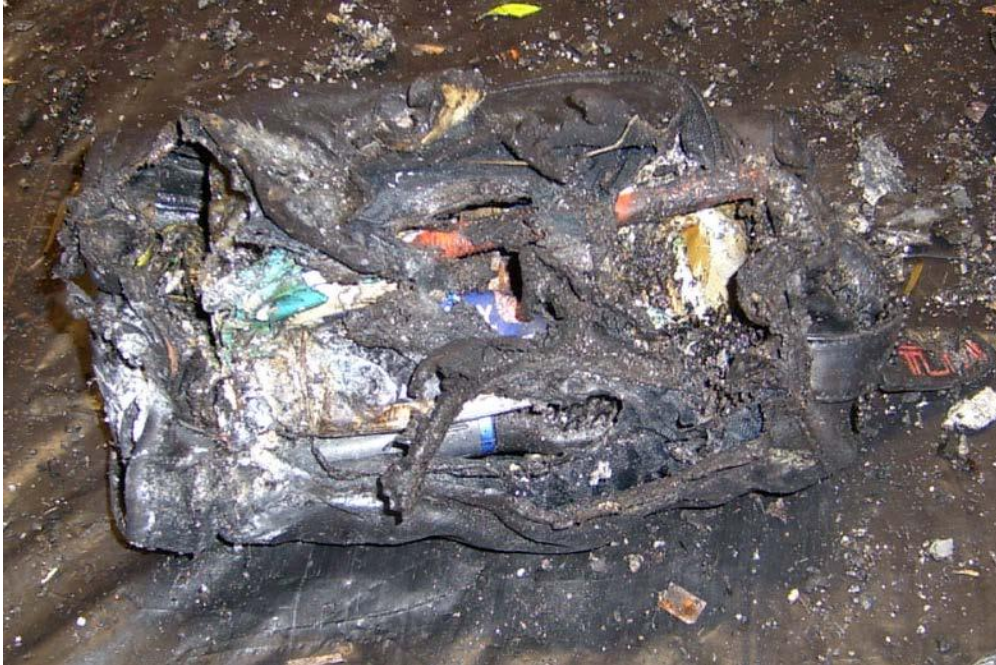
**Figure 9 – Small black Tumi carry-on bag recovered in wreckage**

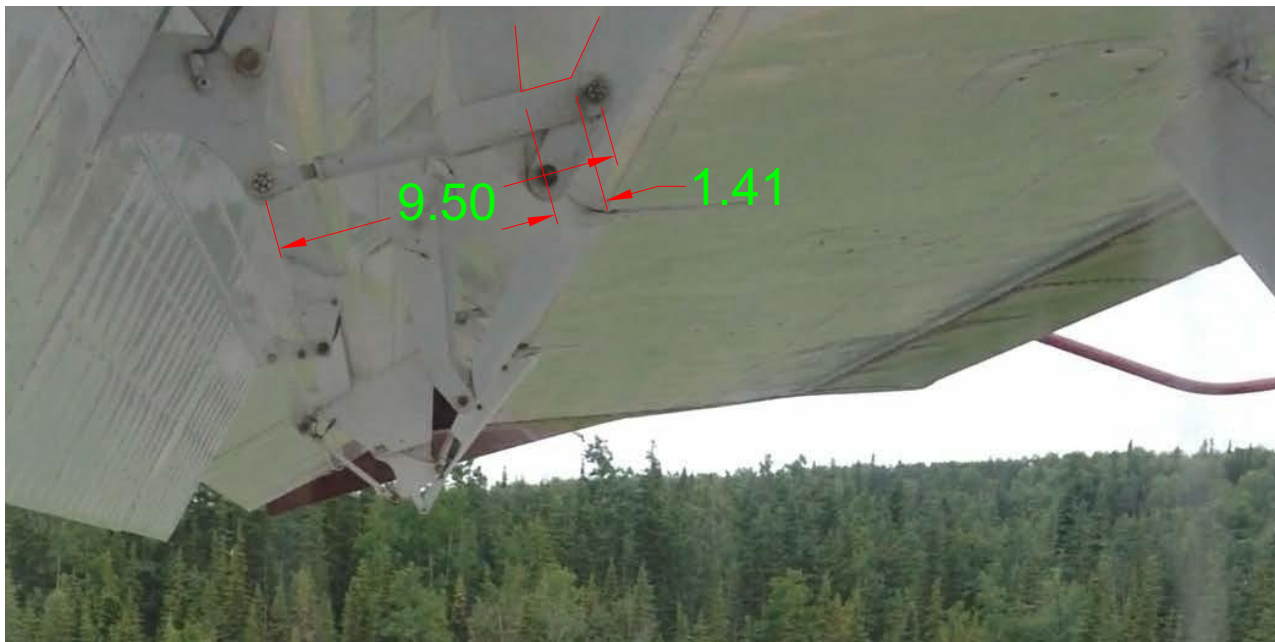
**Figure 12 – N93PC center flap hinge during takeoff**
