**NATIONAL TRANSPORTATION SAFETY BOARD**

**SYSTEMS GROUP CHAIRMAN'S FACTUAL REPORT**

**DCA14FA058**

Operator: Trans States Airlines  
Location: Memphis, TN  
Date: February 5, 2014  
Time: 0015 CST  
Airplane: EMB 145 EP, N802HK

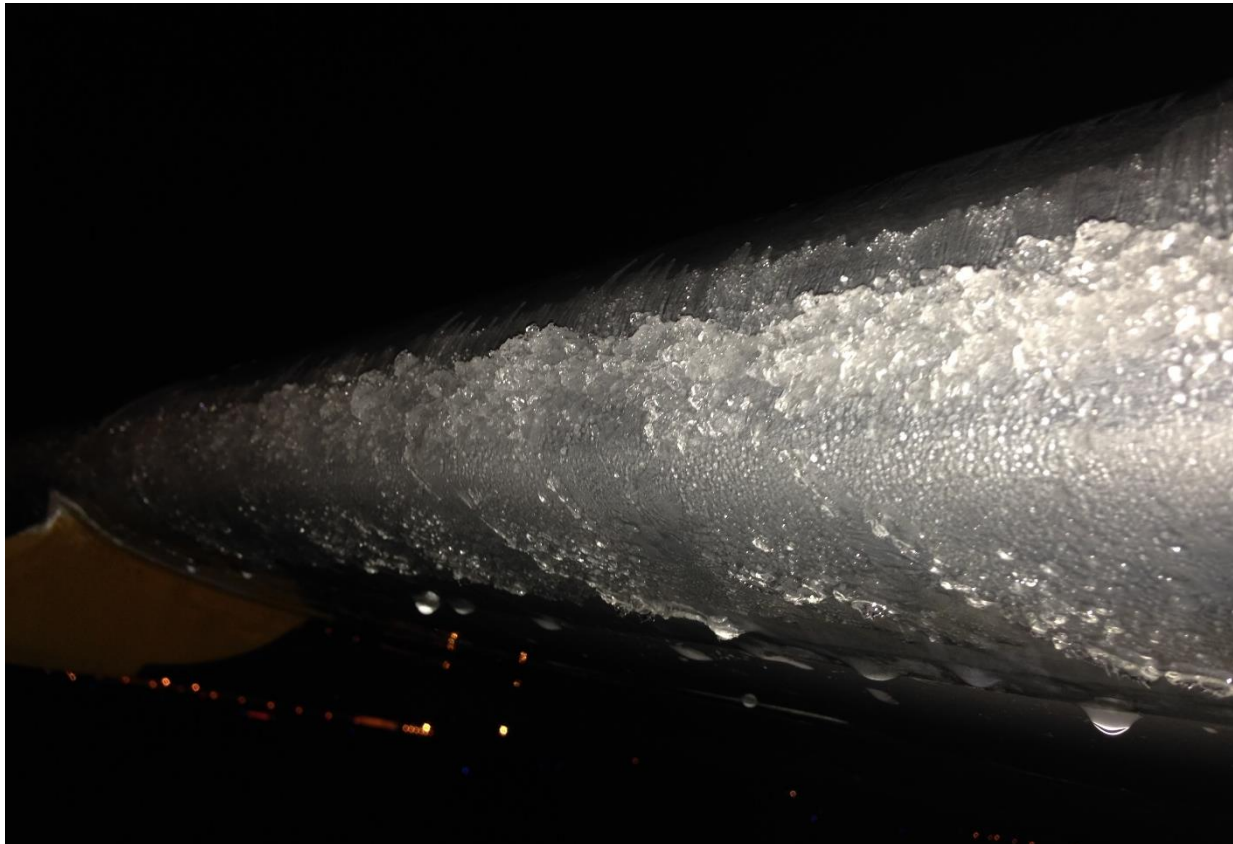
Following the accident the crew observed ice build-up on the wings, horizontal stabilizer, and both engine inlets. See Figure 1 for a picture of the ice-build up taken approximately 40 minutes after the aircraft arrived at the gate. Review of the Flight Data Recorder (FDR) revealed that the ice condition parameter indicated “no ice” and the ice detection fail parameter indicated “normal” (not failed) for the entire flight. Therefore, the systems examination focused on the airworthiness of the ice detection system.

Figure 1: Picture Taken Approximately 40 Minutes After Gate Arrival of Ice Build-Up Discovered On Wing
