# American Airlines 1851

## Airbus A321 N564UW

# Walk-Around Inspection

August 16, 2015

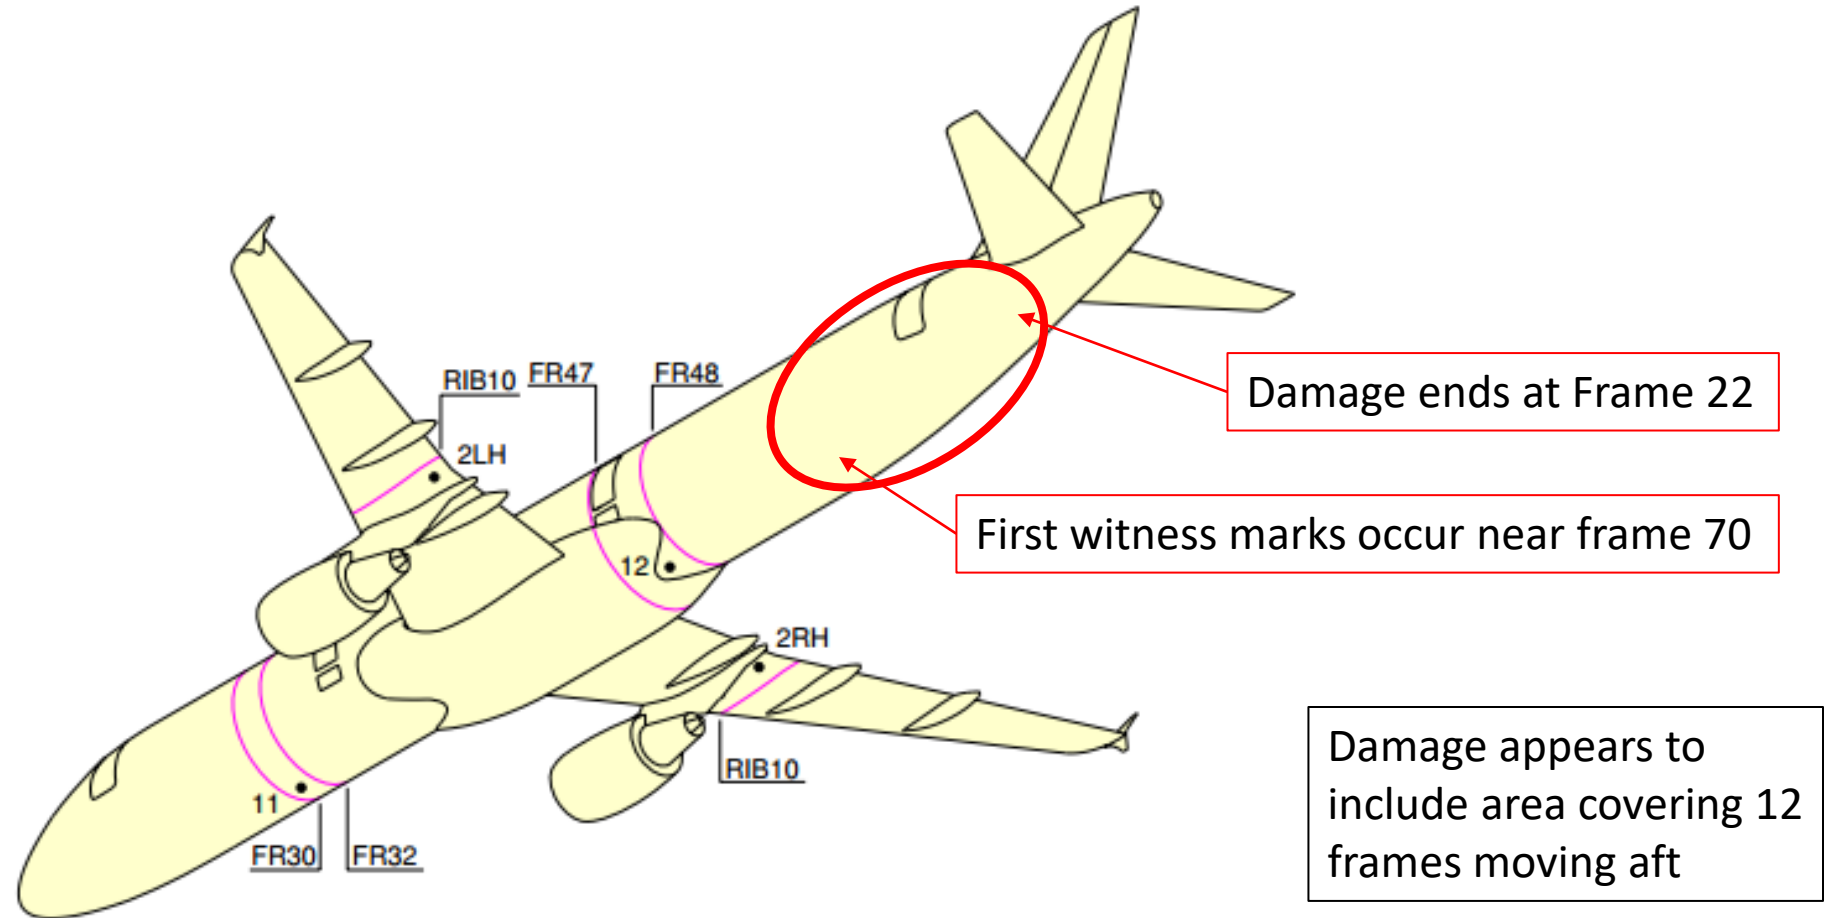
# Aft Fuselage External Damage Area N456UW

A walk-around general inspection of American Airlines N564UW found damage isolated to the aft lower section of the fuselage aft of the bulk cargo compartment door as well as damage to the main landing gear tires.

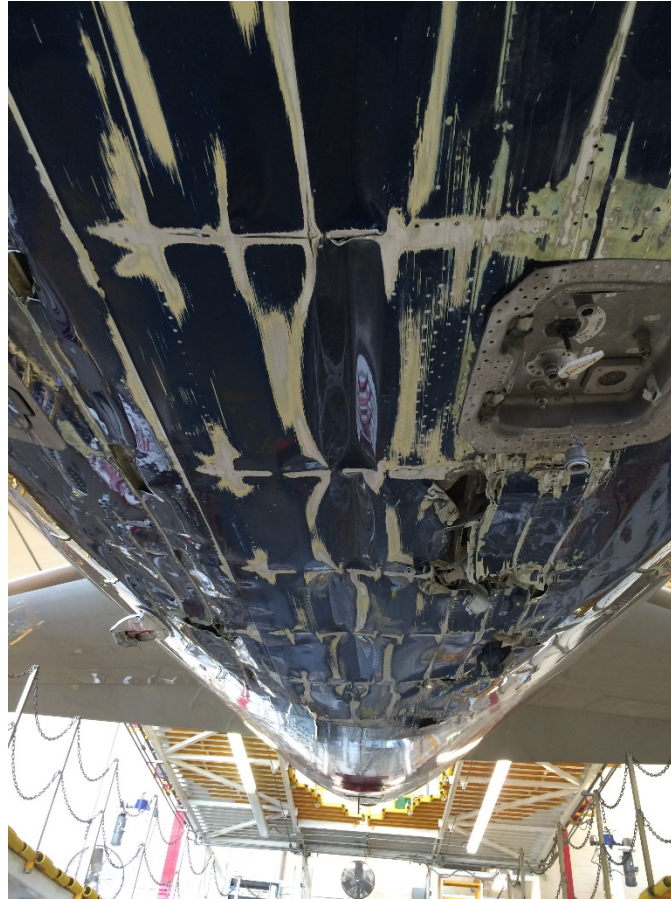
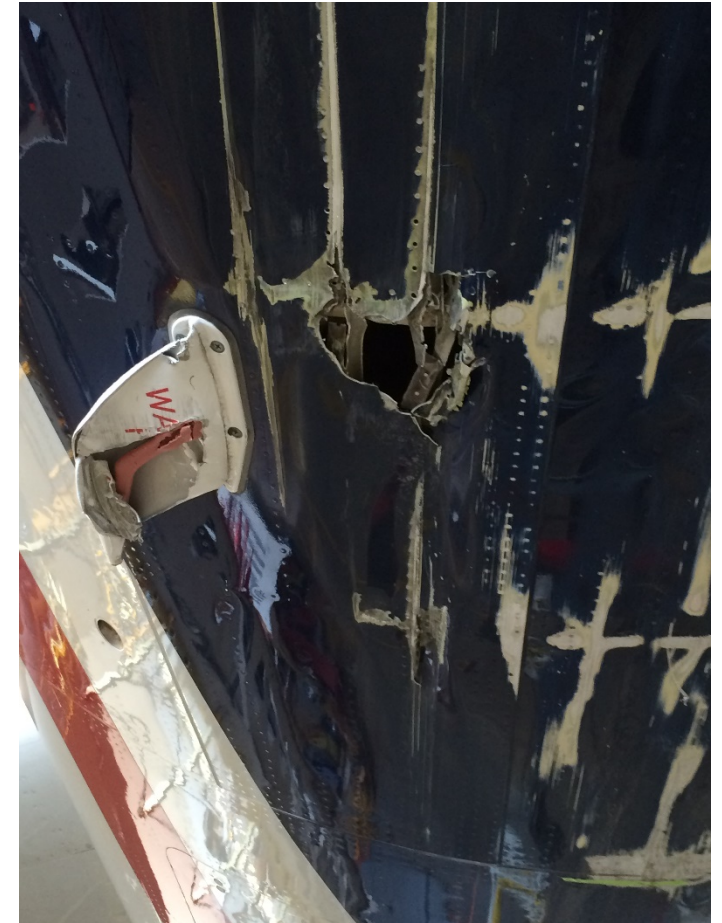
Abraded fuselage skin with penetrations

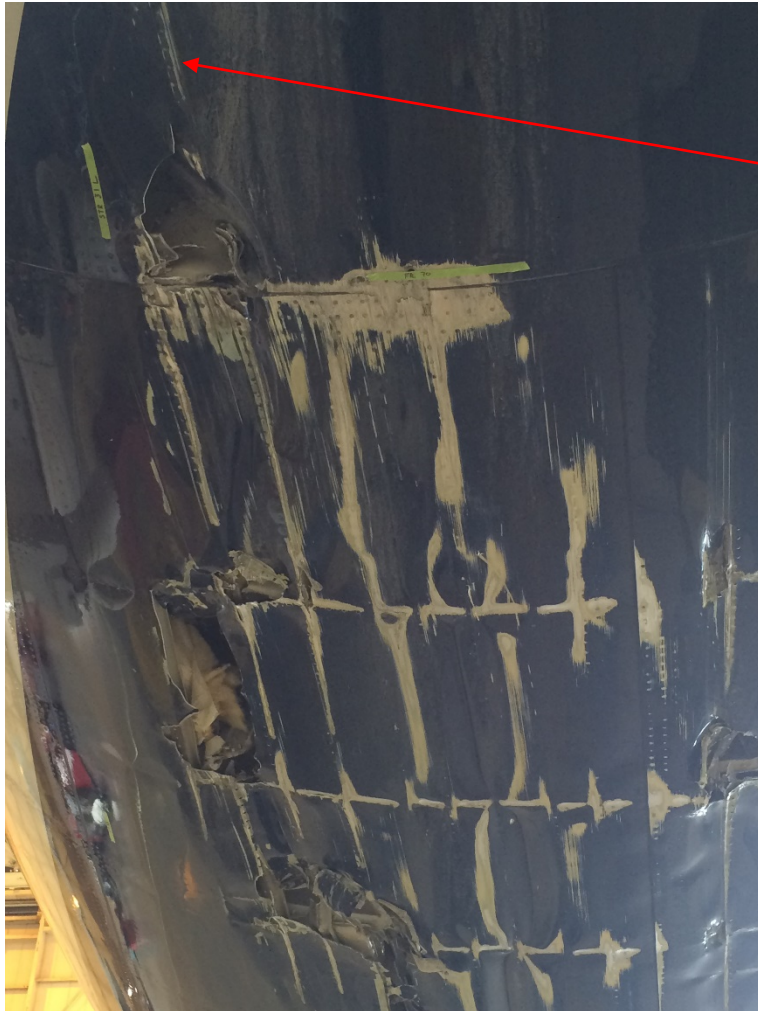
External Damage begins  
at around Frame 70

External Damage  
ends at Frame 22

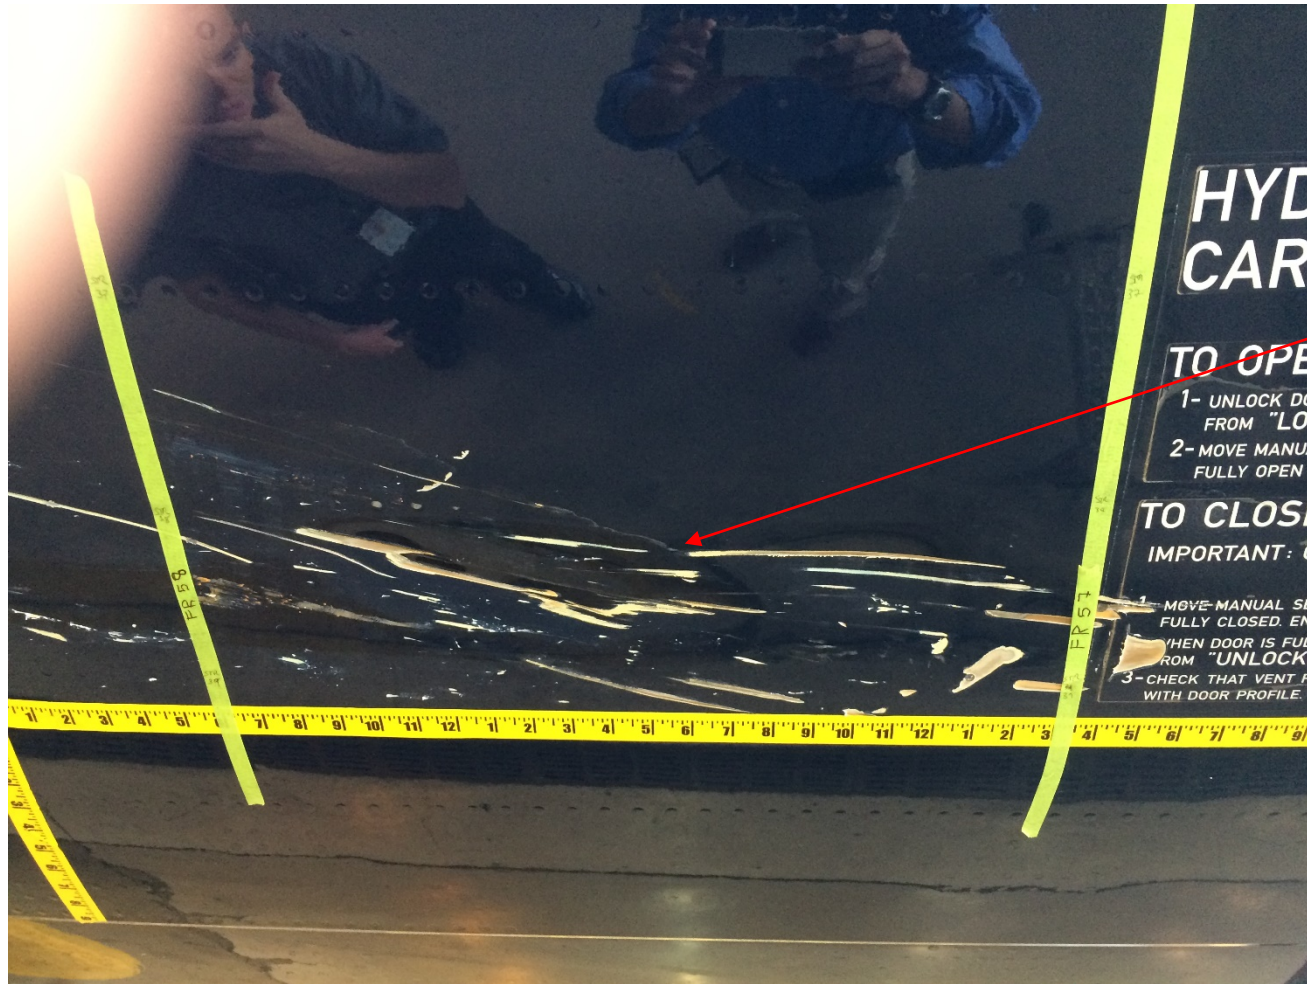
**Location:** Between frame 58 and 57 RH side of aircraft.

Damage appears to have been caused by Runway Light. (appears to have been thrown up against airframe by tire possibly.

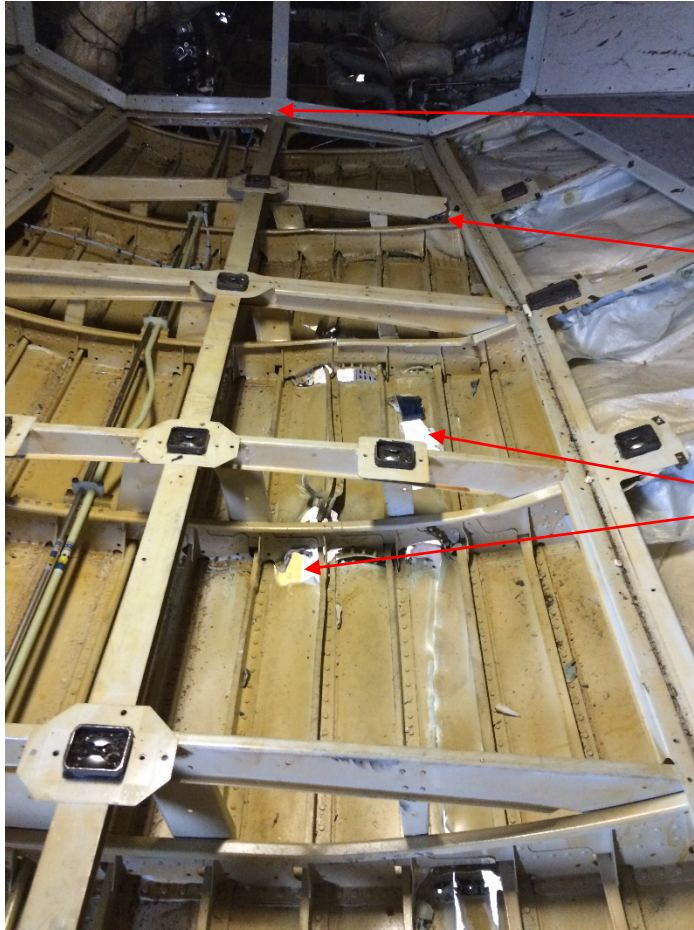
Cargo Compartment Door Aft View

Frames are bent

Fractured Frames

Multiple skin perforations

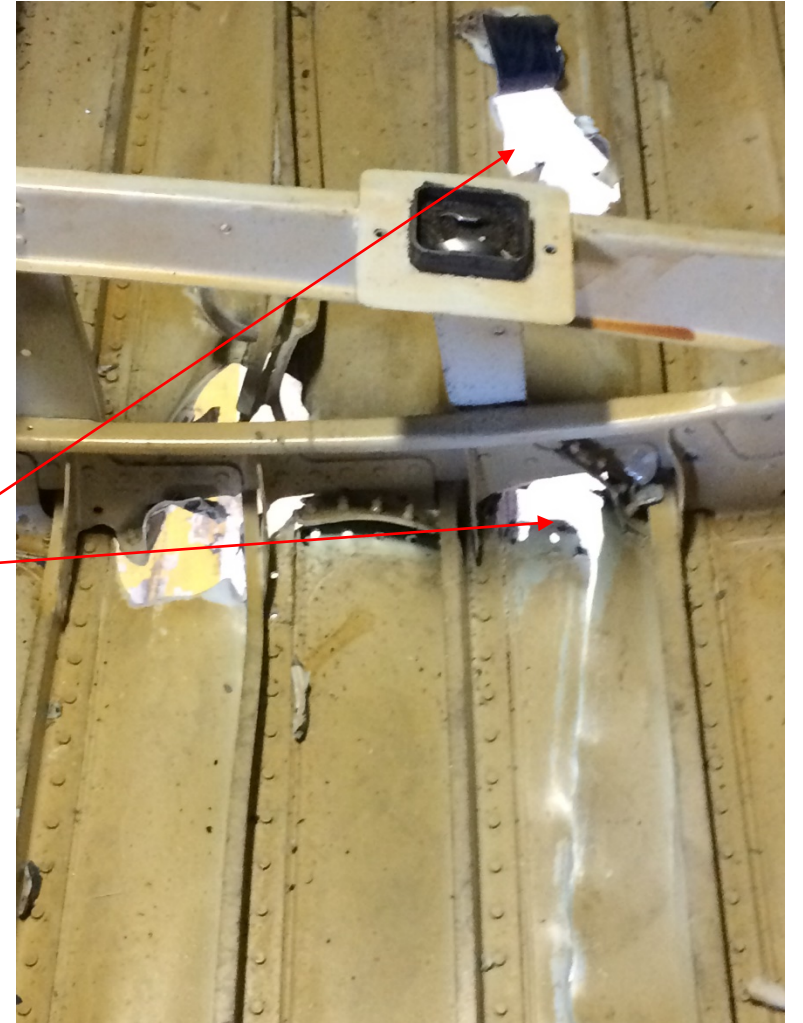
Skin Perforations

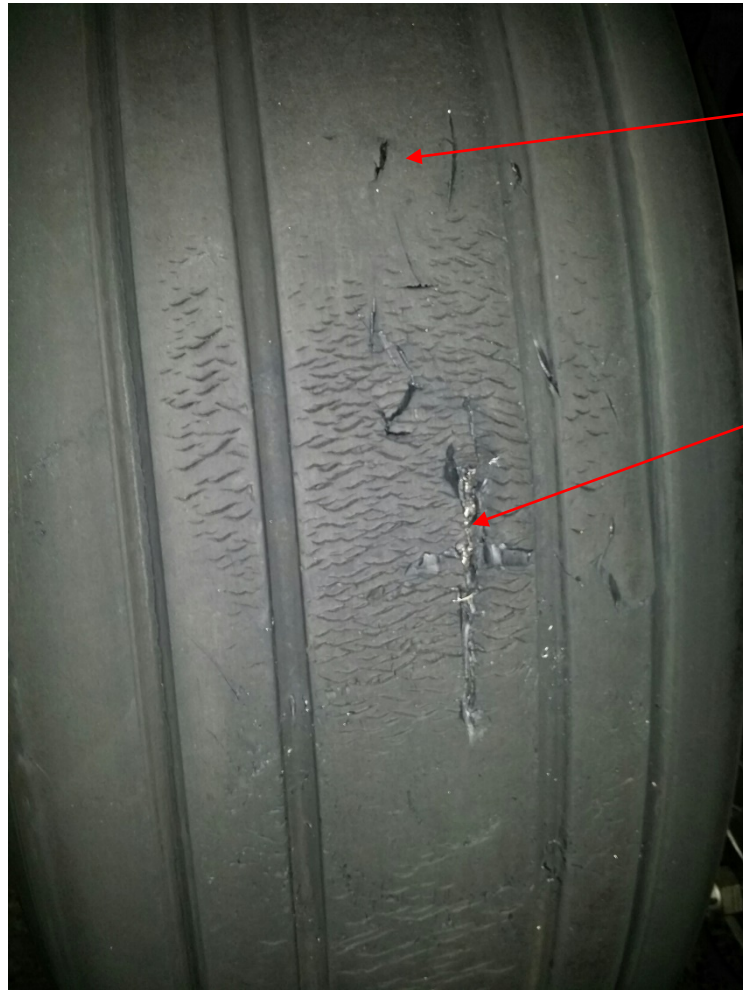
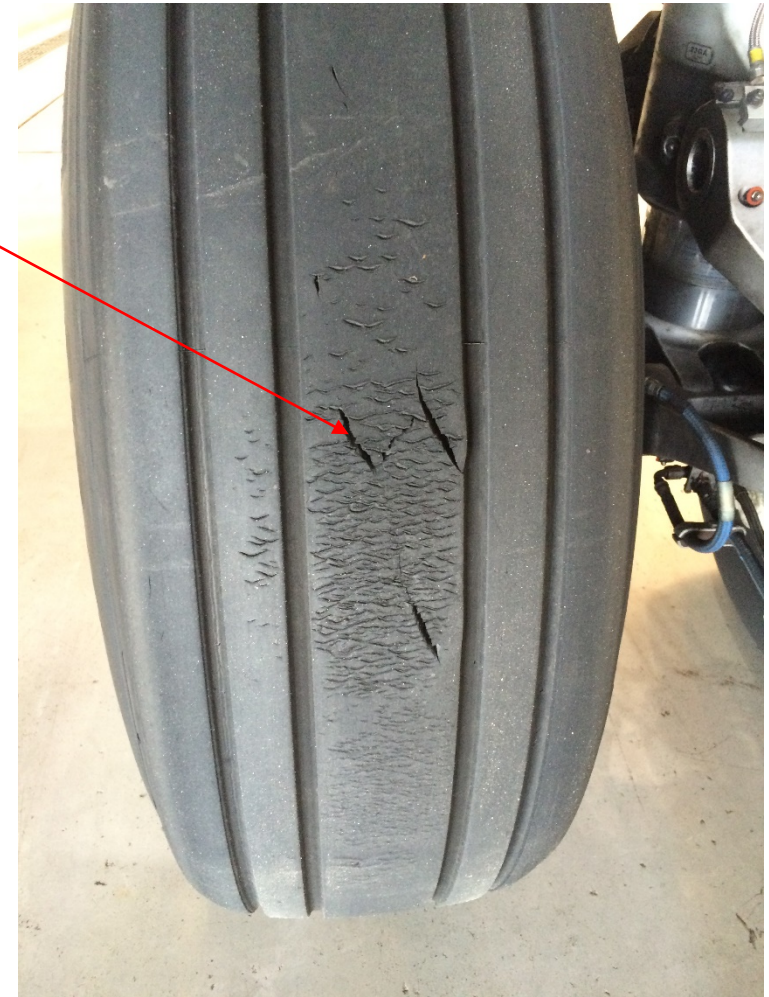
# Tire Damage – LH Main Gear Inboard Tire

- Tire has cuts due to foreign object damage created most likely by the runway approach and end identifier lights
- Embedded FOD
- Chevron Cutting from antiskid braking and possibly grooved runway surface
