# Runway 36L Inspection Data

## American Airlines 1851

Charlotte Douglass International Airport  
Charlotte, North Carolina

August 16, 2015

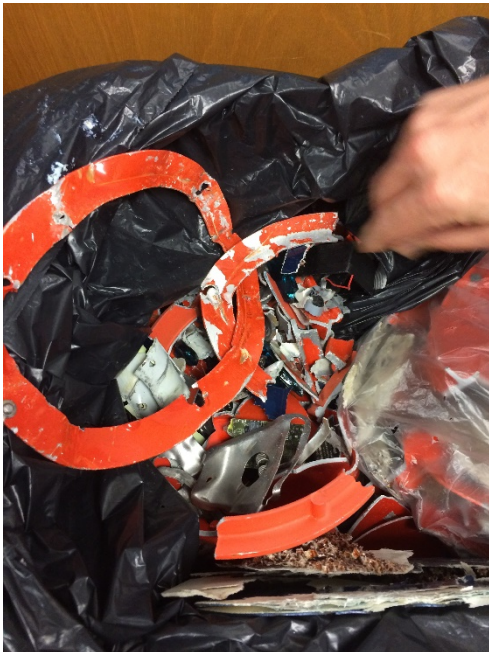
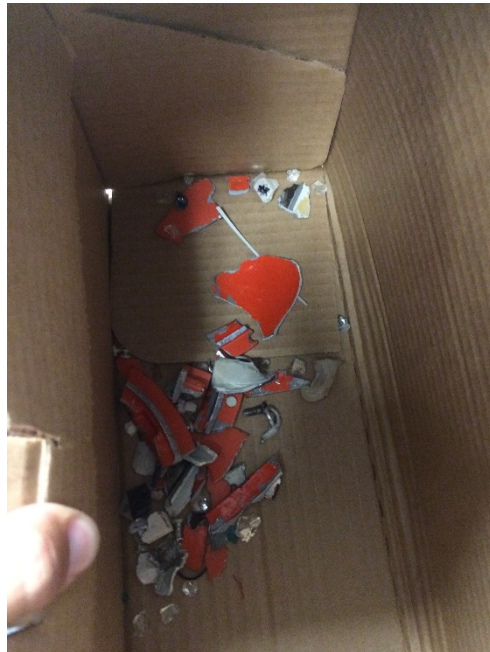
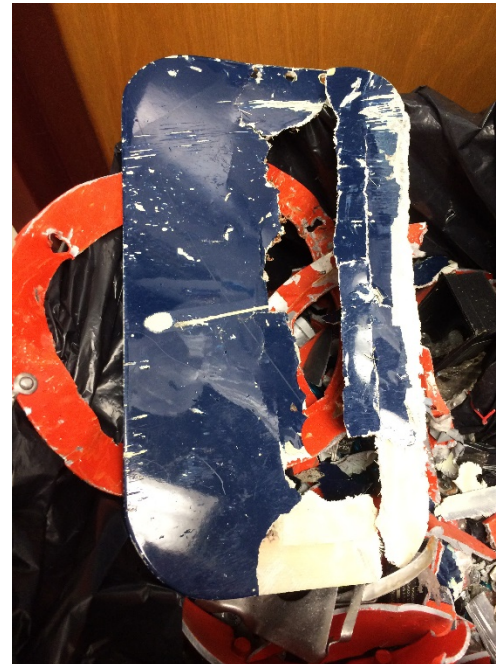
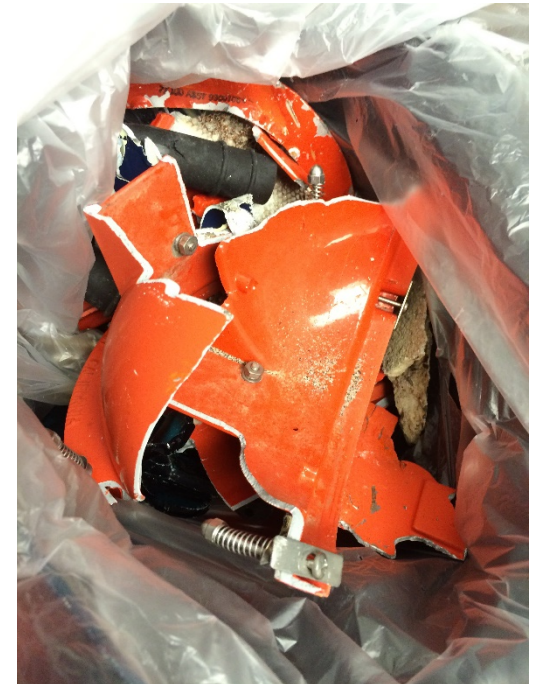
A runway Foreign Object Debris Walkdown was performed the evening of the accident and following morning of Sunday, August 16, 2015 in an effort to open the runway. Debris was found corresponding to runway lights and their structure as well as aircraft components and metal skin.

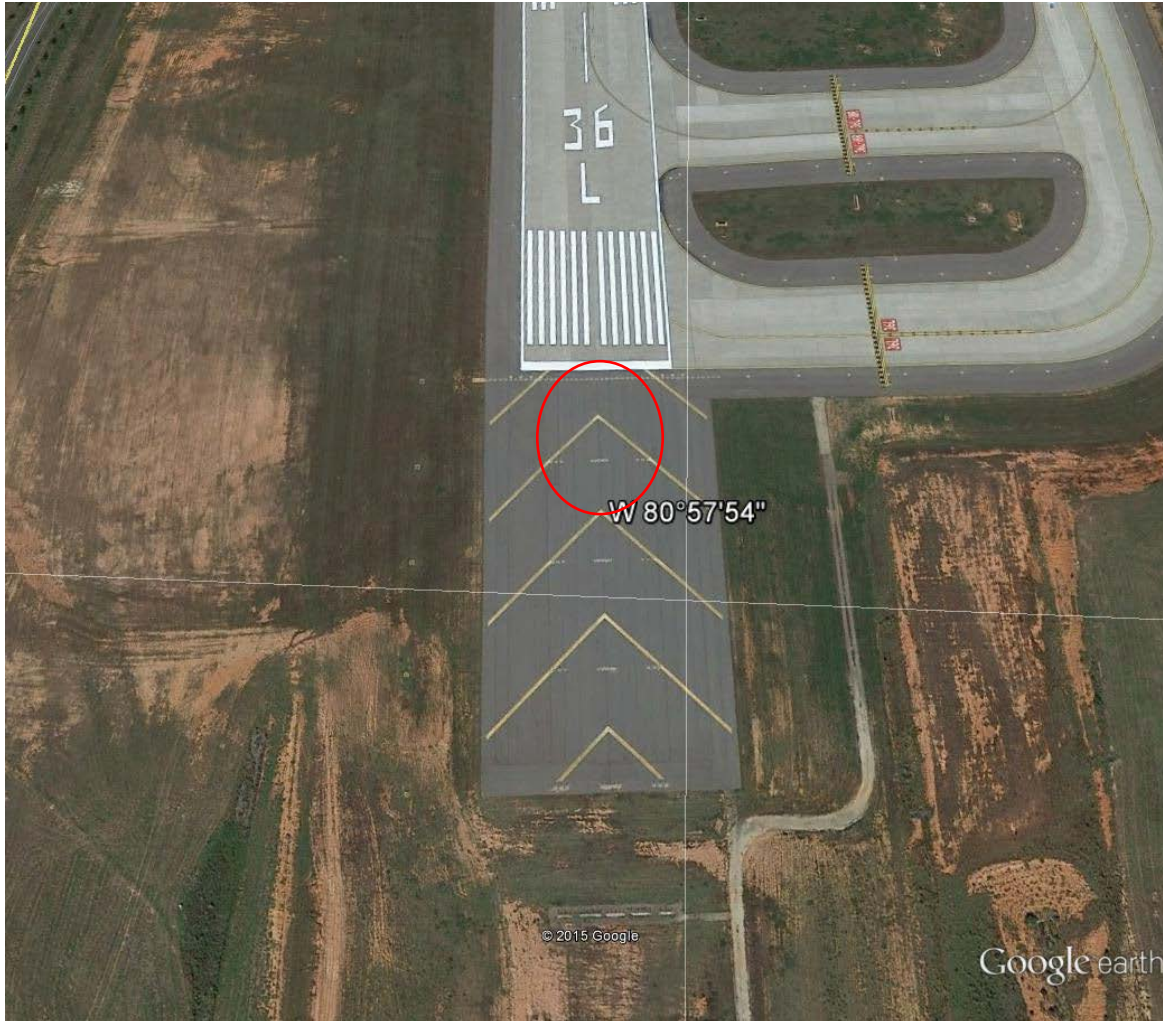
# Damage Area of Runway and Lights

Airport Runway damage was limited to:

- Runway under-run;
- Approach Lights;
- Runway End Identifier Lights

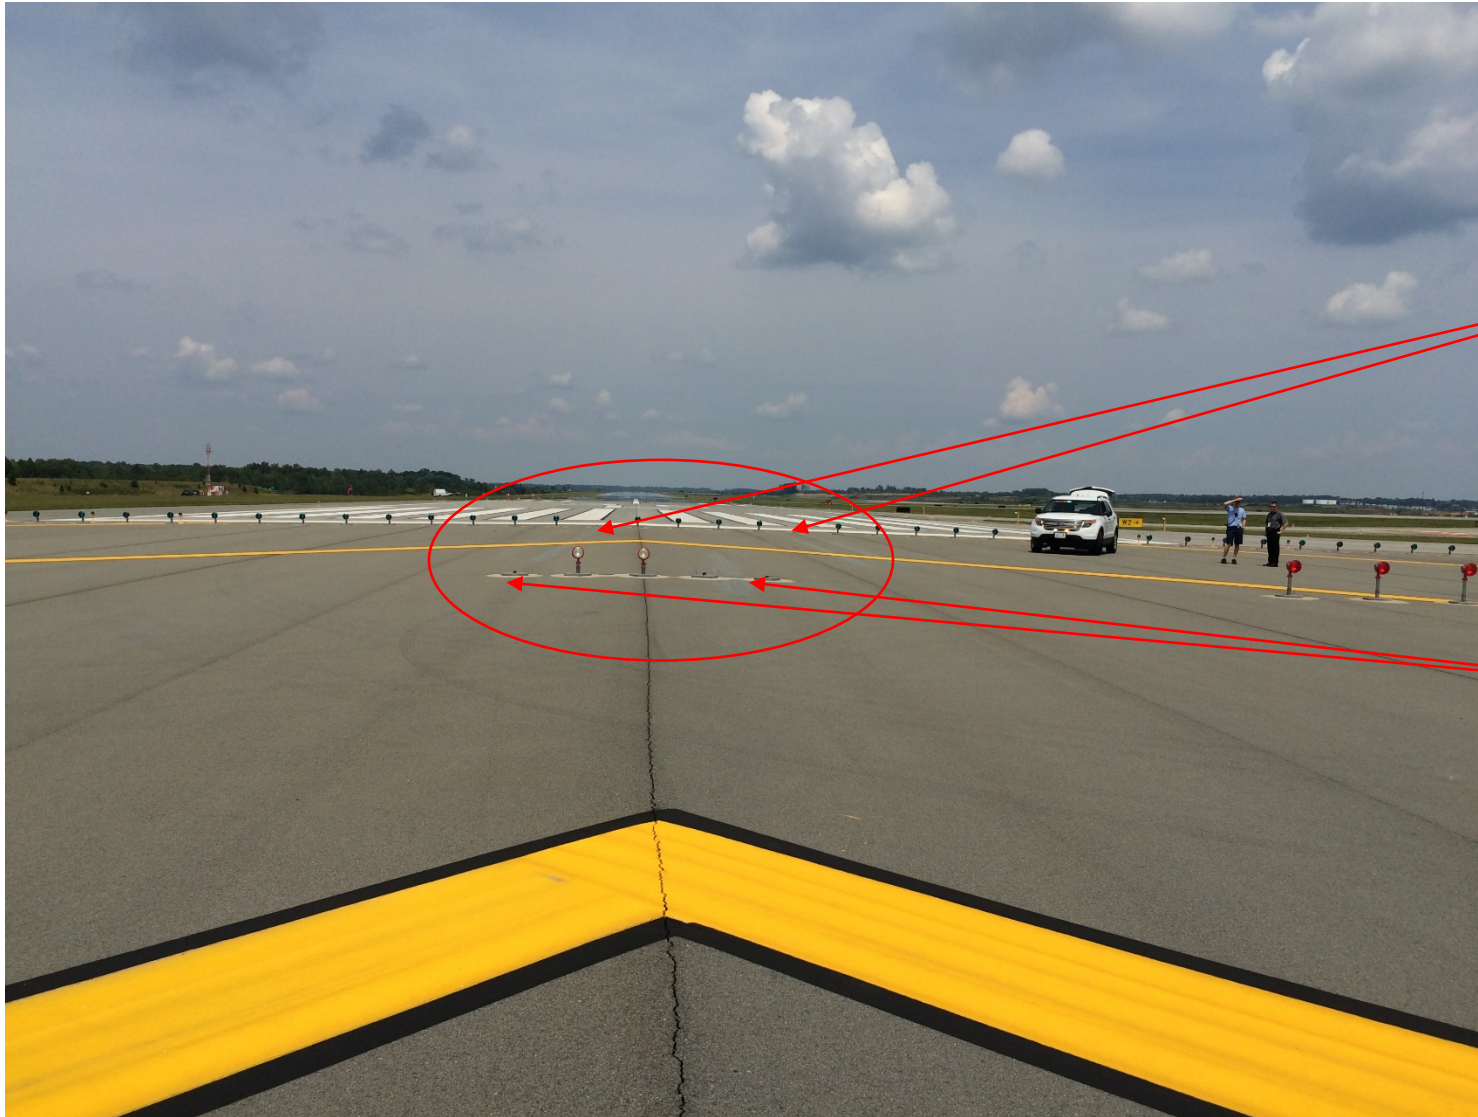
# View Toward Runway – Lighting System Damage

- REIL – Light Damage
  - 2 lights

- ALSF2 Light Damage
  - 3 lights

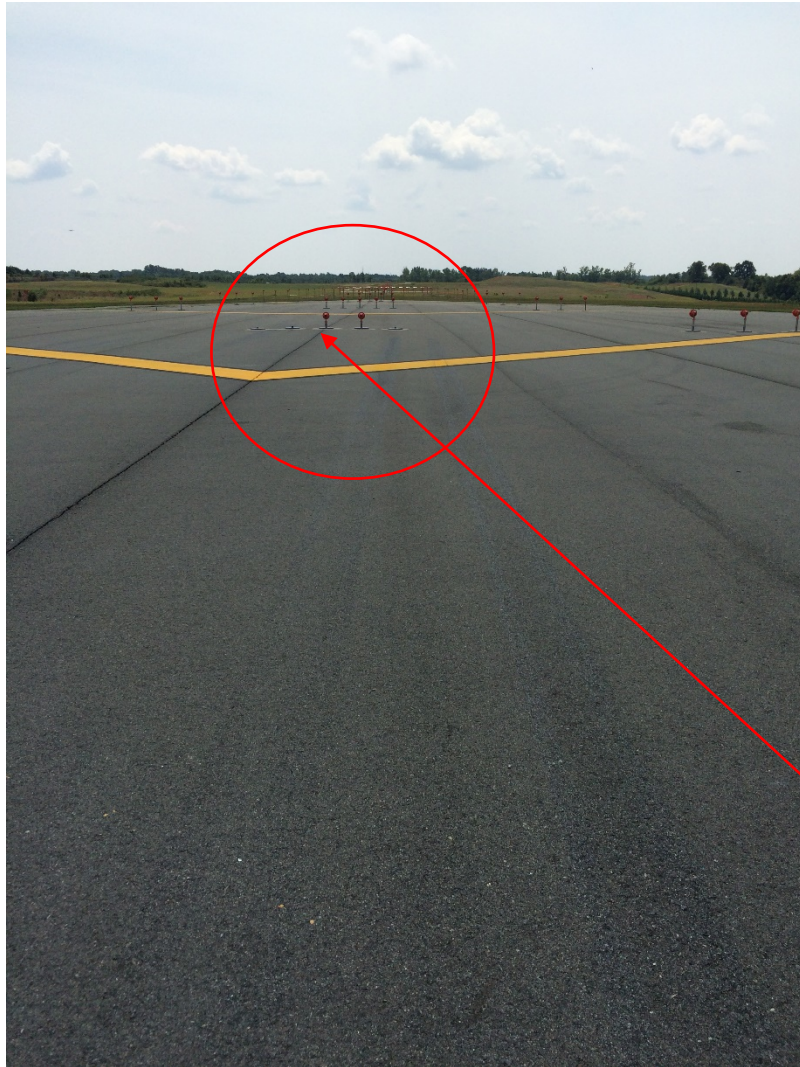
# Runway Light Damage – Approach Lights

Three ALSF-2 Lights were sheared off at the base

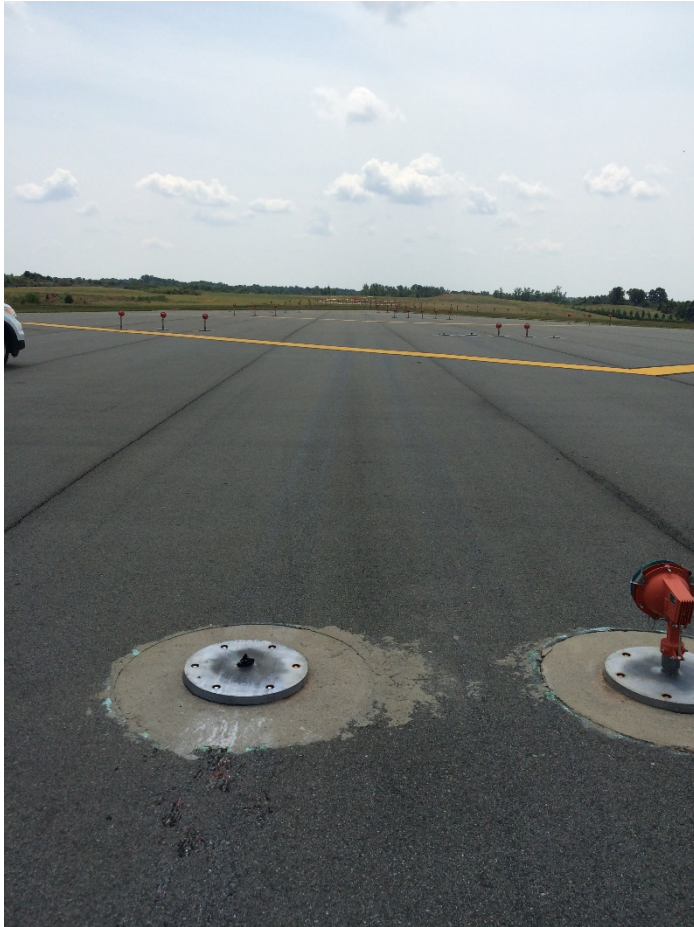
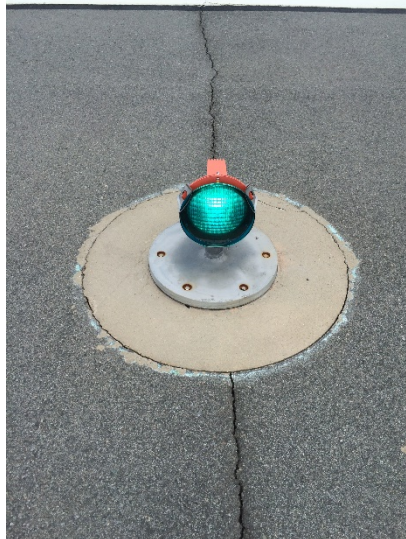
# Runway Light Damage — Runway End Identifier Lights

2 REIL Lights were sheared off at the base

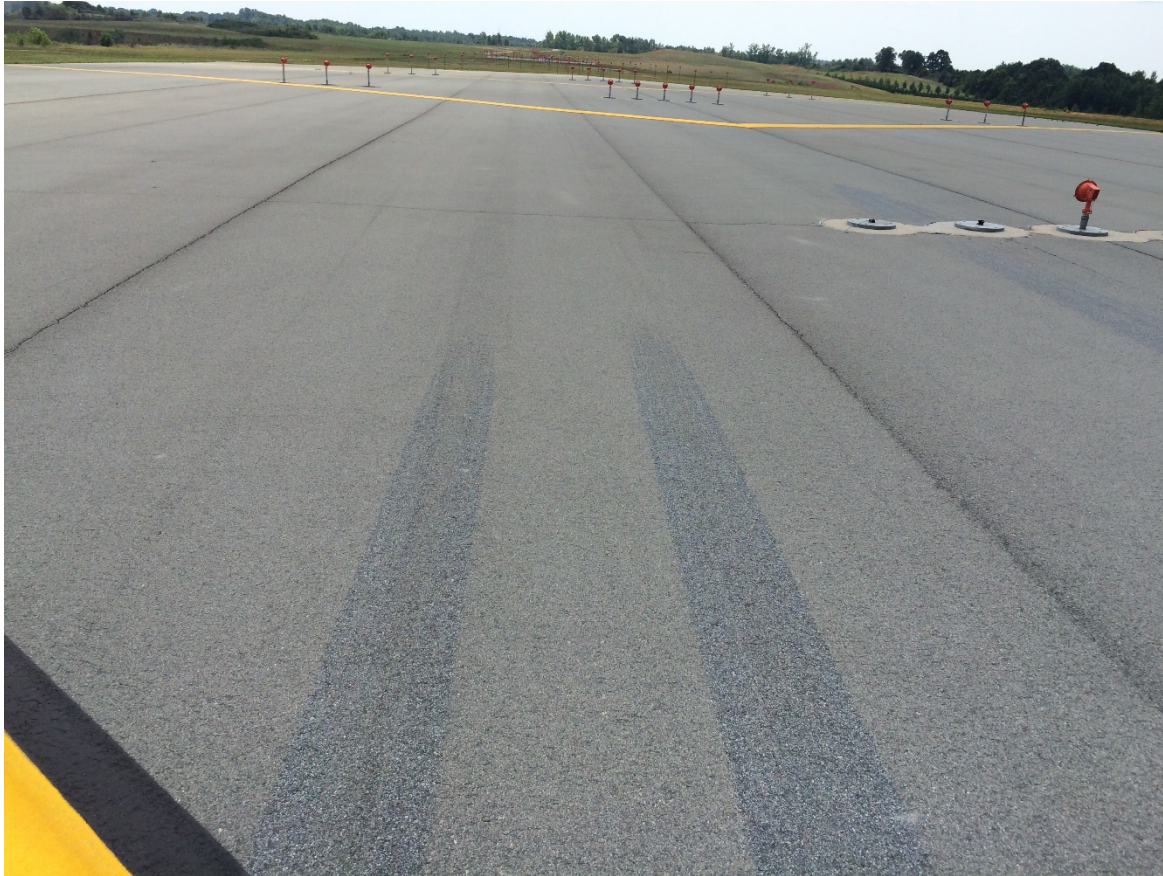
Right Main Gear

MLG  
Touchdown is  
prior to last row  
of ALSF2 lights.

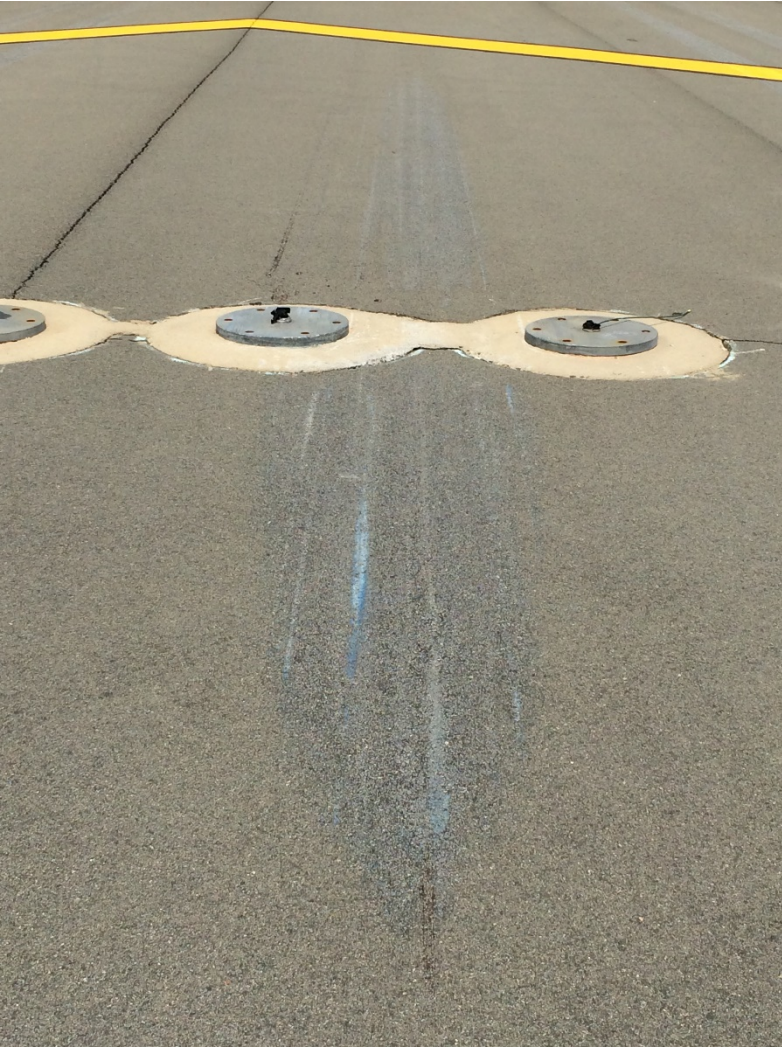
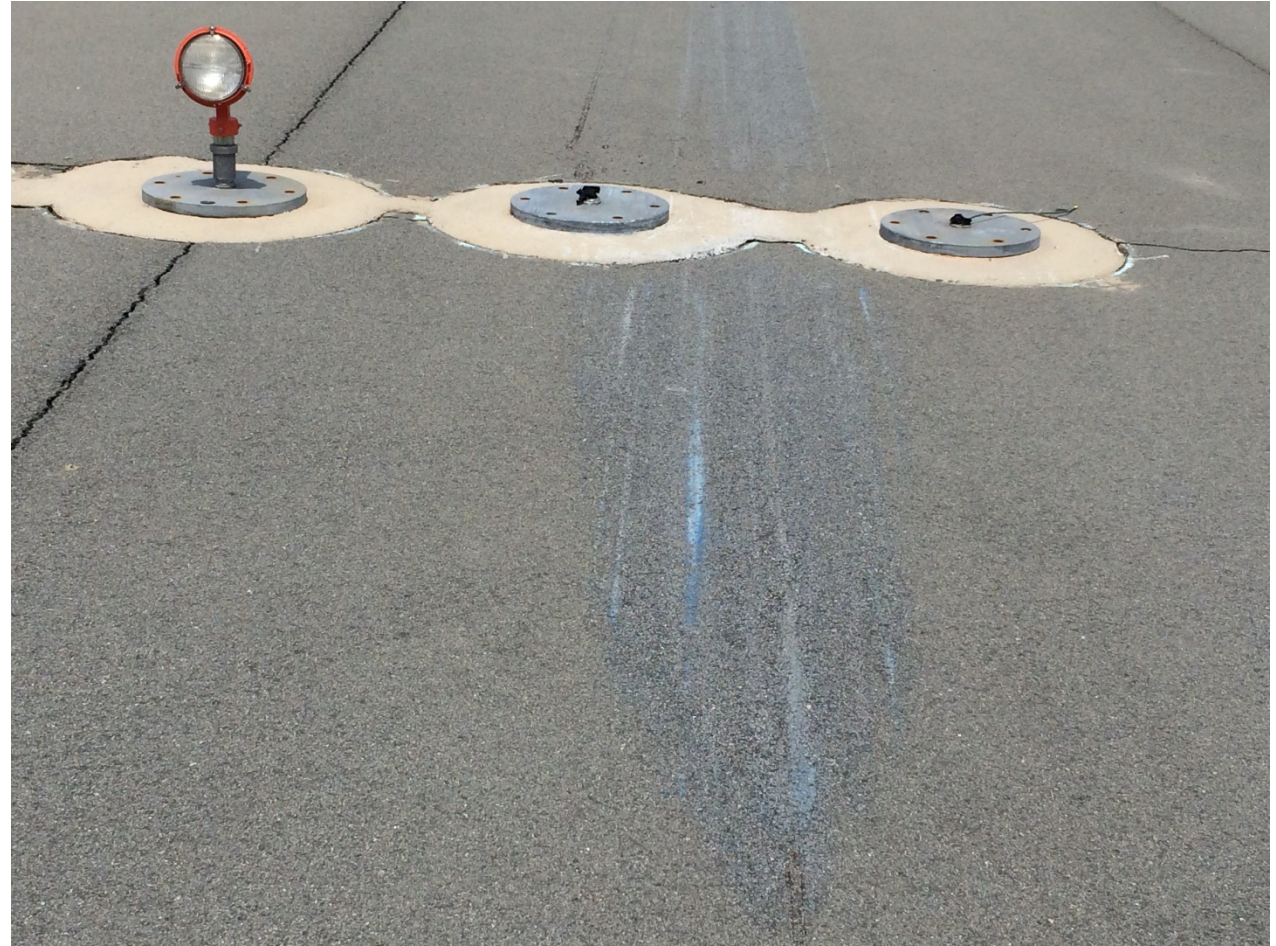
# Runway Impact – Aft Fuselage Scrap Marks

~ 42' x ~3' Scrape Mark

Initial point is ~ 106' from threshold
