## **NATIONAL TRANSPORTATION SAFETY BOARD**

### **Group Chairman's Factual Report**

# **METEOROLOGY**

DCA16LA214

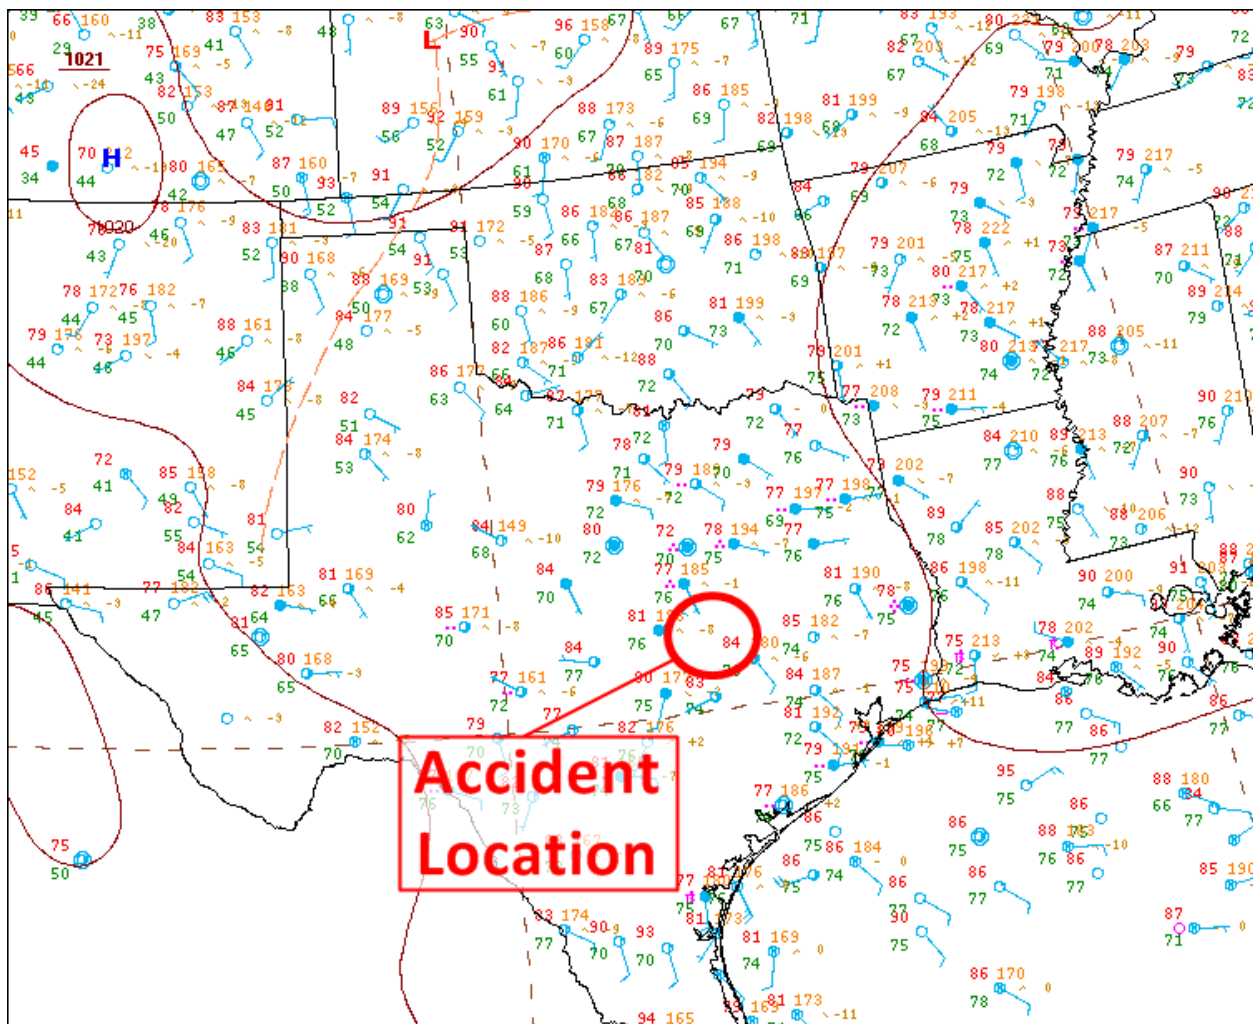
**Figure 1 - NWS Surface Analysis Chart for 1300 CDT.**

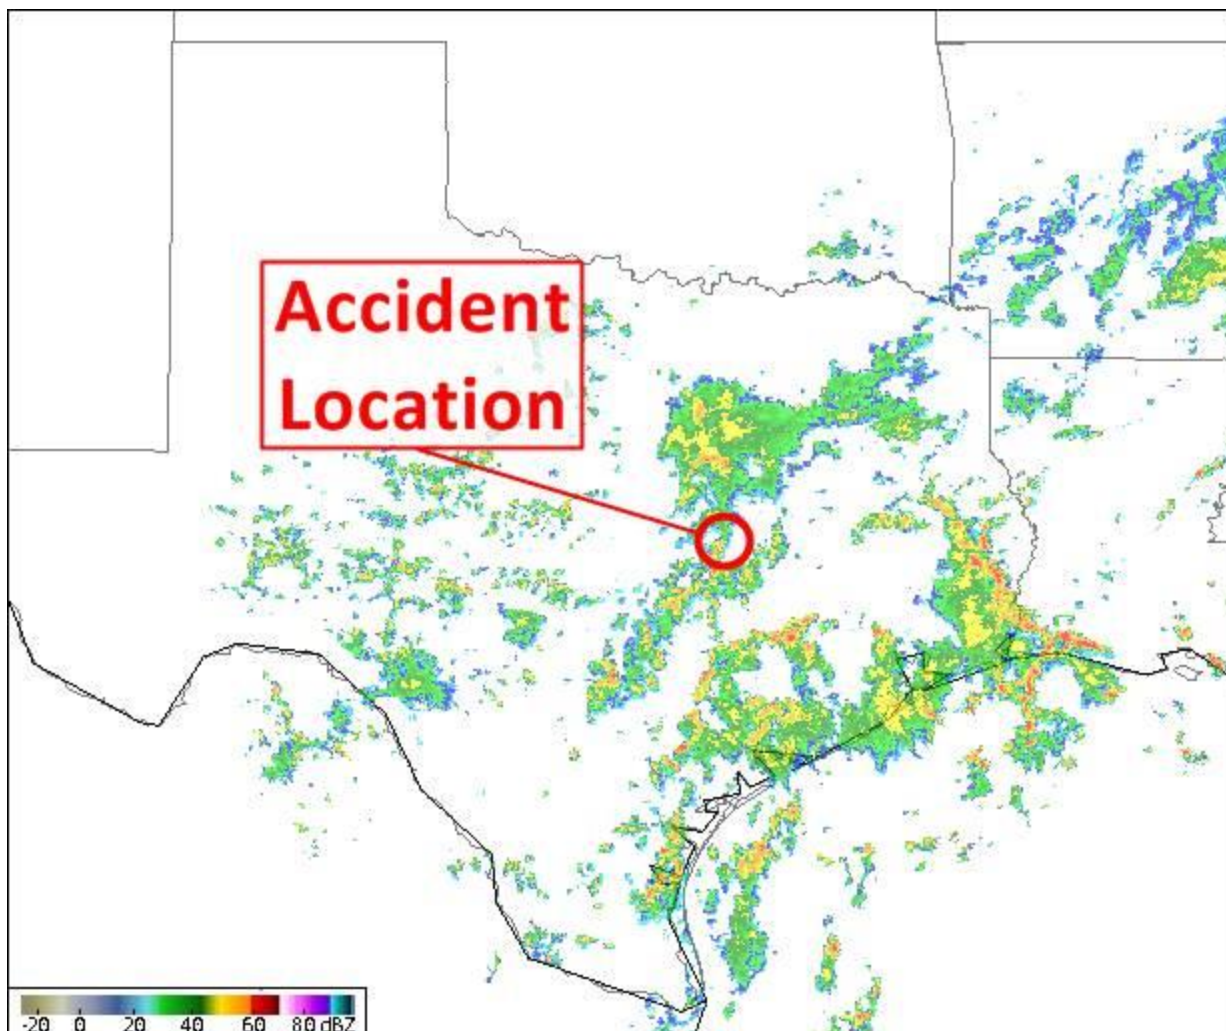
The National Weather Service (NWS) Surface Analysis Chart for 1300 CDT is presented in figure 1. A WSR-88D regional radar composite reflectivity mosaic obtained from the National Centers for Environmental Information (NCEI) for 1215 CDT (figure 2) identified extensive light to intense levels of reflectivity across much of eastern Texas, including the accident area.

**Figure 2** – NCEI WSR-88D mosaic from 1215 CDT.

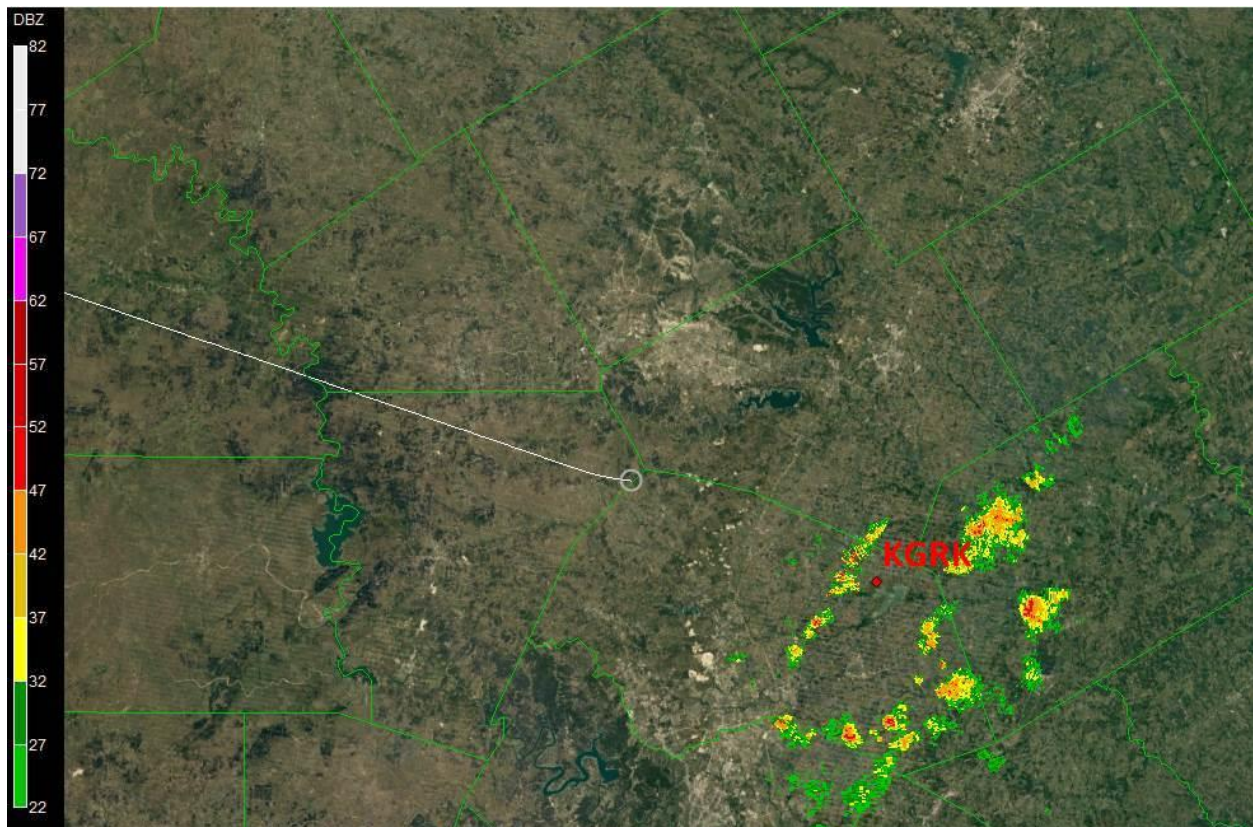
**Figure 3** – KGRK 10.0° Level-II reflectivity product from a sweep initiated at 1211:46 CDT. Accident flight path denoted by white line with aircraft location at white circle at 1212:02 CDT. Reflectivity values less than 22 dBZ have been masked.

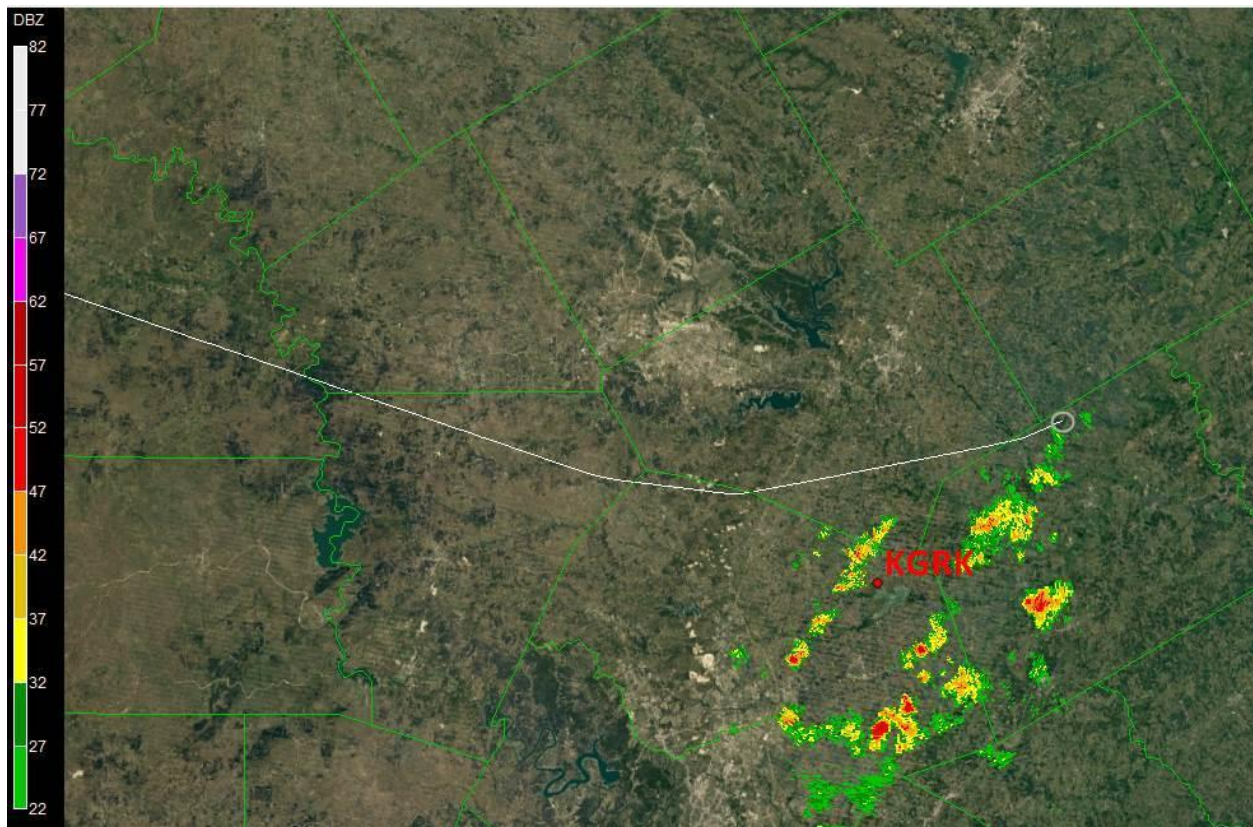
**Figure 4** – KGRK 10.0° Level-II reflectivity product from a sweep initiated at 1216:47 CDT. Accident flight path denoted by white line with aircraft location at white circle at 1217:22 CDT (turbulence event). Reflectivity values less than 22 dBZ have been masked.

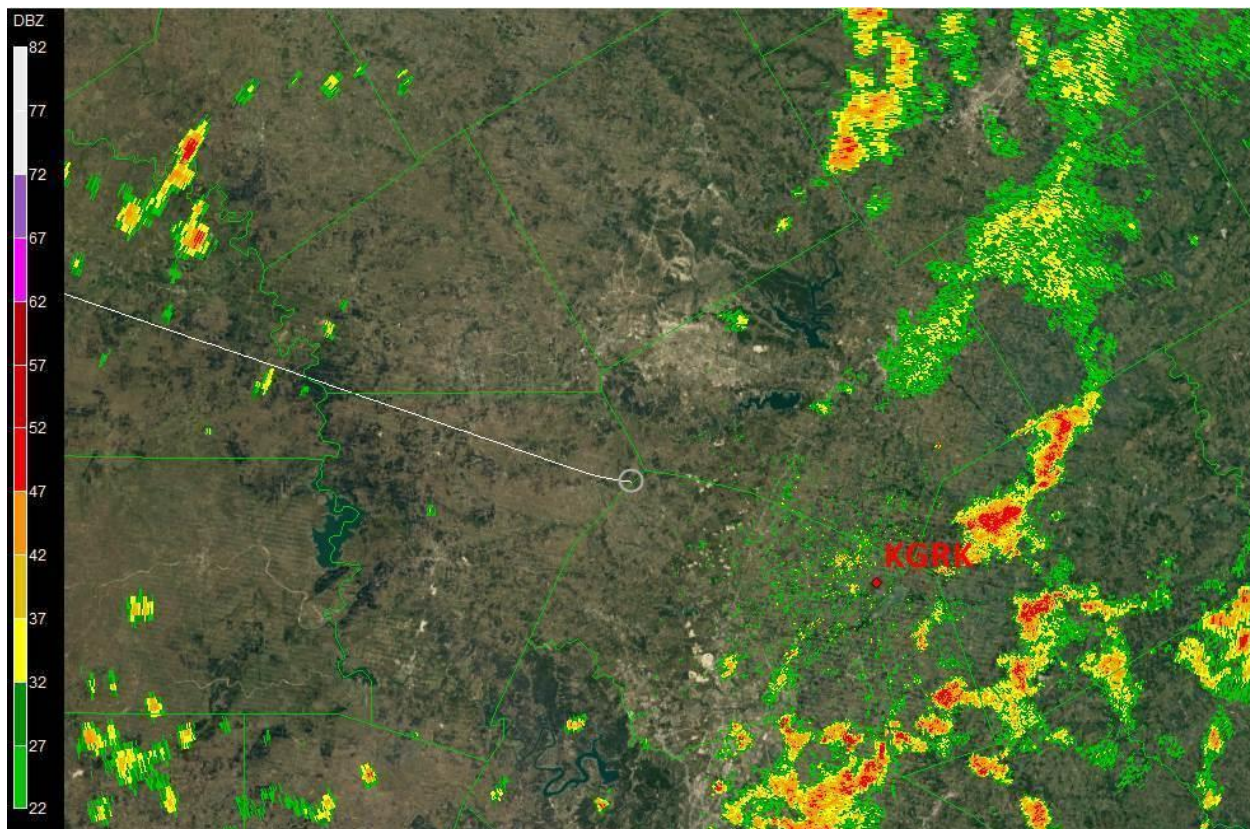
**Figure 5** – KGRK 0.52° Level-II reflectivity product from a sweep initiated at 1208:10 CDT. Accident flight path denoted by white line with aircraft location at white circle at 1212:02 CDT. Reflectivity values less than 22 dBZ have been masked.

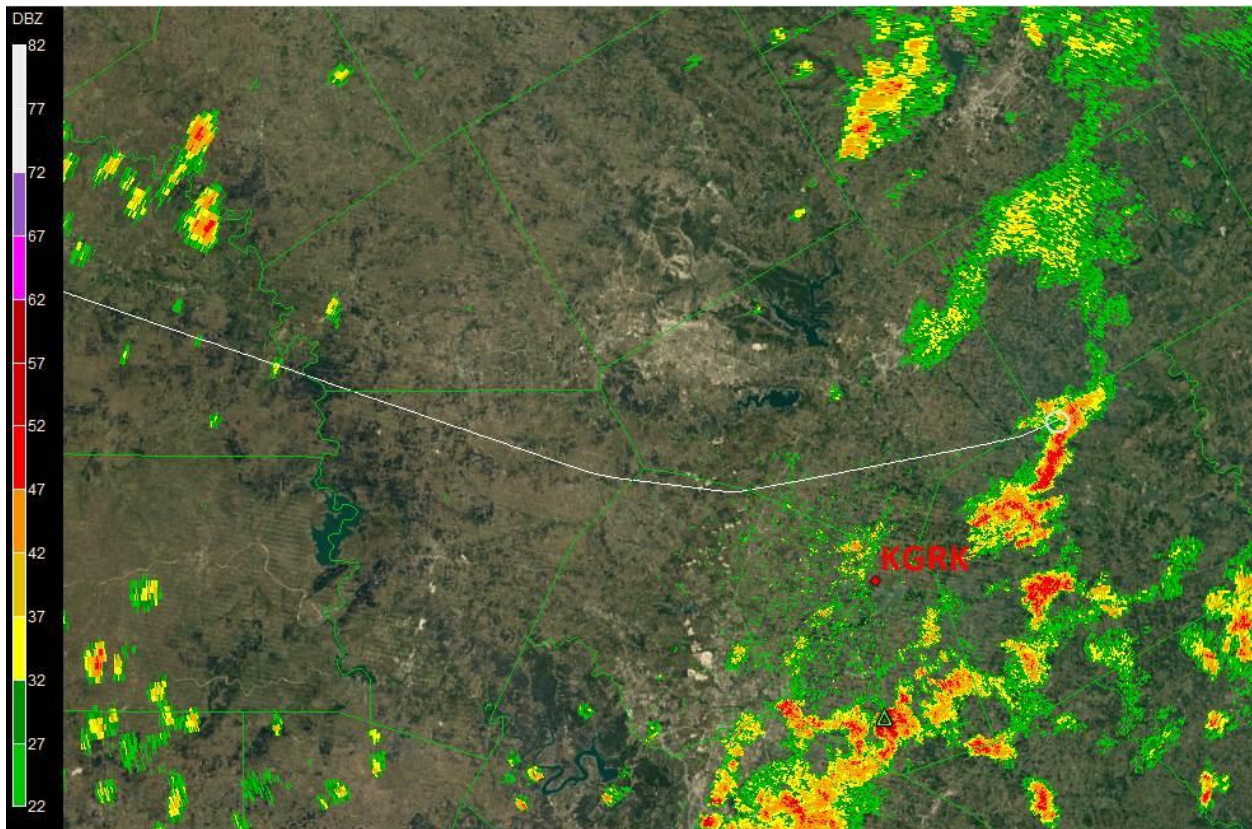
**Figure 6** – KGRK 0.52° Level-II reflectivity product from a sweep initiated at 1213:18 CDT. Accident flight path denoted by white line with aircraft location at white circle at 1217:22 CDT (turbulence event). Reflectivity values less than 22 dBZ have been masked.

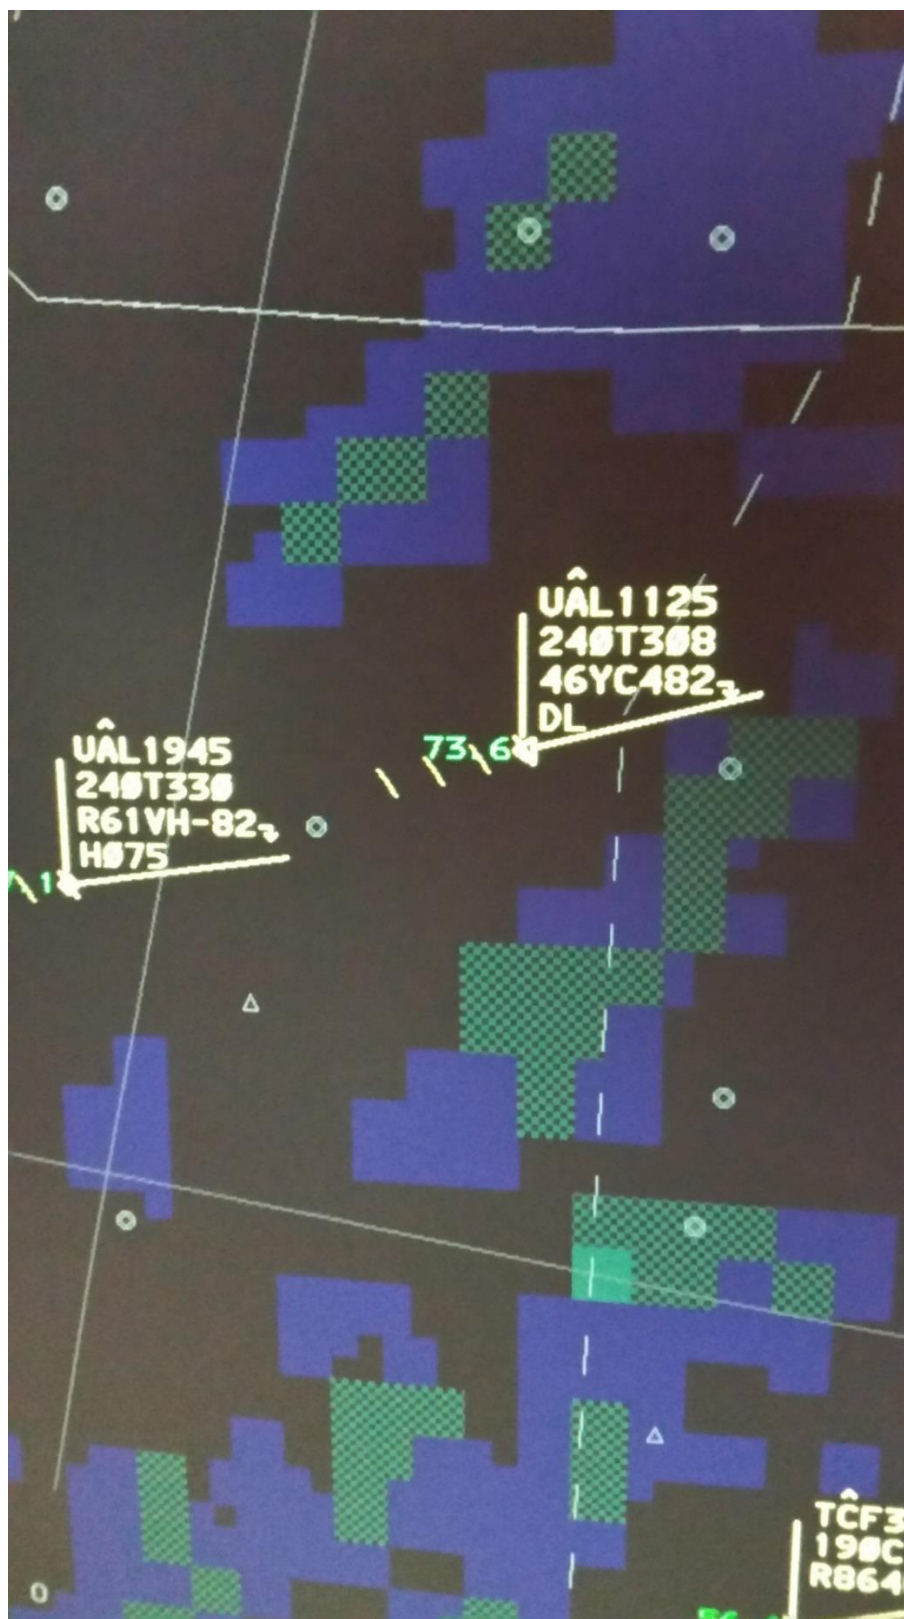
**Figure 7** – Screenshot of the Houston ARTCC WARP replay for a time close to the accident time. The accident airplane is “UAL1945.”

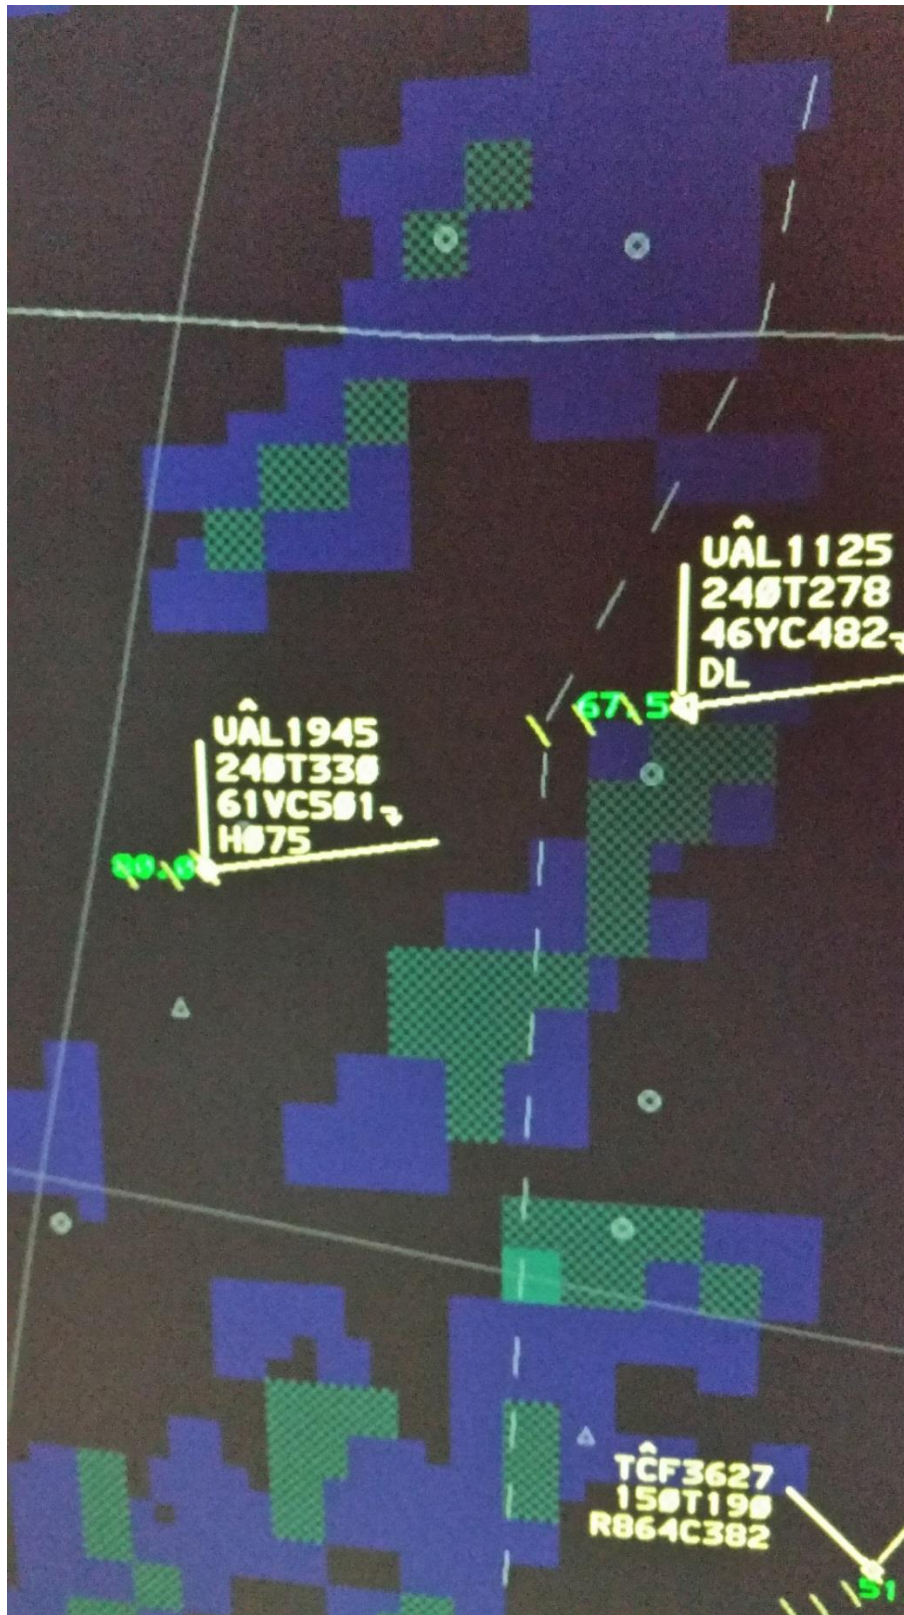
**Figure 8** – Screenshot of the Houston ARTCC WARP replay for a time close to the accident time. The accident airplane is “UAL1945.”

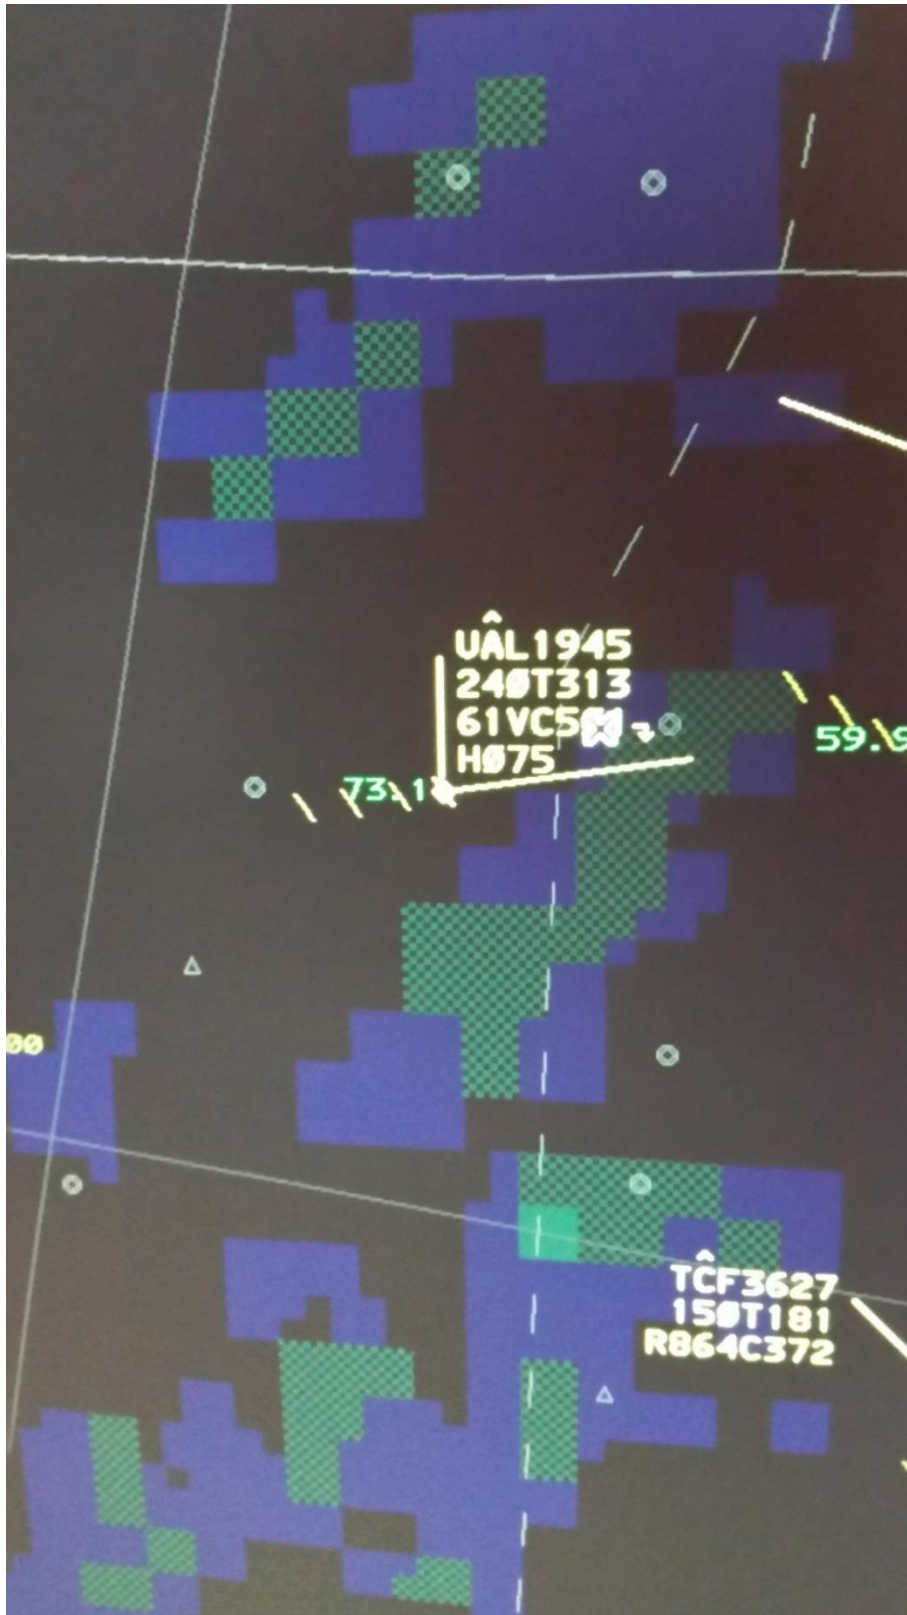
**Figure 9** – Screenshot of the Houston ARTCC WARP replay for a time close to the accident time. The accident airplane is “UAL1945.”

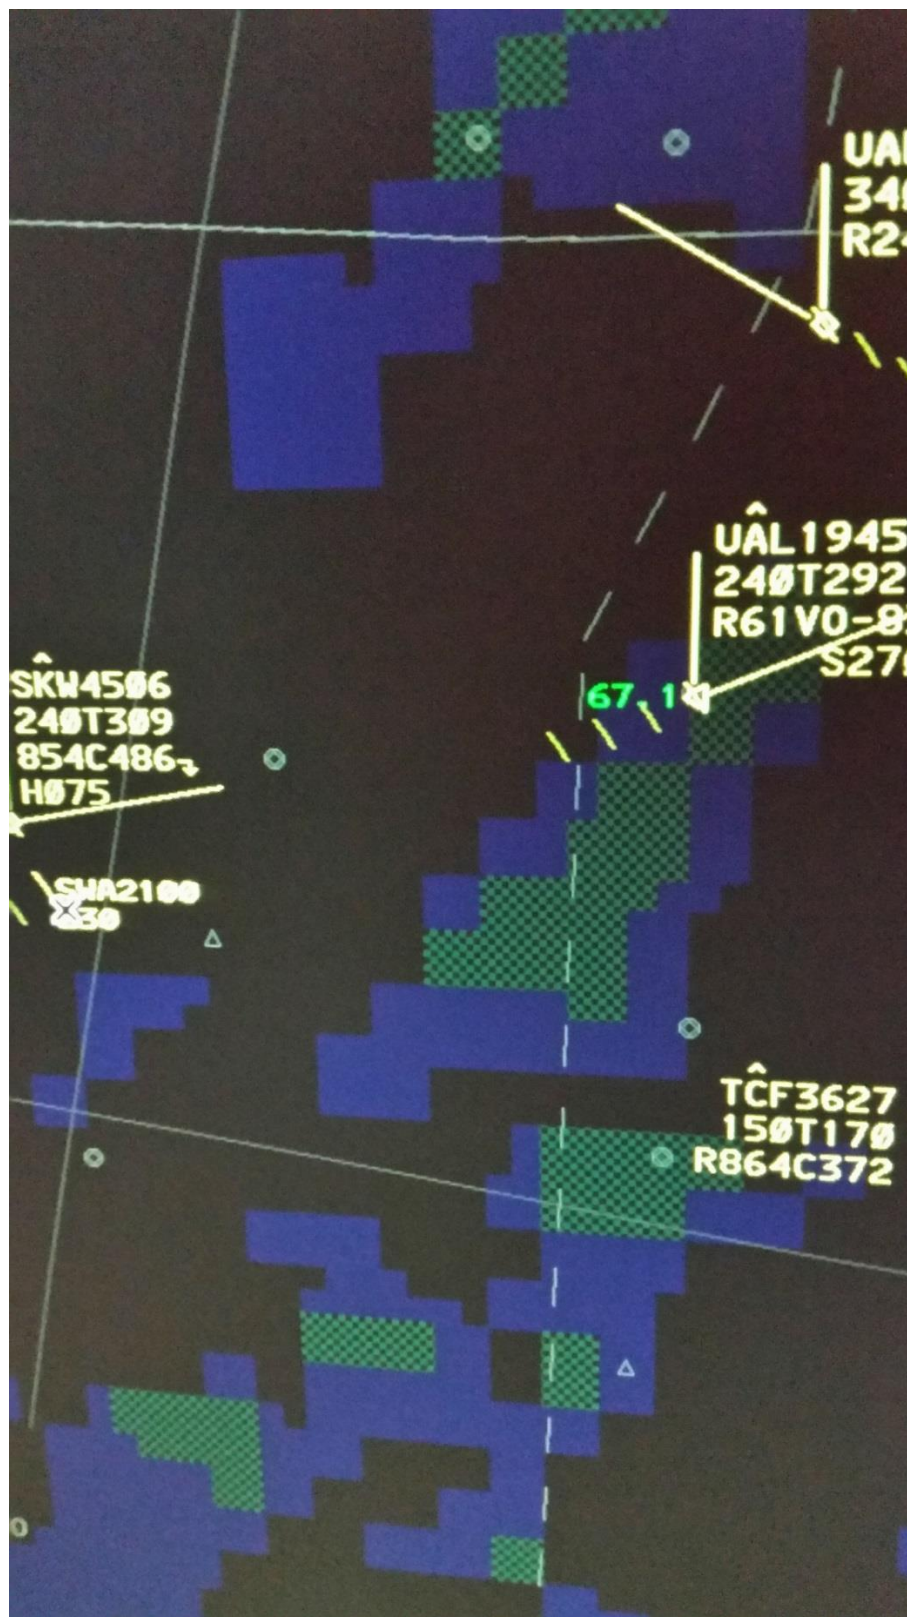
**Figure 10** – Screenshot of the Houston ARTCC WARP replay for a close to the accident time. The accident airplane is “UAL1945.”

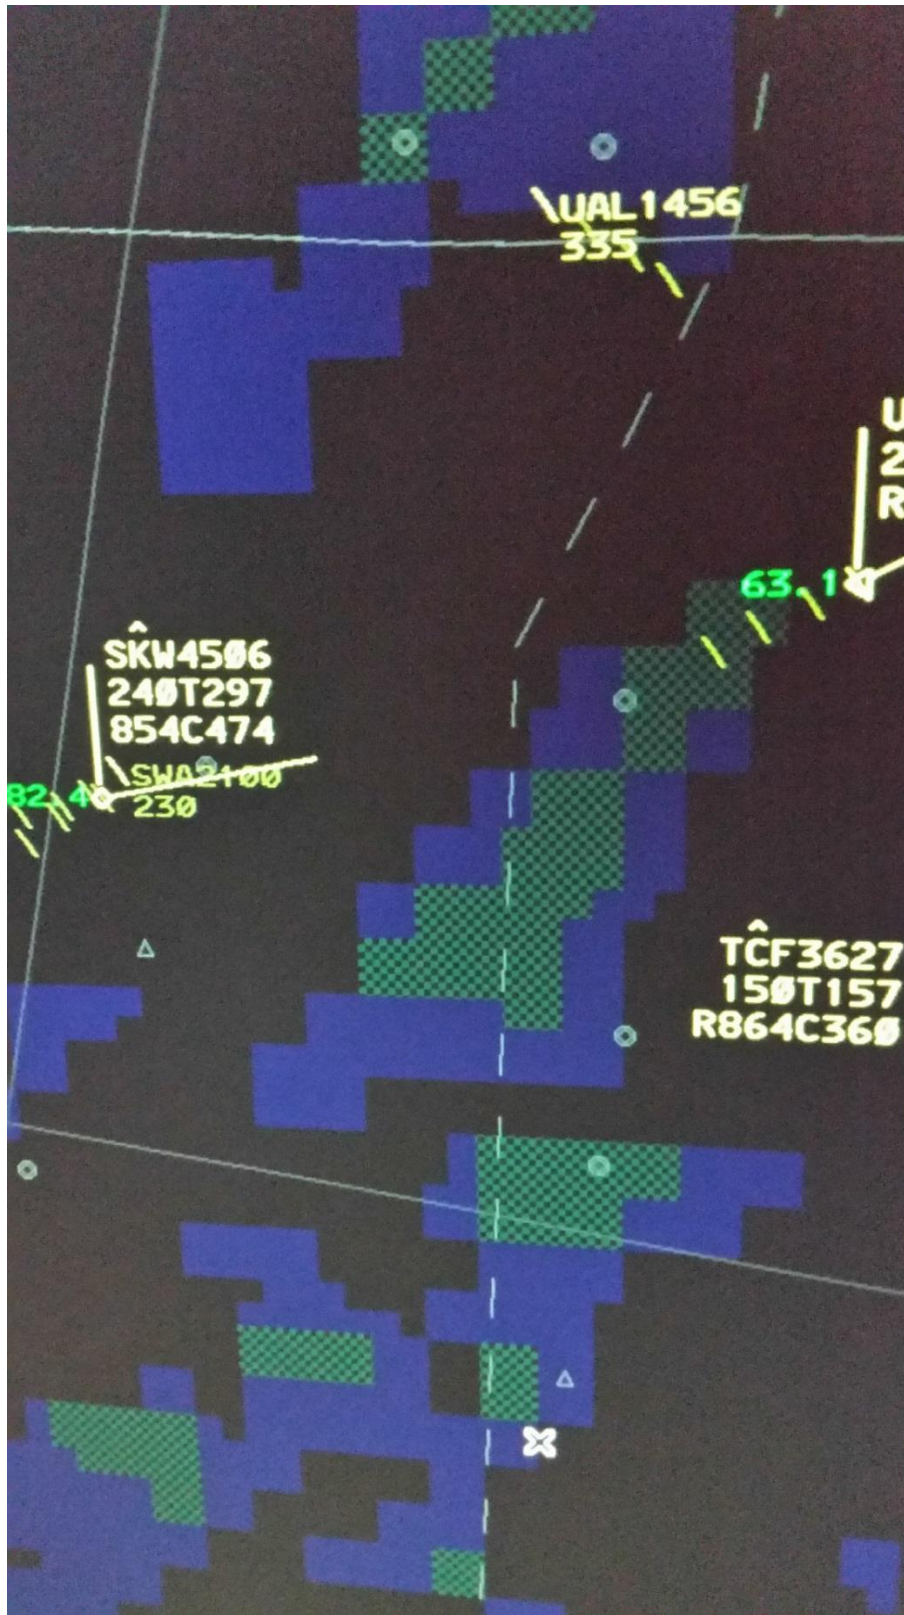
**Figure 11** – Screenshot of the Houston ARTCC WARP replay for a time close to the accident time.

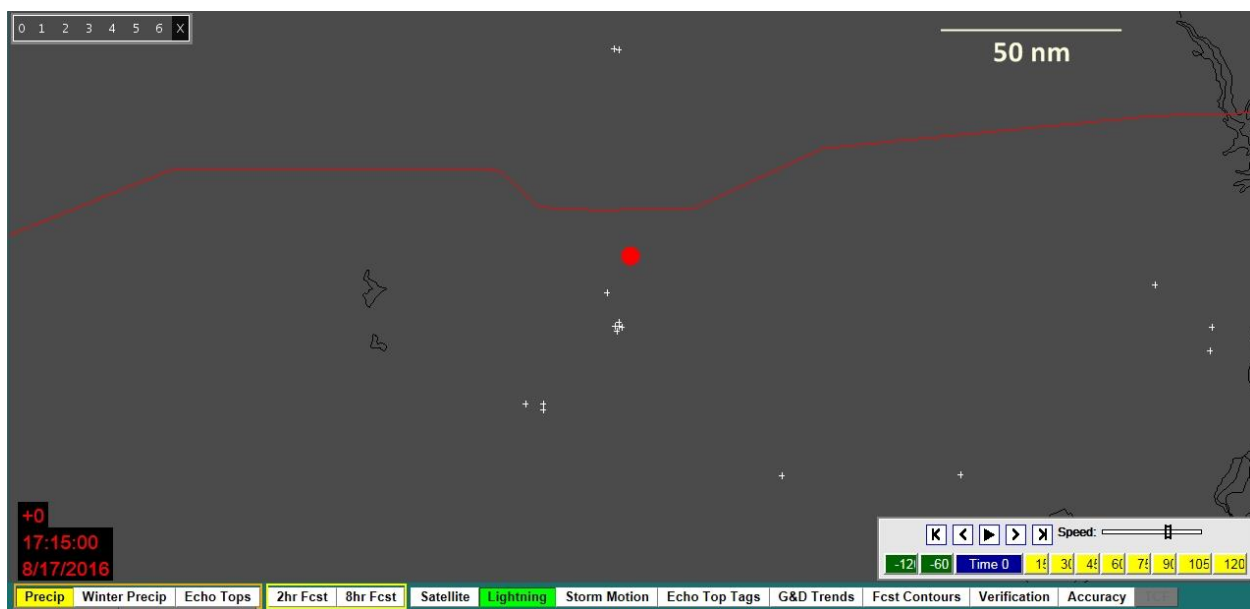
Archive data from the Federal Aviation Administration's Corridor Integrated Weather System (CIWS; figure 12), which presents cloud-to-ground lightning flash detections from the National Lightning Detection Network, identified lightning activity within about 50 miles of the accident location between 1209 and 1215 CDT.

**Figure 12** – Archive CIWS display from 1215 CDT. Red circle denotes accident location. White “+” symbols denote lightning activity.

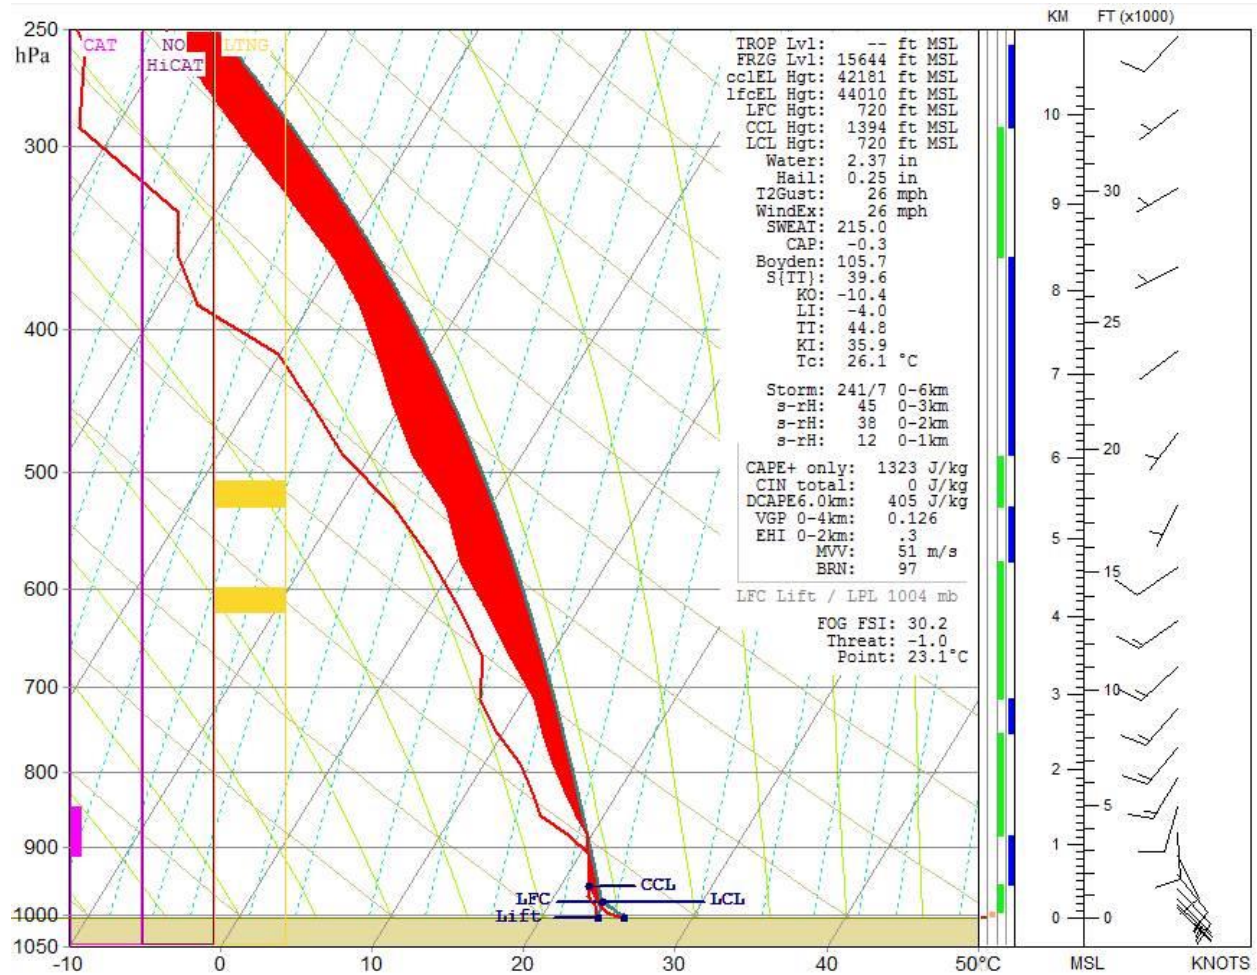
A High-Resolution Rapid Refresh (HRRR) model<sup>5</sup> sounding (figure 13) for the accident location at 1200 CDT was retrieved from the National Oceanic and Atmospheric Administration's (NOAA) Air Resources Laboratory. Near the surface, the wind was from the southwest at about 5 knots. Above this level the wind veered with height and increased in magnitude to a southwest wind at about 15 knots near 13,000 feet. Above this level, the wind remained generally southeast and relatively light (below 7 knots) through 30,000 feet. Calculations made by the Rawinsonde OBservation Program did not yield any significant areas of non-convective turbulence for this atmosphere. The freezing level was at about 15,600 feet and the tropopause was located above 35,000 feet.

The most-unstable Convective Available Potential Energy (CAPE)<sup>6</sup> parameter was 1,323 Joules/kilogram (from 1004 hectopascals [hPa]). The Lifting Condensation Level<sup>7</sup> (LCL) and Level of Free Convection<sup>8</sup> (LFC) were calculated to be 720 feet. Maximum vertical velocity (MVV) for this atmosphere was calculated as 51 meters/second (about 10,040 feet per minute).<sup>9</sup> Downdraft CAPE (DCAPE; 6 kilometers agl)<sup>10</sup> was measured at 405 Joules/kilogram.

**Figure 13** – HRRR model sounding data in SkewT/LogP format for 1200 CDT at the accident site, surface to 250 hPa.

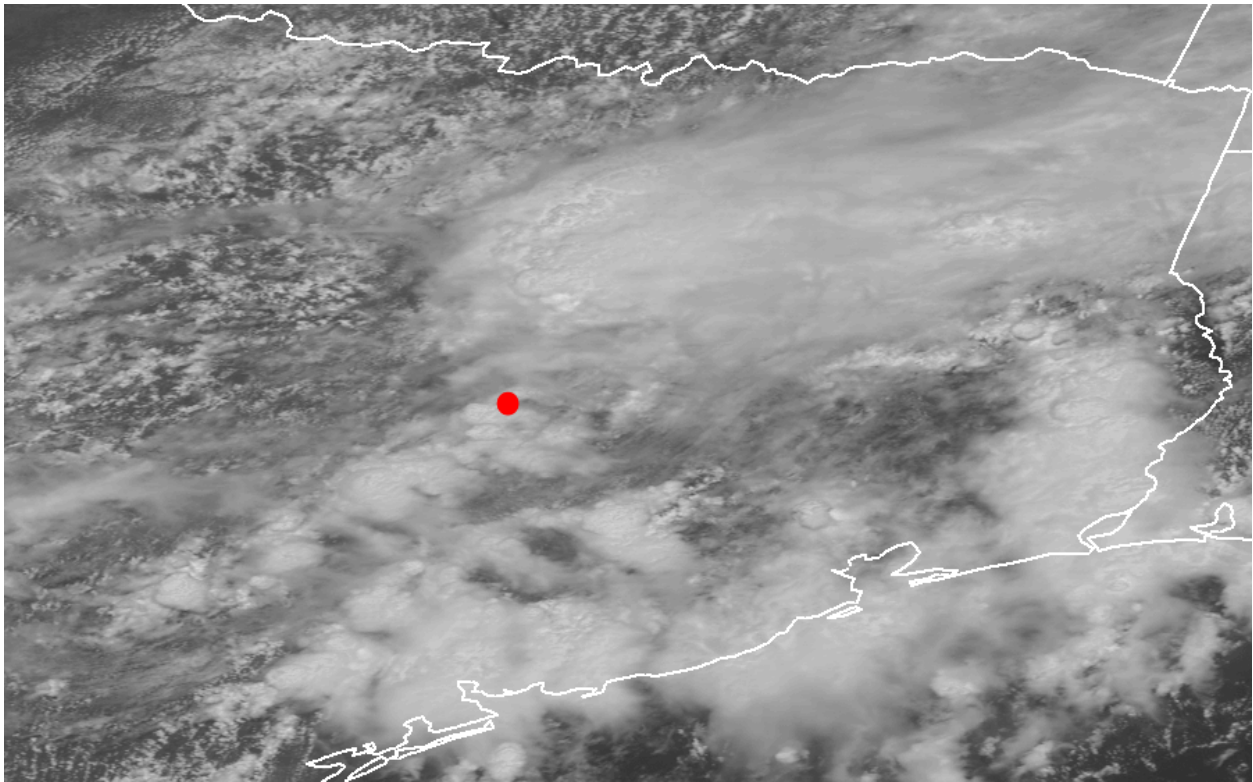
Geostationary Operational Environmental Satellite (GOES)-13 visible ( $0.63\mu\text{m}$ ) and infrared ( $10.7\mu\text{m}$ ) data were obtained from an archive at the Space Science Engineering Center at the University of Wisconsin-Madison. Imagery from 1215 CDT is presented in figures 14 and 14. The GOES-13 infrared cloud-top temperatures varied between  $-25^{\circ}\text{C}$  and  $-58^{\circ}\text{C}$  in the immediate area of the accident location. When considering the HRRR model sounding,  $-25^{\circ}\text{C}$  corresponded to cloud top heights of about 31,000 feet and  $-58^{\circ}\text{C}$  was well above 35,000 feet. It should be noted that these figures have not been corrected for any parallax error.

**Figure 14** – GOES-13 visible imagery from 1215 CDT. Accident location denoted by red dot.

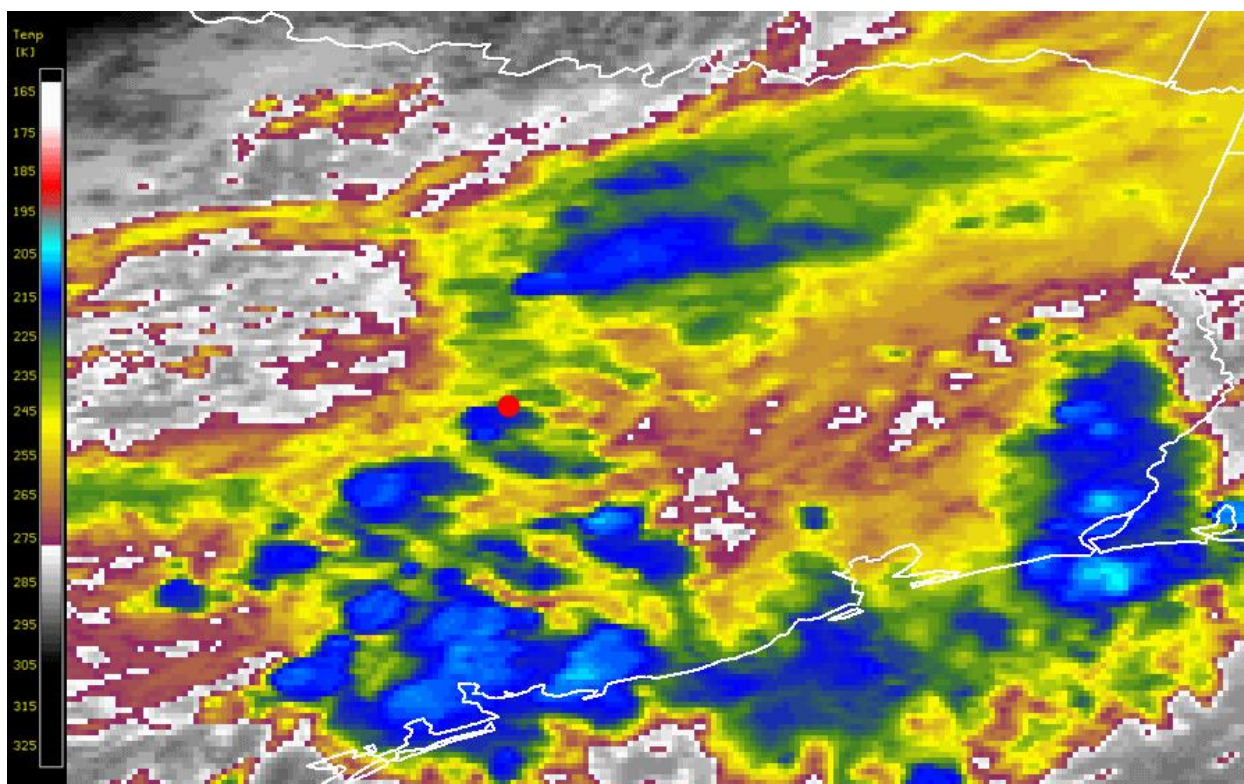
**Figure 15** – GOES-13 infrared imagery from 1215 CDT. Accident location denoted by red dot.

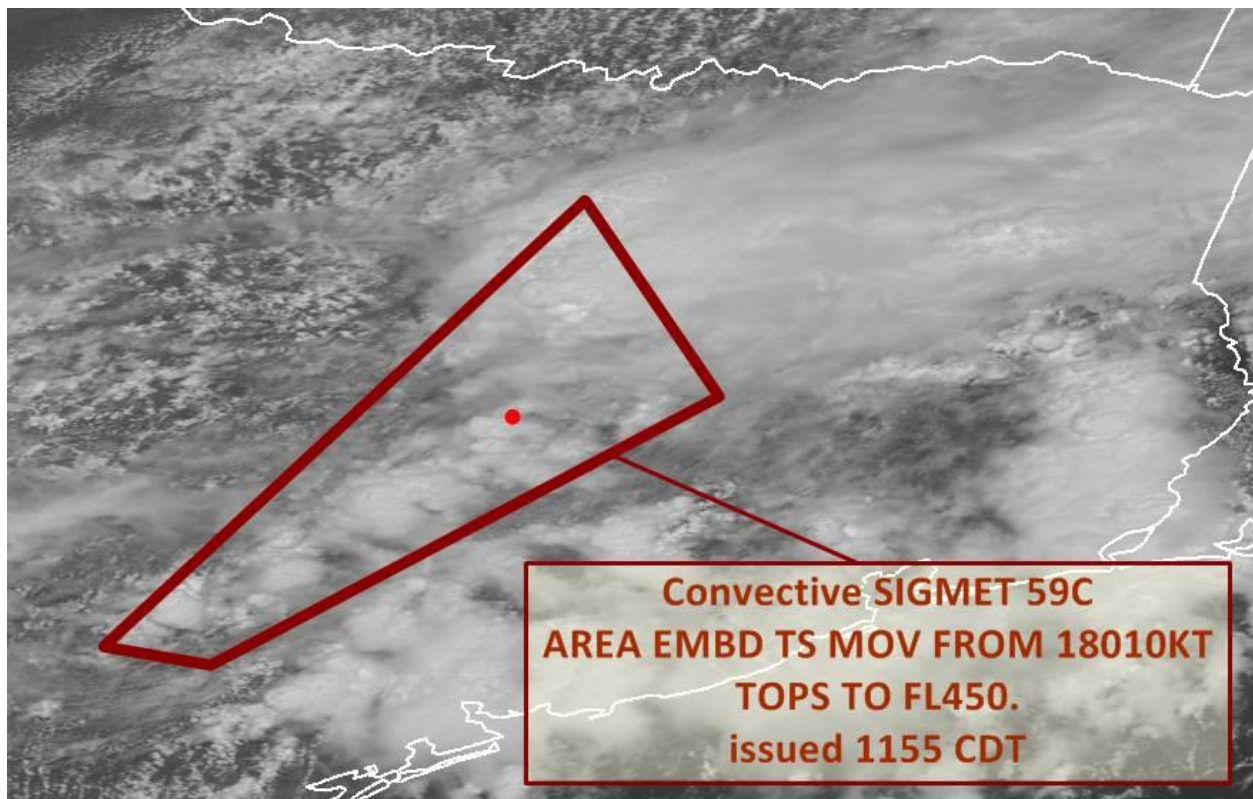
At 1155 CDT, the AWC issued the following convective SIGMET, which was valid for two hours (also see figure 16) and active for the accident location at the accident time. It advised of an area of embedded thunderstorms moving from 180° at 10 knots, with tops above FL450.

**Figure 16** – Boundaries of convective SIGMET 59C issued at 1155 CDT. Red dot denotes accident location.
